# Sonia Fine Knit Ltd.

South Shilmandi, Pachdona, Narsinghdi  
(24.004348N, 90.320706E)

28<sup>th</sup> October, 2015

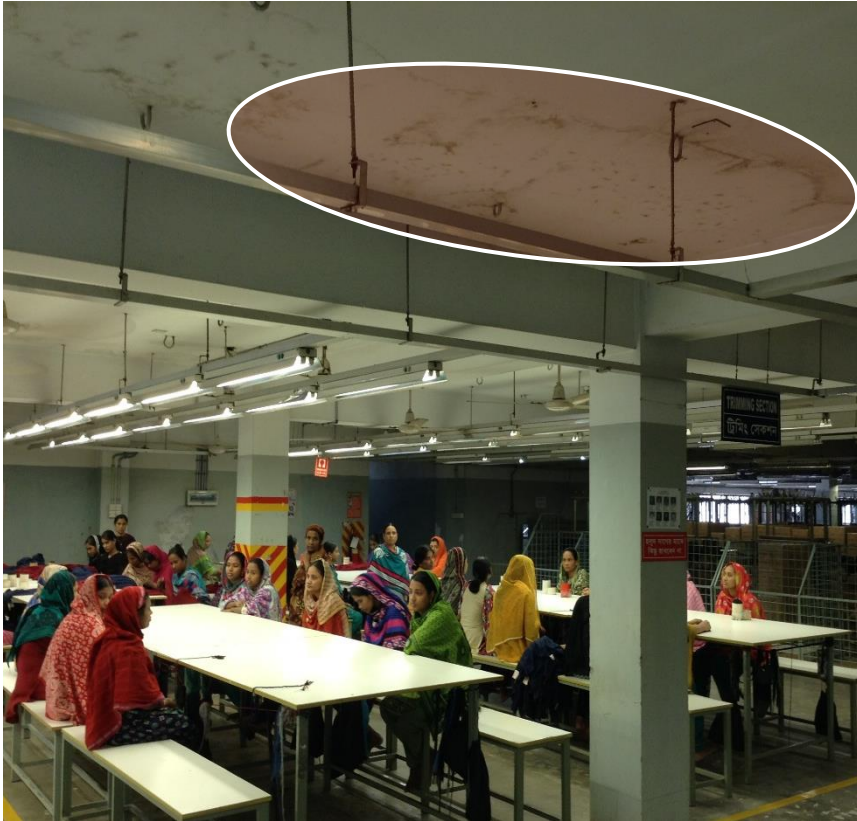
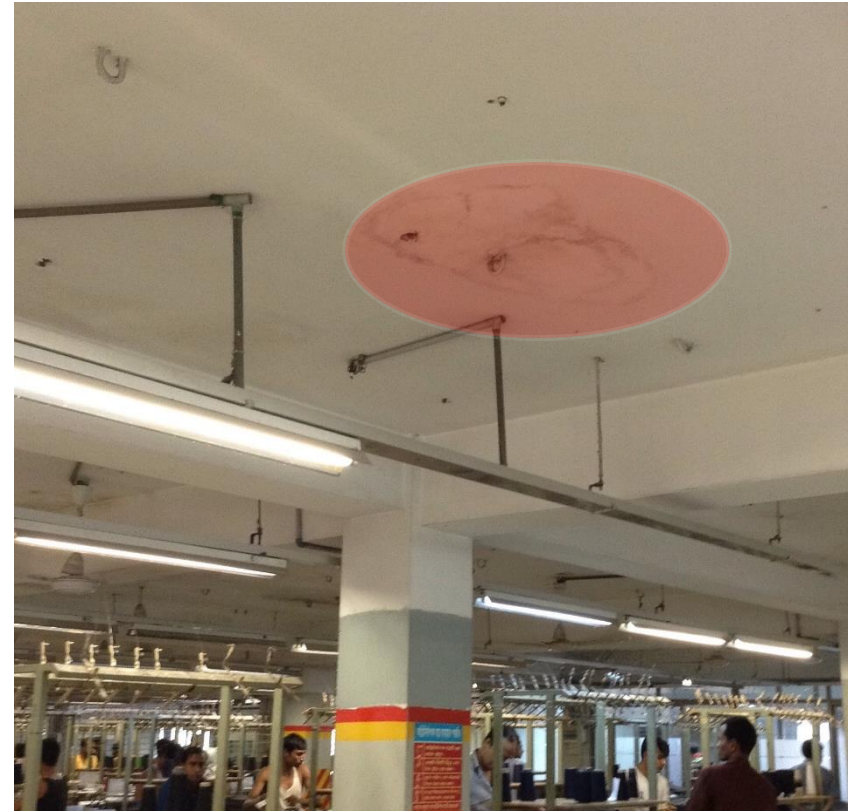
**Water Ponding on Roof Causes Dampness on Slab Soffit Below**

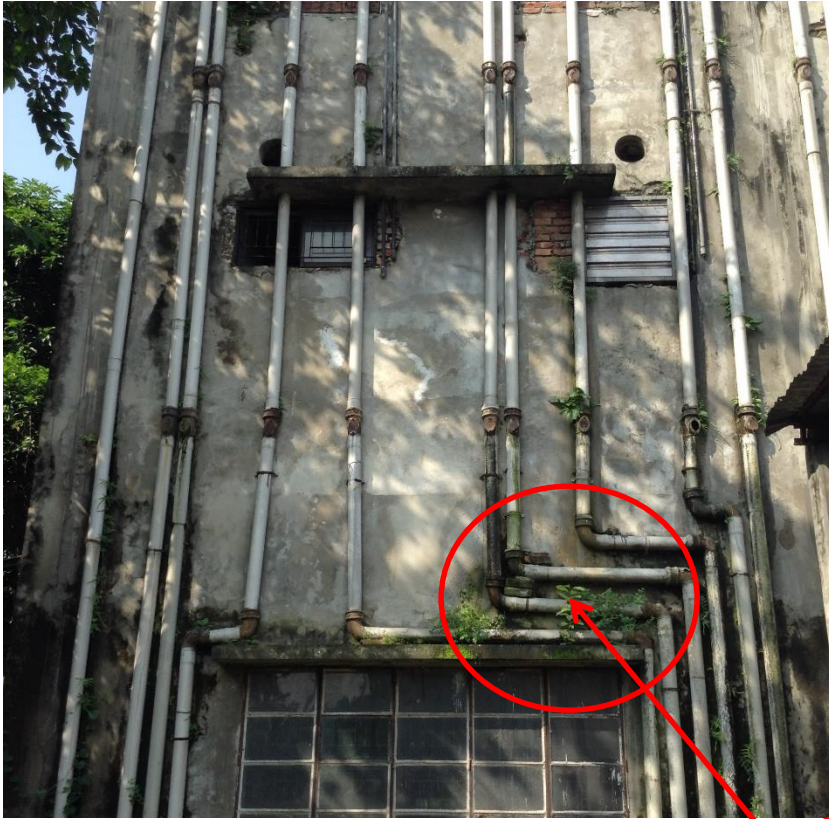
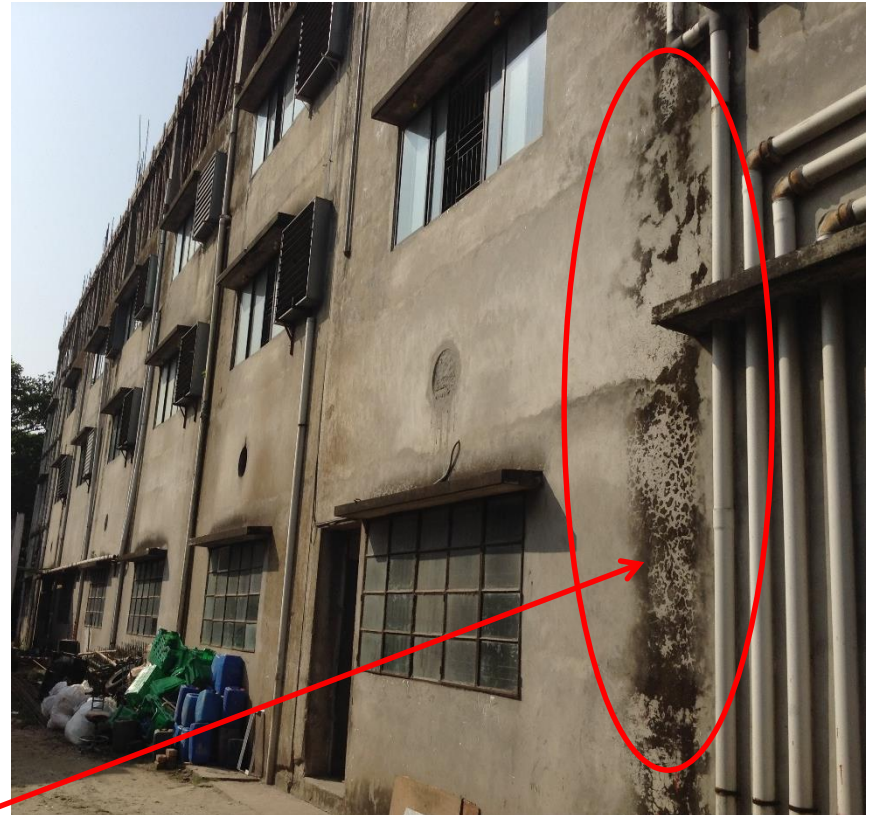
**Lack of Proper Rainwater Disposal on Roof causing Dampness on 2<sup>nd</sup> Floor Slab Soffit**
