# KAS Group Knitwear Ltd.

Bypass Road, Peyarabagan, Joydevpur, Gazipur  
(23.977060 N, 90.376332 E)

1<sup>st</sup> November 2015

# Observations

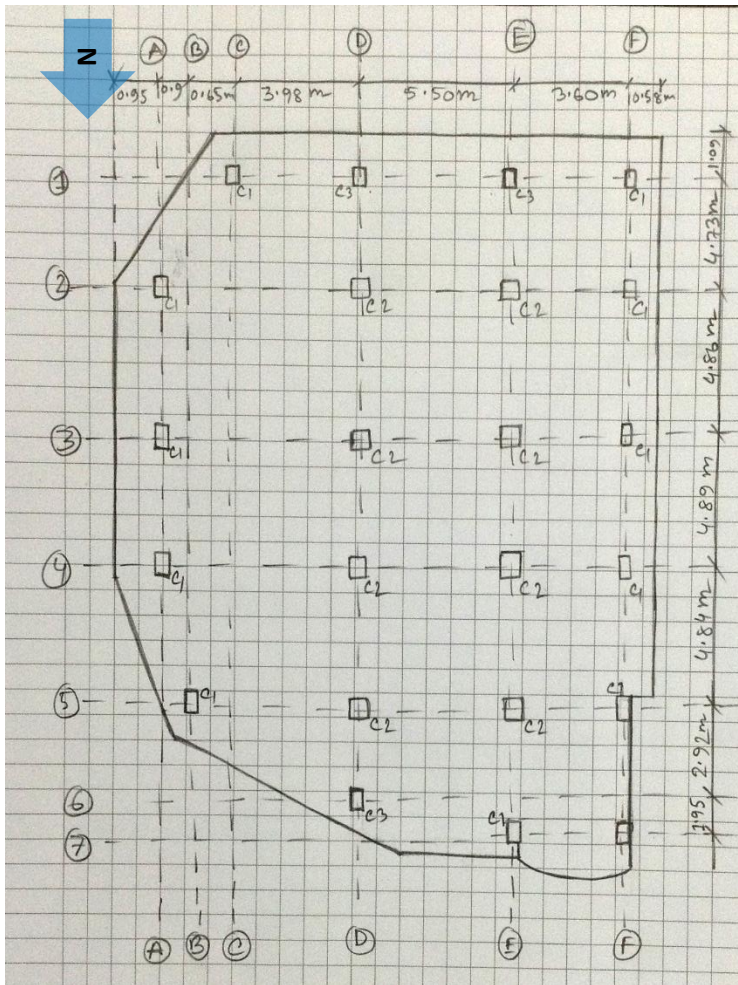
As-built floor plan

Differences at:-  
Column locations  
Floor extents and cantilevers

Structural drawings were not  
presented

| Item No. | Observation | Recommended Action Plan | Recommended Timeline |
|---|---|---|---|
| 1 | Discrepancies between Permit drawing and As-built condition | Building engineer to be appointed to produce accurate and complete as-built documentation. | 6-weeks |
| 2 | Discrepancies between Permit drawing and As-built condition | Building engineer to produce accurate and complete as-built documentation. A note should be put on the drawings warning that no extension of the building should be permitted without structural checks being carried out. | 6-months |

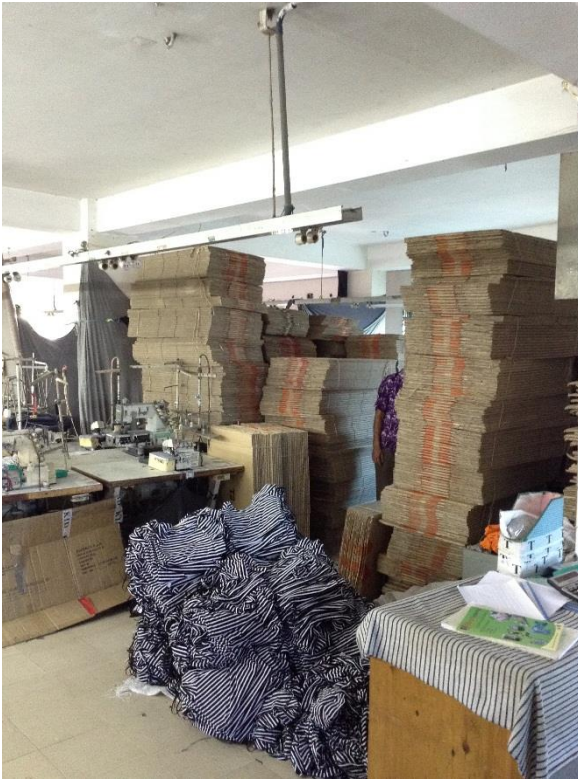
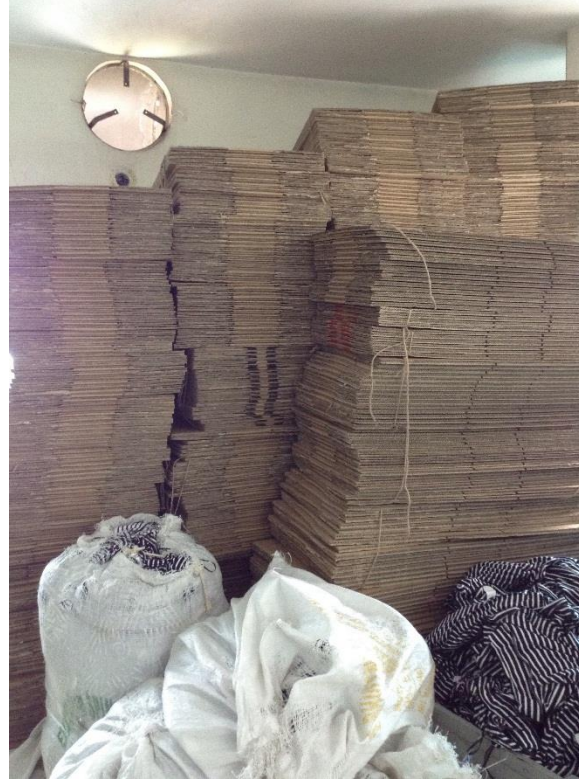
Stacked cardboard and packed finished goods stored at 1st and 3rd floors.

Vibration on 1st floor was noticeable when packing process is ongoing.

Note flat slab at 2nd Floor: punching shear failure is a concern. Excessive storage must be prevented.

Building Engineer to create controlled loading plans for all floors which will designate where storage can be placed.

| Item No. | Observation | Recommended Action Plan | Recommended Timeline |
|---|---|---|---|
| 3 | Cardboard and packed boxes stacked in dense piles | Building Engineer to create controlled loading plans for all floors designating location and intensity of storage. | 6-weeks |
| 4 | Cardboard and packed boxes stacked in dense piles | Continue to implement load plan. | 6-months |

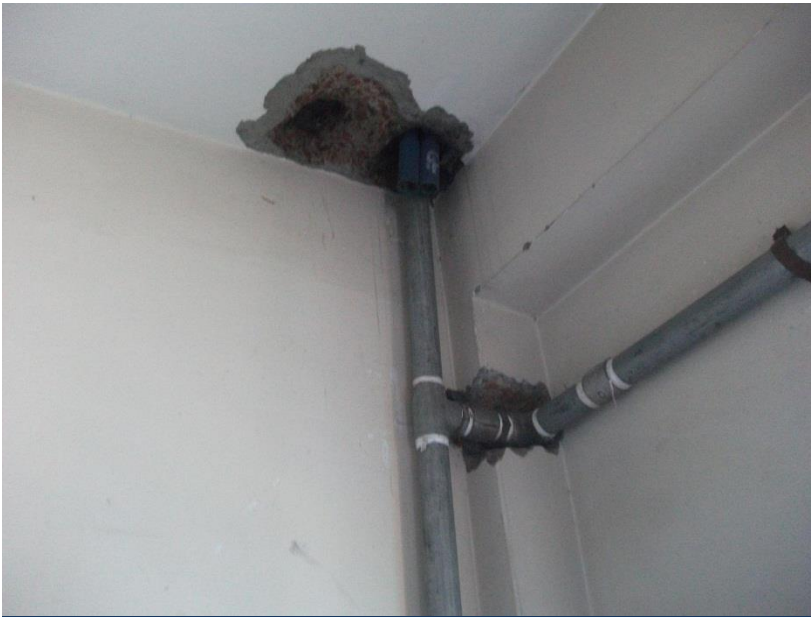
Services chased through slab

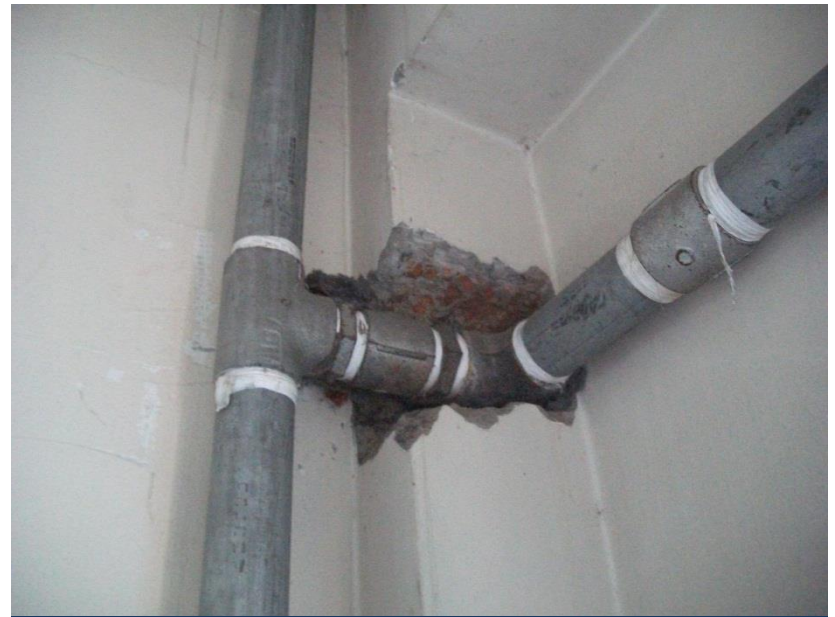
A significant portion of column has been removed, possibly cutting rebar.

| Item No. | Observation | Recommended Action Plan | Recommended Timeline |
|---|---|---|---|
| 5 | Damage on columns due to service pipes. | Engineer to inspect penetration through altered column and check column capacity. Relocate services and repair column with high-strength mortar. | 6-weeks |

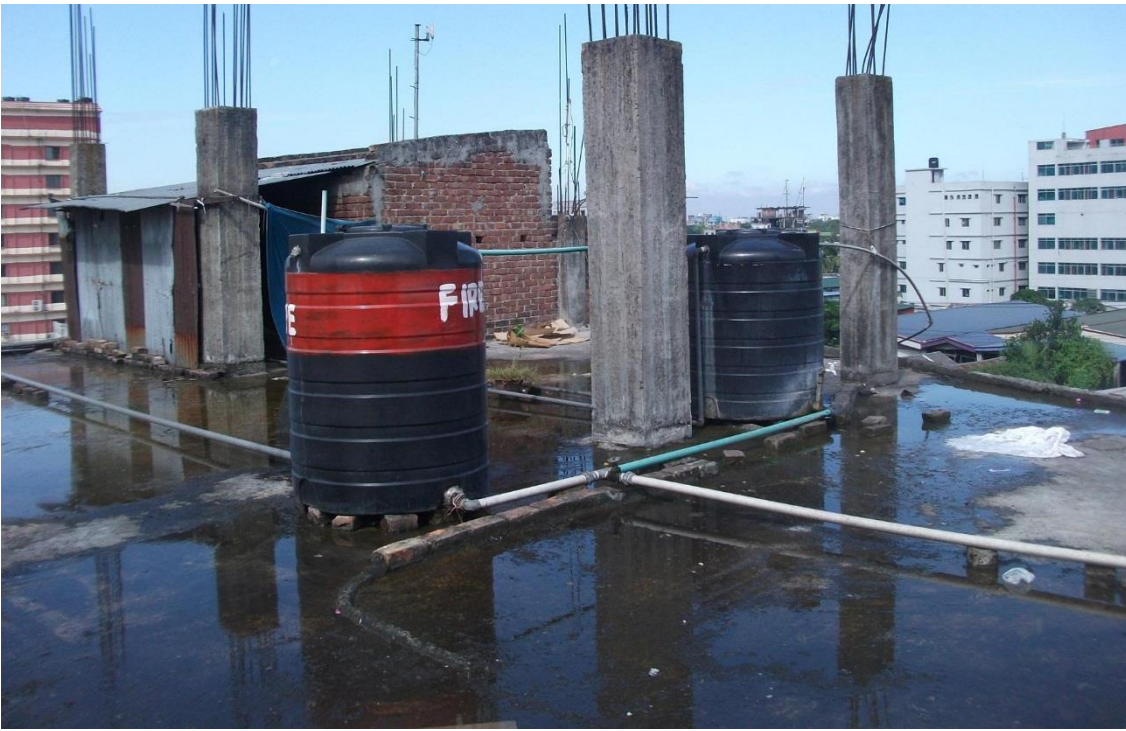
Significant water accumulation observed at roof level.

| Item No. | Observation | Recommended Action Plan | Recommended Timeline |
|---|---|---|---|
| 6 | Water accumulation at roof level | Building Engineer to inspect areas with water damage, propose measures to prevent further damage and carry out repair works. | 6-months |

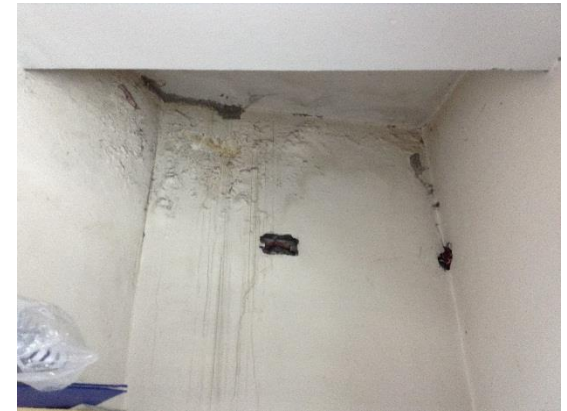
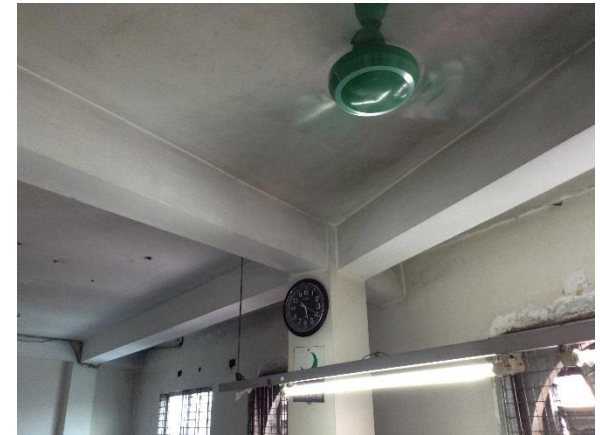
Moisture was observed due to water ingress at 3rd floor under Roof slab causing deterioration of structure

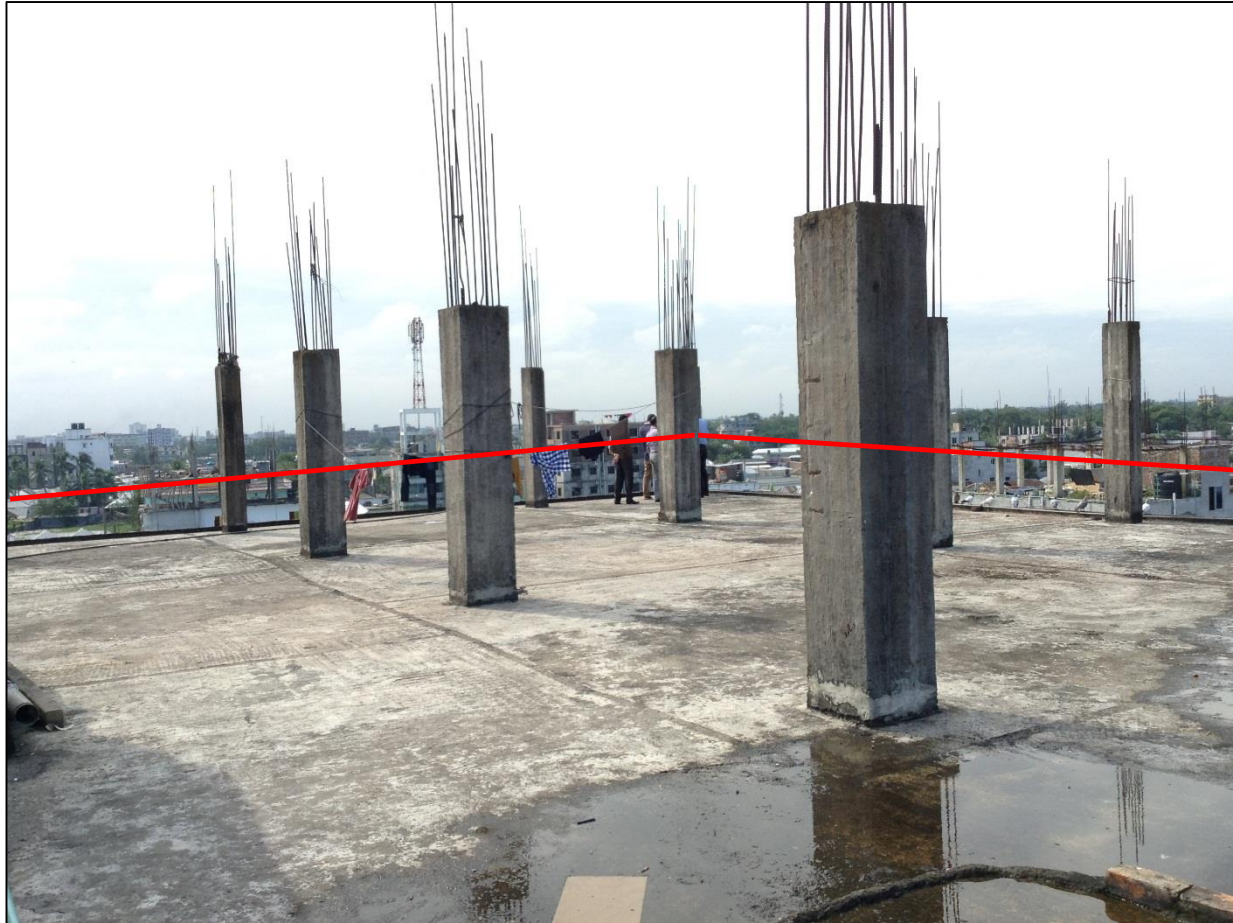
No edge protection provided at roof level.

| Item No. | Observation | Recommended Action Plan | Recommended Timeline |
|---|---|---|---|
| 7 | No edge protection provided at roof | Provide proper edge protection to prevent risk of falling. | 6-weeks |

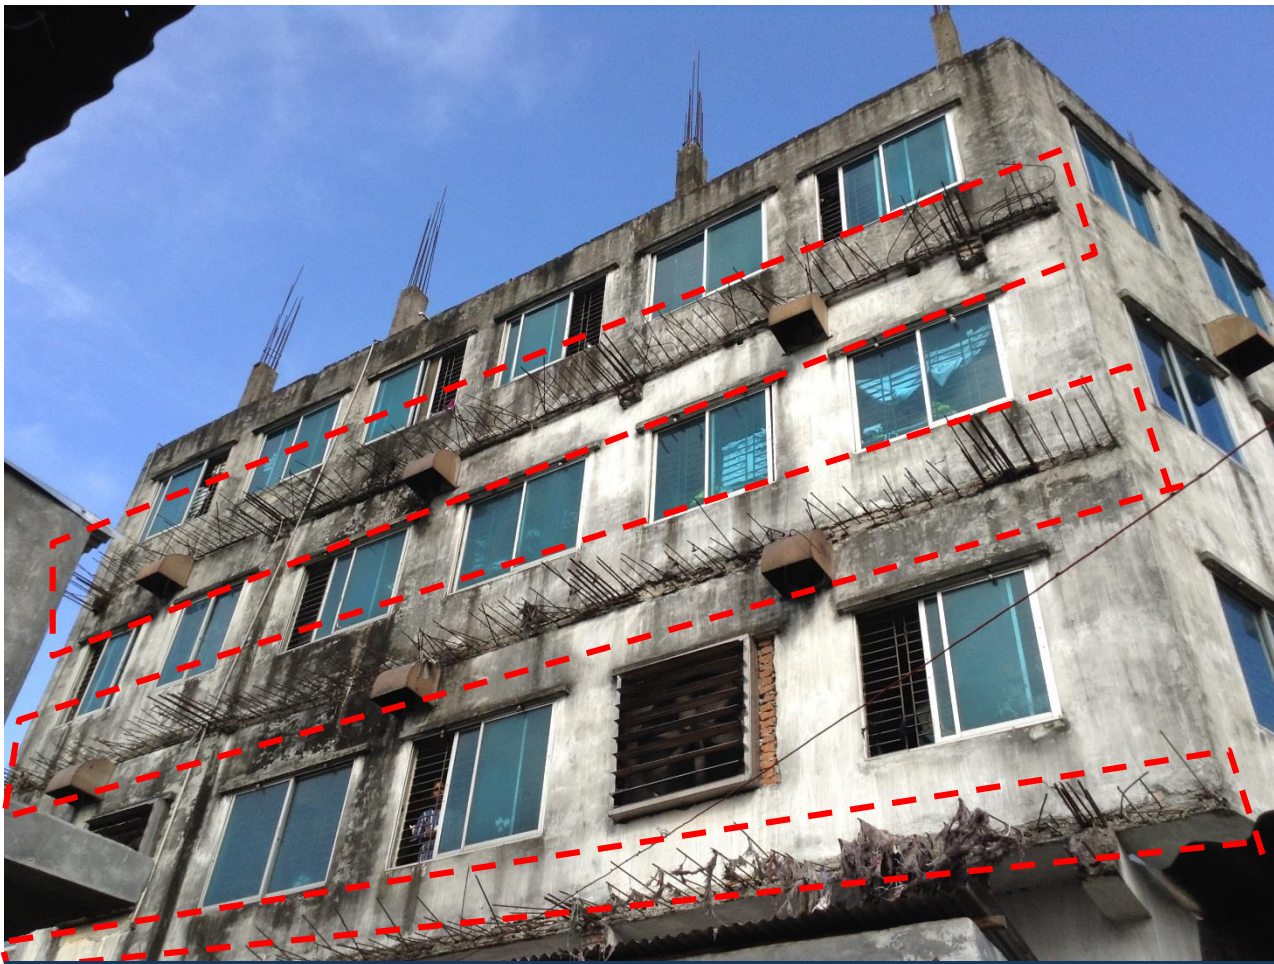
Exposed beam and slab rebars observed from cantilever portion at South elevation. Indication of possible further expansion contradicting the permit drawings. Factory Management should ensure that this should be avoided. Edge columns may become overstressed.

| Item No. | Observation | Recommended Action Plan | Recommended Timeline |
|---|---|---|---|
| 8 | Exposed reinforcing bars for slab/beam extension at South elevation | Exposed rebars to be cut back to prevent further expansion. | 6-weeks |

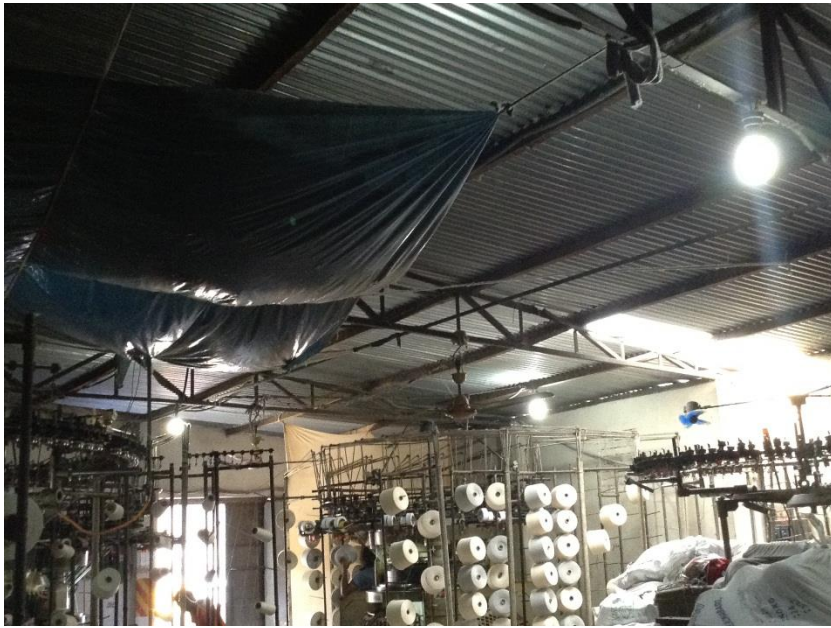
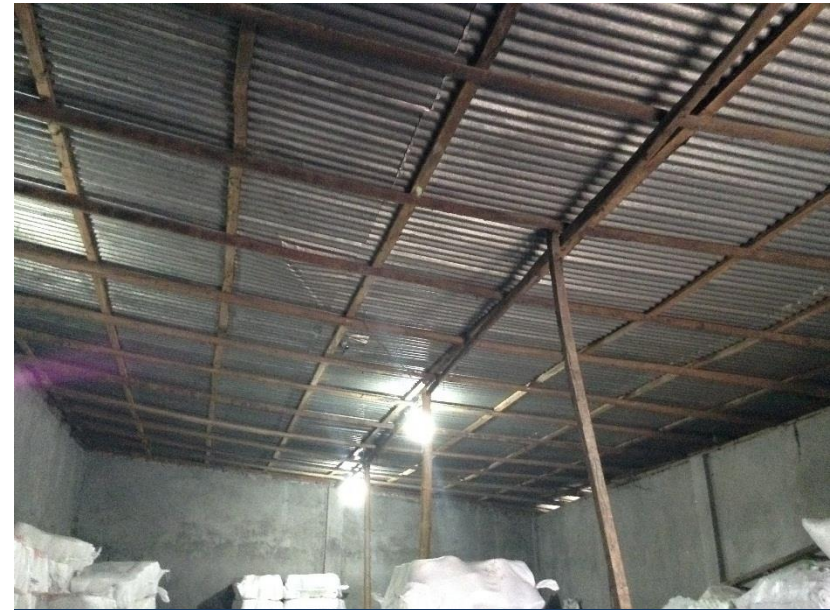
Non-engineered wooden framing of Generator/Storage building

Non-engineered steel truss system with lack of proper supports at columns/brick walls without any stability bracing. Unlikely to resist any strong wind action.

| Item No. | Observation | Recommended Action Plan | Recommended Timeline |
|---|---|---|---|
| 9 | Non-engineered shed structures - Generator Building and Knitting Building. | Inspect the adequacy of current construction and stability of metal roofing. | 6-weeks |
| 10 | Non-engineered shed structures - Generator Building and Knitting Building. | Shed structures should be designed and upgraded to support code wind and live loads as determined by the Building Engineer, or they should be vacated and removed. | 6-months |
