# Euro Arte Apparels Ltd. (Extension)

344, 345 Kabirpur, Ashulia, Savar, Dhaka-1349.

11 December 2023

1. Extension building is a six-storied reinforced concrete (RC) building.

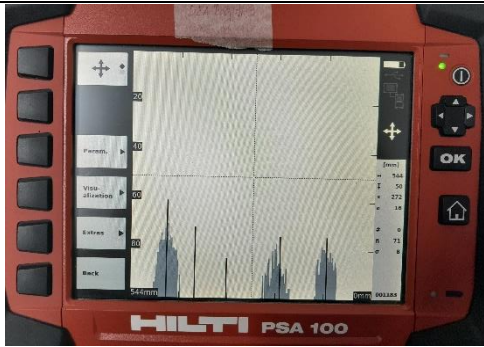
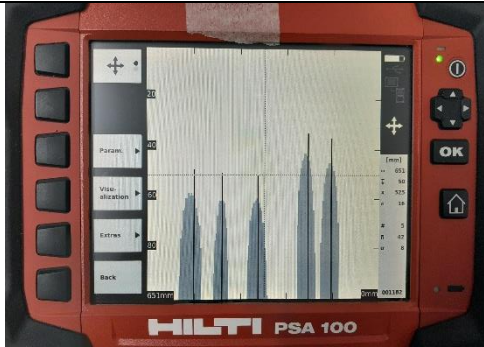
**Observation-2:** Mismatch in as-built drawing. (Extension Building)

**Description:** During the inspection, rebar mismatch was found in C2 column. 16 rebars were found onsite instead of 18 rebars. The building engineer is required to survey the full structure and update the as-built drawing accordingly.

| SL | Observation | Action Plan | Timeline |
|---|---|---|---|
| 04 | Mismatch in as-built drawing. (Extension Building) | The building engineer is required to survey the full structure and update the as-built drawing accordingly. | within 6 weeks |
| 05. | Mismatch in as-built drawing. (Extension Building) | Carry out suggested remedial works if required. | within 6 months |

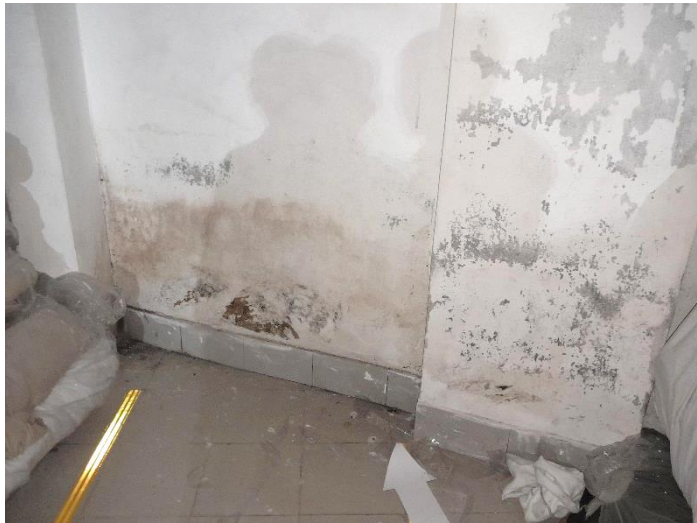
**Observation-3:** Dampness on brick wall. (Extension Building)

**Description:** During the inspection, dampness was found on the brick wall on the ground floor. Factory is required to check the extent of dampness and repair as per engineer’s suggestion.

| SL | Observation | Action Plan | Timeline |
|---|---|---|---|
| 06. | Dampness on brick wall. (Extension Building) | The factory is required to check the extent of dampness and repair as per engineer's suggestion. | within 6 weeks |

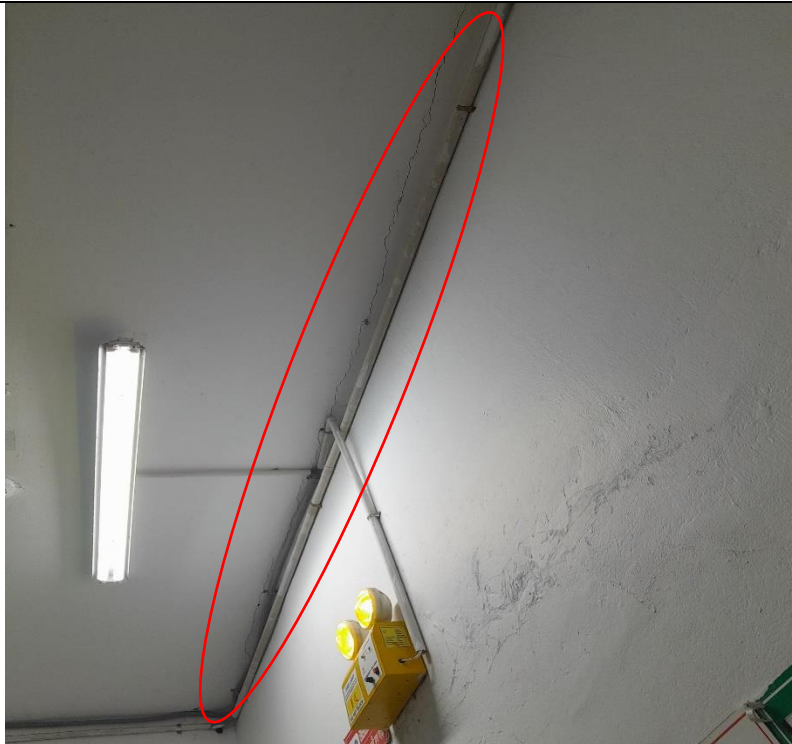
**Observation-4:** Expansion joint filled with rigid material. (Extension Building)

**Description:** Expansion joint with adjacent building was found filled with rigid material which may result in development of crack and falling hazard during an earthquake or lateral movement of the buildings. Factory is required to fill the gap with any flexible material suggested by the structural/fire engineer.

| SL | Observation | Action Plan | Timeline |
|---|---|---|---|
| 07. | Expansion joint filled with rigid material. (Extension Building) | Factory is required to fill the gap with any flexible material suggested by the structural/fire engineer. | within 6 months |
