# Mega Yarn Dyeing Mills Ltd (Extension 2)

18 December 2023

## 2. Observations:

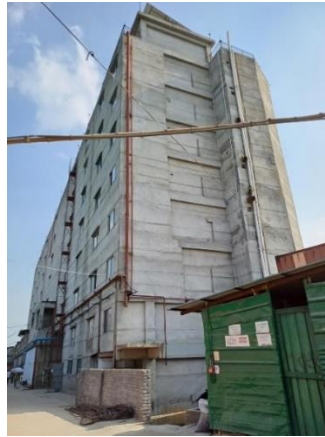
#### Observation-1: Absence of design report. (Building 12)

**Description:** As per BNBC, every building or structure designed shall have its design documents prepared following the provision of Section 1.9.1. The design document shall include a design report, a set of as-built drawings and load plans which shall be prepared in compliance with section 1.9.1.1 and section 1.9.1.2, part 6 of BNBC.

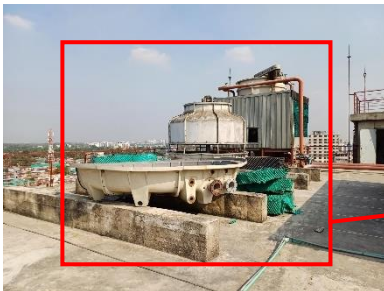
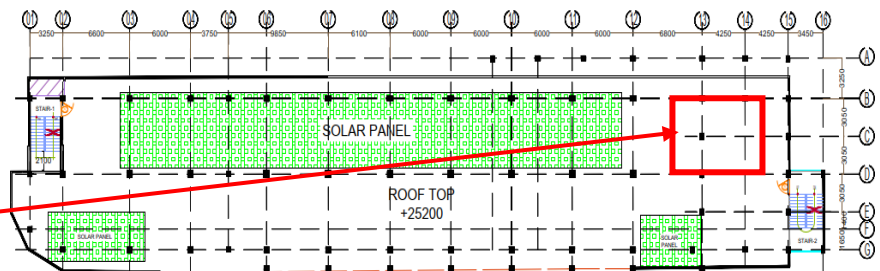
Missing cooling tower in architectural drawing

**Description:** During the inspection, mismatches were found in the as-built drawings. In the roof, a cooling tower was found on-site but in the architectural drawing, no cooling tower is shown. The floor height doesn't match the on-site condition. In structural drawing, each floor beam size is shown 300(w)X375(d/s) in the drawing; but during inspection, floor beam size was found 300(w)X300(d/s), 300(w)X400(d/s) and 300(w)X475(d/s). Grid distance at GL 13-14 & 14-15 doesn't match with drawing. During inspection, 16nos. rebar was found instead of 20nos. rebar in the C6 column and 12nos. rebar was found instead of 18 nos. rebar in the C12 column on the 6<sup>th</sup> floor. As-built structural drawings of the ETP Office Room, Filter Press M/C Room and Compressor Room were not found on-site.

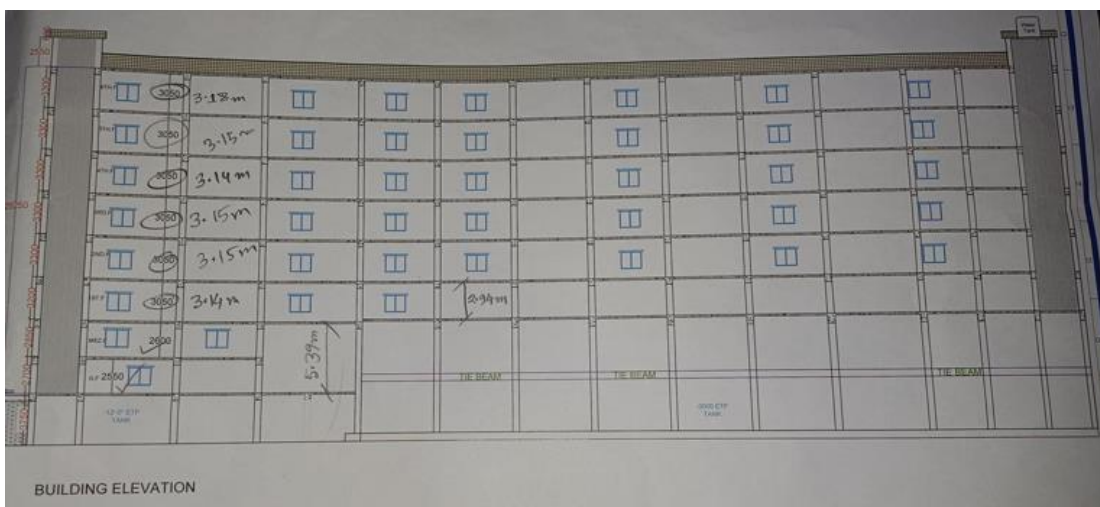
Mismatch in floor height

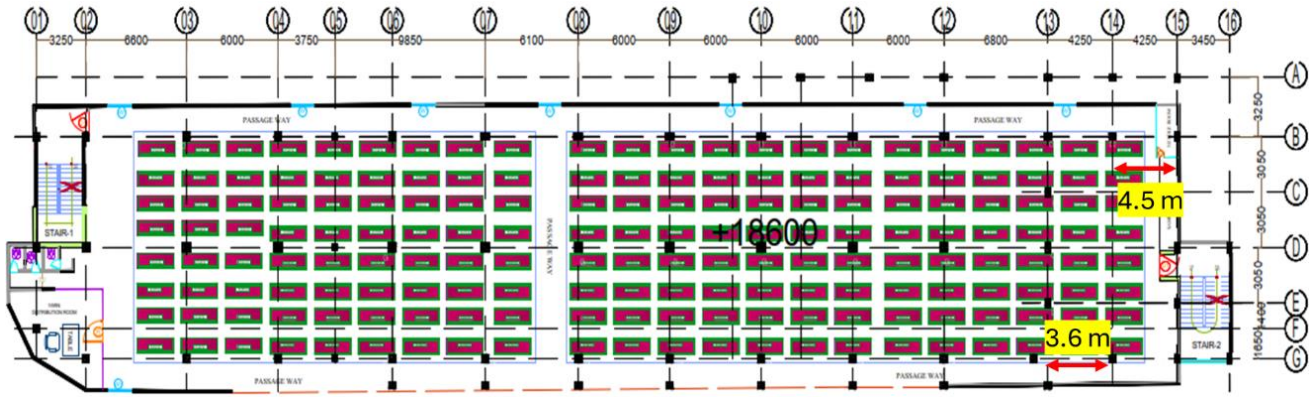
Mismatch in Grid distance

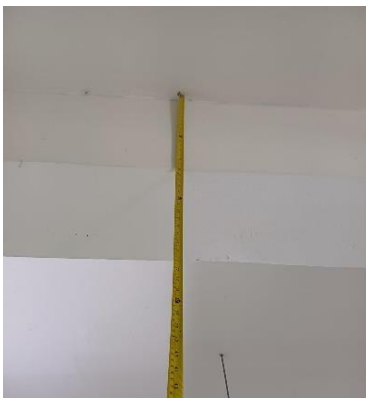
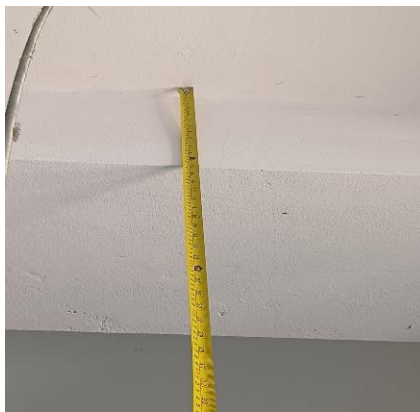
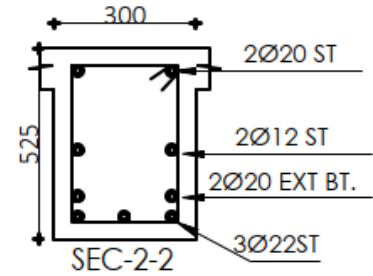
Mismatches in floor beam sizes

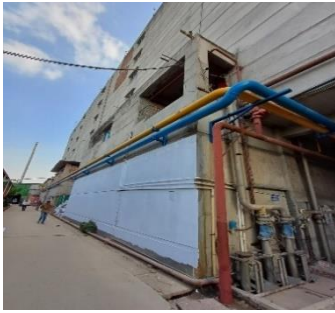
ETP Office Room

Lack of drawings for below mentioned portion

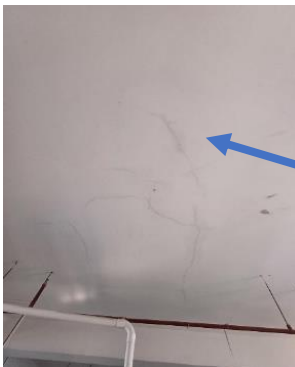
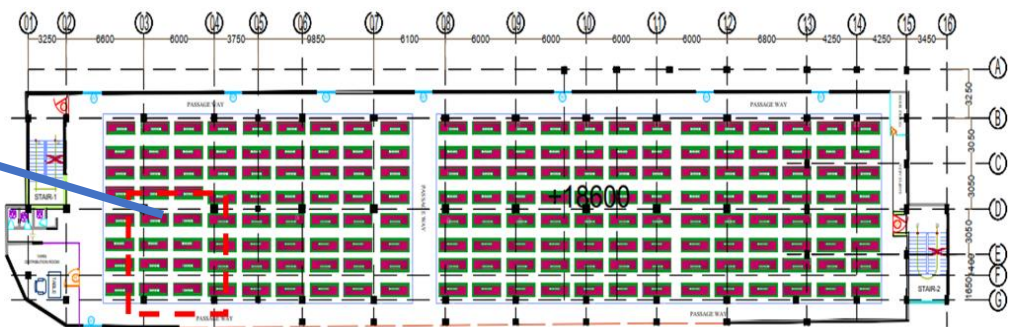
**Observation-3:** Cracks observed at the 6th-floor roof slab. (Building 12)

**Description of observation:** During the inspection, cracks were observed at the 6th-floor roof slab. The building engineer is required to investigate the reason for the crack, suggest necessary remedial actions and submit it to the RSC for review.

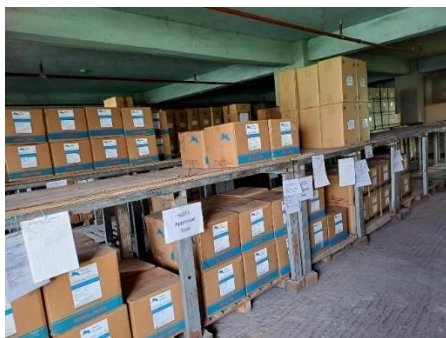
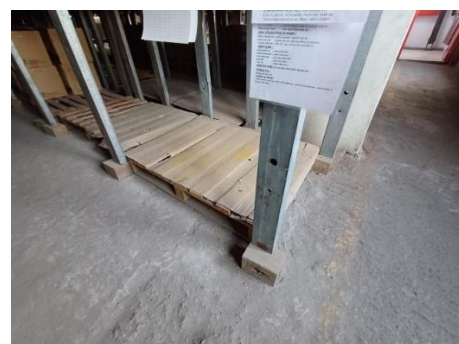
**Observation 4:** Improper racking system observed on the 1<sup>st</sup> floor.

**Description:** An improper racking system was found in the Dyes Chemical Storeroom on the 1<sup>st</sup> floor. Factory management is required to install a proper racking system at the store areas and provide anchorage to the non-structural elements including storage racks.

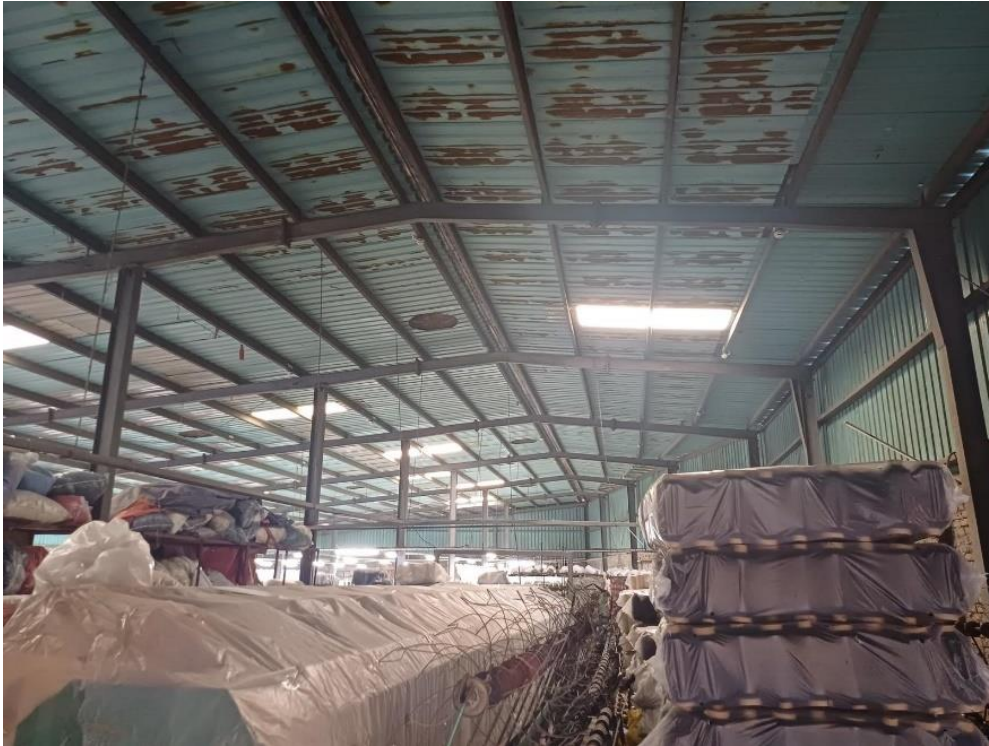
**Observation-5:** Lack of lateral stability.

Absence of load transfer media (Compression Strut) along transverse direction of rafter

**Description:** Lack of lateral stability system (compression strut & vertical bracing) was observed in the structure. The building engineer is required to carry out an Engineering Assessment (EA) to check the lateral stability of the structure and suggest proper remedial actions accordingly.

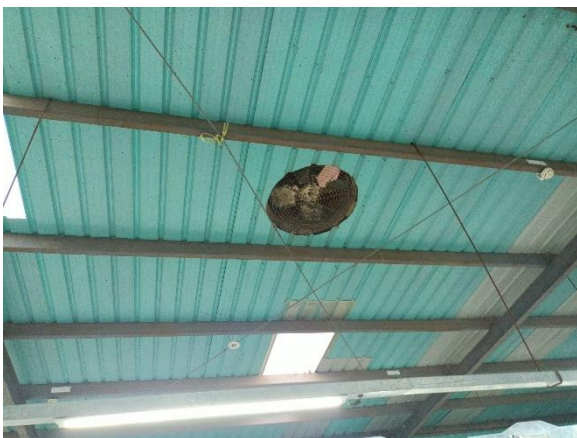
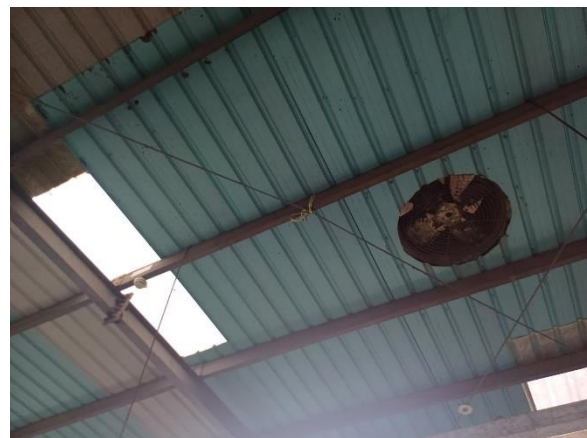
**Observation 6:** Loose cable bracing.

**Description:** Some roof cable bracings were found loose at the Nylon Winding Shed. The building engineer is required to tighten the loose bracings to transfer the lateral loads properly.

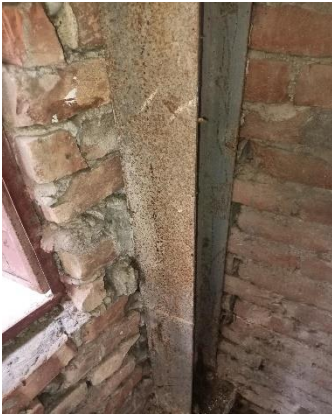
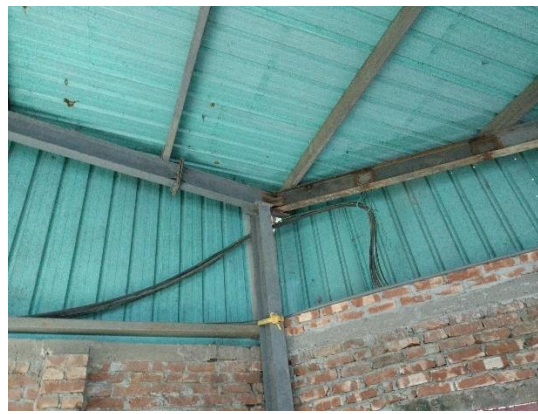
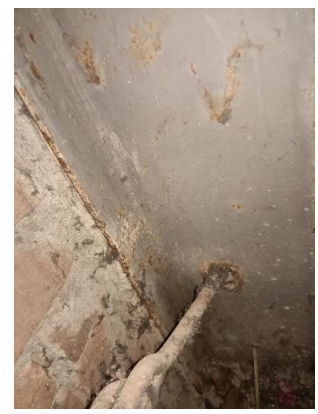
**Observation-7:** Corrosion on steel section.

**Description:** Severe corrosion was observed on steel members (steel column and rafter). The building engineer is required to remove the corrosion and provide a rust-proof coating on all steel members to protect from corrosion.

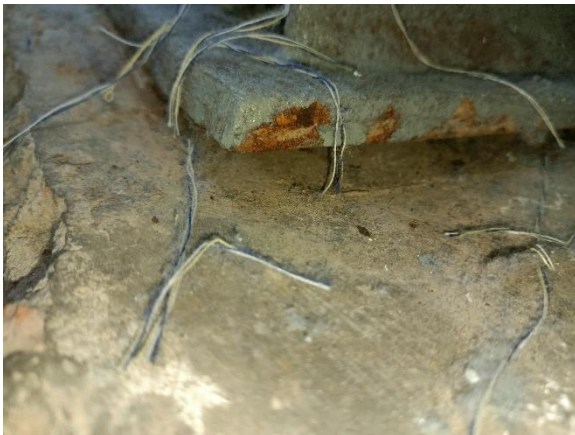
Gap between baseplate and pedestal column

**Description:** During inspection, connection gaps were found in several locations. Building engineer is required to remove connection gap and take remedial actions accordingly.

13	Gap in the connections. (Building 14)	Building engineer is required to survey the whole structure identify the locations of the connection gaps and suggest proper remediation.	within 6 weeks
14	Lack of design report. (Building 15)	The building engineer is required to prepared design report in compliance with section 1.9.1.1 and section 1.9.1.2, part-6 of BNBC.	within 6 weeks

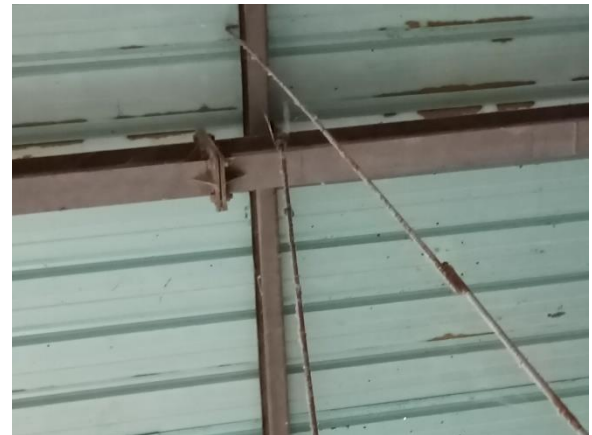
Gap between endplates of steel rafter

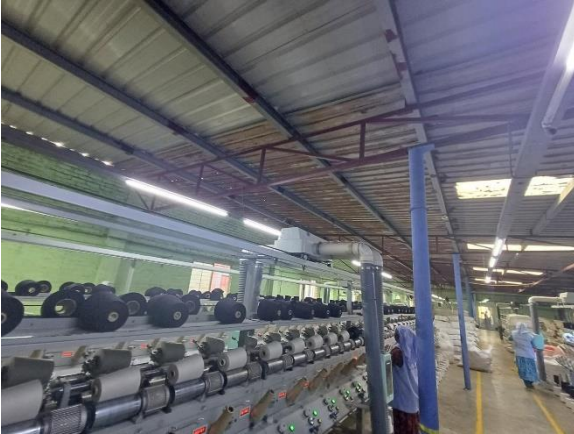
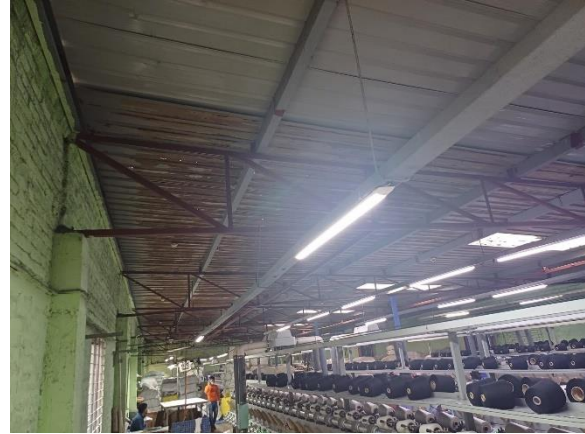
**Observation-9:** Lack of design report.

**Description:** As per BNBC, every building or structure designed shall have its design documents prepared following the provision of Section 1.9.1. The design document shall include a design report, a set of as-built drawings and load plans which shall be prepared in compliance with section 1.9.1.1 and section 1.9.1.2, part 6 of BNBC.

15	Lack of design report. (Building 15)	Carry out remedial work where required.	within 6 months
16	Lack of lateral stability. (Building 16)	Building engineer is required to check the lateral stability of the shed as part of the Engineering Assessment (EA).	within 6 weeks
17	Lack of lateral stability. (Building 16)	Carry out remedial work where required.	within 6 months
18	Lack of lateral stability. (Building 17)	Building engineer is required to check the lateral stability of the shed as part of the Engineering Assessment (EA).	within 6 weeks
19	Lack of lateral stability. (Building 17)	Carry out remedial work where required.	within 6 months
20	Corrosion on steel section. (Building 17)	Building engineer is required to remove the corrosion and provide rust-proof coating on all steel members to protect from corrosion.	within 6 weeks
21	Lack of lateral stability. (Building 18)	Building engineer is required to check the lateral stability of the shed as part of the Engineering Assessment (EA).	within 6 weeks

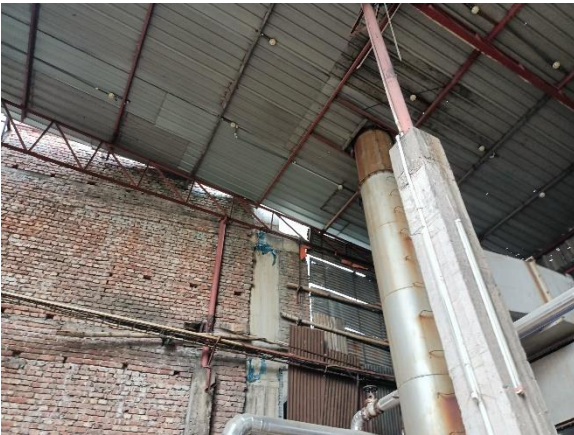
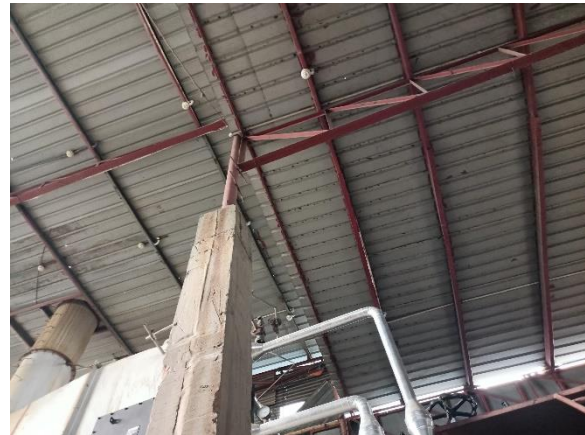
**Observation-10:** Lack of lateral stability.

Absence of load transfer media (Strut & bracings) along the transverse direction of truss

**Description:** Lack of lateral stability system (strut & bracings) was observed in the structure. The building engineer is required to carry out an Engineering Assessment (EA) to check the lateral stability of the structure and suggest proper remedial actions accordingly.

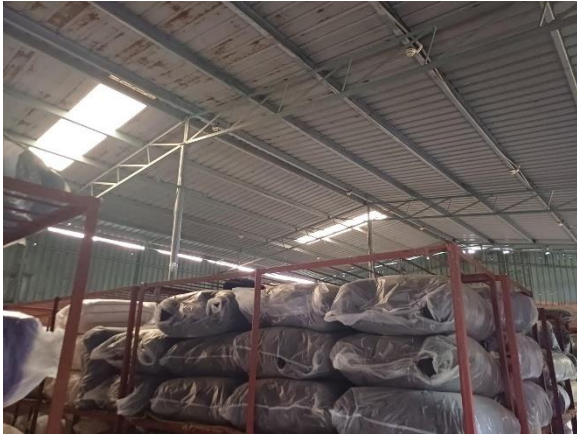
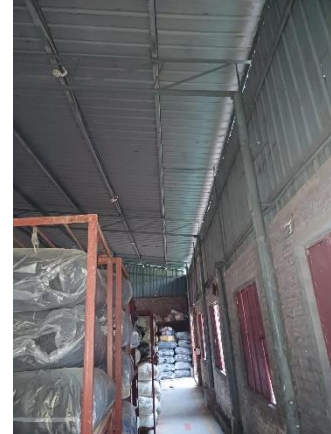
**Observation-11:** Lack of lateral stability.

**Description:** Lack of lateral stability system (strut & bracings) was observed in the structure. The building engineer is required to carry out an Engineering Assessment (EA) to check the lateral stability of the structure and suggest proper remedial actions accordingly.

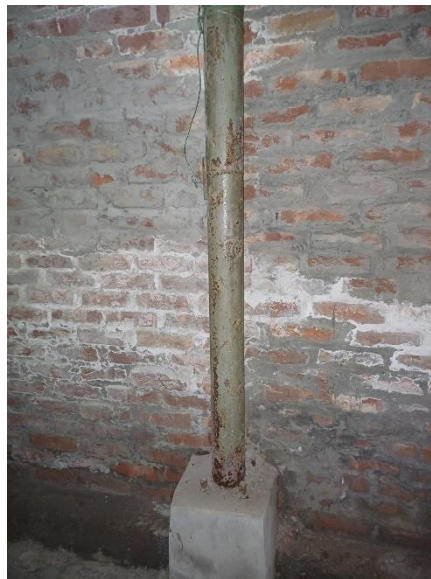
**Observation-12:** Corrosion on steel section.

**Description:** Severe corrosion was observed on steel columns. The building engineer is required to remove the corrosion and provide a rust-proof coating on all steel members to protect from corrosion.

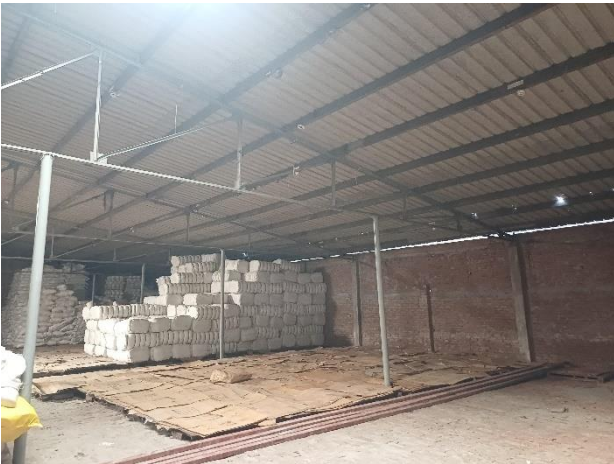
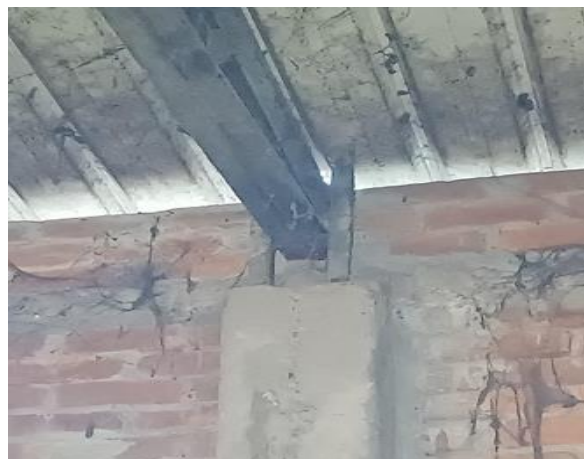
**Observation 13:** Lack of lateral stability and improper connections.

Absence of load transfer media (Strut & bracings) along long directions & improper connections

**Description:** Lack of lateral stability system (strut & bracings) & improper connections were observed in the structure. The building engineer is required to carry out an Engineering Assessment (EA) to check the lateral stability of the structure and suggest proper remedial actions accordingly.

7	Lack of lateral stability and improper connections. (Building 13)	Building engineer is required to check the lateral stability of the shed as part of the Engineering Assessment (EA).	within 6 weeks
8	Lack of lateral stability and improper connections. (Building 13)	Carry out remedial work where required.	within 6 months
9	Lack of lateral stability. (Building 14)	Building engineer is required to check the lateral stability of the shed as part of the Engineering Assessment (EA).	within 6 weeks
10	Lack of lateral stability. (Building 14)	Carry out remedial work where required.	within 6 months
11	Loose cable bracing. (Building 14)	Building engineer is required to tighten all the loose cable bracings.	within 6 weeks
12	Corrosion on steel section. (Building 14)	Building engineer is required to remove the corrosion and provide a rust-proof coating on all steel members to protect from corrosion.	within 6 weeks

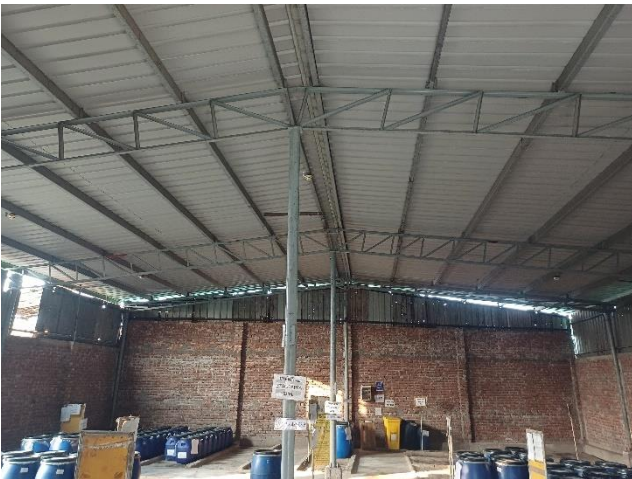
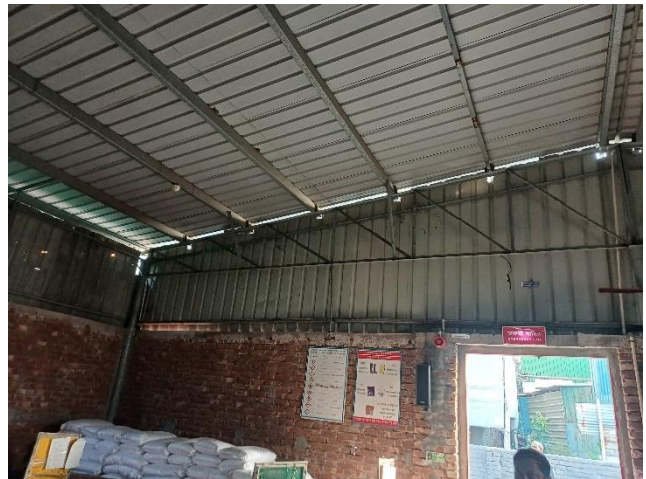
**Observation 14:** Lack of lateral stability.

Absence of load transfer media (strut & bracings) along the long direction

**Description:** Lack of lateral stability system (strut & bracings) was observed in the structure. The building engineer is required to carry out an Engineering Assessment (EA) to check the lateral stability of the structure and suggest proper remedial actions accordingly.

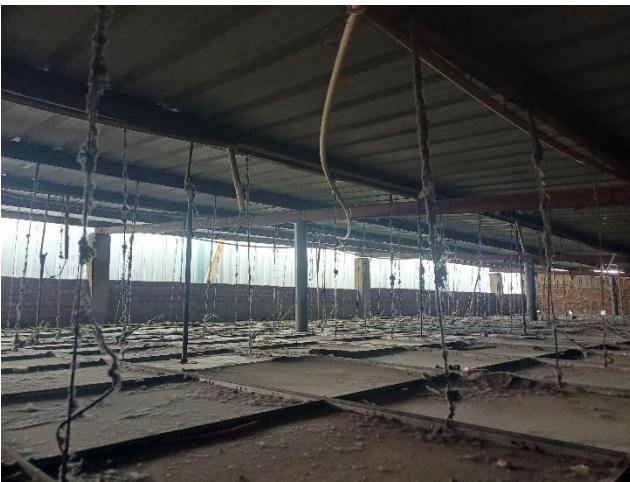
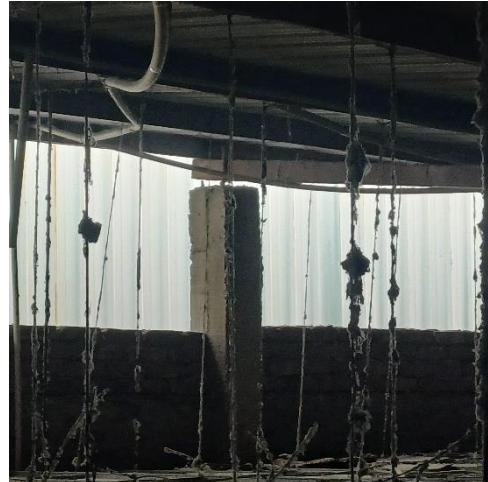
**Observation 15:** Lack of lateral stability and improper connections.

Absence of load transfer media (Strut & bracings) along long directions & improper connections

**Description:** Lack of lateral stability system (strut & bracings) & improper connections were observed in the structure. The building engineer is required to carry out an Engineering Assessment (EA) to check the lateral stability of the structure and suggest proper remedial actions accordingly.

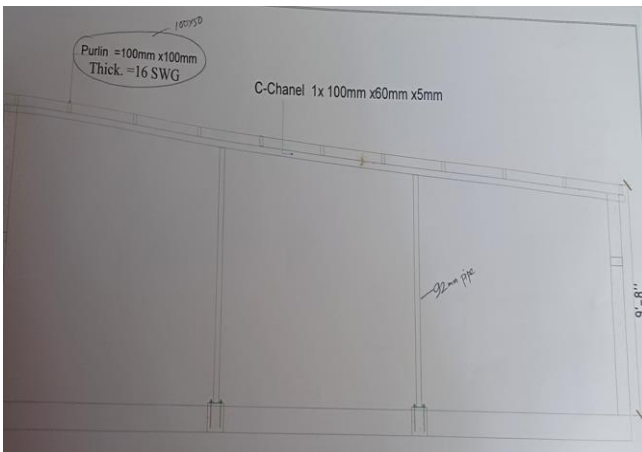
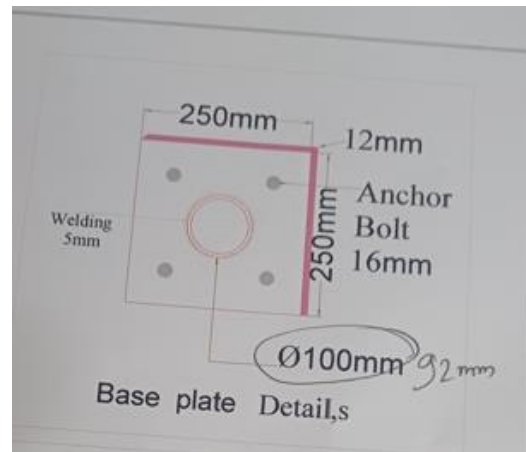
**Observation 16:** Mismatch in as-built drawings.

Member size not matched in as-built drawing

**Description:** During the inspection, mismatches were found in the as-built drawings (member sizes did not match). The building engineer is required to survey the whole structure and revise the as-built drawing as per actual site condition.

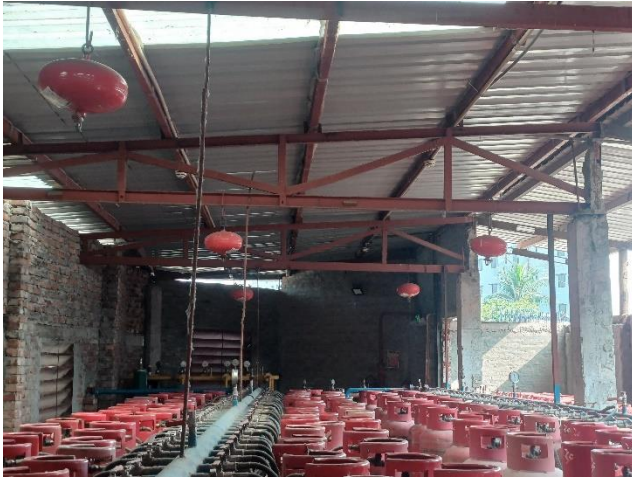
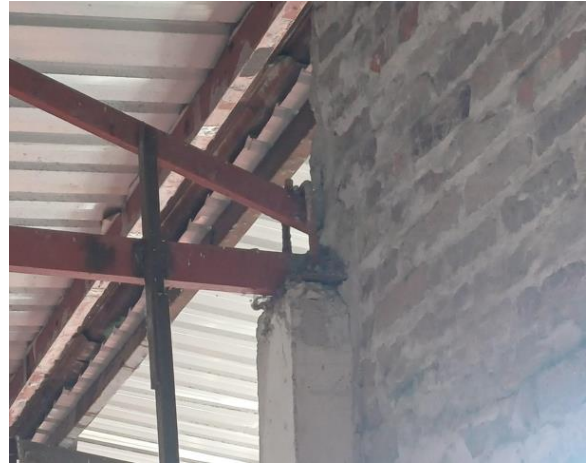
**Observation 17:** Lack of lateral stability and improper connections.

Absence of load transfer media (Strut & bracings) along long directions & improper connections

**Description:** Lack of lateral stability system (strut & bracings) & improper connections were observed in the structure. The building engineer is required to carry out an Engineering Assessment (EA) to check the lateral stability of the structure and suggest proper remedial actions accordingly. Submit the EA documents to RSC for review.

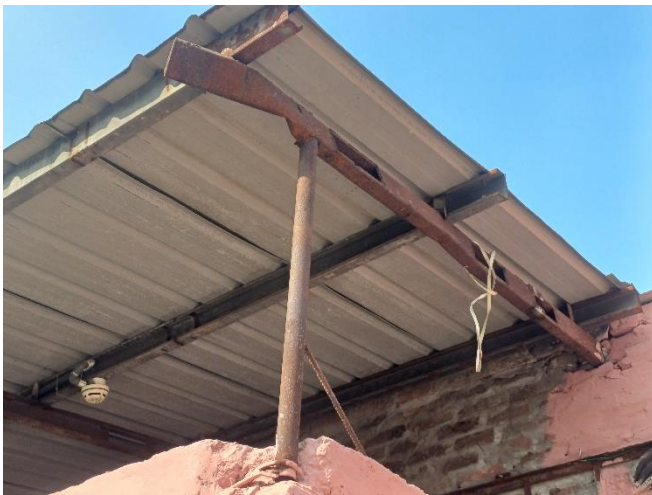
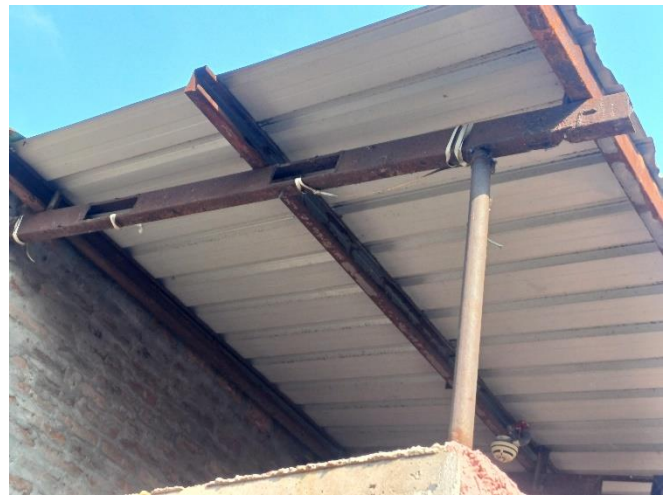
**Observation 18:** Corrosion on steel section.

**Description:** Severe corrosion was observed on steel columns. The building engineer is required to remove the corrosion and provide rust-proof coating on all steel members to protect from corrosion.

28	Corrosion on steel section. (Building 20)	Building engineer is required to remove the corrosion and provide rust-proof coating on all steel members to protect from corrosion.	within 6 weeks
29	Mismatch in as-built drawings. (Building 20)	The building engineer is required to survey the whole structure and revise the as-built drawing as per actual site condition.	within 6 weeks
30	Lack of lateral stability and improper connections. (Building 21)	Building engineer is required to check the lateral stability of the shed as part of the Engineering Assessment (EA).	within 6 weeks
31	Lack of lateral stability and improper connections. (Building 21)	Carry out remedial work where required.	within 6 months

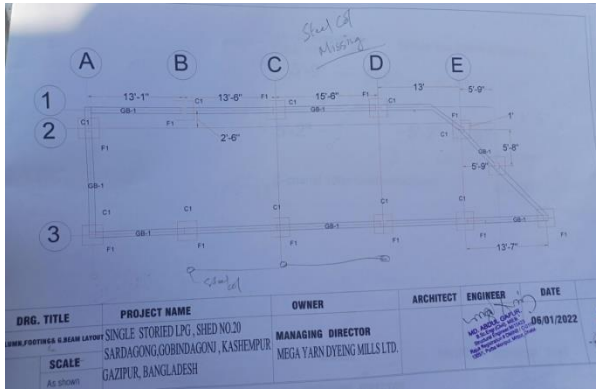
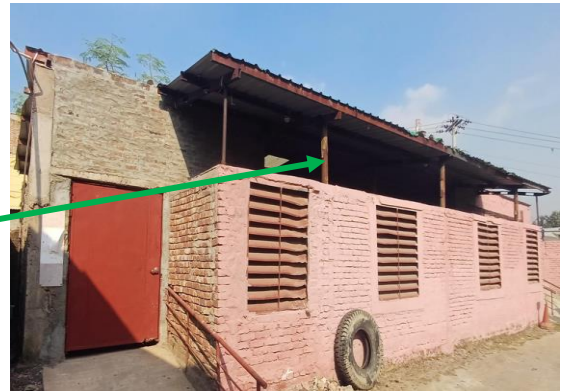
**Observation 19:** Mismatch in as-built drawings.

Steel column not shown in as-built drawing

**Description:** During the inspection, mismatches were found in the as-built drawings. The steel columns were not shown in the as-built drawing. The building engineer is required to survey the whole structure and revise the as-built drawing as per actual site condition.

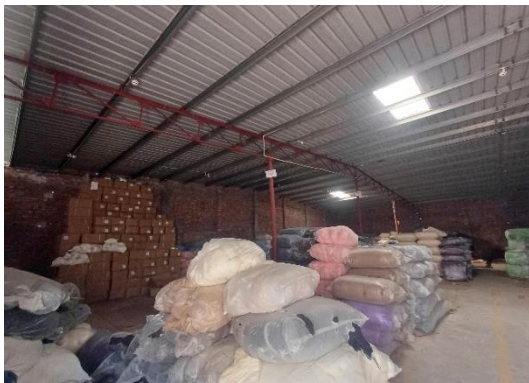
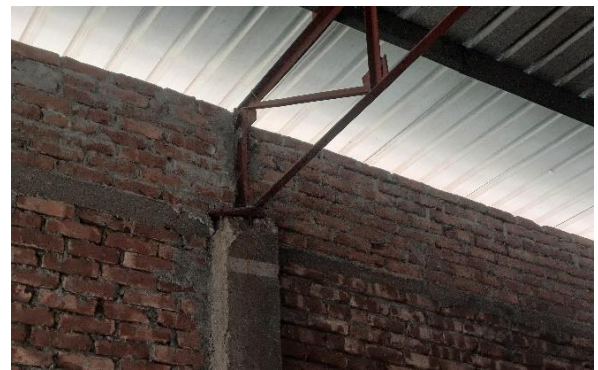
**Observation 20:** Lack of lateral stability and improper connections.

Absence of load transfer media (Strut & bracings) along long directions & improper connections

**Description:** Lack of lateral stability system (strut & bracings) & improper connections were observed in the structure. The building engineer is required to carry out an Engineering Assessment (EA) to check the lateral stability of the structure and suggest proper remedial actions accordingly. Submit the EA documents to RSC for review.

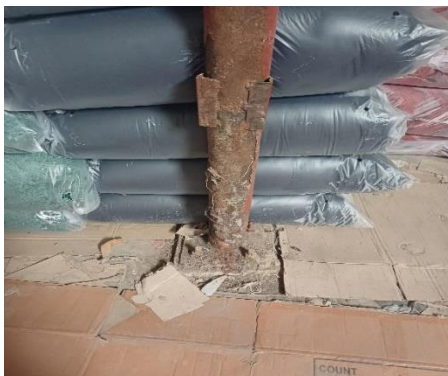
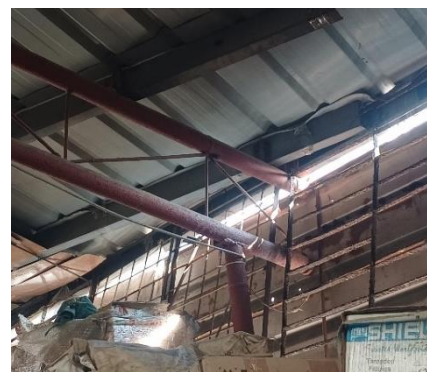
**Observation 21:** Corrosion on steel section.

**Description:** Severe corrosion was observed on steel columns. The building engineer is required to remove the corrosion and provide a rust-proof coating on all steel members to protect from corrosion.

32	Corrosion on steel section. (Building 21)	Building engineer is required to remove the corrosion and provide rust-proof coating on all steel members to protect from corrosion.	within 6 weeks
33	Lack of lateral stability and improper connections. (Building 22)	Building engineer is required to check the lateral stability of the shed as part of the Engineering Assessment (EA).	within 6 weeks
34	Lack of lateral stability and improper connections. (Building 22)	Carry out remedial work where required.	within 6 months
35	Mismatch in as-built drawings. (Building 22)	The building engineer is required to survey the whole structure and revise the as-built drawing as per actual site condition.	within 6 weeks
36	Lack of lateral stability. (Building 23)	Building engineer is required to check the lateral stability of the shed as part of the Engineering Assessment (EA).	within 6 weeks
37	Lack of lateral stability. (Building 23)	Carry out remedial work where required.	within 6 months

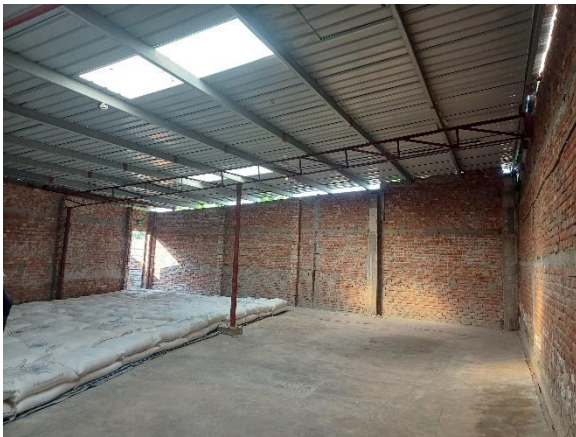
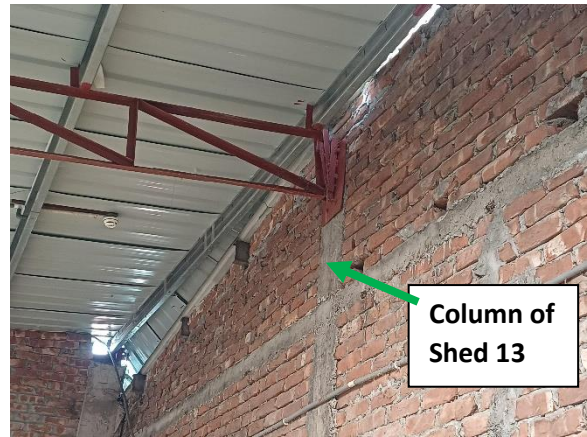
**Observation 22:** Lack of lateral stability and improper connections.

Absence of load transfer media (Strut & bracings) along long the direction & improper connections

**Description:** Lack of lateral stability system (strut & bracings) & improper connections were observed in the structure. The building engineer is required to carry out an Engineering Assessment (EA) to check the lateral stability of the structure and suggest proper remedial actions accordingly. Submit the EA documents to RSC for review.

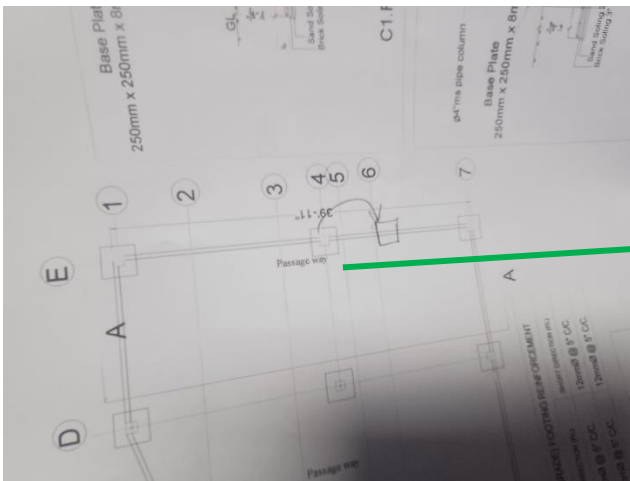
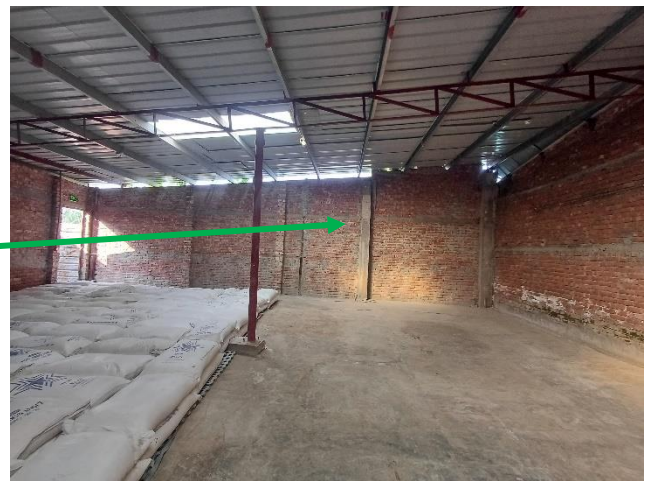
**Observation 23:** Mismatch in as-built drawings.

RCC column location not matched in as-built drawing

**Description:** During inspection, mismatches were found in the as-built drawings. The RCC column location did not match in the as-built drawing. The building engineer is required to survey the whole structure and revise the as-built drawing as per actual site condition.

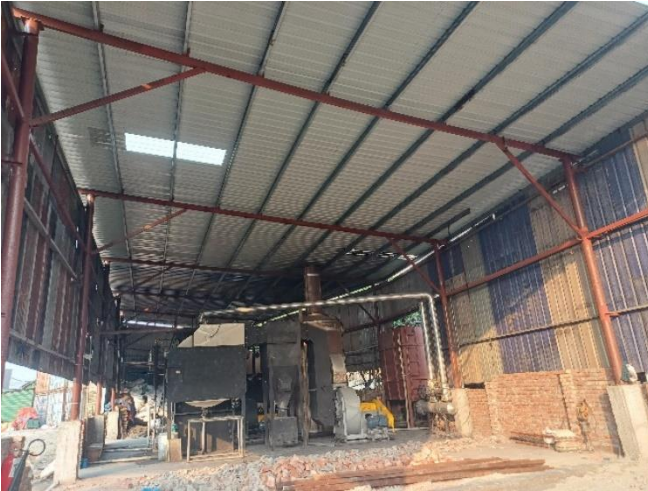
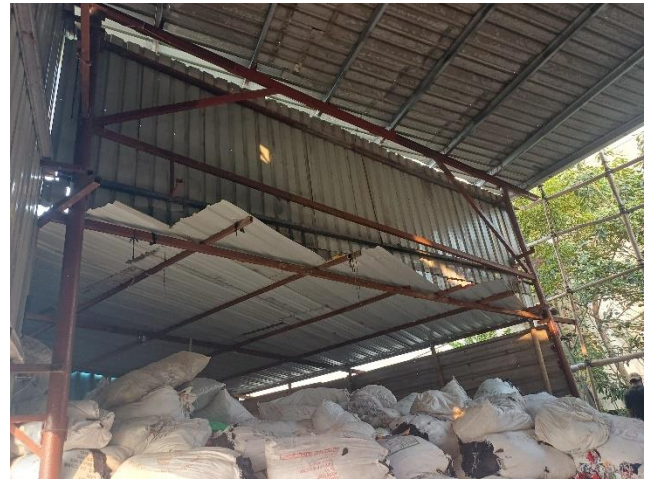
**Observation 24:** Lack of lateral stability.

Absence of load transfer media (Strut & bracings) along long direction

**Description:** Lack of lateral stability system (strut & bracings) was observed in the structure. The building engineer is required to carry out Engineering Assessment (EA) to check the lateral stability of the structure and suggest proper remedial actions accordingly. Submit the EA documents to RSC for review.

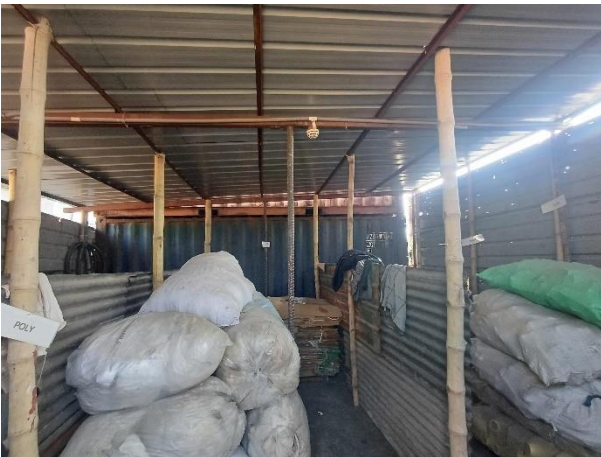
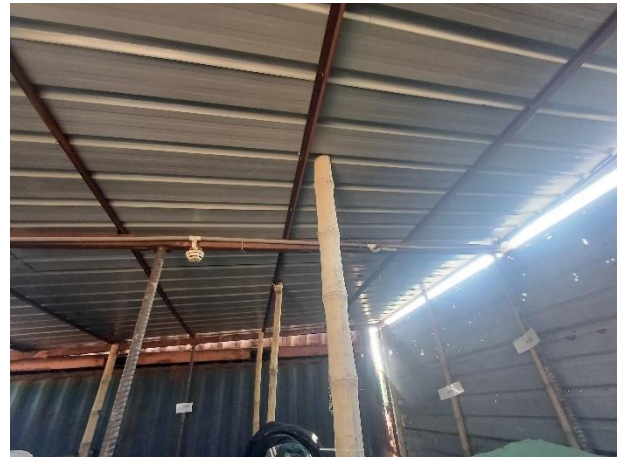
**Observation 25:** Apparently non-engineered shed

Apparently non-engineered shed (supported on bamboo)

**Description:** During the inspection, the non-engineered bamboo-supported shed was found. The factory is required to replace the shed with a properly engineered one or demolish the shed.

38	Apparently non-engineered shed. (Building 24)	The factory is required to replace the shed with a properly engineered one or demolish the shed.	within 6 weeks
