Pole Star Knit Composite Ltd.

Noibari, Pubail, Gazipur City Corporatoin, Gazipur.

11 January 2024

Building Information

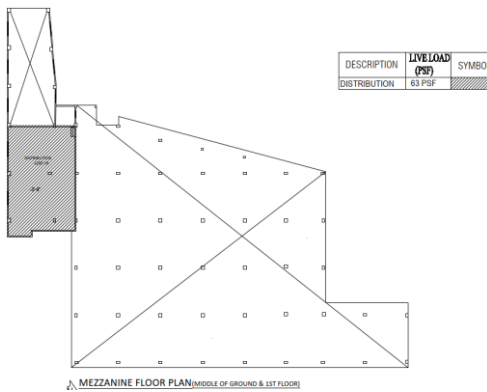
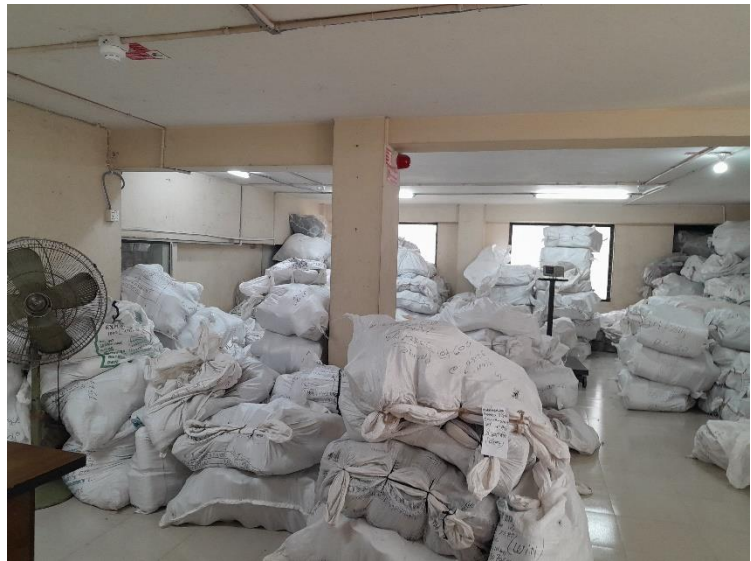
Observation-1: Uncontrolled floor loading. (Production Building).

Description: Uncontrolled storage found on the Mezzanine floor. The building engineer is required to implement a floor load management program including posting the accepted floor load plan, marking the area & height of storage and maintaining floor loading accordingly.

| SL NO. | Observation | Action Plan | Timeline |
|---|--|---|---|
| 1. | Uncontrolled floor loading. (Production Building). | The building engineer is required to develop a floor load management program including posting the accepted floor load plan, marking the area & height of storage, and maintaining floor loading accordingly. | within 6 weeks |
| 2. | Uncontrolled floor loading. (Production Building). | Implement remediation work if required. | within 6 months |

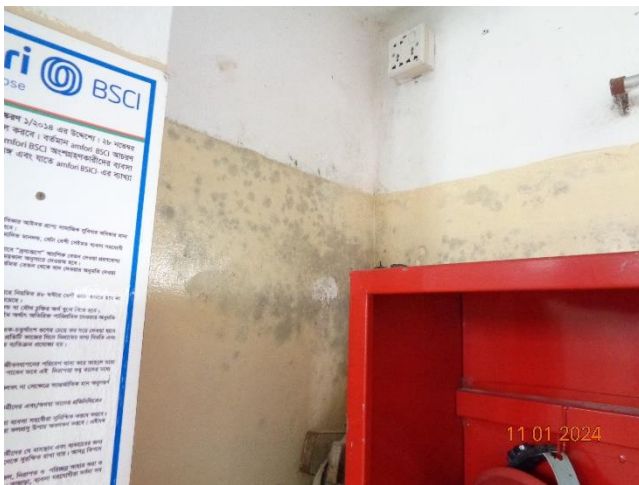
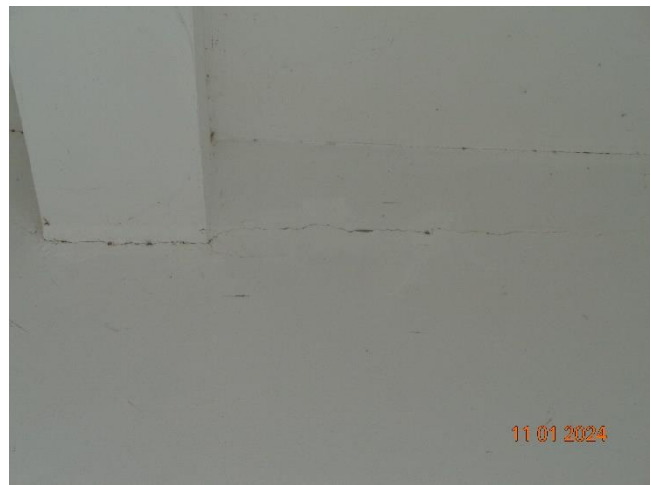
Observation-2: Crack and dampness on brick wall. (Production Building).

Description: During inspection, crack and dampness on the brick wall surface (Production Building). The building engineer is required to investigate the extent of dampness and repair with a suitable method.

| SL NO. | Observation | Action Plan | Timeline |
|---|--|---|---|
| 3. | Crack and dampness on brick wall. (Production Building). | The building engineer is required to investigate the extent of dampness and repair with a suitable method. | within 6 weeks |

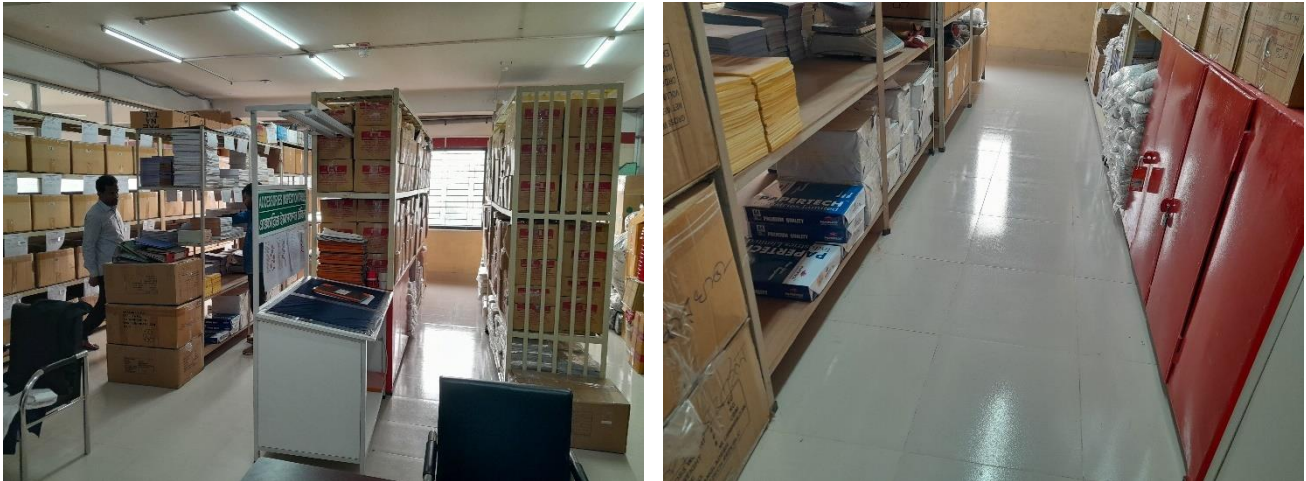
Observation-3: Lack of anchorage/braced of non-structural elements. (Production Building)

Description: During inspection, non-structural elements (Racks) were found not anchored & unbraced. The factory is required to brace/anchor all the non-structural elements.

| SL NO. | Observation | Action Plan | Timeline |
|---|--|---|---|
| 4. | Lack of anchorage/braced of non-structural elements. (Production Building) | The factory is required to brace/anchor all the non-structural elements. | within 6 months |

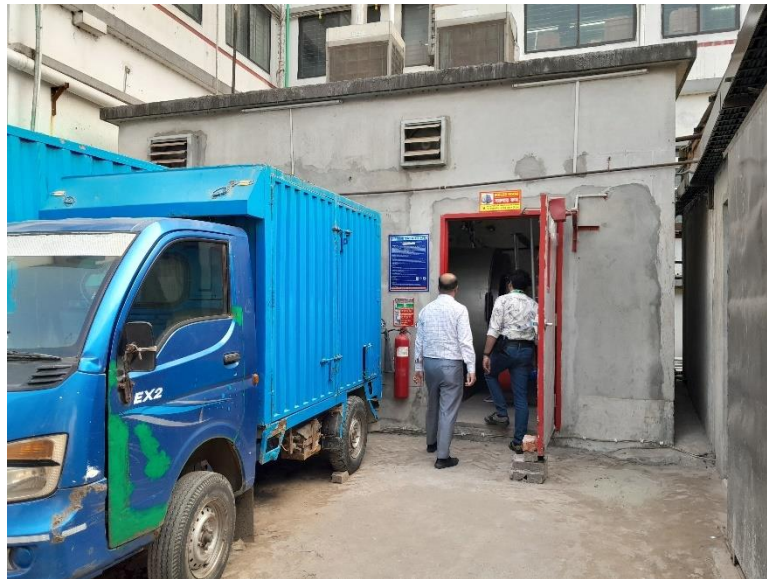
Observation-4: Lack of as-built drawing. (Boiler room)

Description: As-built drawing of the structures was not available on-site. The building engineer is required to prepare as-built drawing of the structure.

| SL NO. | Observation | Action Plan | Timeline |
|---|--|---|---|
| 5. | Lack of as-built drawing. (Boiler room) | The building engineer is required to prepare as-built drawing of the structure. | within 6 weeks |

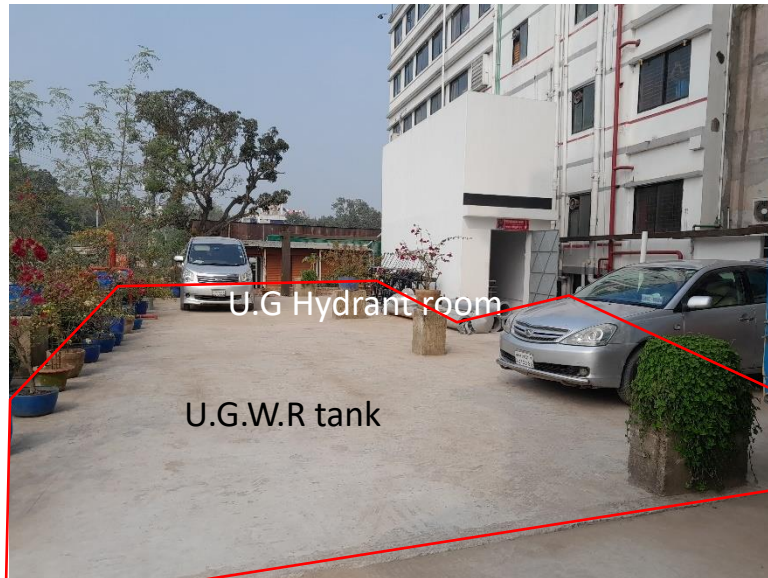
Observation-5: Absence of design documents. (Hydrant room).

Description: A parking area was observed over the underground water reservoir tank of fire hydrant. During inspection, the design report and as built structural drawing was not available on site. The building engineer is required to prepare a set of design documents including as built drawings, live load plan at roof and a design report based on in-situ material strength and software-based analysis which shall be prepared in compliance with section 1.9.1, part-6 of BNBC.

| SL NO. | Observation | Action Plan | Timeline |
|---|--|---|---|
| 6. | Absence of design documents. (Hydrant room). | The building engineer is required to prepare a set of design documents including as-built drawings, live load plan at roof and a design report based on in-situ material strength and software-based analysis which shall be prepared in compliance with section 1.9.1, part-6 of BNBC. | within 6 weeks |
| 7. | Absence of design documents. (Hydrant room). | Implement remediation work if required. | within 6 months |
