# Auko-Tex Limited (Extended building)

South Panishail zerani bazar, BKSP, Gazipur, Dhaka

14 January 2024

## 2. Observation

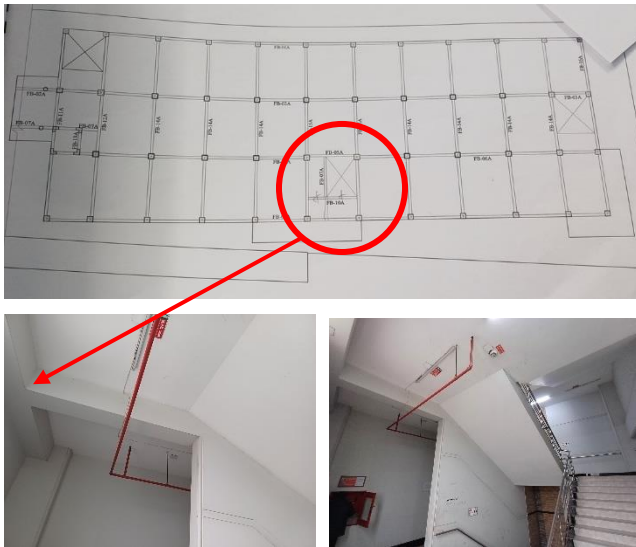
Beam Layout

**Description:** Beam layout didn't fully match with the drawings. Mismatches are shown in red on the layout. Also, first floor layout was found different with the drawings. Moreover, no drawings were available for the roof steel stair.

| Observation | Action Plan | Timeline |
|---|---|---|
| Mismatches in as-built drawings (Knitting and Store Building) | Building engineer is required to prepare the as-built drawings with complete structural details. | within 6 weeks |

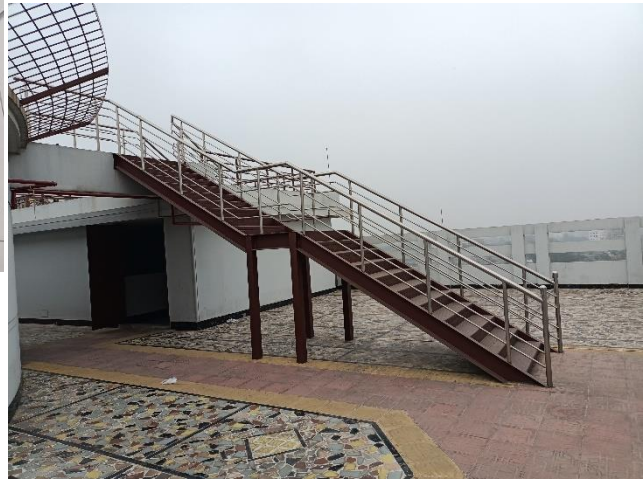
Steel stair on roof

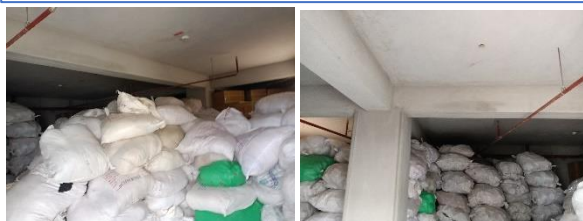
Roof floor loading

**Description:** In the provided design report concrete compression strength considered 3500 psi for column. But no cylinder test report was available from ground floor column in this regard, which does not meet the frequency of testing of BNBC. Thus, ground columns are observed marginally overstressed from cursory calculation considering minimum concrete strength. Also, the live load plan (42 psf) for roof storage (below the helipad) does not comply with BNBC. The building engineer is required to revise the design report incorporating BNBC live load requirements and in-situ material strength.

| Observation | Action Plan | Timeline |
|---|---|---|
| Inconsistencies between design report and floor loading & material test report. (Knitting and Store Building) | The building engineer is required to revise the design report incorporating BNBC live load requirements and verifying in-situ concrete strength by taking concrete cores from lower tier columns of the building. | within 6 weeks |

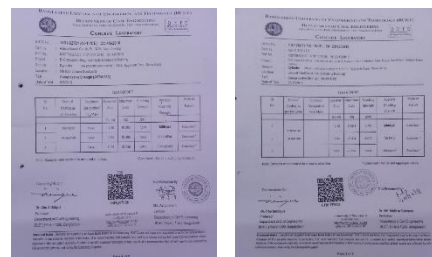
Test report

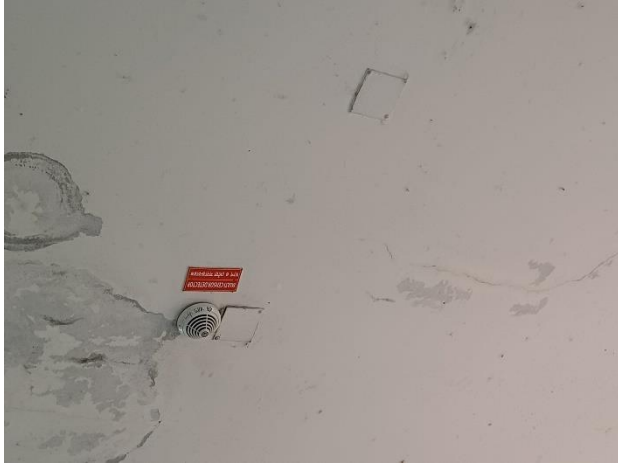
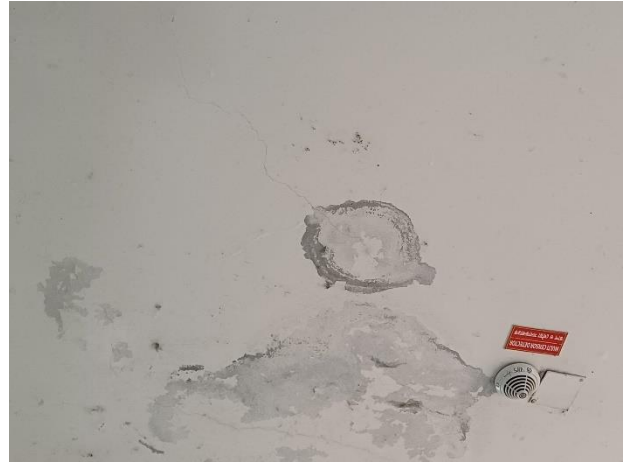
Cracks on slab soffit

**Description:** Crack found under the slab soffit at 3<sup>rd</sup> floor. Building engineer is required to investigate the reason and extent of the crack and repair the crack as per investigation report.

| Observation | Action Plan | Timeline |
|---|---|---|
| Cracks found on the slab soffit. (Knitting and Store Building) | Building engineer is required to investigate the reason and extent of the crack and repair the crack as per investigation report. | within 6 weeks |

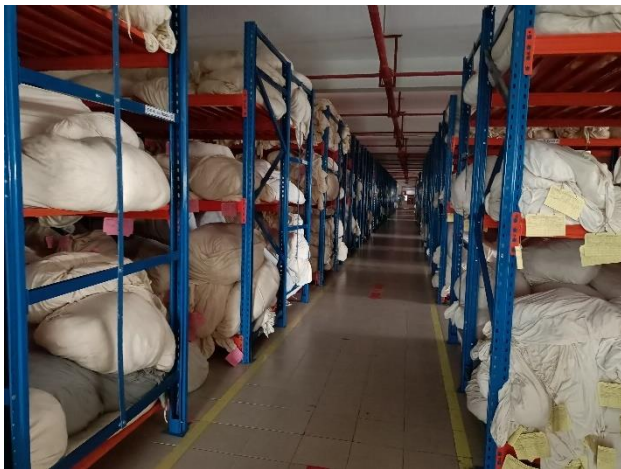
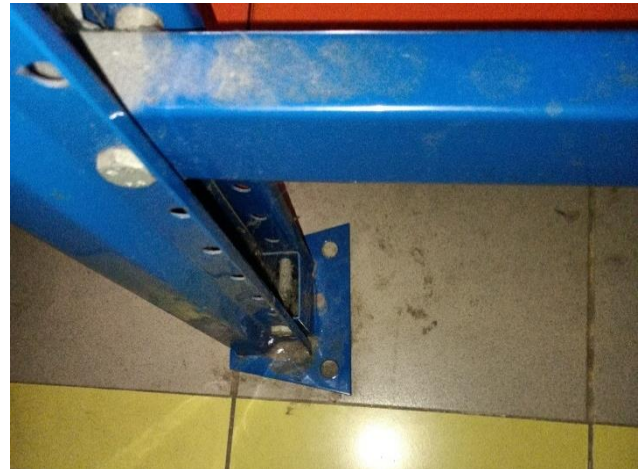
Unbraced racks on floor

**Description:** Some racks on floors are not anchored or braced to resist lateral (earthquake) forces. The factory is required to anchor/brace all non-structural elements adequately to resist earthquake forces.

| Observation | Action Plan | Timeline |
|---|---|---|
| Non-structural elements not anchored or braced. (Knitting and Store Building) | The factory is required to anchor/brace all non-structural elements adequately to resist earthquake forces. | within 6 weeks |

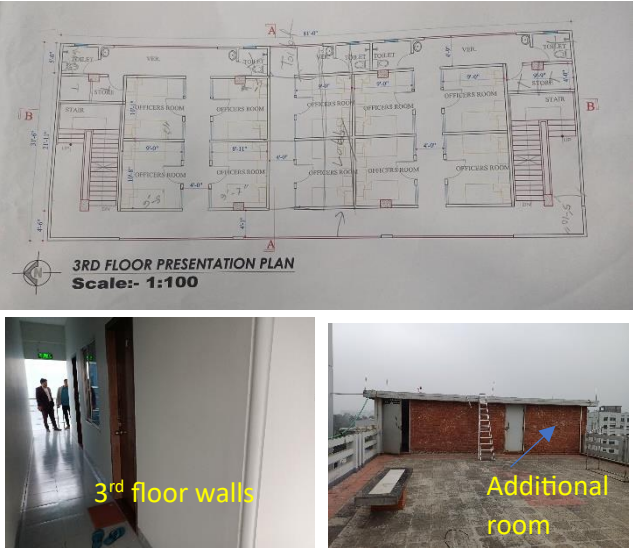
Beam Layout

**Description:** Roof and 3<sup>rd</sup> floor layout didn't fully match with as built drawings. Additional room beside of stair on roof not shown in the drawings. Also, the number of partition walls on 3<sup>rd</sup> floor were found different with as-built drawings. Moreover, no as built drawings were available for steel stair.

| Observation | Action Plan | Timeline |
|---|---|---|
| Discrepancies in as-built drawings. (Officers Resting Room) | Building engineer is required to prepare the as-built drawings with complete structural & architectural details. | within 6 weeks |

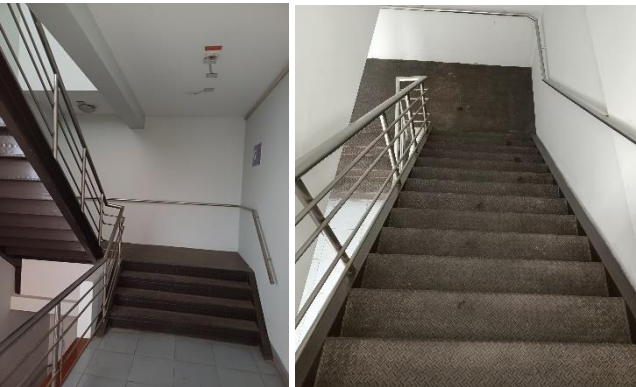
Steel stairs

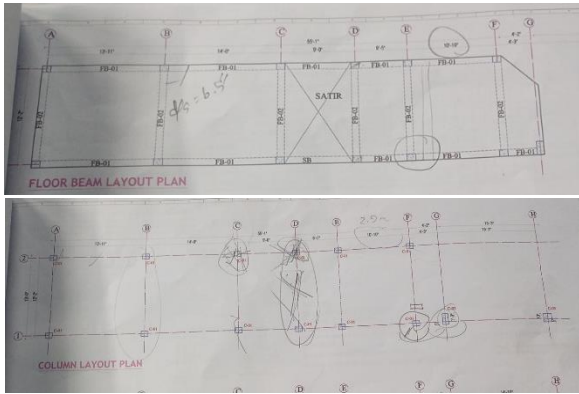
Beam Layout

**Description:** Column and beam layouts were not fully matched with as built drawings. Also, the column of sub-station room was found brick masonry instead of RCC. Moreover, no as built drawings were available for steel stair.

| Observation | Action Plan | Timeline |
|---|---|---|
| Discrepancies in as-built drawings. (Security Post & Sub-Station Building) | Building engineers are required to survey the whole structure and prepare accurate as-built drawings. | within 6 weeks |

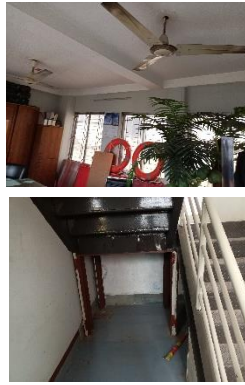
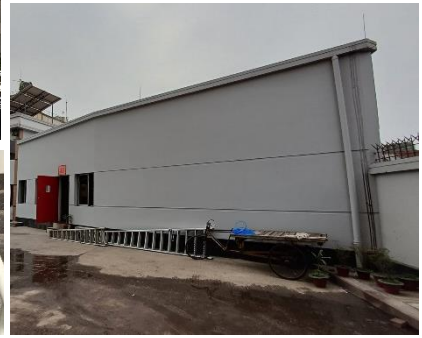
Steel stair, floor Beam and Sub-station Room

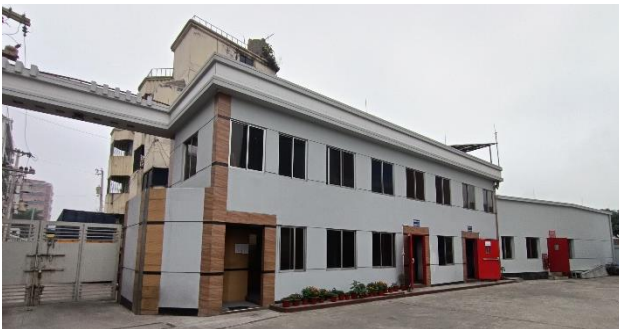
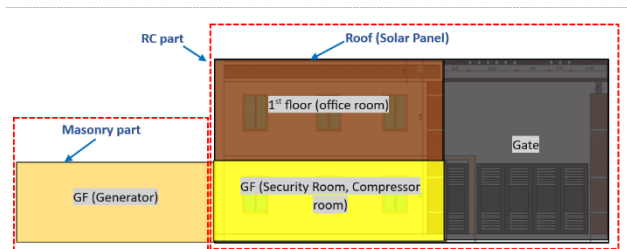
**Description:** As per BNBC, every building or structure designed shall have its design documents prepared following the provision of Section 1.9.1. The design document shall include a design report, and a set of structural drawings, which shall be prepared in compliance with section 1.9.1.1 and section 1.9.1.2, part 6 of BNBC.

| Observation | Action Plan | Timeline |
|---|---|---|
| Lack of design report. (Security Post & Sub-Station Building) | Building engineer is required to prepare the design documents including a design report, and a set of structural drawings in compliance with section 1.9.1.1 and section 1.9.1.2, part-6 of BNBC and submit it to RSC for review. | within 6 weeks |

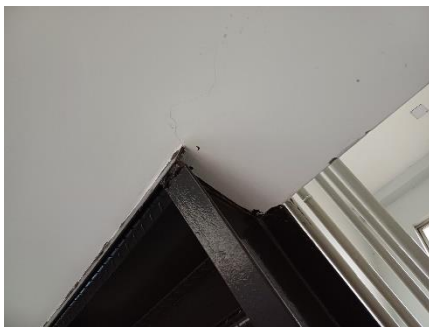
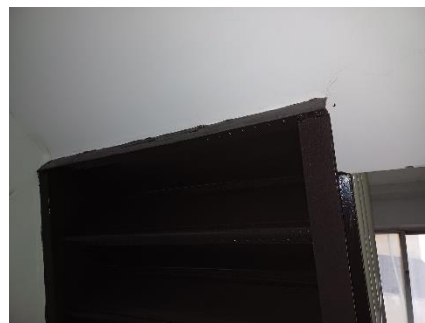
**Description:** Cracks found in the junction of the steel stair and RC slab connection on 1<sup>st</sup> floor. Building engineer is required to investigate the reason and extent of the crack and repair the crack as per investigation report.

| Cracks observed at steel stair and RCC slab connection. (Security Post & Sub-Station Building) | Building engineer is required to investigate the reason and extent of the crack and repair the crack as per investigation report. | within 6 weeks |
