# L Usine Fashion Ltd. (Extension)

Ansar Road, Kawya, Chonnapara, Sreepur, Gazipur-1740, Gazipur.

18 January 2024

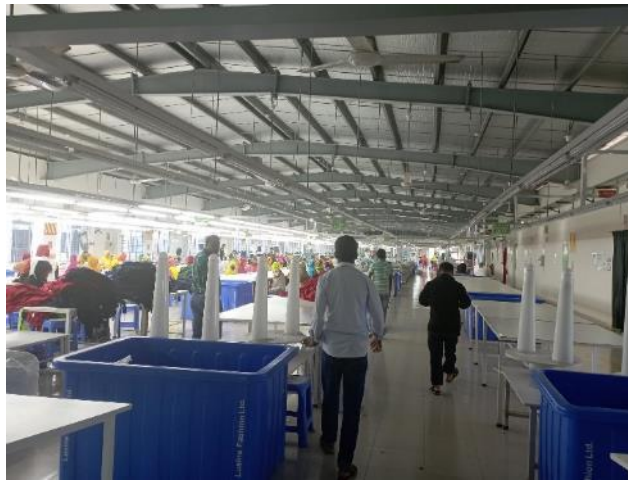
**Observation-1:** Lack of lateral stability of steel roof (Steel Building).

**Description:** No roof bracing is provided for the shed. The building engineer is required to check the lateral stability of the roof structure and propose a remediation plan.

| Observation | Action Plan | Timeline |
|---|---|---|
| Lack of lateral stability of steel roof (Steel Building). | The building engineer is required to check the lateral stability of the structure and revise the design report following BNBC-2020 with necessary remedial actions. Submit revised design documents to the RSC for detail review. | within 6 weeks |
| Lack of lateral stability of steel roof (Steel Building). | Implement remediation work if required. | within 6 months |

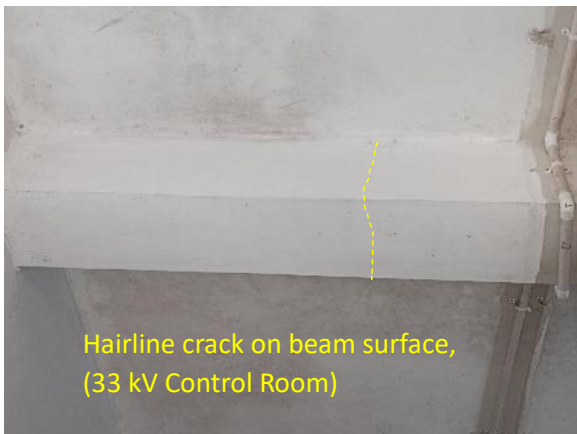
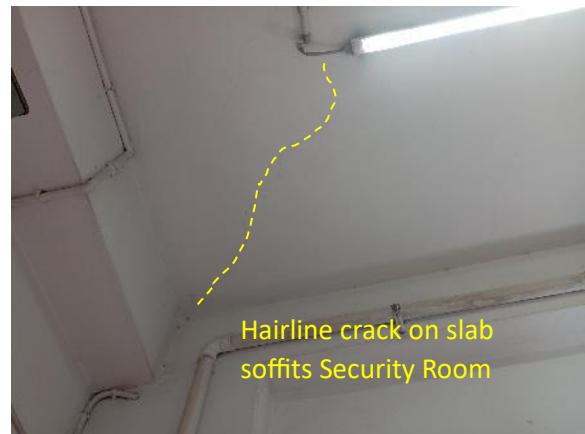
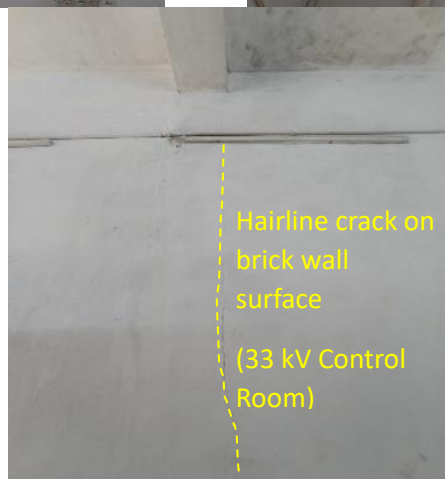
**Observation-2:** Hairline crack on beam, slab, and brick wall (Security Room, 33 kV Control Room)

**Description:** Hairline crack was found on beam, slab, and brick wall surface. The building engineer is required to investigate the cracked areas and repair the crack with a suitable method.

| Observation | Action Plan | Timeline |
|---|---|---|
| Hairline crack on beam, slab, and brick wall (Security Room, 33 kV Control Room) | The building engineer is required to investigate the cracked areas and repair the crack with a suitable method. | within 6 weeks |
