# SUPREME EMBELLISHMENT LIMITED

140/1, East Baghbari, Kashimpur, Gazipur-1700

12 November 2023

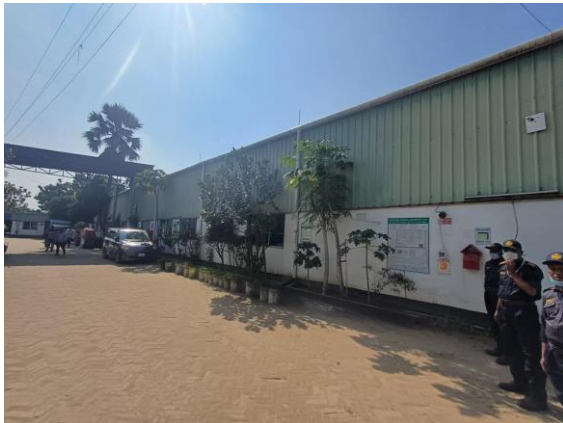
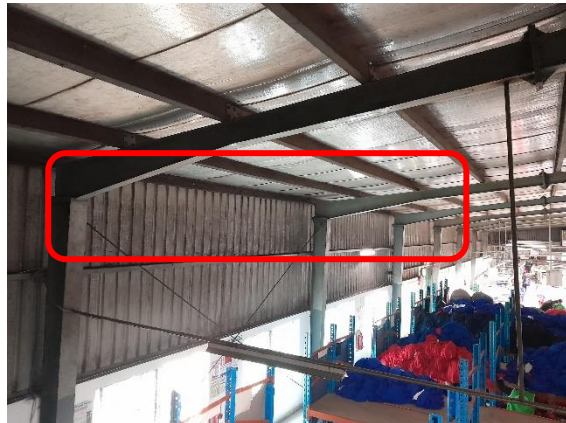
### Observation-1: Lack of lateral stability (Shed 1).

**Description:** The structure has no lateral load transfer media (compression strut) along long direction. Also, the foundation detail of the structure was missing in the drawing. During inspection no design documents were available for this shed.

The building engineer is required to carry out Detail Engineering Assessment (DEA) to check the lateral stability and adequacy of all structural elements of the structure based on in-situ material strength and software-based analysis which shall be prepared in compliance with section 1.9.1, part-6 of BNBC. Also, investigate the foundation system and incorporate the adequacy check in the DEA.

| Item No. | Observation | Action Plan | Timeline |
|---|---|---|---|
| 1. | Lack of lateral stability (Shed 1). | The building engineer is required to carry out Detail Engineering Assessment (DEA) to check the lateral stability and adequacy of all structural elements of the structure based on in-situ material strength and software-based analysis which shall be prepared in compliance with section 1.9.1, part-6 of BNBC. Also, investigate the foundation system and incorporate the adequacy check in the DEA. | within 6 weeks |
| 2. | Lack of lateral stability (Shed 1). | Produce and actively manage load plan for mezzanine floor. | within 6 weeks |
| 3. | Lack of lateral stability (Shed 1). | Carry out suggested remedial works where required. | within 6 months |

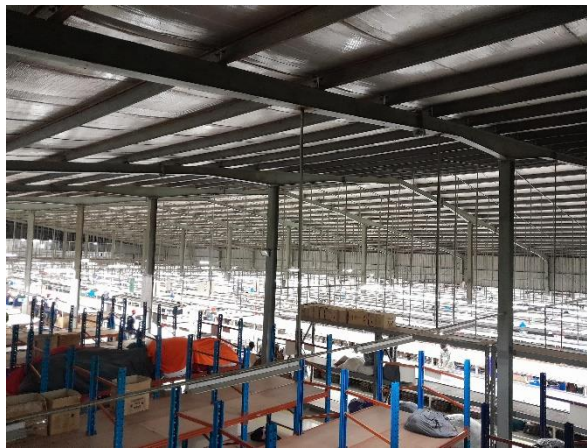
### Observation-2: Lack of as built drawings (Shed 1).

**Description:** As built drawing of the shed was not available on-site. The building engineer is required to prepare as-built drawing for the shed with necessary connection details.

| Item No. | Observation | Action Plan | Timeline |
|---|---|---|---|
| 4. | Lack of as built drawings (Shed 1) | The building engineer is required to prepare as-built drawing for the shed with necessary connection details. | within 6 weeks |

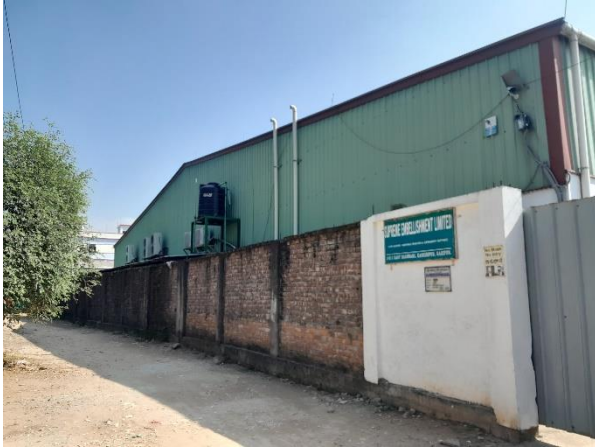
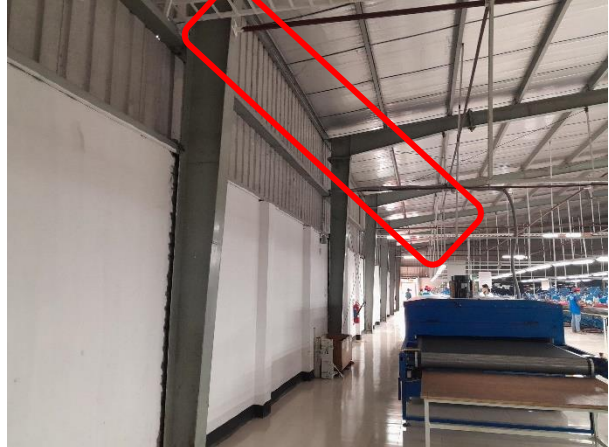
**Observation-3:** Lack of Lack of lateral stability (Shed 2).

**Description:** The structure has no lateral load transfer media (compression strut) along long direction. Also, the foundation detail of the structure was missing in the drawing. During inspection no design documents were available for this shed.

The building engineer is required to carry out Detail Engineering Assessment (DEA) to check the lateral stability and adequacy of all structural elements of the structure based on in-situ material strength and software-based analysis which shall be prepared in compliance with section 1.9.1, part-6 of BNBC. Also, investigate the foundation system and incorporate the adequacy check in the DEA.

| Item No. | Observation | Action Plan | Timeline |
|---|---|---|---|
| 5. | Lack of lateral stability (Shed 2). | The building engineer is required to carry out Detail Engineering Assessment (DEA) to check the lateral stability and adequacy of all structural elements of the structure based on in-situ material strength and software-based analysis which shall be prepared in compliance with section 1.9.1, part-6 of BNBC. Also, investigate the foundation system and incorporate the adequacy check in the DEA. | within 6 weeks |
| 6. | Lack of lateral stability (Shed 2). | Carry out remedial works if required. | within 6 months |

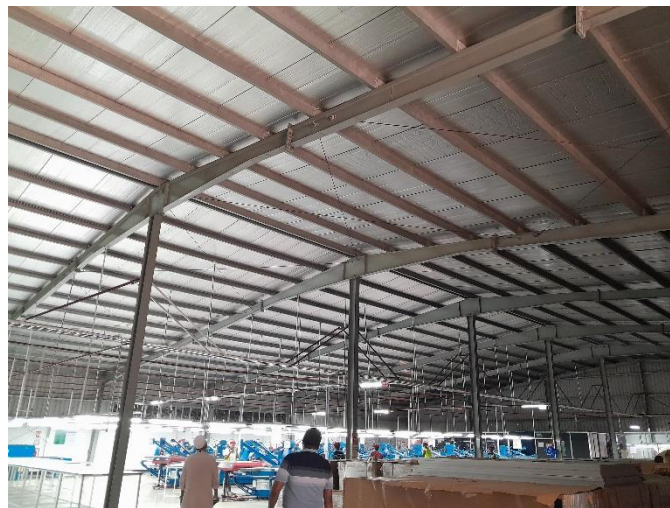
**Observation-4:** Lack of as built drawings (Shed 2).

**Description:** As-built drawing of the structure was not available on-site. The building engineer is required to prepare as-built drawing of the structure with necessary connection details.

| Item No. | Observation | Action Plan | Timeline |
|---|---|---|---|
| 7. | Lack of as built drawings (Shed 2) | The building engineer is required to prepare as-built drawing for the shed with necessary connection details. | within 6 weeks |

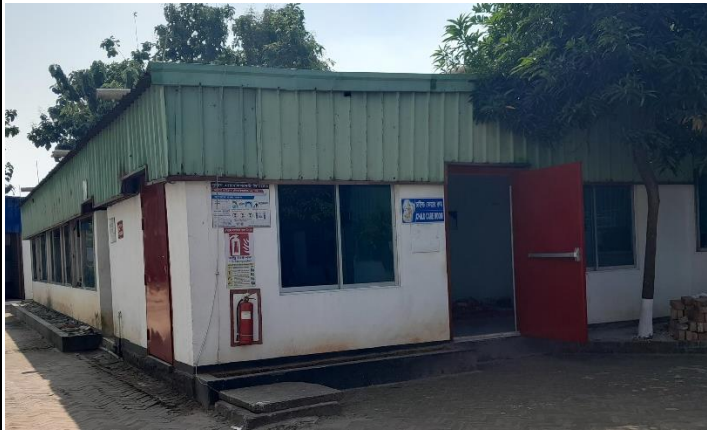
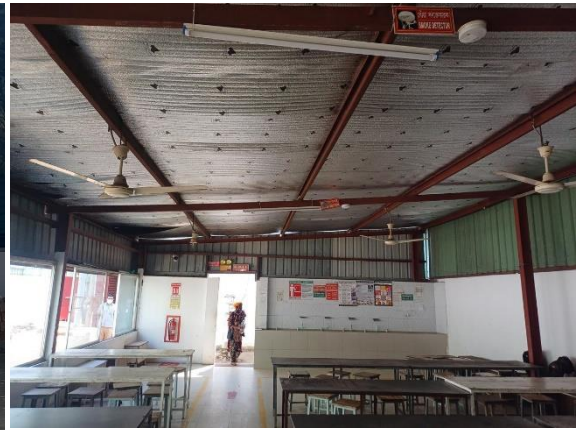
**Observation-5:** Lack of design report (Shed 4).

**Description:** As per BNBC, every building or structure designed shall have its design documents prepared in accordance with the provision of Section 1.9.1. During inspection, the design report and as built structural drawing was not available on site.

The building engineer is required to prepare a set of design documents including as built drawings, live load plan at roof and a design report based on in-situ material strength and software-based analysis which shall be prepared in compliance with section 1.9.1, part-6 of BNBC.

| Item No. | Observation | Action Plan | Timeline |
|---|---|---|---|
| 8. | Lack of design report. (Shed 4) | The building engineer is required to prepare a design report based on in-situ material strength & software-based analysis and submit the documents to RSC for review. | within 6 weeks |

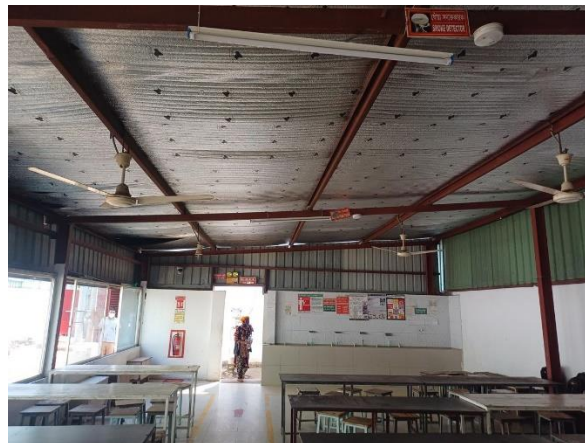
**Observation-6:** Lack of as built drawings (Shed 4).

**Description:** As-built drawing of the structure was not available on-site. The building engineer is required to prepare as-built drawing of the structure with necessary connection details.

| Item No. | Observation | Action Plan | Timeline |
|---|---|---|---|
| 10. | Lack of as built drawings (Shed 4) | The building engineer is required to prepare as-built drawing for the shed with necessary connection details. | within 6 weeks |

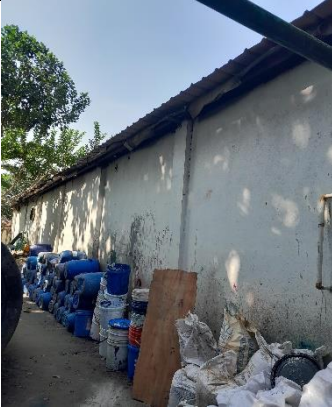
Shed 3

**Observation-7:** Apparently non-engineered structures. (Shed 3, Shed 5 & Shed 6).

**Description:** Lack of lateral stability system (strut and bracing), apparent inadequate members and non-engineered connection was observed. Also, structural elements (Truss) were found cutoff at several places in Shed 5. The building engineer is required to check the member, connection & stability system of the structure and suggest proper alternatives accordingly.

| 11. | Apparently non-engineered structures. (Shed 3, Shed 5 & shed 6). | The building engineer is required to check the member, connection & stability system of the structure and suggest proper alternatives accordingly. | within 6 weeks |
| 12. | Apparently non-engineered structures. (Shed 3, Shed 5 & shed 6). | Carry out suggested remedial works. | within 6 months |

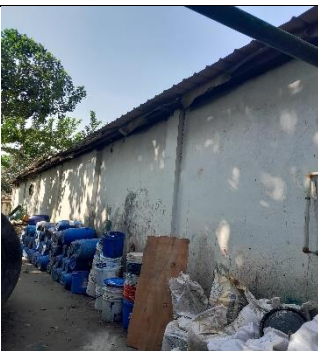
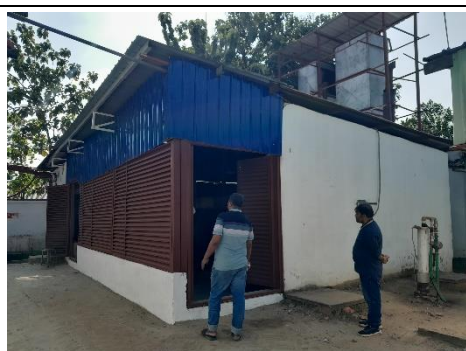
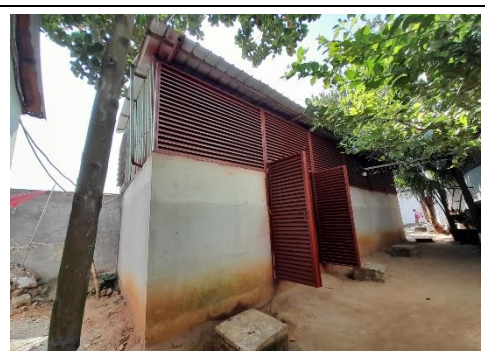
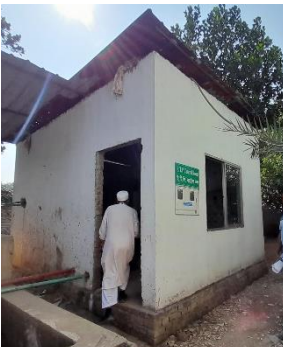
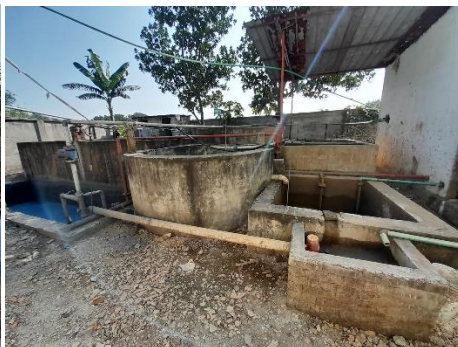
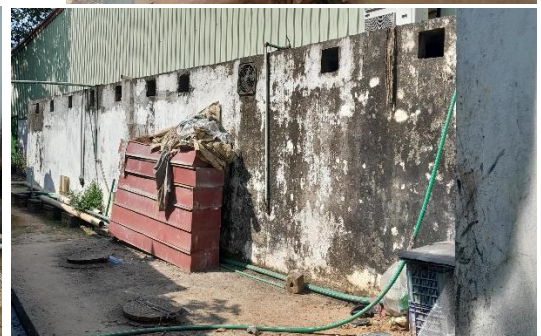
**Observation-8:** Lack of as-built drawings (Shed 3, 5, 6, 7, ETP & Toilet Block).

**Description:** As-built drawing of the structures was not available on-site. The building engineer is required to prepare as-built drawing of the structure with necessary connection details.

| 13. | Lack of as-built drawings (Shed 3, 5, 6, 7, ETP & Toilet block). | The building engineer required to prepare as built drawing of the Shed 3, 5, 6, 7, ETP & Toilet block. | within 6 weeks |

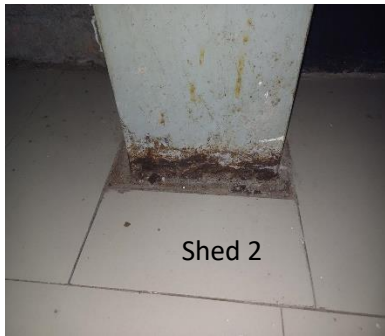
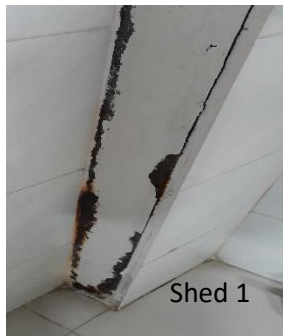
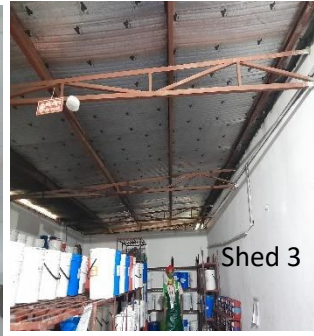
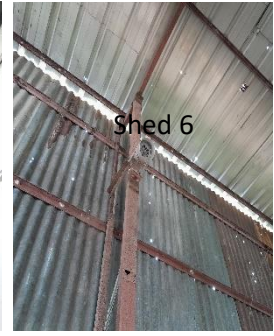
**Observation-9:** Corrosion observed on steel member.

**Description:** During inspection, corrosion was observed on steel members at several sheds. The building engineer is required to remove corrosion and provide anti corrosive coating.

| 14. | Corrosion observed on steel member. | The building engineer is required to remove corrosion and provide anti corrosive coating. | within 6 months |

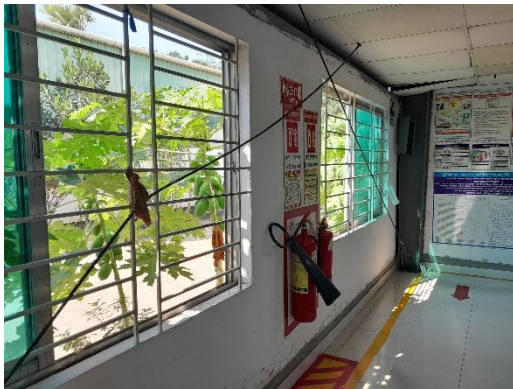
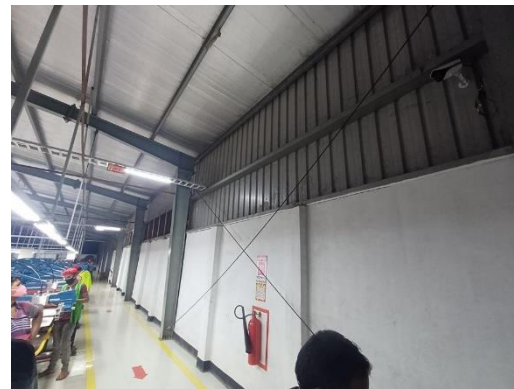
**Observation-10:** Loose cable bracing (Shed 2).

**Description:** During inspection, loose cable bracing was observed at Shed 2. The building engineer is required to identify and tighten all the loose bracings.

| 15. | Loose cable bracing (Shed 2). | The building engineer is required to identify and tighten all the loose bracings. | within 6 months |

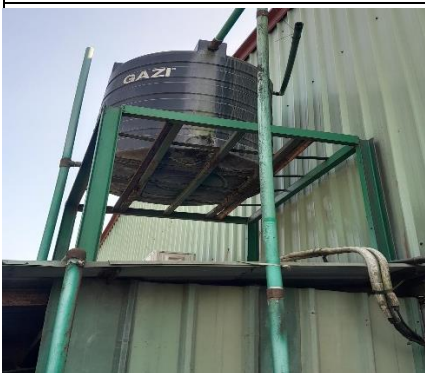
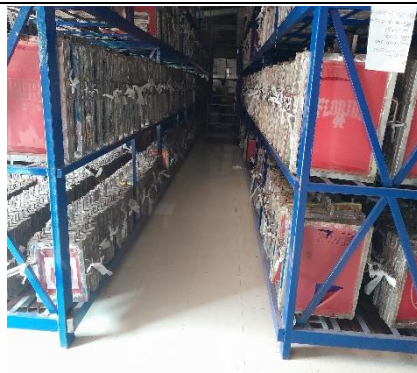
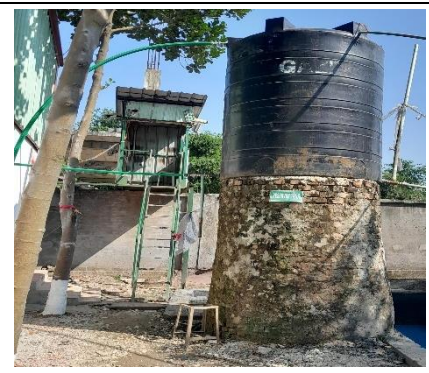
**Observation-11:** Lack of anchorage/braced of non-structural elements.

**Description:** During inspection, non-structural elements (Racks & water tanks) were found not anchored & unbraced. The factory is required to brace/anchor all the non-structural elements.

| 16. | Lack of anchorage/braced of non-structural elements | The factory is required to adequately brace/anchor all the non-structural elements. | within 6 months |

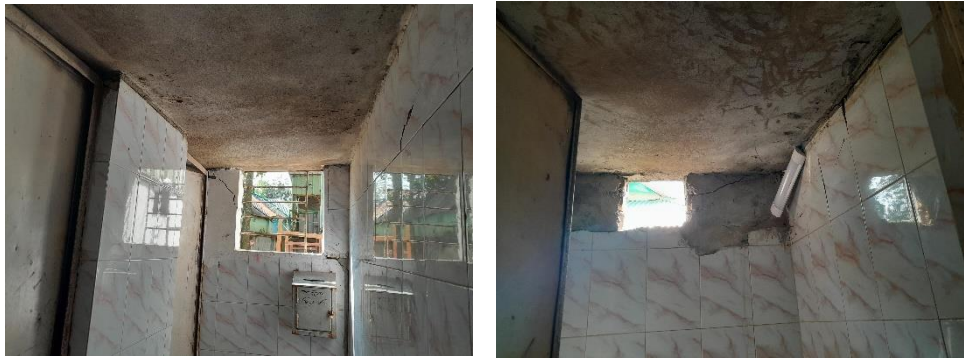
**Observation-12:** Crack on brick wall (Toilet Block)

**Description:** During inspection, diagonal cracks in brick walls were observed at several places in the toilet block. The building engineer is required to produce a crack investigation report and suggest proper remedial measures. The factory is required to repair the crack as per the investigation report.

| 17. | Crack on brick wall (Toilet Block) | The building engineer is required to produce a crack investigation report and suggest proper remedial measures. | within 6 weeks |
| 18. | Crack on brick wall (Toilet Block) | The factory is required to repair the crack as per the investigation report. | within 6 months |

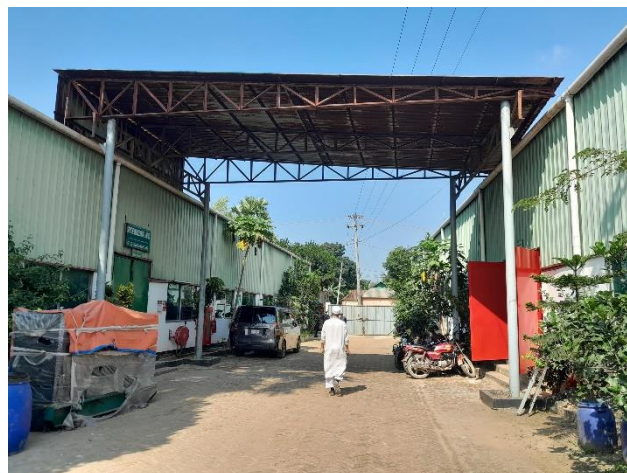
**Observation-13:** Lack of as-built drawings for the steel canopy.

**Description:** During inspection, an undocumented canopy was found at the middle of shed 1 and shed 2. The building engineer is required to survey the structure and prepare as-built drawings accordingly.

| 19. | Lack of as-built drawings for the steel canopy. | The building engineer is required to survey the structure and prepare as-built drawings accordingly. | within 6 weeks |
