# Epoch Garments Ltd (Extension)

10 December 2023

## 1. Executive Summary

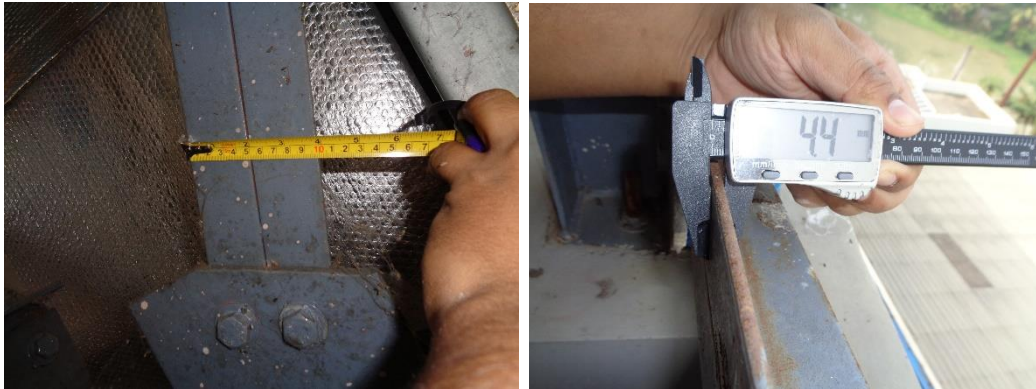
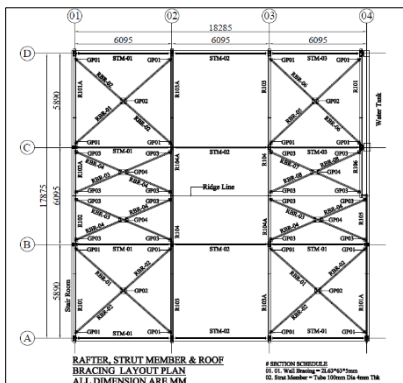
### Observation-1: Mismatch in as-built drawing. (Admin Building)

**Description:** Mismatch was found between the as-built drawing and the actual site condition. During the inspection, bracing size was found 2L-50X50X4mm but in the as-built drawing, the bracing size was shown as 2L-63X63X5mm. The building engineer is required to survey the whole structure and update the as-built drawing as per the actual site condition.

| Serial No | Observation | Action Plan | Timeline |
|---|---|---|---|
| 1 | Mismatch in the as-built drawing. (Admin Building) | The building engineer is required to survey the whole structure and prepare accurate as-built drawings as per BNBC. | within 6 weeks |

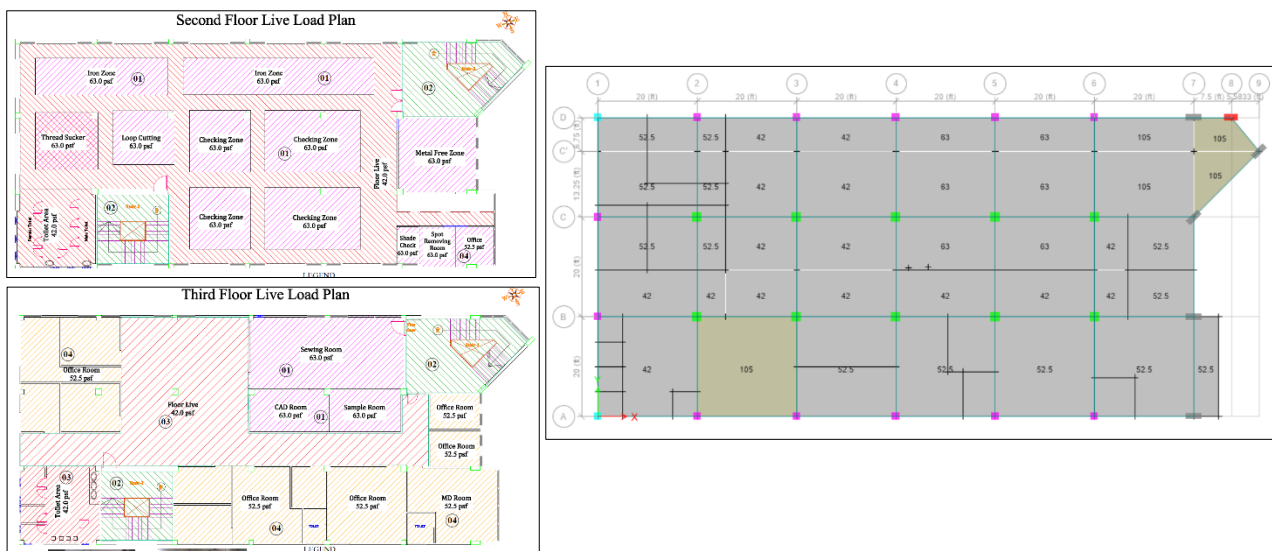
### Observation-2: Load plan does not comply with BNBC requirement (Admin Building).

**Description:** A set of load plans was prepared where 2kPa floor loading has been considered in the production floor area. Also assigned in the FEA model. The consideration of the 2kPa floor live load for the factory building does not comply with the minimum requirement of BNBC. The building engineer is required to revise the design documents for the building considering floor loading as per BNBC.

| Serial No | Observation | Action Plan | Timeline |
|---|---|---|---|
| 2 | The load plan does not comply with BNBC requirement (Admin Building). | Building Engineer to revise the design documents including loads, column and foundation capacity considering BNBC live load requirements. | within 6 weeks |
| 3 | The load plan does not comply with BNBC requirement (Admin Building). | Produce and actively manage a loading plan for all floor plates considering floor, column and foundation capacity. | within 6 weeks |
| 4 | The load plan does not comply with BNBC requirement (Admin Building). | Carry out remedial work where required. | within 6 months |
| 5 | The load plan does not comply with BNBC requirement (Admin Building). | Continue to implement the floor loading plan | within 6 months |

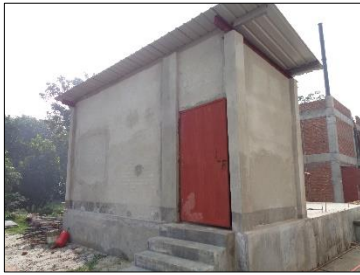
Fire Pump Room

**Description:** As built drawings of the Fire Pump Room, Security & RMS Room and Jhute Godown were not available on site at the time of inspection. The building engineer is required to prepare as built drawing of all these structures.

| Serial No | Observation | Action Plan | Timeline |
|---|---|---|---|
| 6 | Lack of as-built drawing (Fire Pump Room). | The building engineer is required to prepare as-built drawing for the structure. | within 6 weeks |
