# DANYS KNITWEAR LTD.

Surabari, Kashimpur, Gazipur sadar, Gazipur.

27<sup>th</sup> October 2015

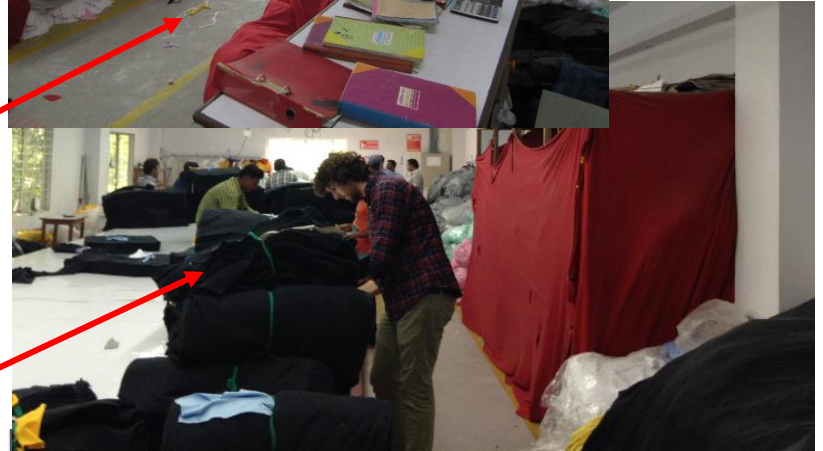
# Overloaded storage areas

| Item No. | Observation | Recommended Action Plan | Recommended Timeline |
|---|---|---|---|
| 1 | Overloaded storage areas | The quantity of the stored materials must be reduced to the level specified by the original designer | 6-weeks |
| 2 | Overloaded storage areas | Building Engineer to provide a Load Plan for each level | 6-weeks |
| 3 | Overloaded storage areas | Reduce loading to the recommendations of the loading plans | 6-months |

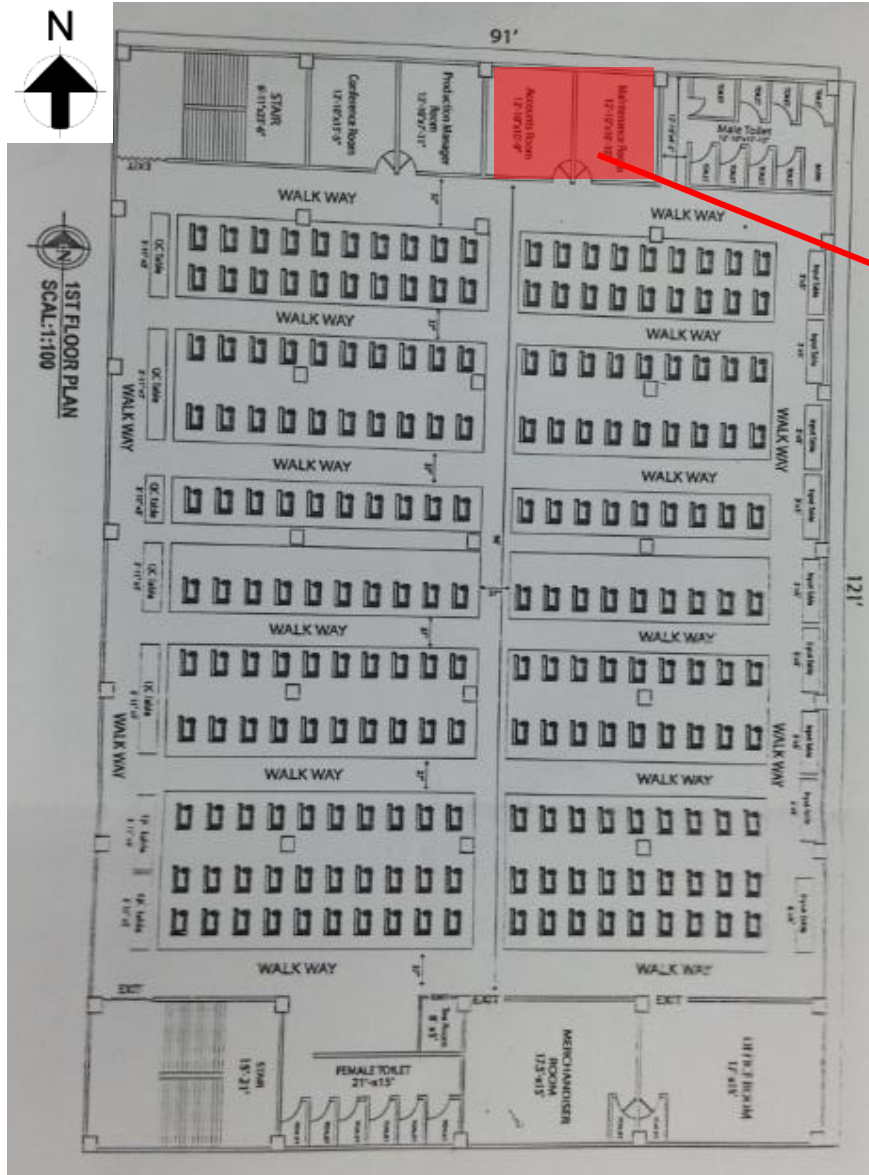
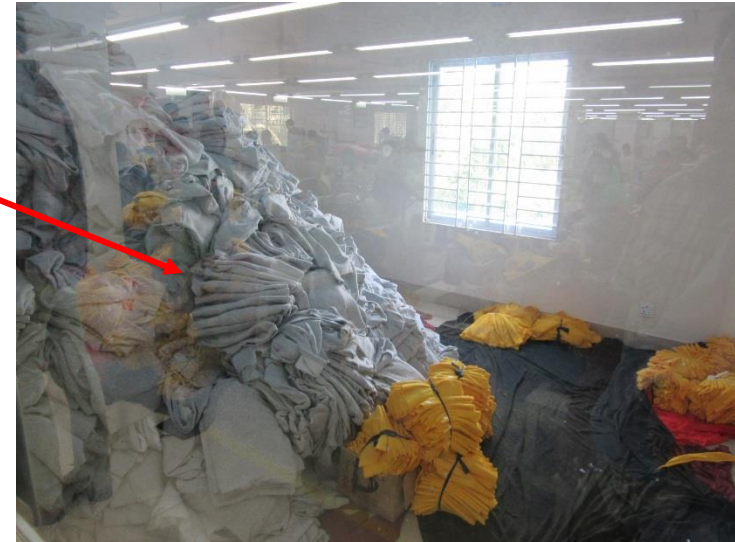
1<sup>st</sup> Floor. Uncontrolled storage area

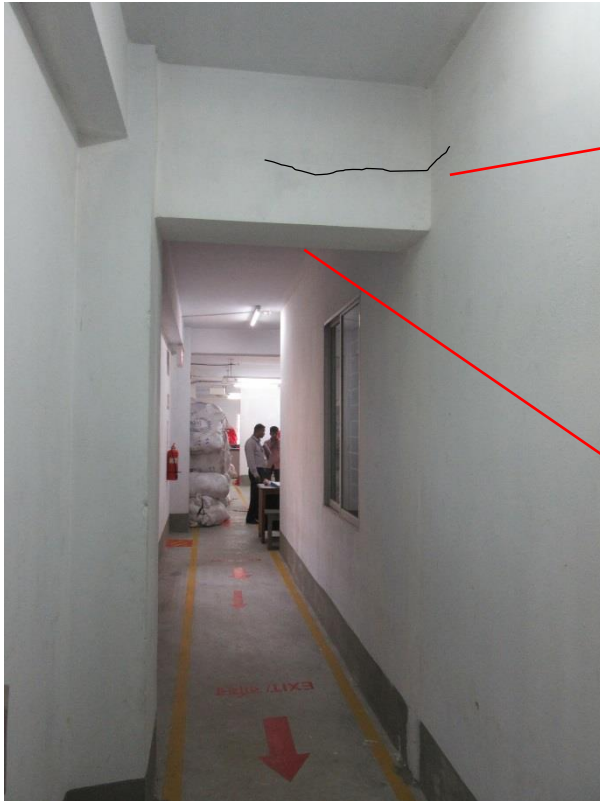
2nd Floor. Horizontal crack on the beam

| Item No. | Observation | Recommended Action Plan | Recommended Timeline |
|---|---|---|---|
| 4 | Cracks on the beams and partition walls | Remove the plaster and engage an Building Engineer to investigate the cracks on the beam | 6-weeks |

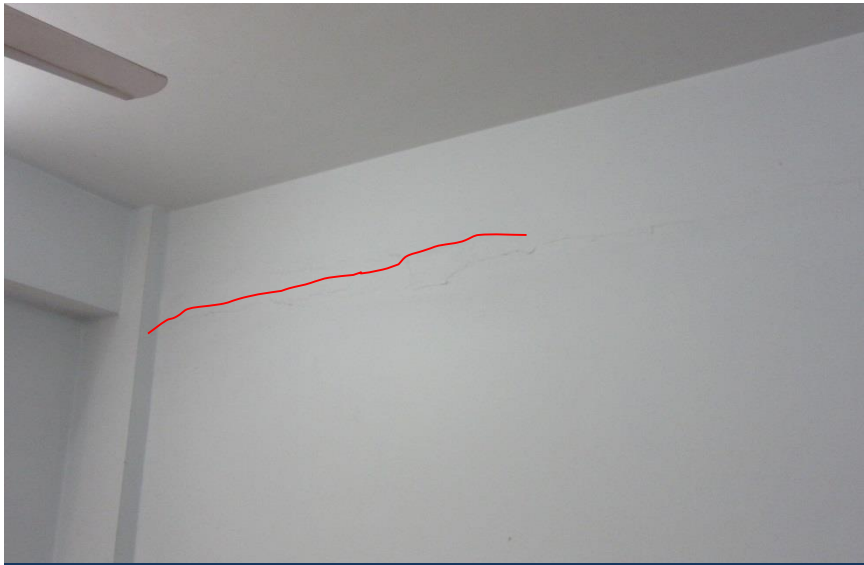
1st Floor. Horizontal crack on the partition walls

| Item No. | Observation | Recommended Action Plan | Recommended Timeline |
|---|---|---|---|
| 5 | Cracks on the beams and partition walls | Repair cracks on the partition walls | 6-months |

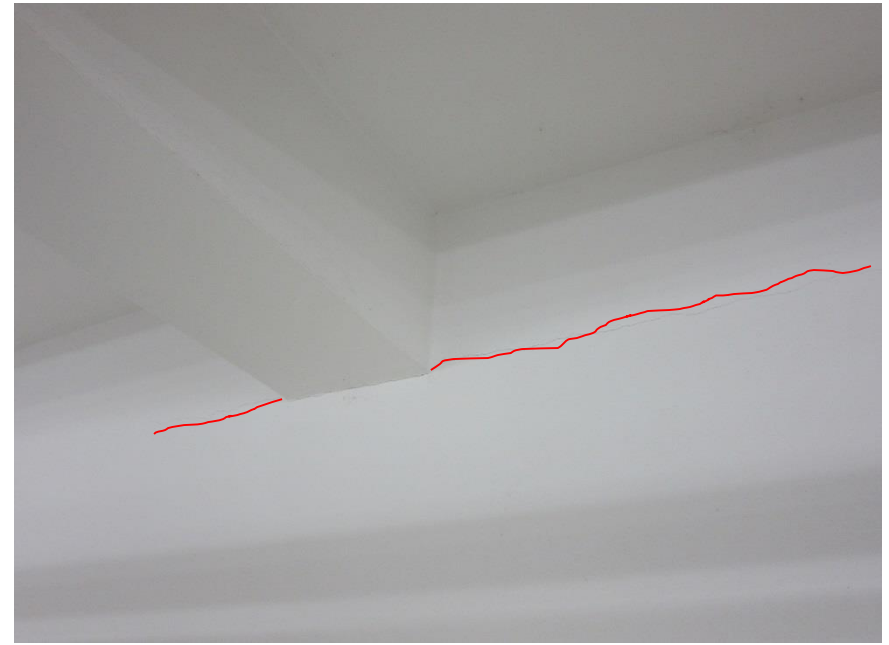
1st Floor. Horizontal crack on the partition walls

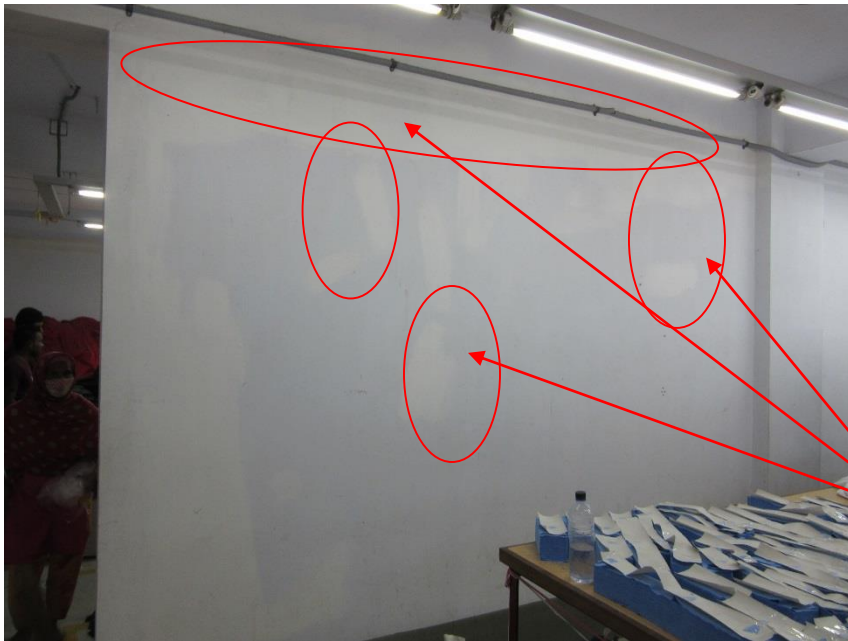
2nd Floor. Visible repairs on the partitions
