# DYNAMIC SWEATER IND. LTD

10, Ganda, Savar, Dhaka  
(23.827699N, 90.260594E)

1<sup>st</sup> November 2015

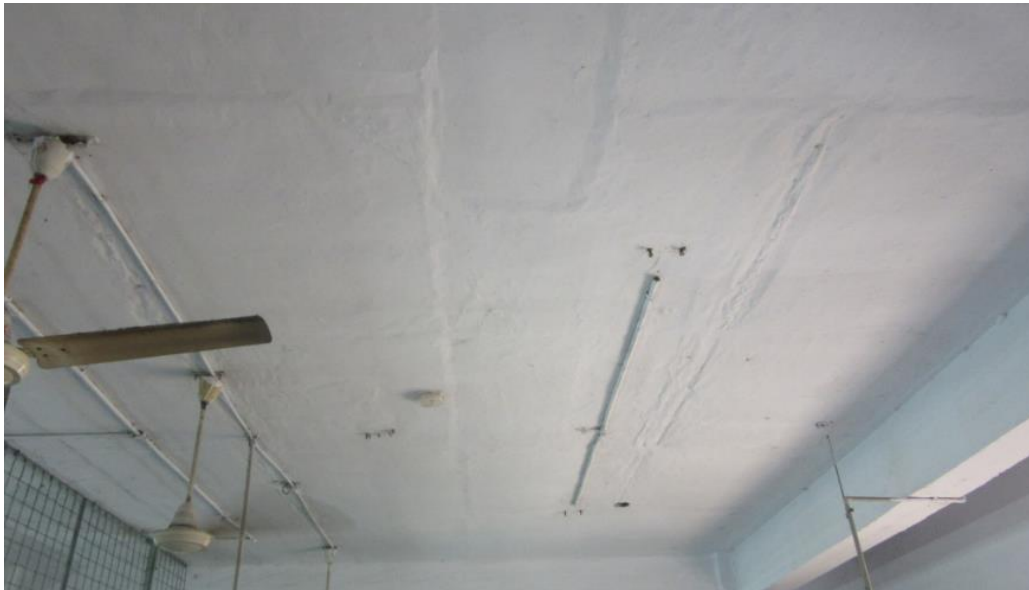
# **Poor construction quality of the RC elements observed**

**Uneven slab due to bad formwork**

| Item No. | Observation | Recommended Action Plan | Recommended Timeline |
|---|---|---|---|
| 1 | Poor construction quality of the RC elements observed | Building Engineer to investigate the quality of concrete on site and design remedial actions | 6-weeks |
| 2 | Poor construction quality of the RC elements observed | Carry out repairs to all voided concrete in accordance with the design engineers recommendations | 6-months |

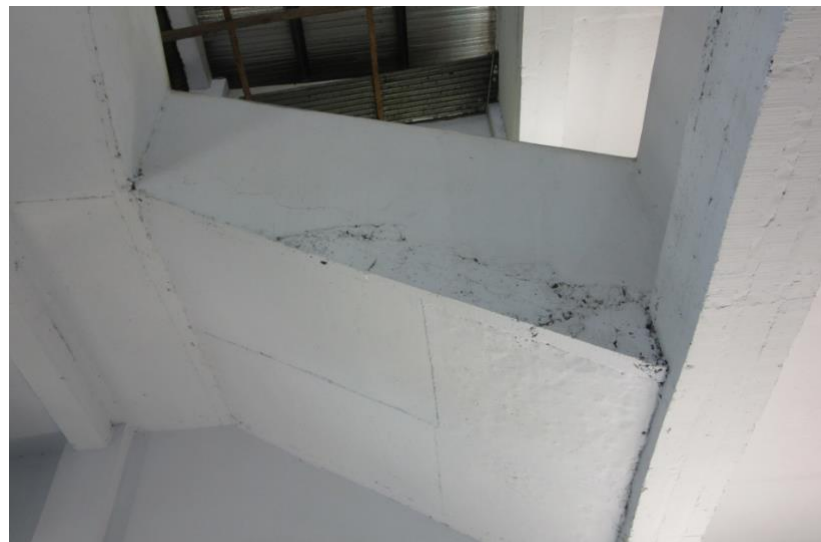
**Insufficiently compacted concrete**

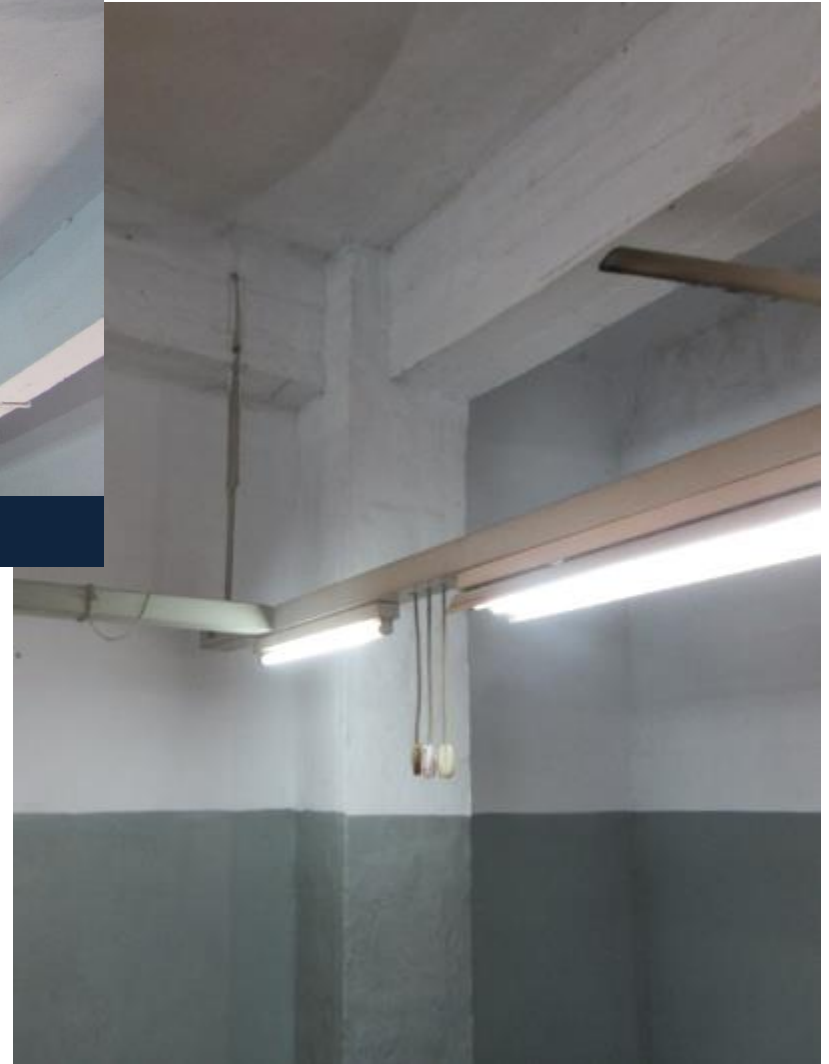
**Uneven slab due to bad formwork**

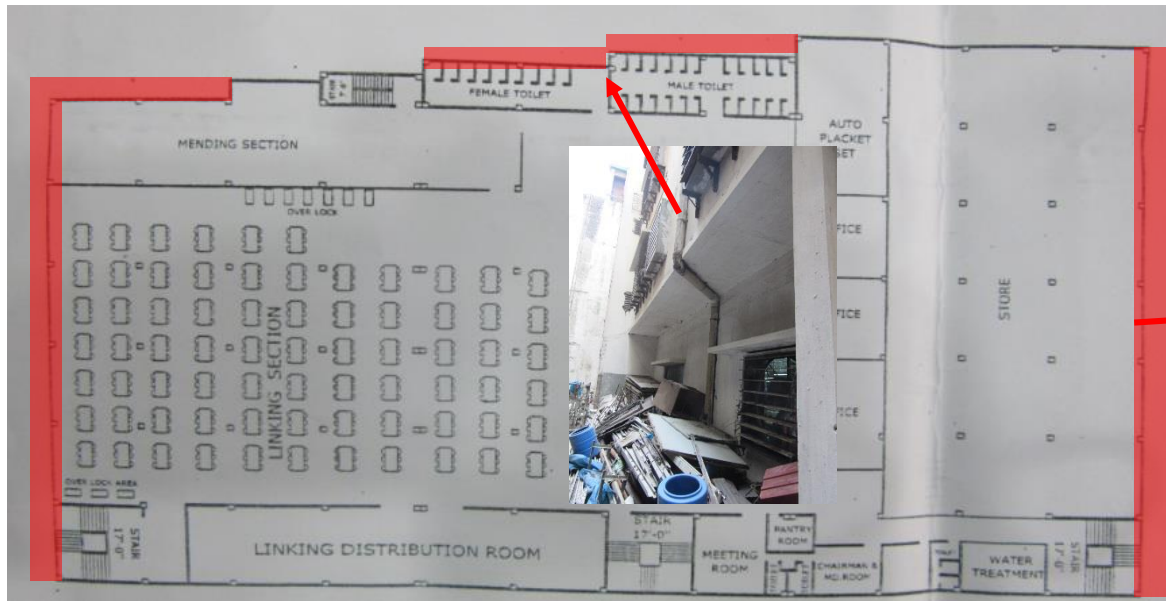
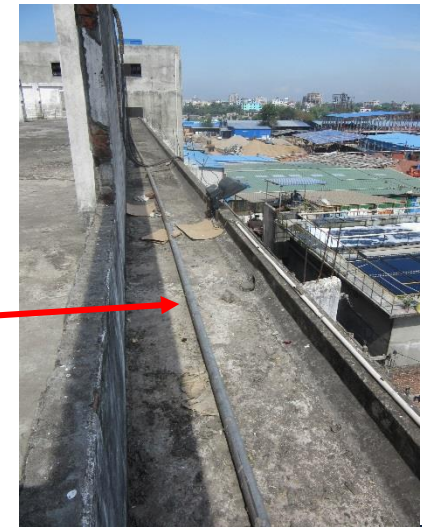
# **Discrepancy between Permit Drawings and Site observations**

**Additional cantilevers**

| Item No. | Observation | Recommended Action Plan | Recommended Timeline |
|---|---|---|---|
| 3 | Discrepancy between Permit Drawings and Site observations (additional cantilevers, additional level on the roof, apparent scope for future extension observed) | Building Engineer to prepare a set of as built drawings and static calculations | 6-weeks |
| 4 | Discrepancy between Permit Drawings and Site observations (additional cantilevers, additional level on the roof, apparent scope for future extension observed) | Any future extension should be based on structural engineering design and should be approved by proper Authorities | 6-months |

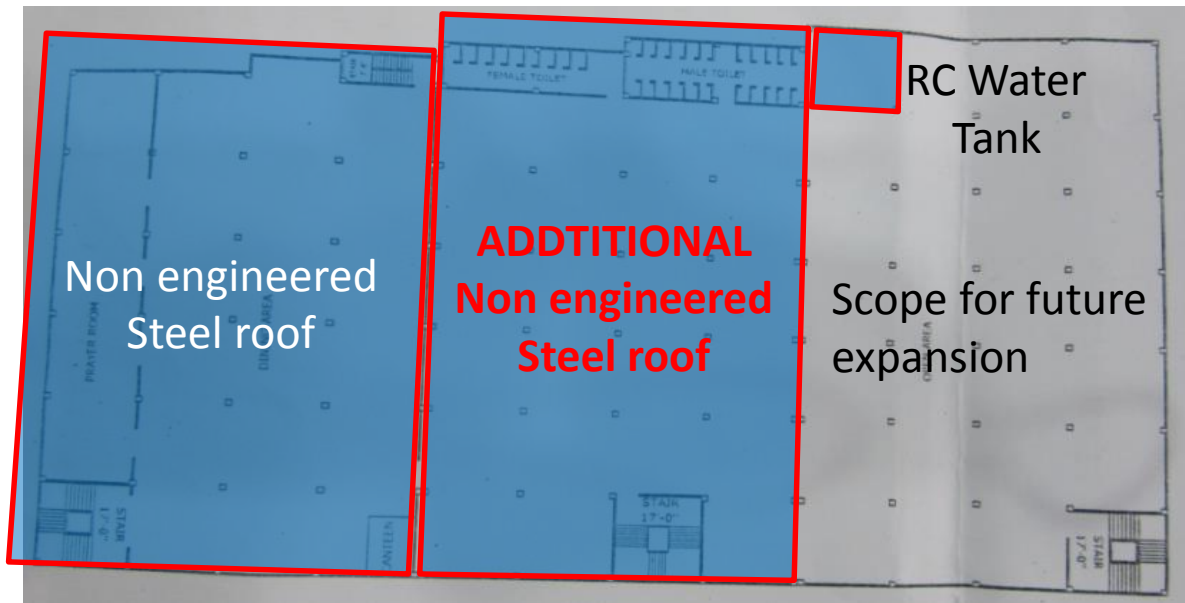
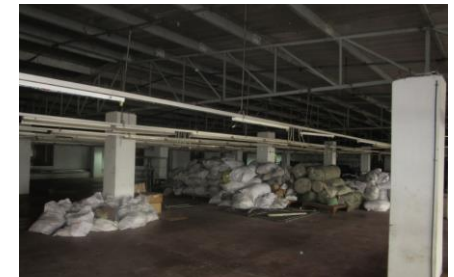
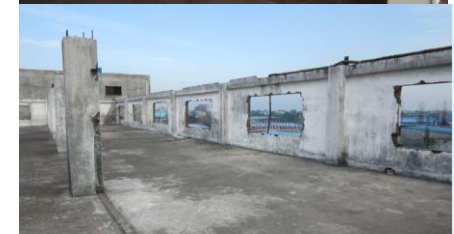
**Additional level**

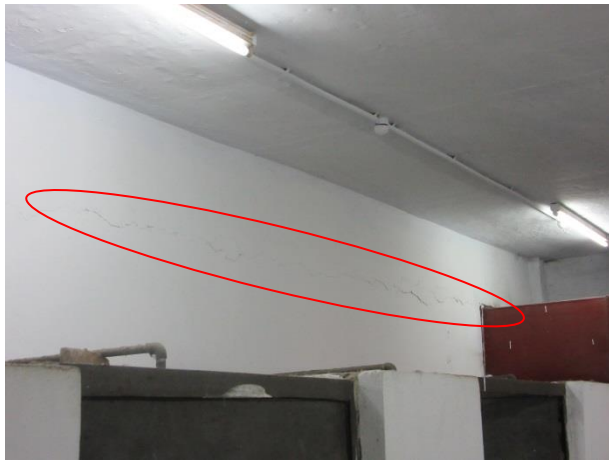
**3<sup>rd</sup> Floor**

# Cracks on the East façade wall

| Item No. | Observation | Recommended Action Plan | Recommended Timeline |
|---|---|---|---|
| 5 | Cracks on the façade walls | Repair cracks on the façade walls | 6-months |

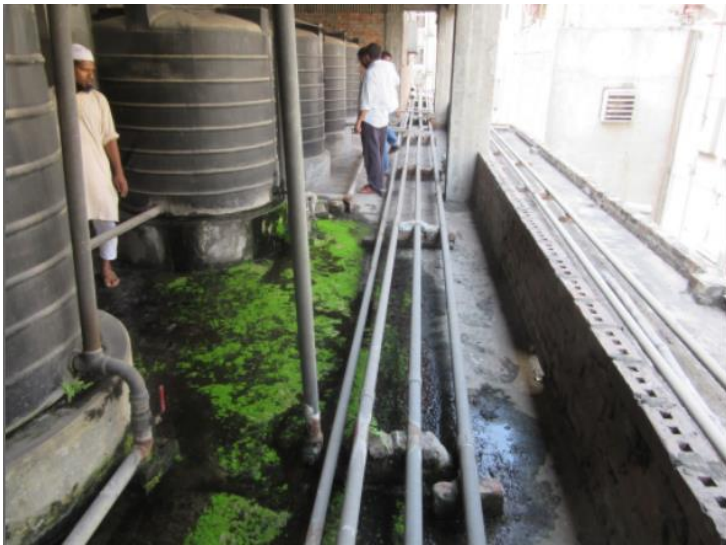
**Wet surface, leakages on the walls below  
water tanks**

**Standing water on the roof**

| Item No. | Observation | Recommended Action Plan | Recommended Timeline |
|---|---|---|---|
| 6 | Wet surface, leakage on the walls below water tanks | Building Engineer to check the cause of the water leak and it should be repaired | 6-months |

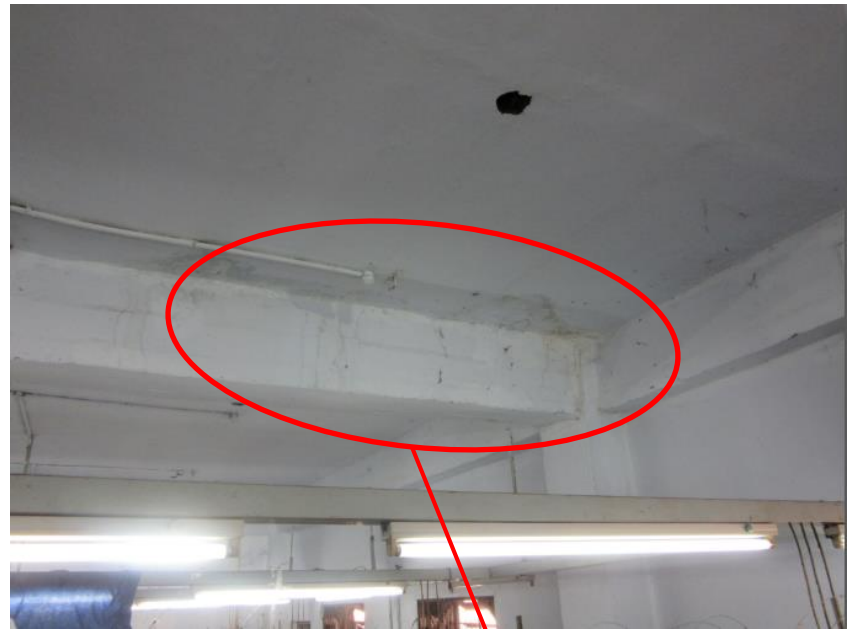
**Wet surfaces underneath the water tanks**

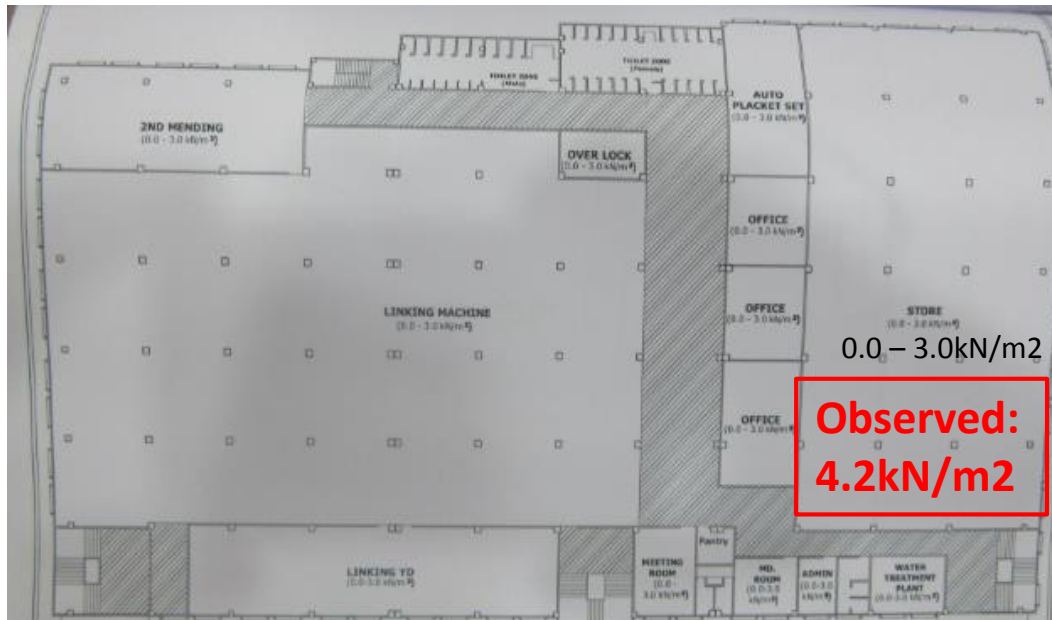
**1<sup>st</sup> Floor layout**

# Overloaded storage areas

| Item No. | Observation | Recommended Action Plan | Recommended Timeline |
|---|---|---|---|
| 7 | Overloaded Storage Areas | The quantity of the stored materials must be reduced to the level specified by the original designer | 6-weeks |
| 8 | Overloaded Storage Areas | Reduce loading to the recommendations of the loading plans | 6-months |

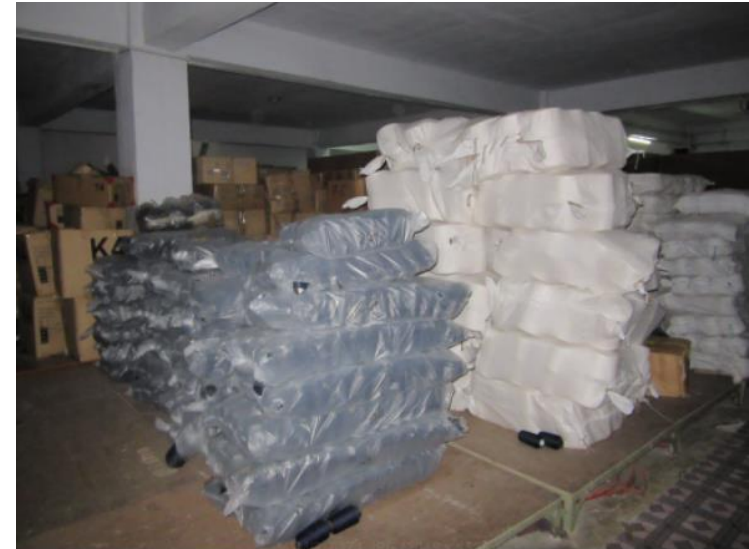
**Storage material on 1st floor**

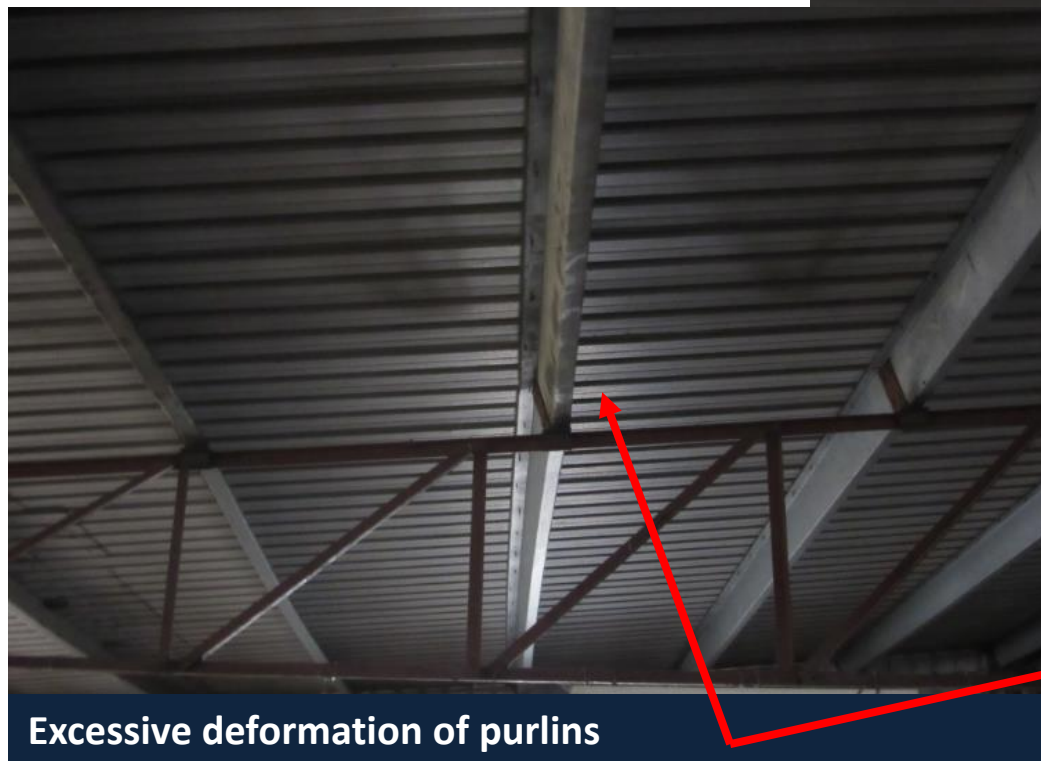
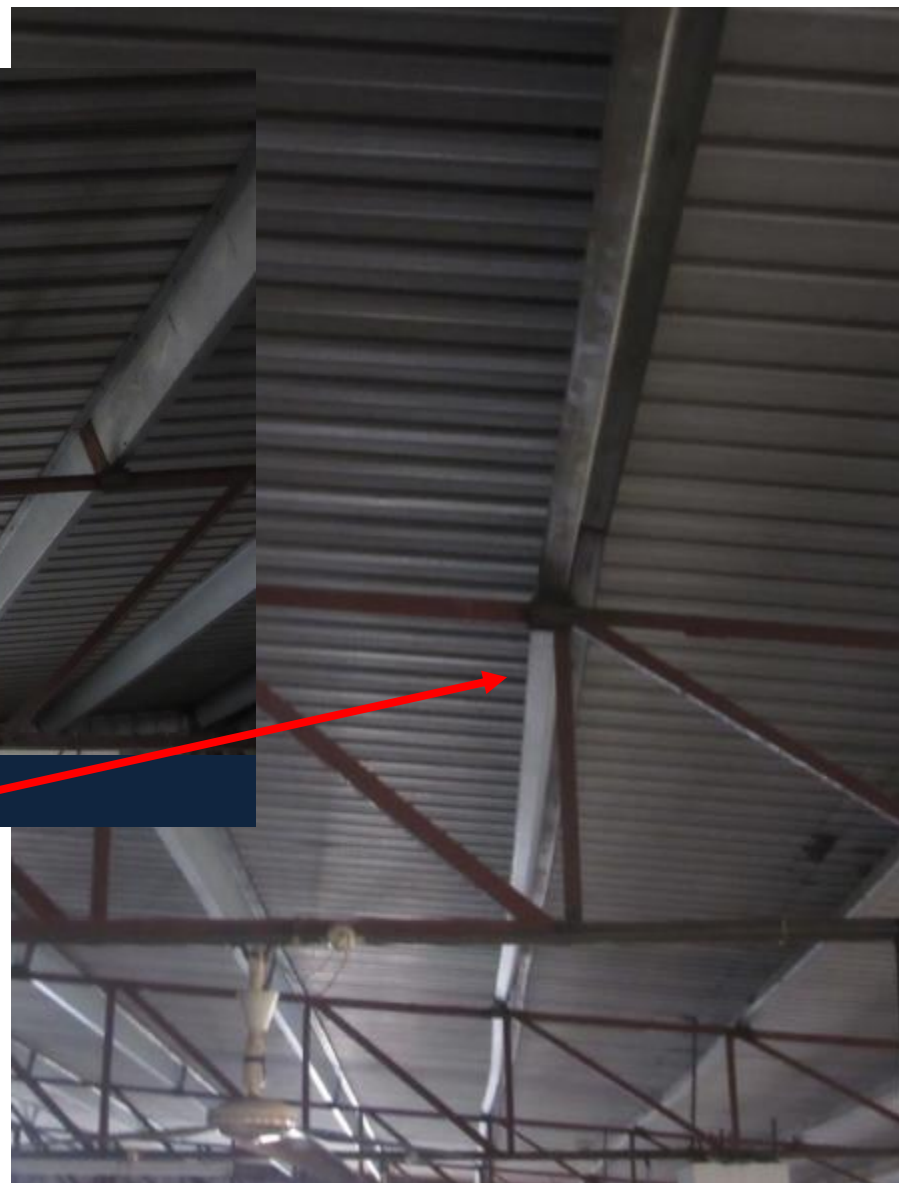
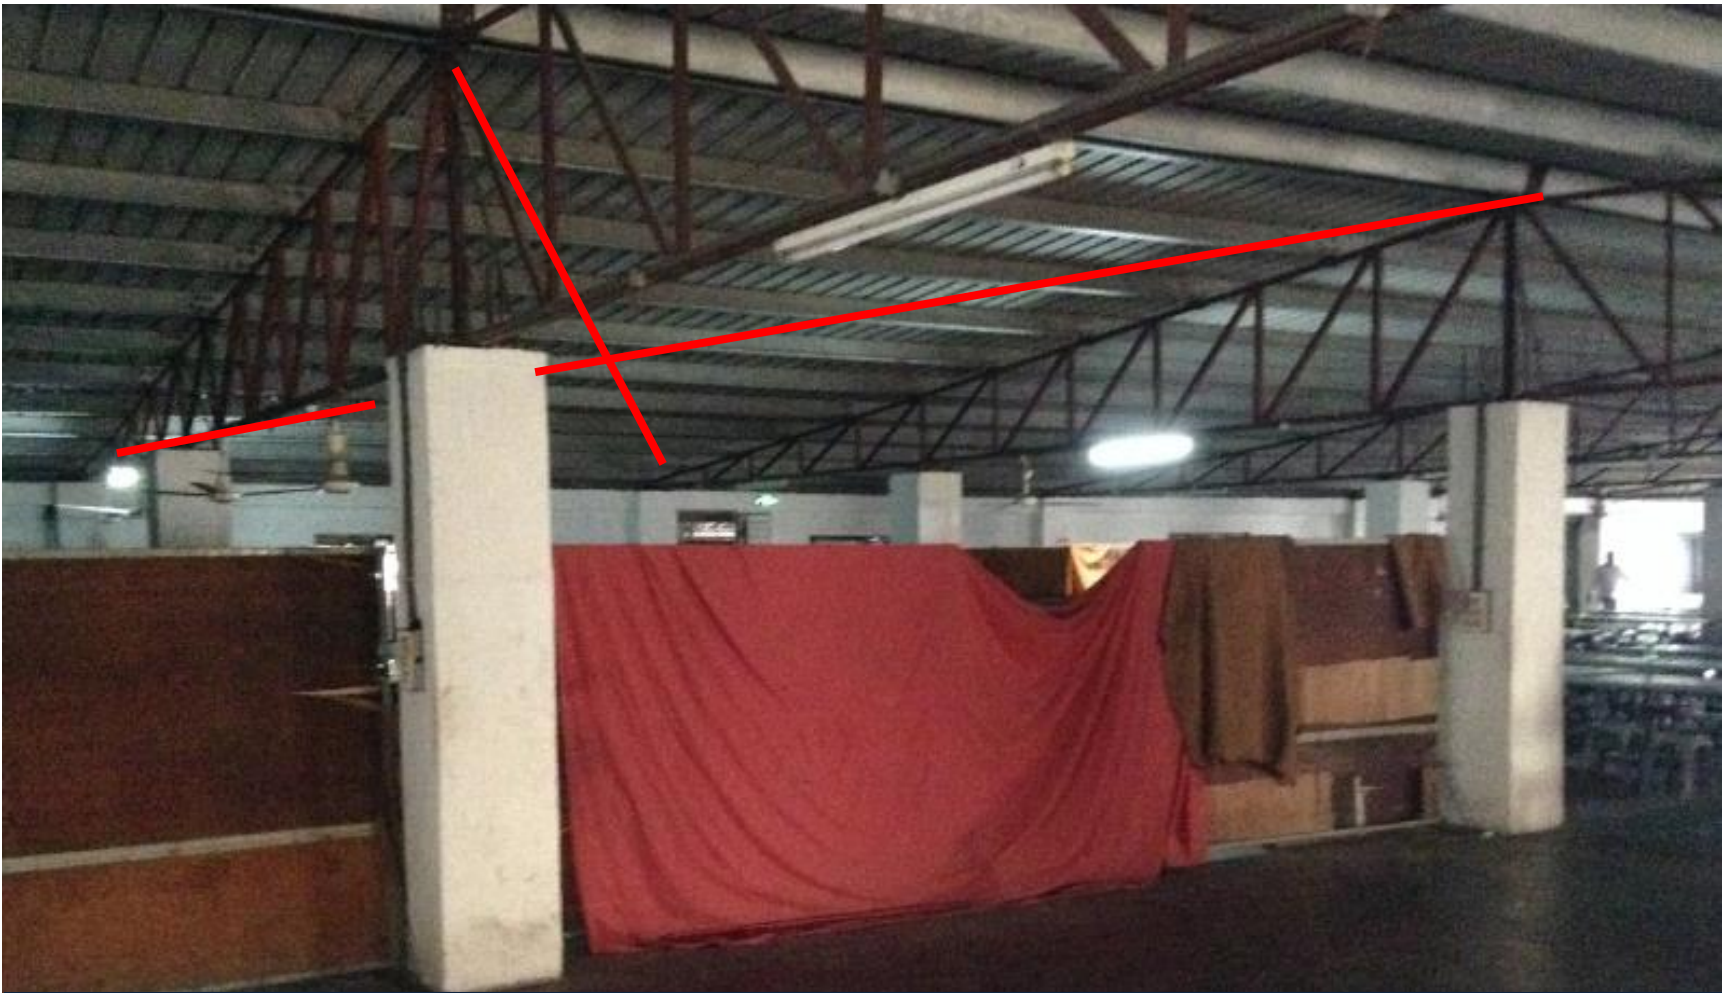
# **Non-engineered roof structure**

(Twisted purlins, lack of bracing, weak support details)

**Lack of bracing in roof structure**

| Item No. | Observation | Recommended Action Plan | Recommended Timeline |
|---|---|---|---|
| 9 | Non engineered steel roof (twisted purlins, lack of bracings, weak support details) | Building Engineer to check the capacity of the lightweight roofs | 6-weeks |
| 10 | Non engineered steel roof (twisted purlins, lack of bracings, weak support details) | Carry out any remedial works from the design Engineers study | 6-months |

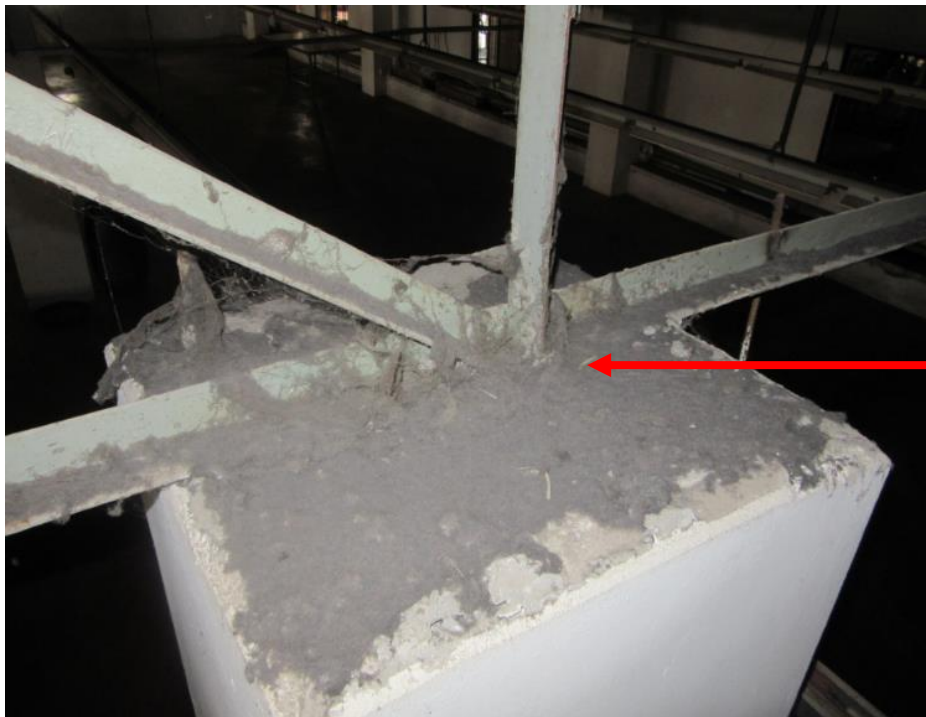
Non-engineered connections

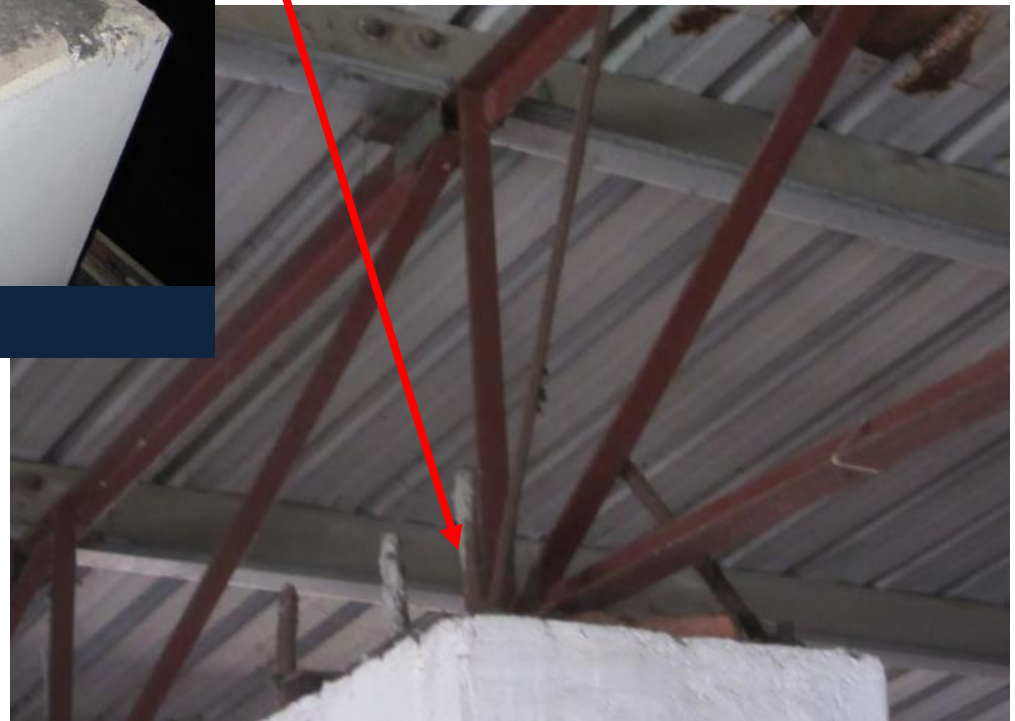
**Lack of anchors**
