# Pioneer Denim Limited (Garments Division)

Horitola, Shahpur Bazar, Madhabpur, Habiganj

4 January 2024

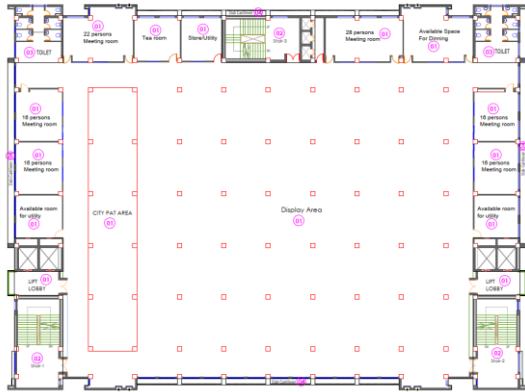
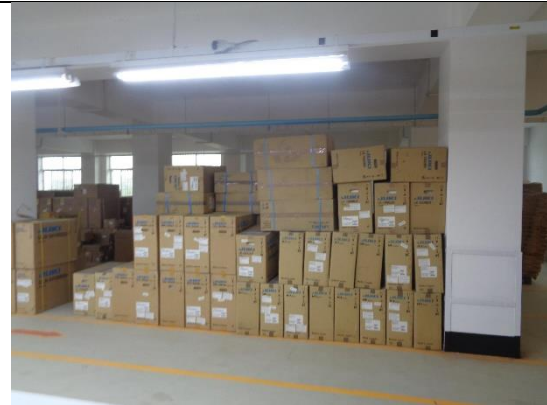
### Observation-1: Undesignated storage on 4<sup>th</sup> floor (Building-6: R&D Building).

**Description:** Undesignated storage found on the 4<sup>th</sup> floor. The building engineer is required to update the load plan considering 6 kPa for storage areas and check the design accordingly.

| Item No. | Observation | Action Plan | Timeline |
|---|---|---|---|
| 1 | Undesignated storage on 4th floor (Building-6: R&D Building). | The building engineer is required to update the load plan considering 6 kPa for storage areas and check the design accordingly. | within 6 weeks |

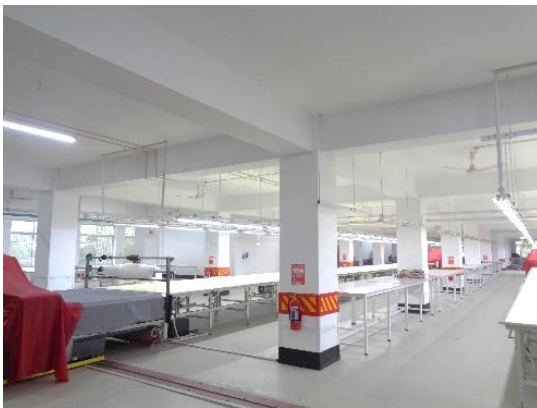
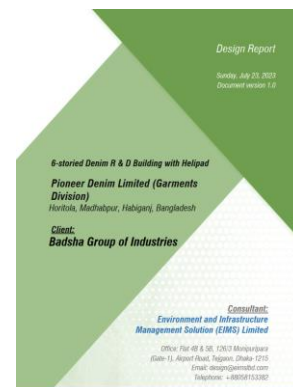
### Observation-2: Building needs to be checked against lateral loading (Building-6: R&D Building).

**Description:** At the time of inspection, a design report was available on site. The building engineer is required to check the structural members against lateral loading and the prepared design report is to be submitted to RSC for review.

| Item No. | Observation | Action Plan | Timeline |
|---|---|---|---|
| 2 | Building needs to be checked against lateral loading (Building-6: R&D Building). | The building engineer is required to check the structural members against lateral loading and the prepared design report is to be submitted to RSC for review. | within 6 weeks |
| 3 | Building needs to be checked against lateral loading (Building-6: R&D Building). | Implement any remediation work if required. | within 6 months |

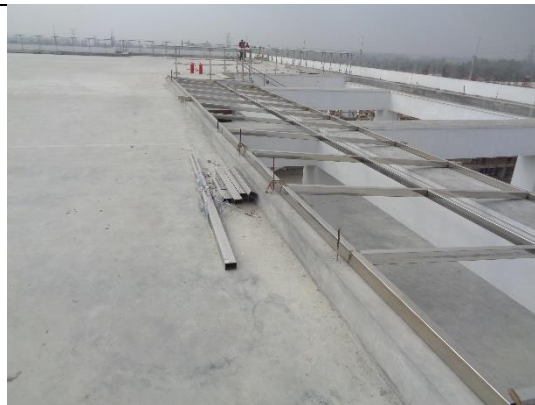
### Observation-3: Falling hazard at the roof (Building-6: R&D Building).

**Description:** No parapet/railing was found on the north side of the roof. The building engineer is required to provide edge protection to avoid falling hazards.

| Item No. | Observation | Action Plan | Timeline |
|---|---|---|---|
| 4 | Falling hazard at the roof (Building-6: R&D Building). | The building engineer is required to provide edge protection to avoid falling hazards. | within 6 weeks |

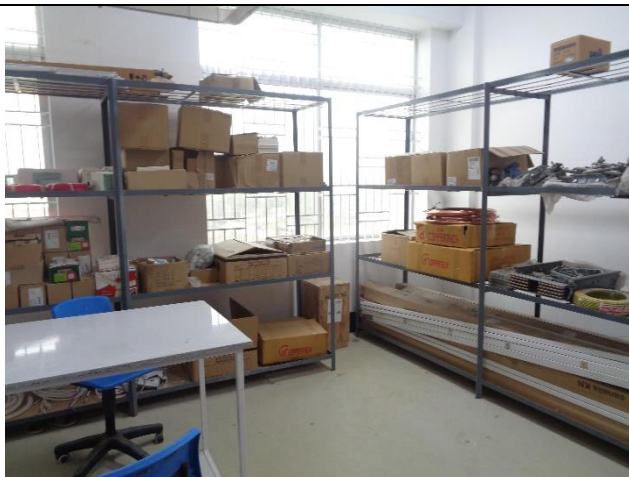
**Observation-4:** Nonstructural elements found not anchored/braced (Building-6: R&D Building).

**Description:** Nonstructural elements (storage racks) were found not anchored/braced. The building engineer is required to anchor/brace all nonstructural elements within the factory.

| Item No. | Observation | Action Plan | Timeline |
|---|---|---|---|
| 5 | Nonstructural elements found not anchored/braced (Building-6: R&D Building). | The building engineer is required to anchor/brace all non-structural elements. | within 6 weeks |

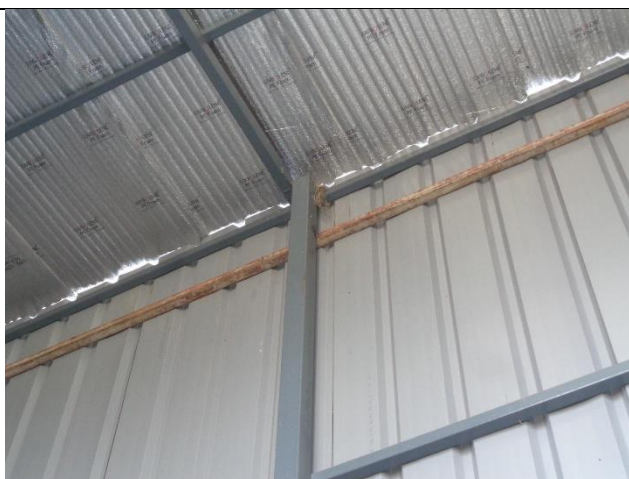
**Observation-5:** Poor connection between steel members (Boiler & Compressor Shed).

**Description:** Poor connection was found between the rafter and the column. The building engineer is required to provide proper anchorage to resist uplift forces.

| Item No. | Observation | Action Plan | Timeline |
|---|---|---|---|
| 6 | Poor connection between steel members (Boiler & Compressor Shed). | The building engineer is required to provide proper anchorage to resist uplift forces. | within 6 weeks |

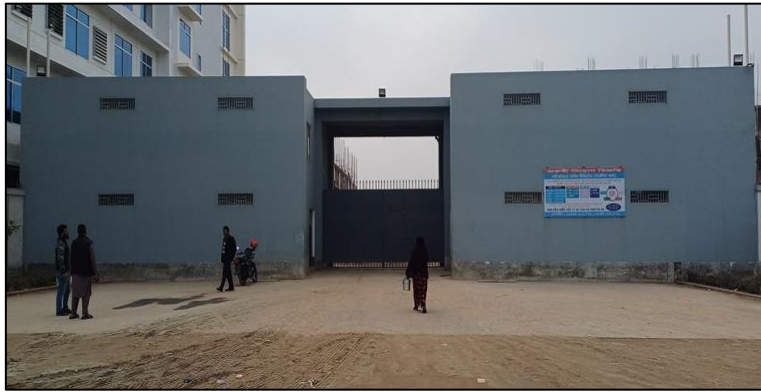
**Observation-6: Lack of design report (Gate Building -01)**

**Description:** As per BNBC, every building or structure designed shall have its design documents prepared following the provision of Section 1.9.1. The design documents shall include geotechnical investigation report, as-built drawings and a design report which shall be prepared in compliance with section 1.9.1, part-6 of BNBC.

During inspection, the design report was not available on site. The building engineer is required to prepare a design report based on in-situ material strength & software-based analysis and submit it to RSC for review.

| Item No. | Observation | Action Plan | Timeline |
|---|---|---|---|
| 7 | Lack of design report (Gate Building -01) | The building engineer is required to prepare a design report based on in-situ material strength & software-based analysis and submit the documents to RSC for review. | within 6 weeks |
| 8 | Lack of design report (Gate Building -01) | Carry out suggested remedial works if required. | within 6 months |

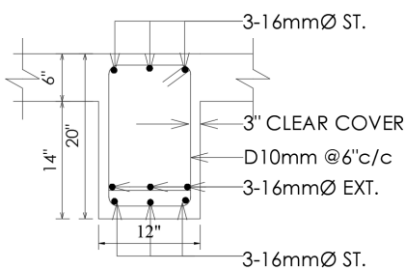
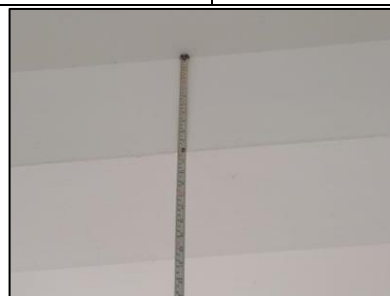
**Observation-7: Inconsistencies in as-built drawing. (Gate Building -01)**

C1 column size found 15"x15" instead of 17"x17"

C2 column size found 20"x20" instead of 22"x22"

The floor beam found 12"d/s instead of 14" d/s.

**Description:** C1 & C2 column size and floor beam size mentioned in the as-built drawing, does not match with on-site condition. The building engineer is required to survey the whole structure and update the as-built drawing.

| Item No. | Observation | Action Plan | Timeline |
|---|---|---|---|
| 9 | Inconsistencies in as-built drawing. (Gate Building -01) | The building engineer is required to survey the whole structure and update the as-built drawing. | within 6 weeks |

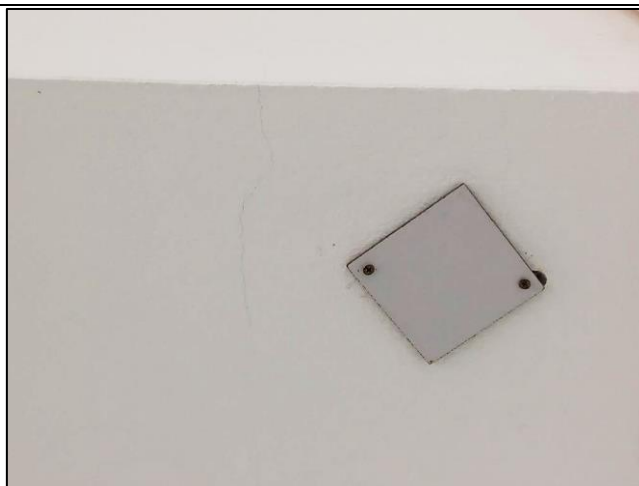
**Observation-8:** Hairline crack on beam. (Gate Building -01)

**Description:** Hairline crack found on floor beam. The building engineer is required to identify the reason for the crack and take remedial measures to repair the beam accordingly.

| Item No. | Observation | Action Plan | Timeline |
|---|---|---|---|
| 10 | Hairline crack on beam. (Gate Building -01) | The building engineer is required to identify the reason for the crack and take remedial measures to repair the beam accordingly. | within 6 weeks |

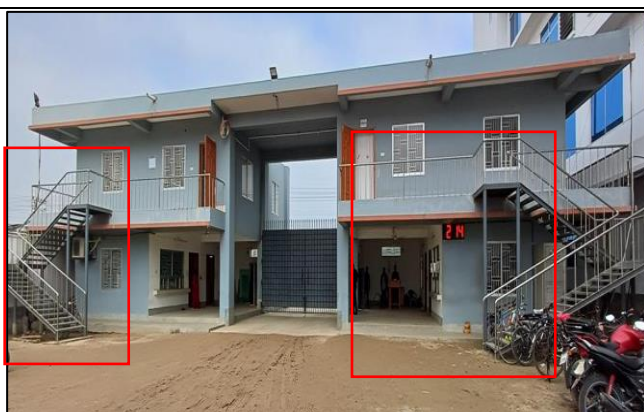
**Observation-9:** Adequacy of steel stairs need to be checked. (Gate Building -01)

**Description:** Inadequate structural connection details were found in the steel stairs. Building engineer is required to check the adequacy of the steel stair.

| Item No. | Observation | Action Plan | Timeline |
|---|---|---|---|
| 11 | Adequacy of steel stairs need to be checked. (Gate Building -01) | Building engineer is required to check the adequacy of the steel stair. | within 6 weeks |
| 12 | Adequacy of steel stairs need to be checked. (Gate Building -01) | Carry out suggested remedial works if required. | within 6 months |

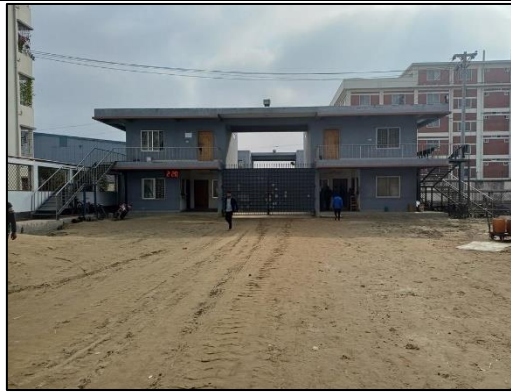
**Observation-10: Lack of design report (Gate Building -02)**

**Description:** As per BNBC, every building or structure designed shall have its design documents prepared following the provision of Section 1.9.1. The design documents shall include geotechnical investigation report, as-built drawings and a design report which shall be prepared in compliance with section 1.9.1, part-6 of BNBC.

During inspection, the design report was not available on site. The building engineer is required to prepare a design report based on in-situ material strength & software-based analysis and submit it to RSC for review.

| 13 | Lack of design report (Gate Building -02) | The building engineer is required to prepare a design report based on in-situ material strength & software-based analysis and submit it to RSC for review. | within 6 weeks |
| 14 | Lack of design report (Gate Building -02) | Implement any remediation work if required. | within 6 months |

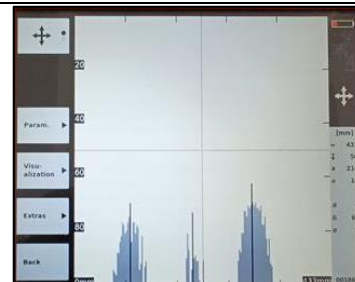
**a.** C1 column size found 15"x15" instead of 17"x17".  
**b.** 8-nos of rebar found instead of 12 nos

| 15 | Inconsistencies in as-built drawing. (Gate Building -02) | The building engineer is required to survey the whole structure and update the as-built drawing. | within 6 weeks |

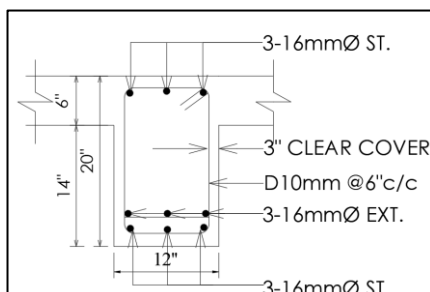
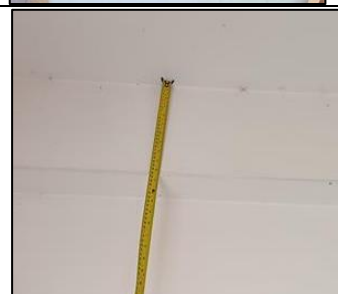
C2 column size found 20"x20" instead of 22"x22"

Floor beam found 10" d/s instead of 14" d/s.

**Description:** C1 & C2 column size, rebar number and floor beam size mentioned in as-built drawing, did not match with on-site condition. The building engineer is required to survey the whole structure and update the as-built drawing.

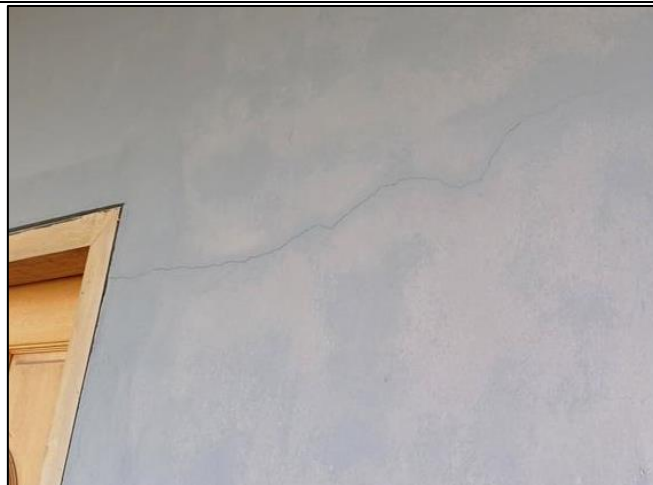
**Observation-12:** Crack on wall. (Gate Building -02)

**Description:** Crack found on wall. The building engineer is required to identify the reason for the crack and take remedial measures to repair the wall accordingly.

| 16 | Crack on the wall. (Gate Building -02) | The building engineer is required to identify the reason for the crack and take remedial measures to repair the wall accordingly. | within 6 months |

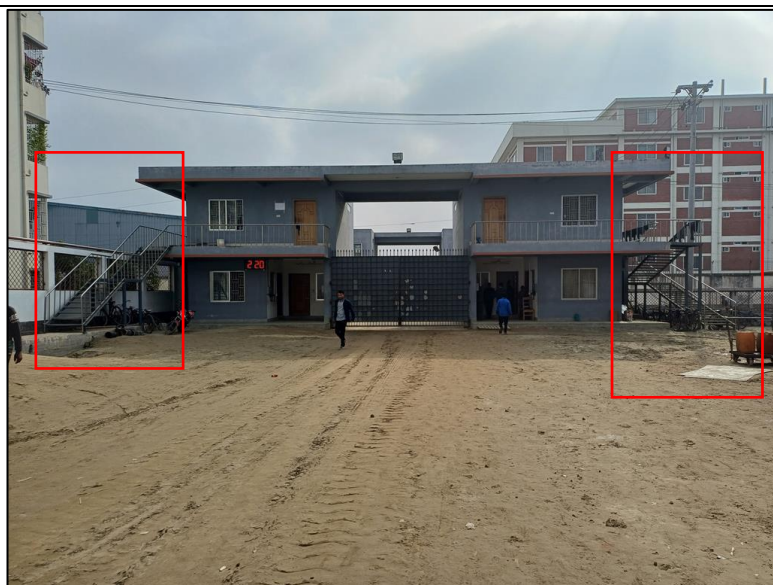
**Observation 13:** Adequacy of steel stairs need to be checked. (Gate Building -02)

**Description:** Inadequate structural connection details were found in the steel stairs. Building engineer is required to check the adequacy of the steel stair.

| 17 | Adequacy of steel stairs need to be checked. (Gate Building -02) | Building engineer is required to check the adequacy of the steel stair. | within 6 weeks |
| 18 | Adequacy of steel stairs need to be checked. (Gate Building -02) | Carry out suggested remedial works if required. | within 6 months |

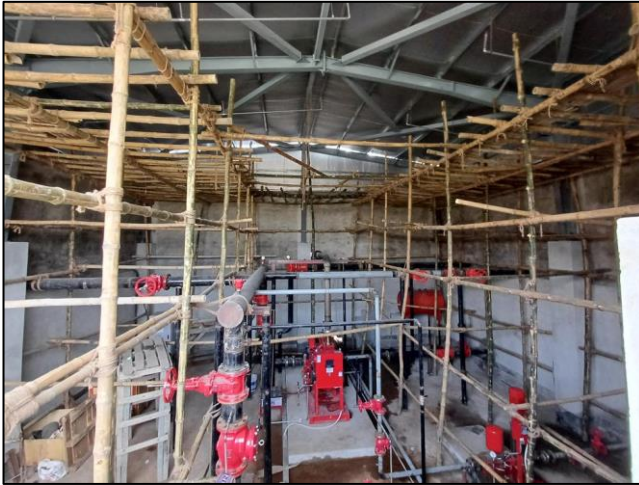
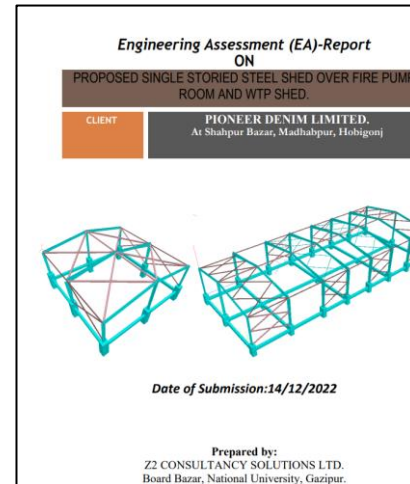
**Observation-14:** Structure needs to be checked against lateral loading (Fire Hydrant Shed)

**Description:** At the time of inspection, a design report was available on site. The building engineer is required to check the structural members against lateral loading and the prepared design report is to be submitted to RSC for review.

| 19 | Structure needs to be checked against lateral loading (Fire Hydrant Shed) | The building engineer is required to check the structural members against lateral loading and the prepared design report is to be submitted to RSC for review. | within 6 weeks |
| 20 | Structure needs to be checked against lateral loading (Fire Hydrant Shed) | Carry out suggested remedial works if required. | within 6 months |

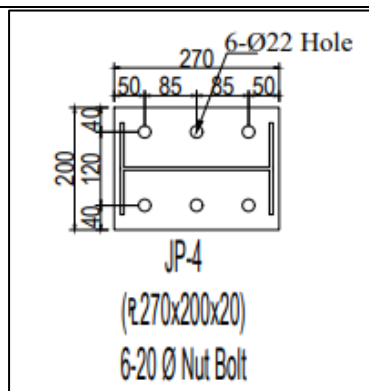
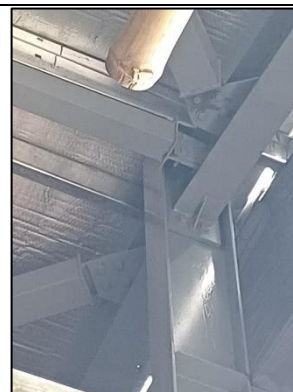
**Observation-15:** Inconsistencies in as-built drawing. (Fire Hydrant Shed)

**Description:** In Joint JP4, 8 nos bolts are found instead of 6 nos and bolt orientation is also different from as-built drawing. The building engineer is required to survey the whole structure and update the as-built drawing.

| 21 | Inconsistencies in as-built drawing. (Fire Hydrant Shed) | The building engineer is required to survey the whole structure and update the as-built drawing. | within 6 weeks |

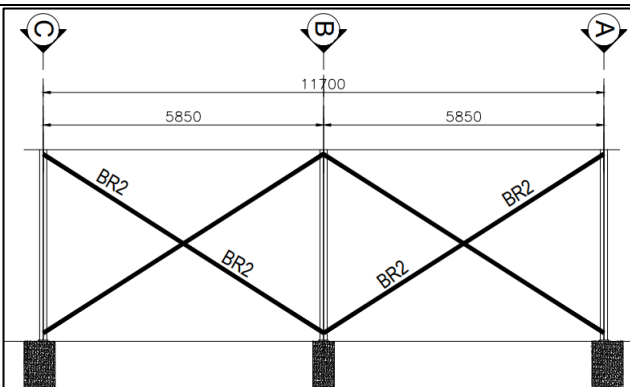
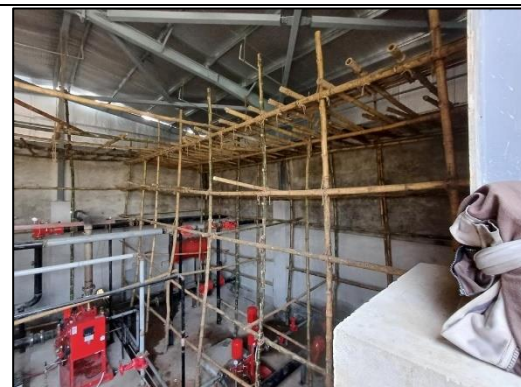
**Observation 16:** Wall bracing is not installed. (Fire Hydrant Shed)

**Description:** Wall bracings were not installed at the time of inspection. The building engineer is required to install the wall bracing according to the design drawing to complete the lateral stability system.

| 22 | Wall bracing is not installed. (Fire Hydrant Shed) | The building engineer is required to install the wall bracing according to the design drawing to complete the lateral stability. | within 6 weeks |
