APS KNIT COMPOSITE LTD.

Kamargaon, Pubail Road, Gazipur Sadar, Gazipur
(23.928538 N, 90.445495 E)

31st October 2015

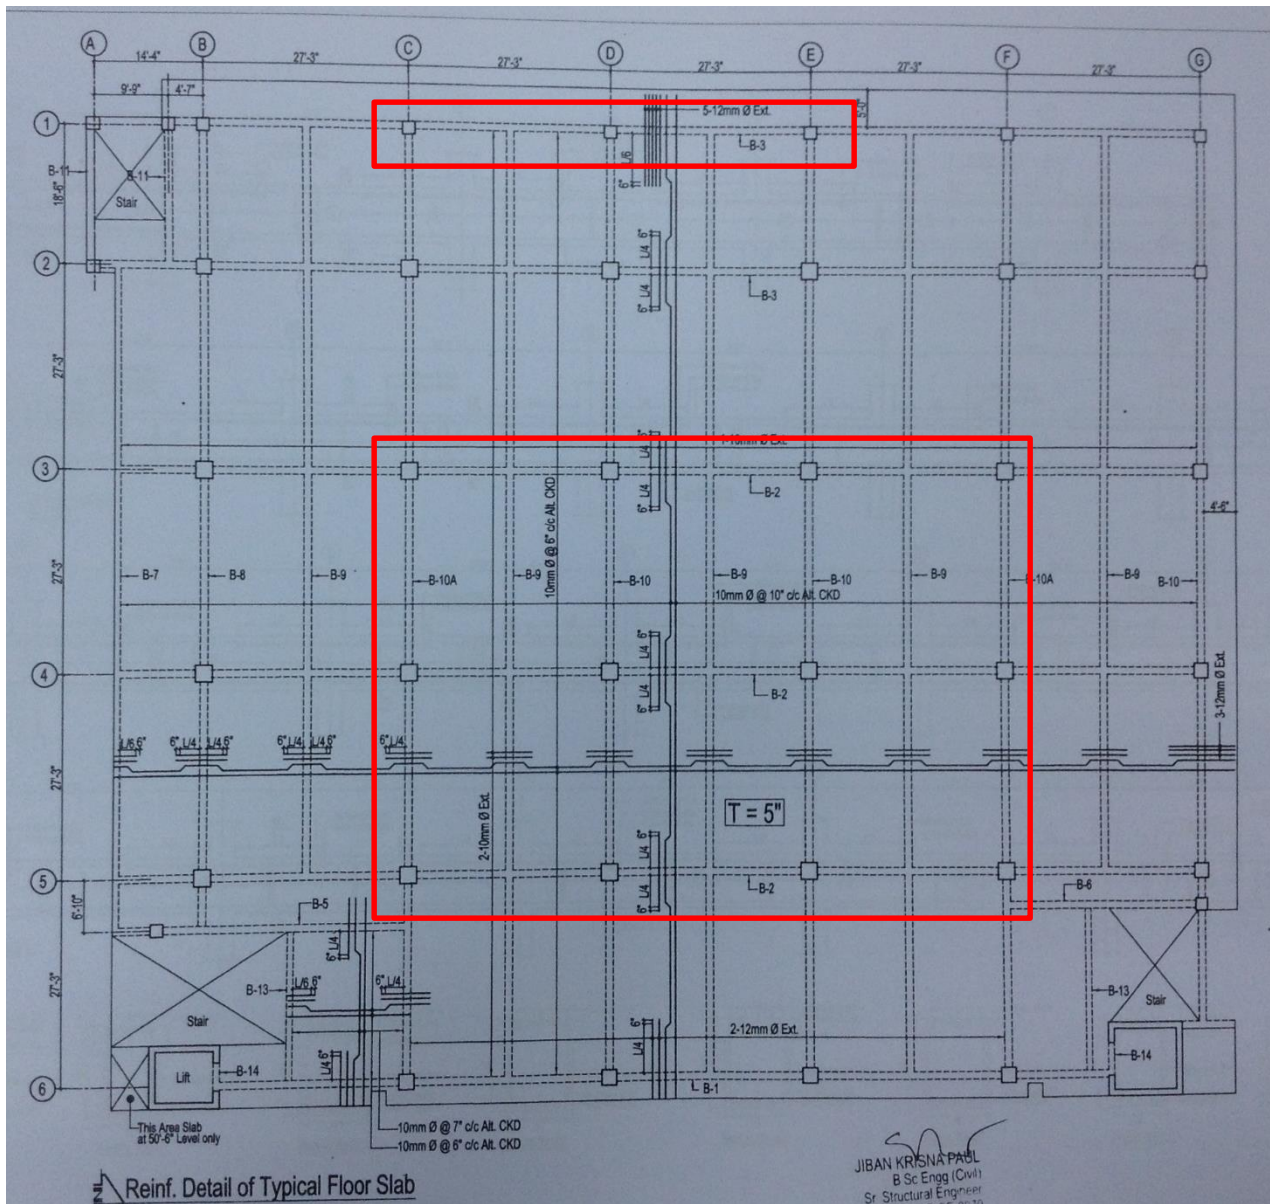
Stress Level of Columns (In Case of 9-storey Building)

Columns at marked areas have high stress level in case of final state (9-storey)

Item No.	Observation	Recommended Action Plan	Recommended Timeline
1	Stress Level in Columns	At the current state of the building, stress level at columns is low however when the 9-storey building (final stage) was checked it was found to be high. Verification of concrete strength should be made by core sample tests before proceeding with the construction.	6-months
2	Stress Level in Columns	Make structural alterations if required as advised by Engineer.	6-months
3	Hairline Cracks at First Floor Slab	The First Floor is used as a storage area and cracks observed at the bottom face of the slab, most probably due to excessive loading. The cracks should be monitored and the loading should be limited with the advise of the Building Engineer.	6-weeks
4	Hairline Cracks at First Floor Slab	Loading plan should be prepared by the Building Engineer for the storage areas.	6-weeks
5	Hairline Cracks at First Floor Slab	Necessary structural alterations should be done based on the outcome of the investigations.	6-months

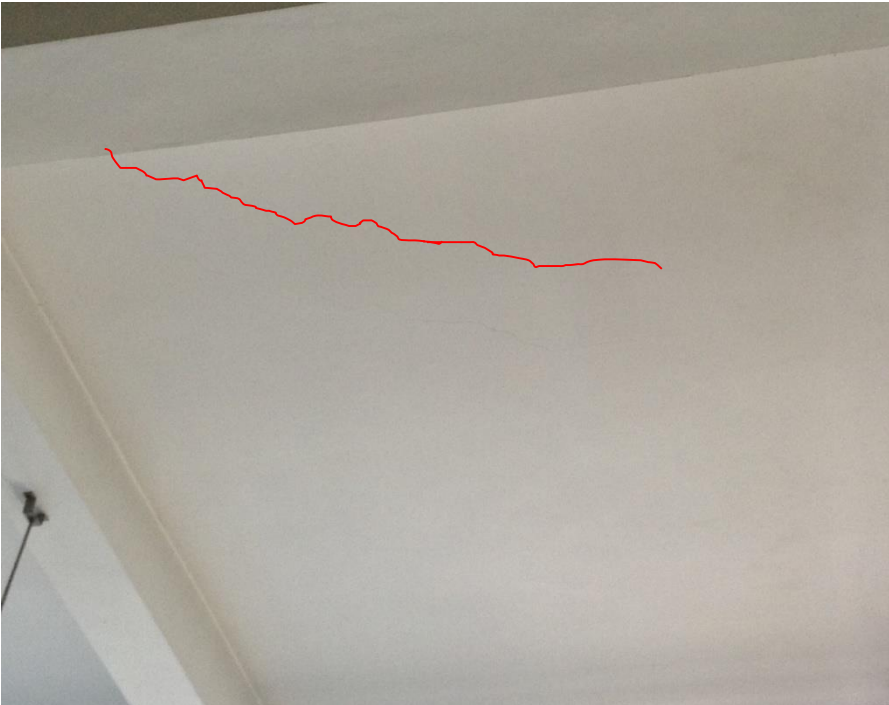
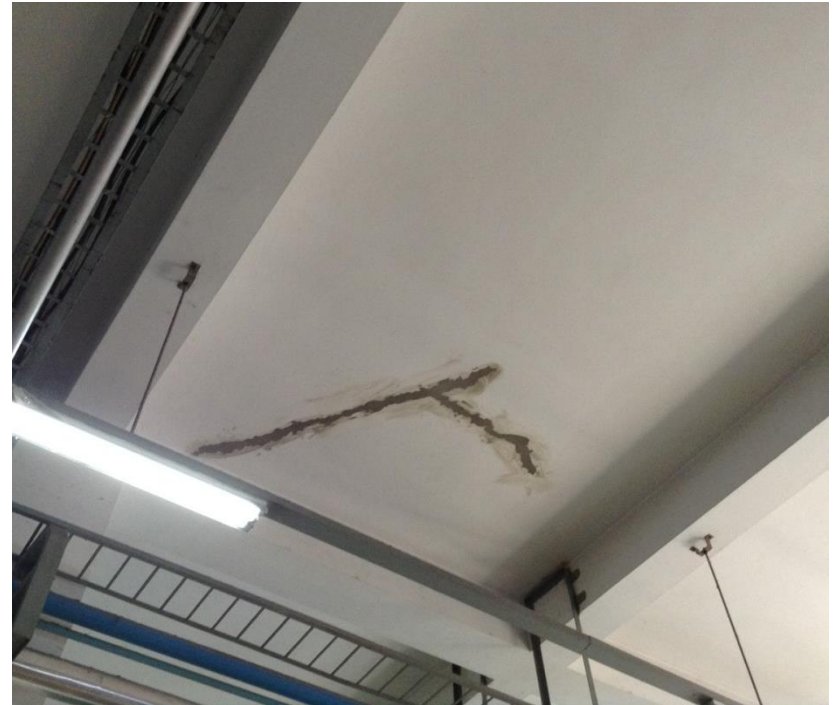
Cracks at First Floor Slab

Hairline cracks observed at the bottom part of the first floor slab on which heavy loads are being applied due to stored materials.

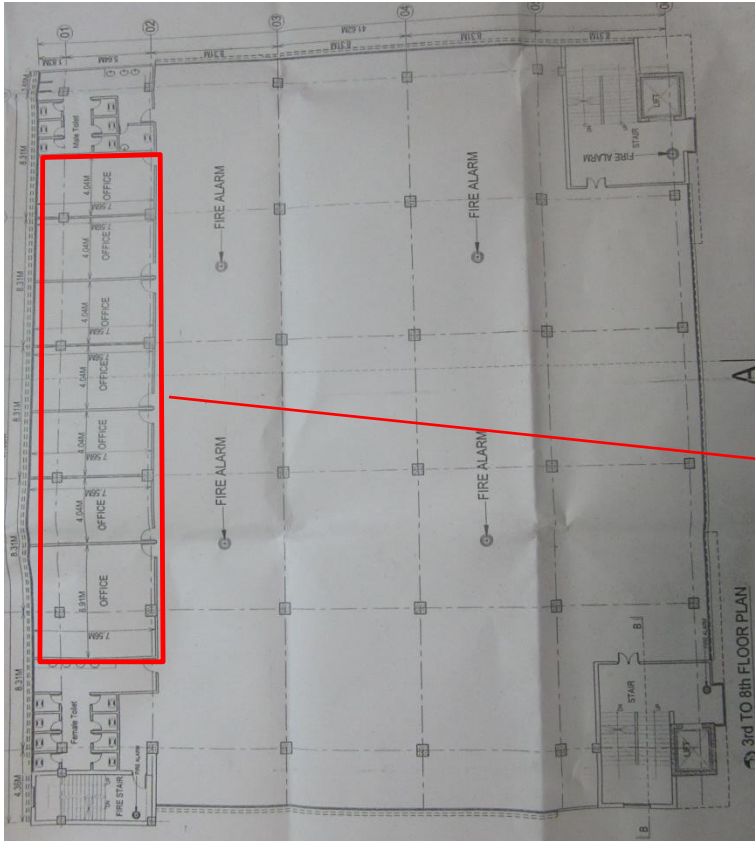
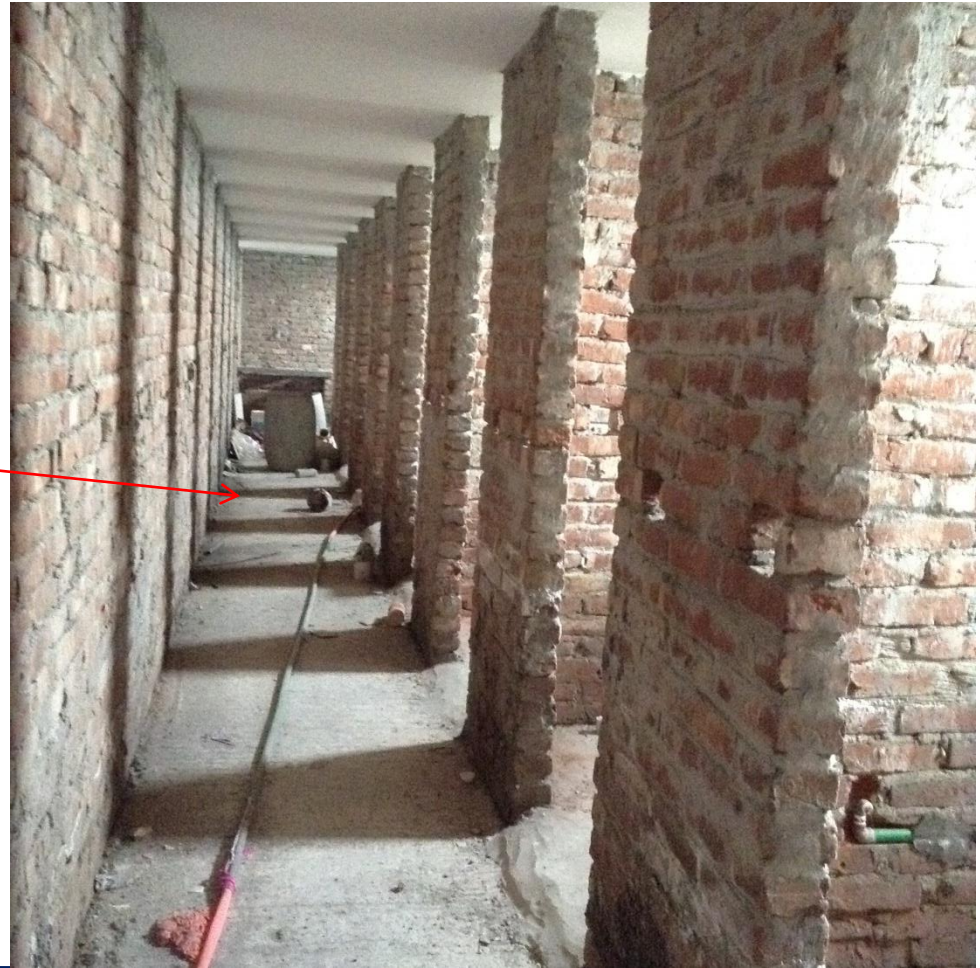
Layout Permit Drawing

On 5th floor there was a large toilet area instead of office room on West end of building which was not present on permit drawing.

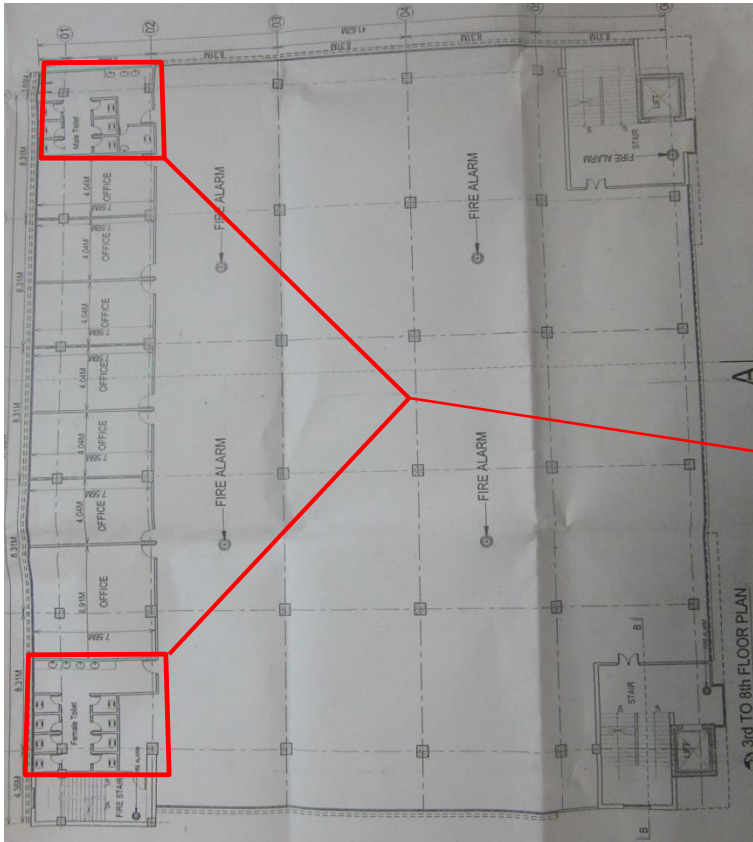
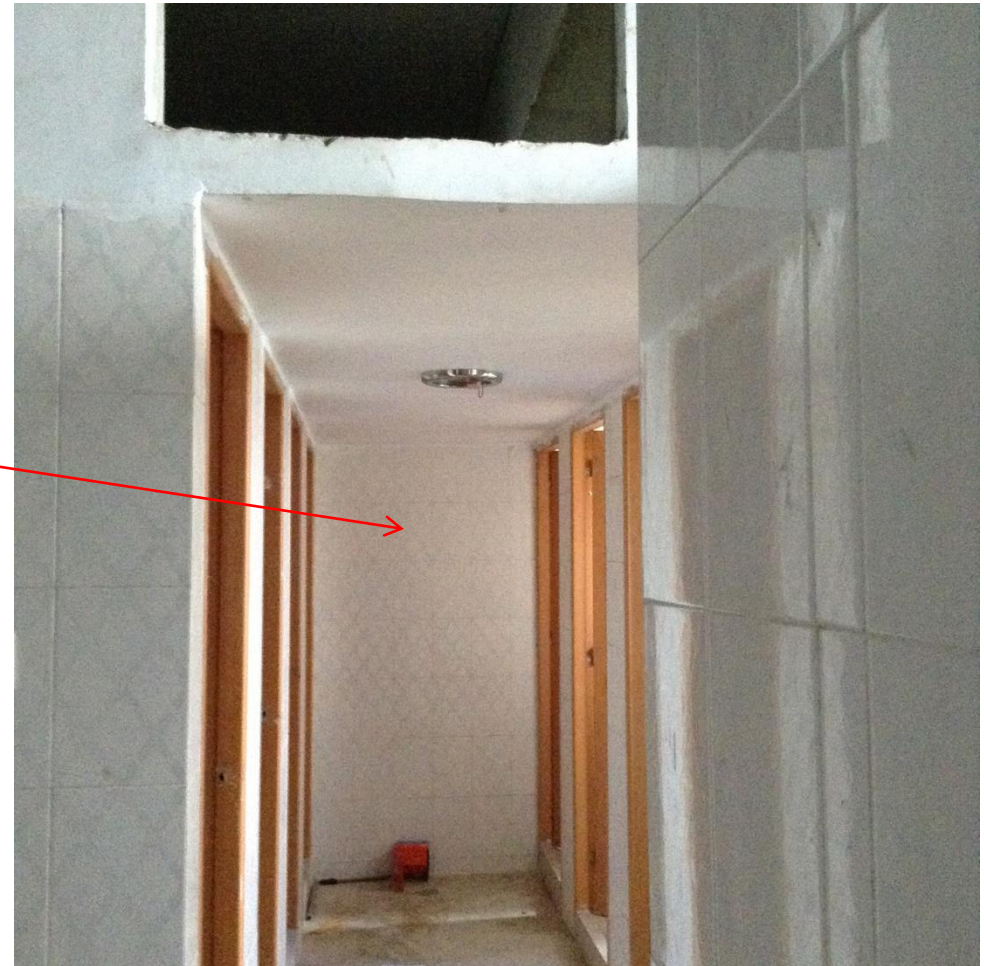
Layout Permit Drawing

On 1st to 4th floors at the West en of the building, there were bigger toilet areas of 11 cubicles instead of 8 cubicles shown on permit drawings.

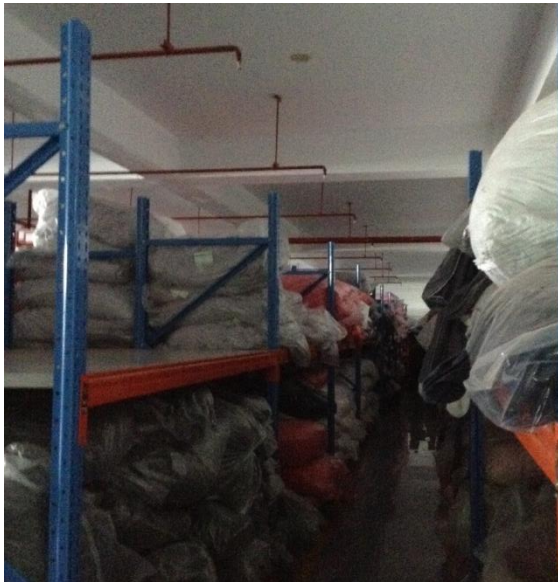
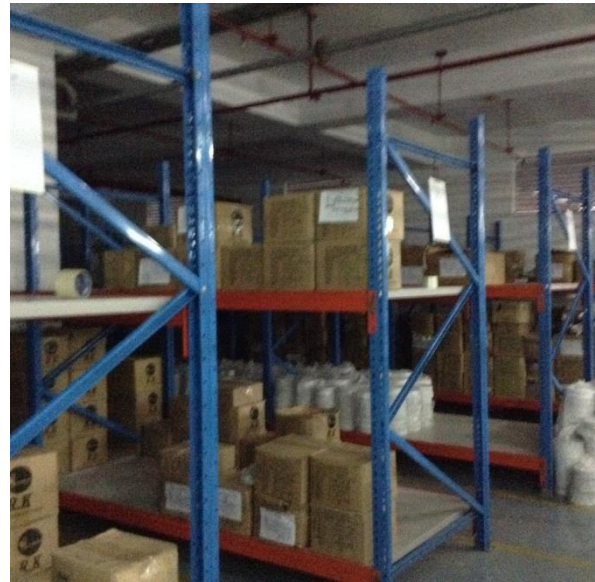
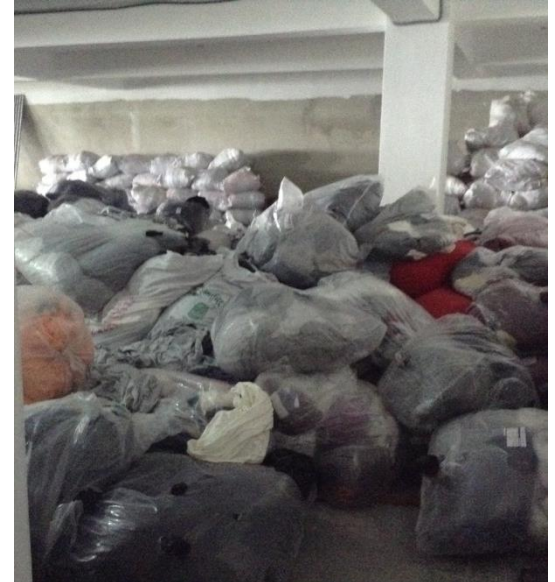
Loading Plan for Storage Areas

No loading plan exists for storage areas. Materials are being stored in a disorganized way.

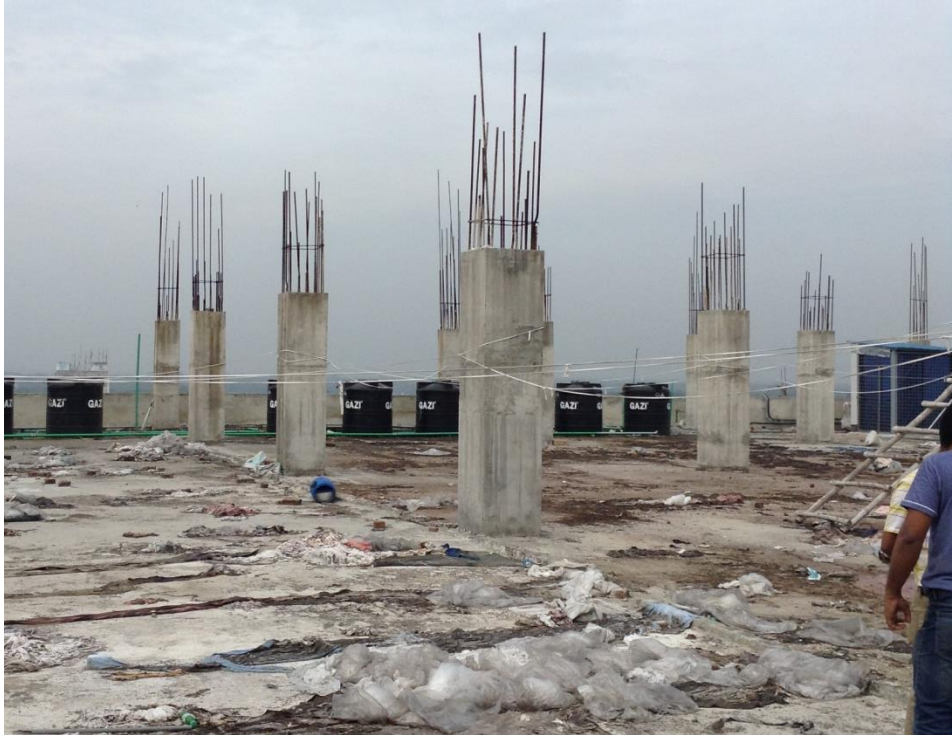
Steel Bars were exposed from the roof column and corrosion may take place in near future.

Item No.	Observation	Recommended Action Plan	Recommended Timeline
6	Protective Measures for Ground Floor Columns	Corner parts of the Ground Floor columns are generally damaged due to hits by the trolleys used for carrying materials. Corner protection should be provided for them.	6-weeks
7	Exposed Column Rebars at Roof Level	The exposed column rebars which will be used for future construction are corroded. Being informed that the construction works will not take place in the near future those exposed rebars should be protected from external effects.	6-weeks

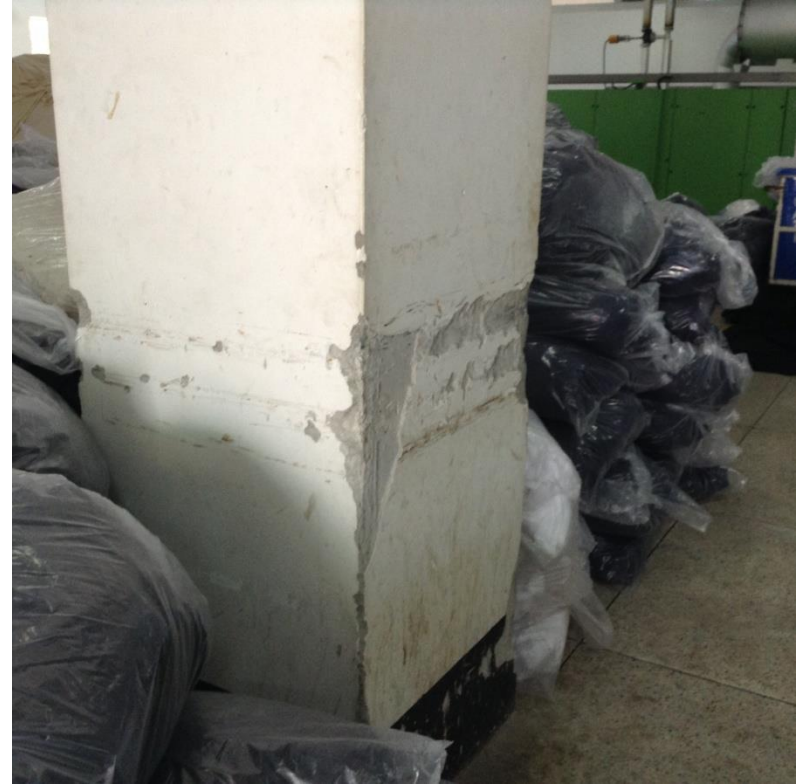
No Protection around column area at ground level.
