WELDONE APPARELS LTD.

Baraidrhalae, Sreepur, Gazipur

Observations

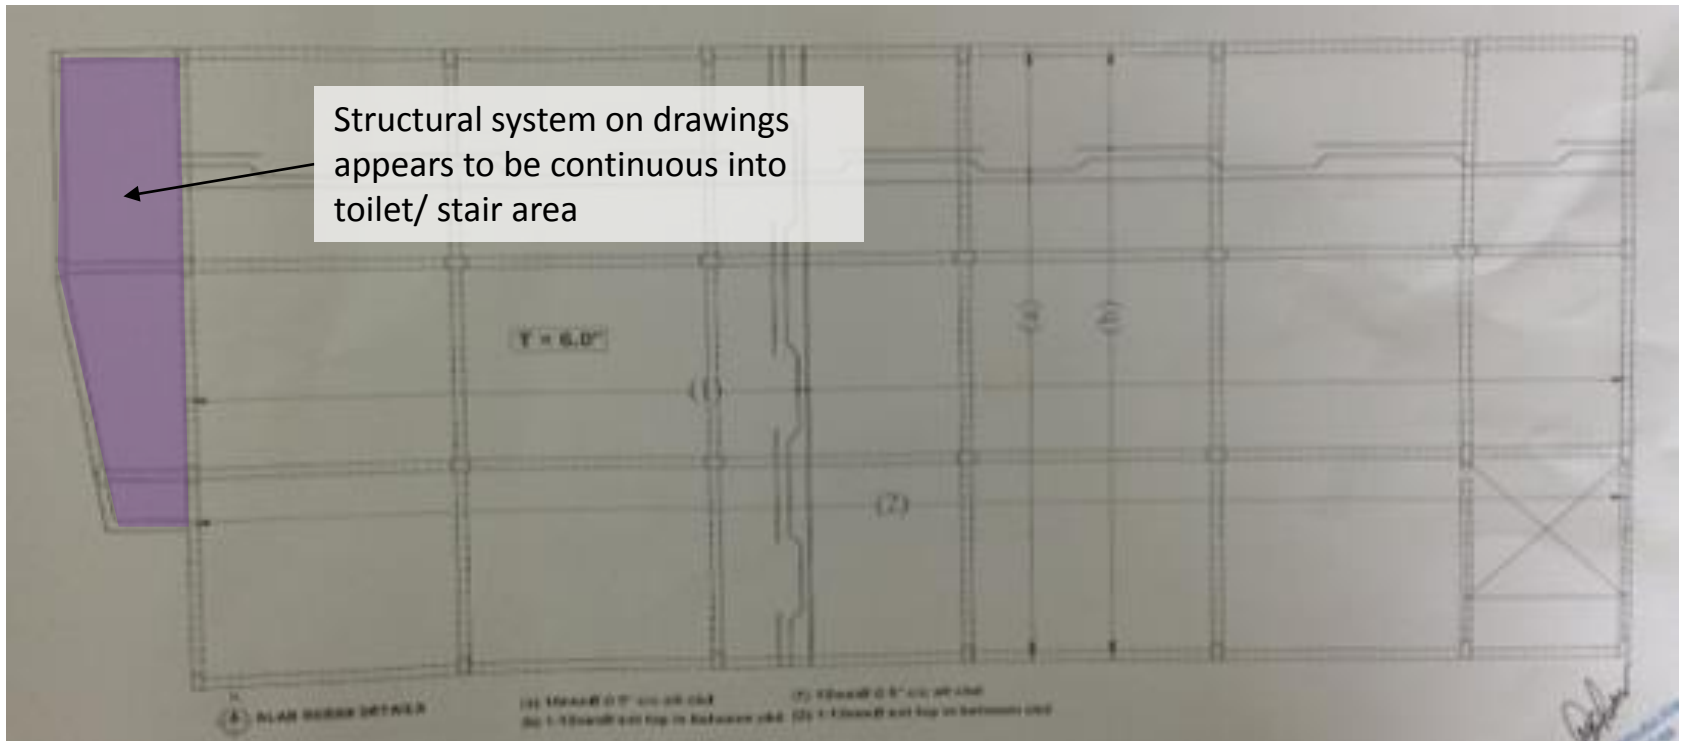
No clear connection method to tie toilet/ stairs area to main structure

Item No.	Observation	Recommended Action Plan	Recommended Timeline
1	No clear connection method to tie toilet/ stairs area to main structure	Building Engineer to review structural design of toilet area.	6-weeks
2	No clear connection method to tie toilet/ stairs area to main structure	Carry out remedial work to slab edge as advised by Engineer in advance of construction of stairs/toilet area.	6-weeks
3	Standing water on 1st floor slab	Standing water to be removed from slab.	6-weeks
4	Proposed 4-storey construction with RC water tank will cause high column stresses	Building Engineer to review design, loads and columns stresses in area identified above.	6-months
5	Proposed 4-storey construction with RC water tank will cause high column stresses	Verify insitu concrete strengths either by 100mm diameter cores or existing cylinder strength data for columns under water tanks	6-months
6	Proposed 4-storey construction with RC water tank will cause high column stresses	Prepare loading plans based on column capacity and floor capacity.	6-months

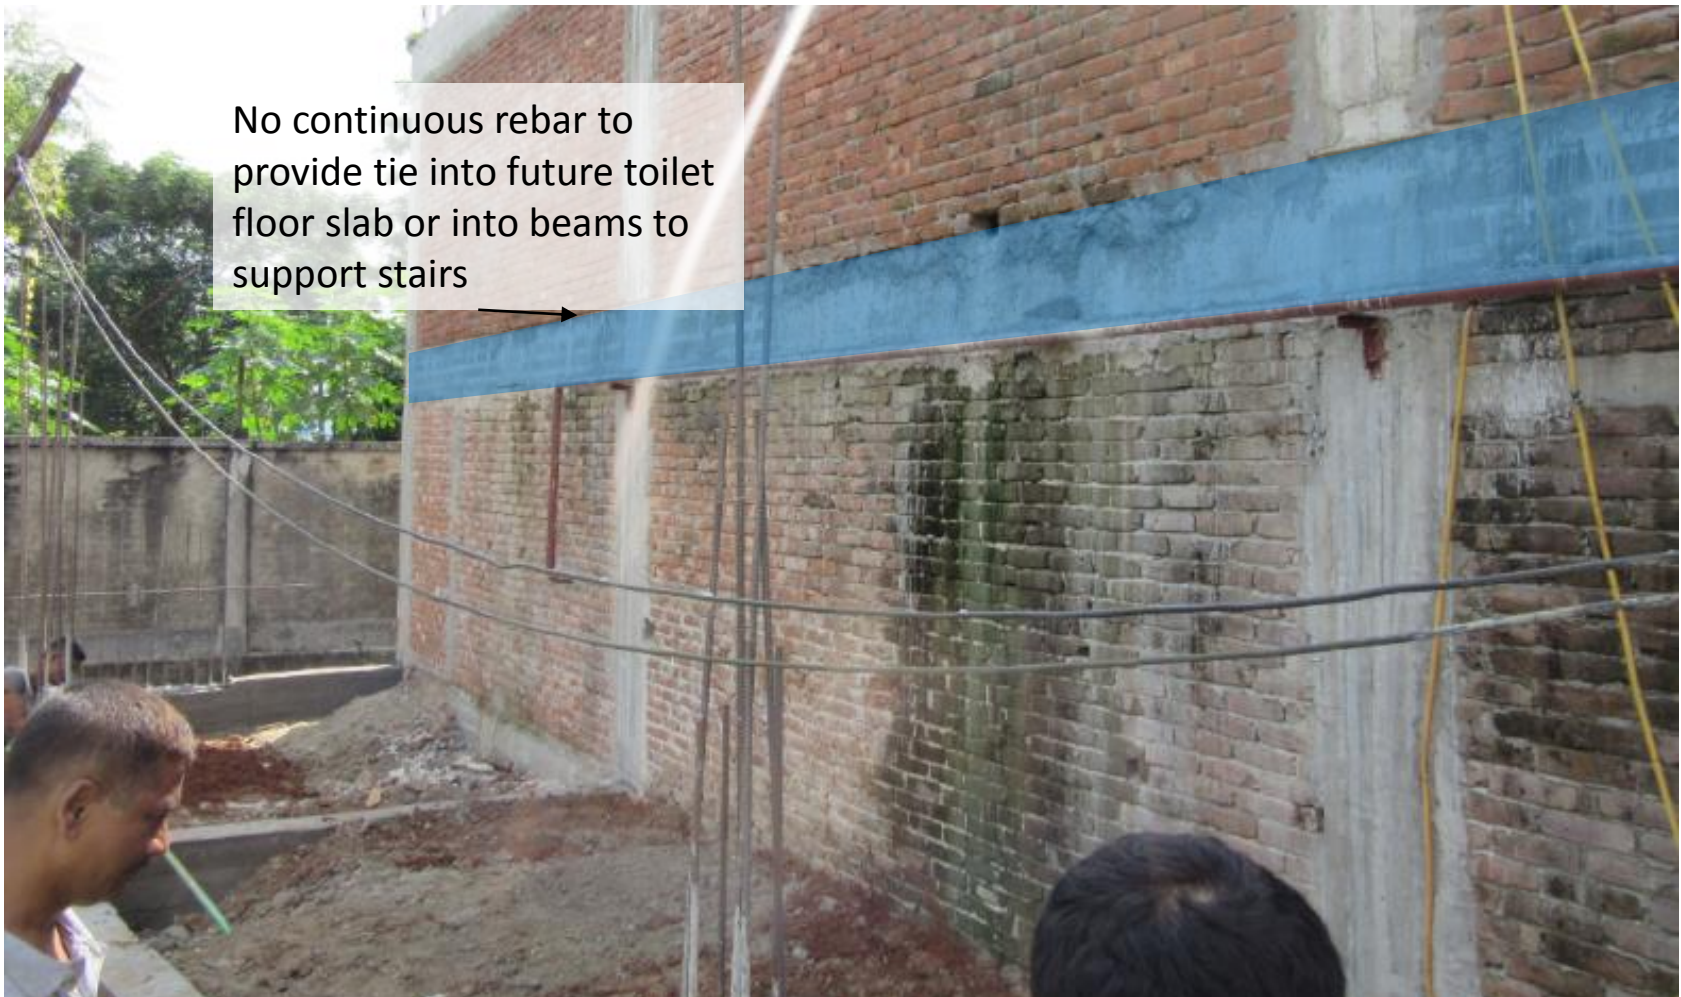
No continuous rebar to provide tie into future toilet floor slab or into beams to support stairs

No clear connection method to tie toilet/ stairs area to main structure

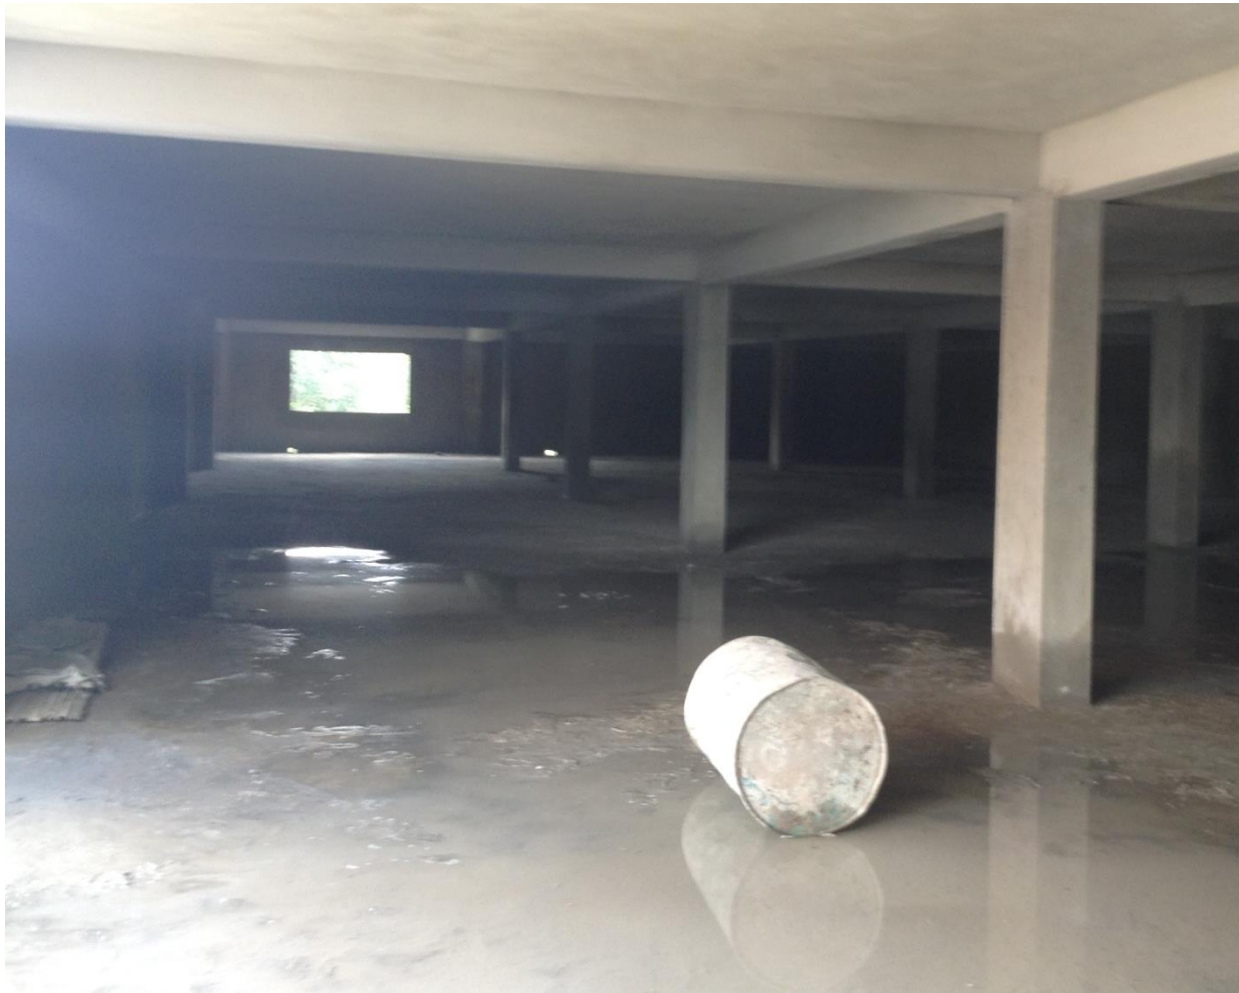
Standing water observed on 1st floor slab

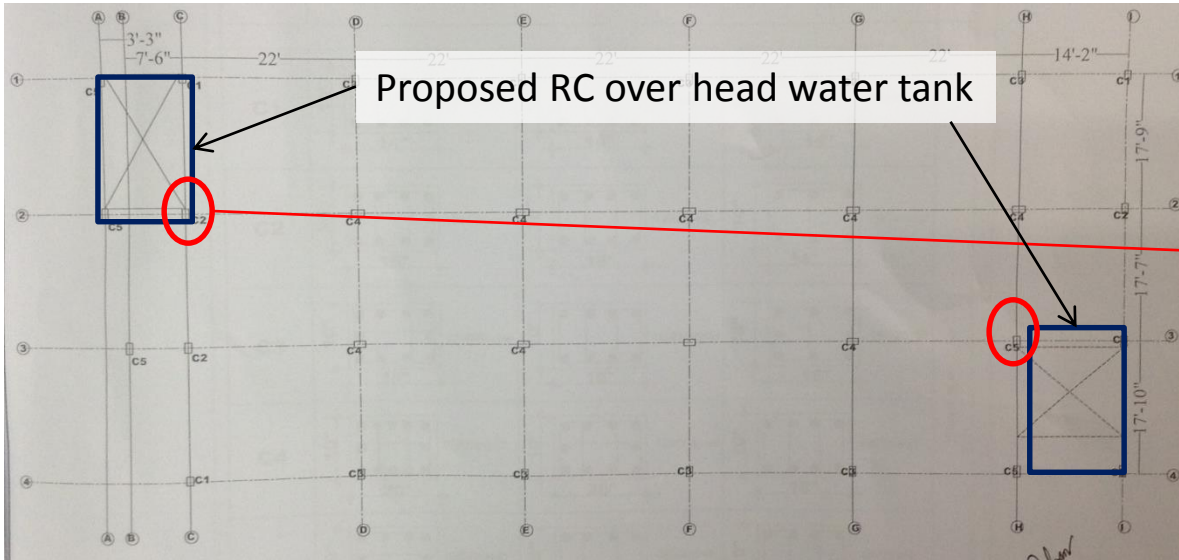
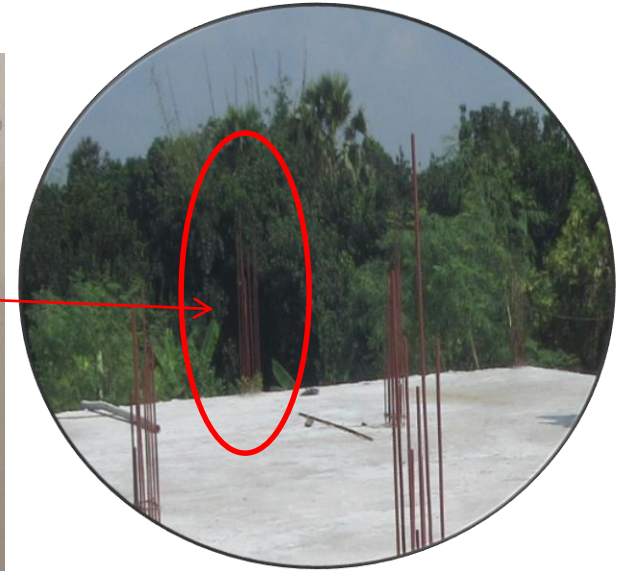
Proposed 4-storey construction with RC water tank will cause high column stresses

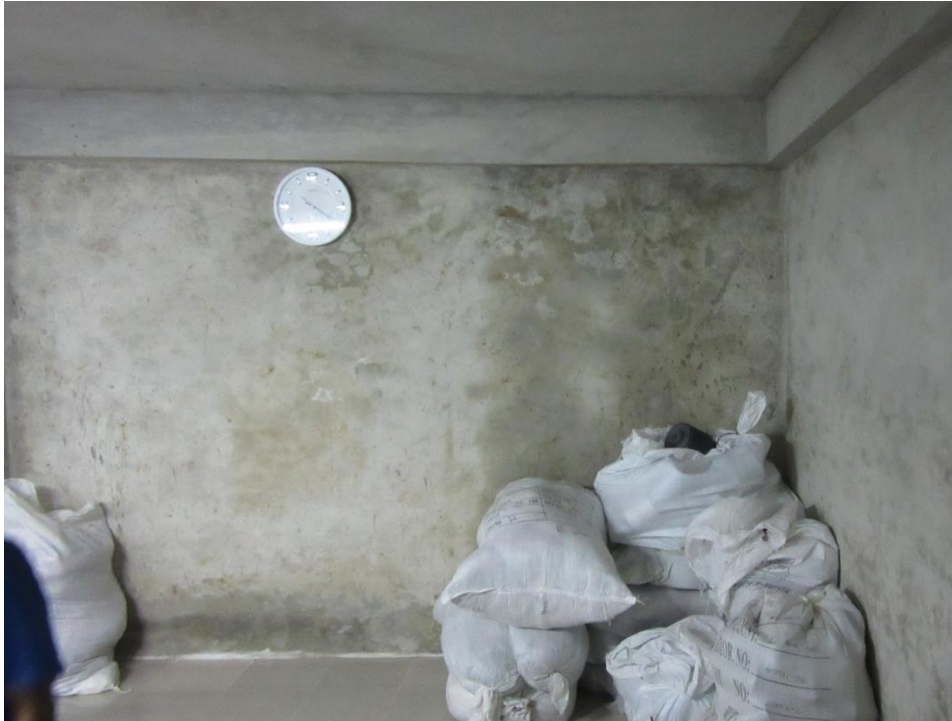
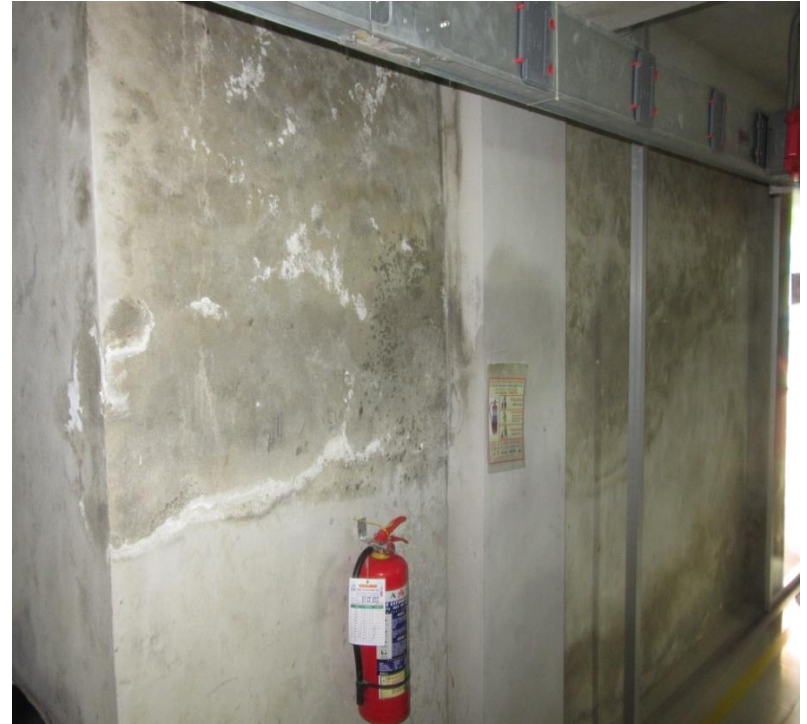
Damp observed on ground floor at East end of building

Item No.	Observation	Recommended Action Plan	Recommended Timeline
7	Damp on ground floor walls	Building engineer to investigate cause of damp and carry out any necessary repairs as advised by Engineer.	6-months
8	Damp on ground floor walls	Monitor for further water ingress.	6-months
9	Plaster over Joint between Factory Building & Dining Shed	Plaster to be removed.	6-months
10	Plaster over Joint between Factory Building & Dining Shed	Movement joint to be constructed between factory building and dining shed	6-months

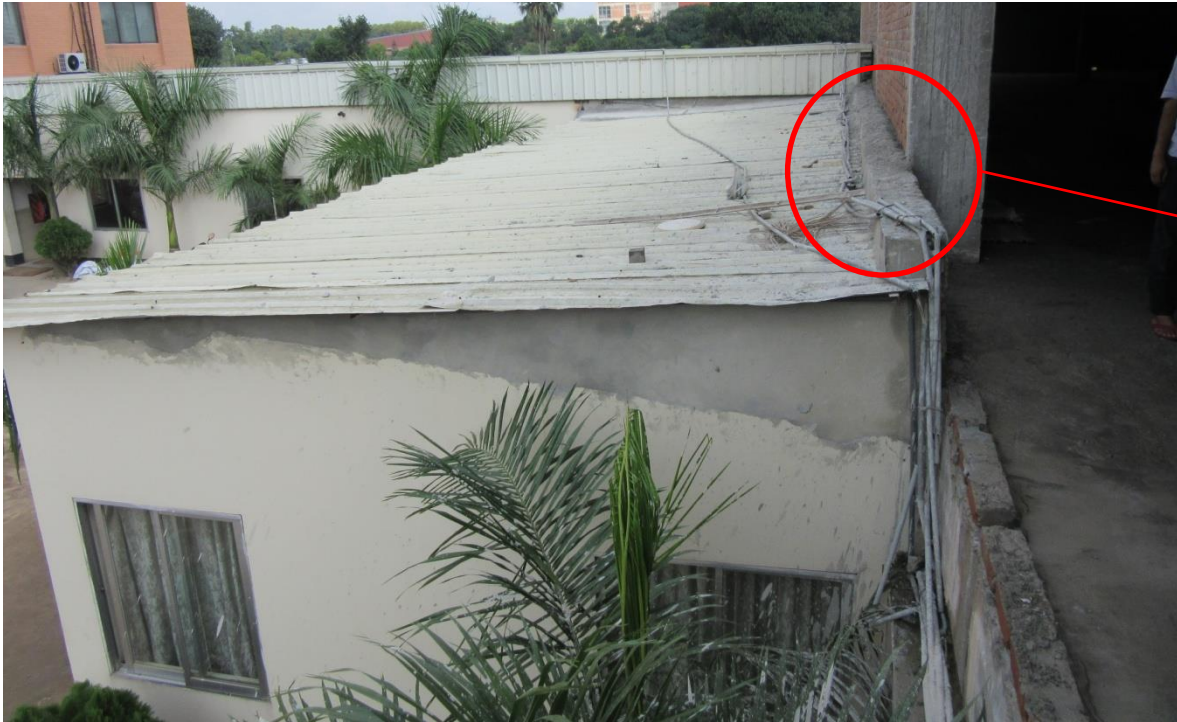
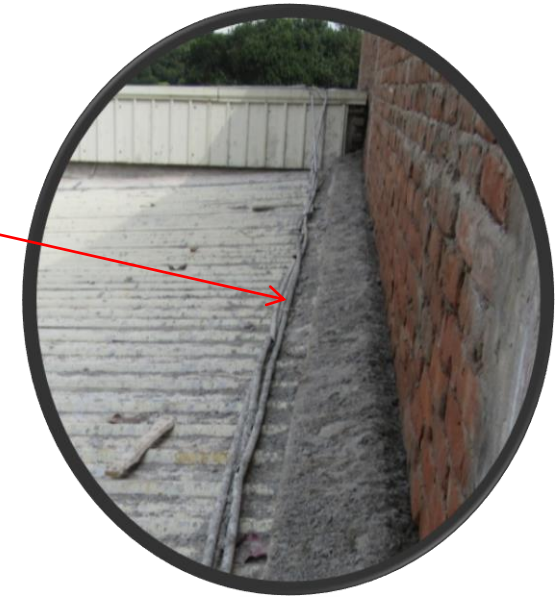
The joint between factory building and existing shed has been plastered over

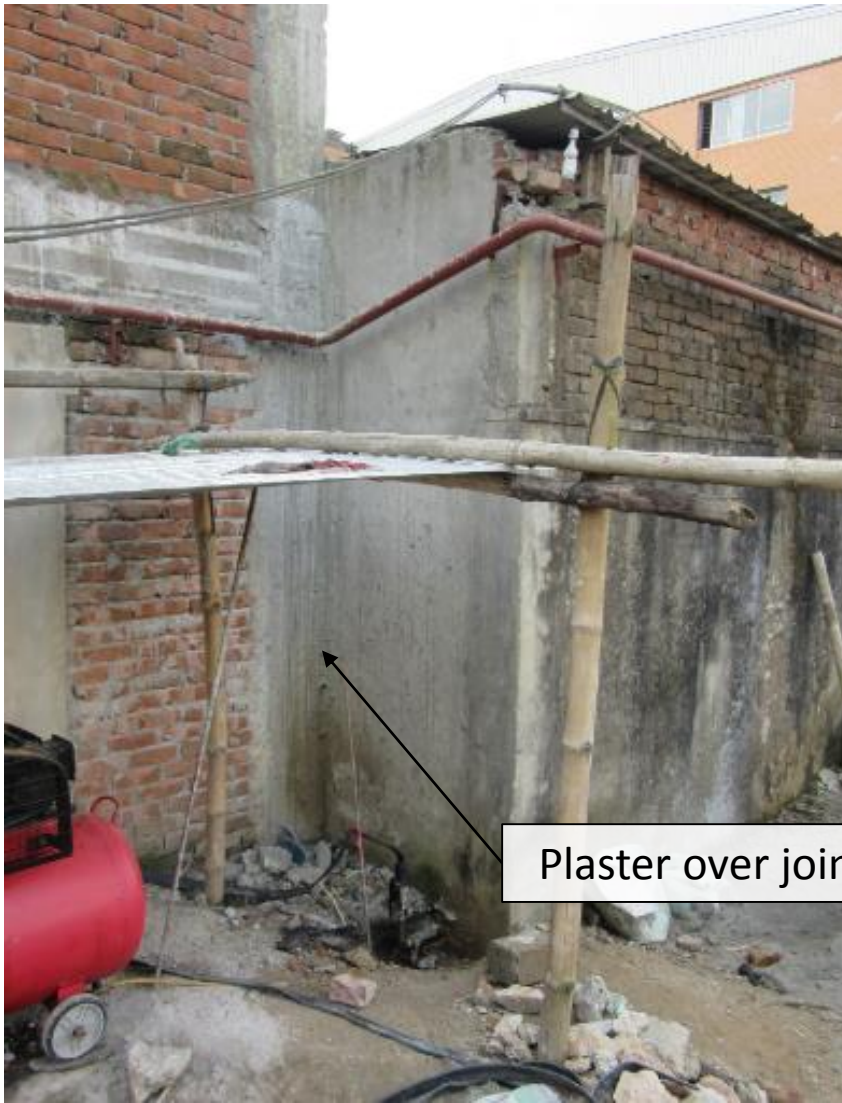
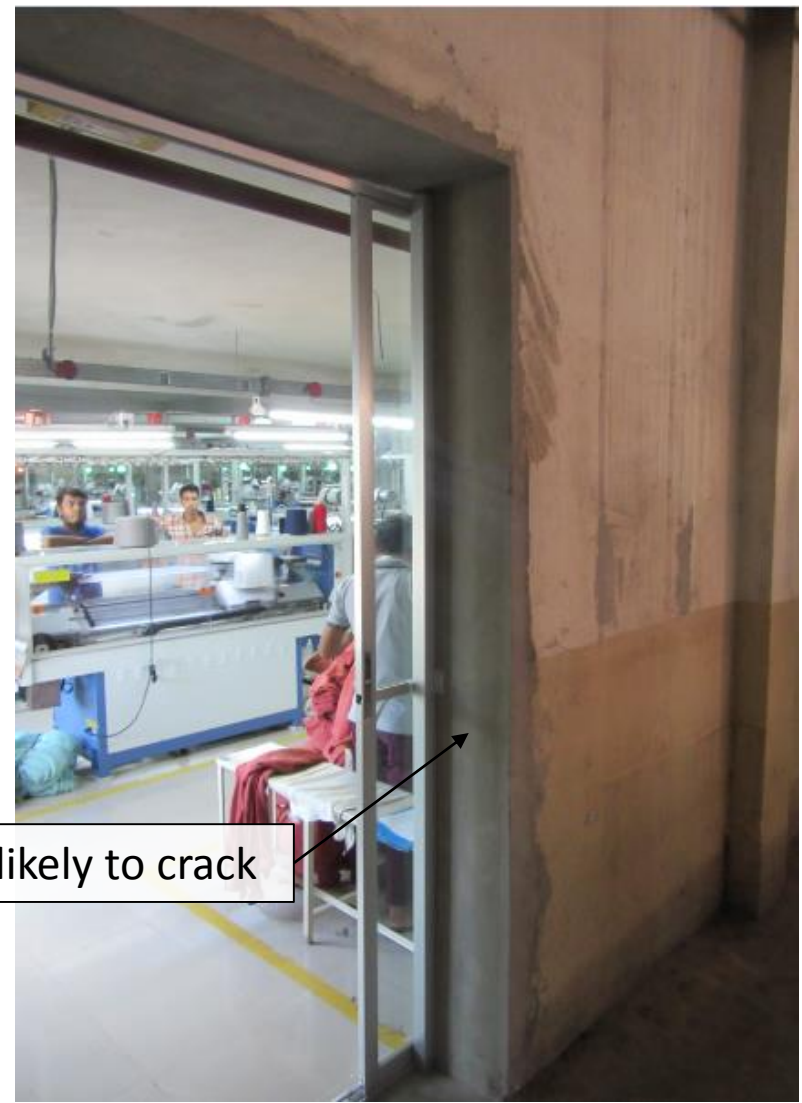
Plaster over joints likely to crack

The joint between factory building and existing shed has been plastered over
