# YAGI BANGLADESH GARMENTS LTD.

HP TOWER, NORTH BARON, P.O: ALIYA MADRASA, P.S: ASHULIA, UZ: SAVAR, DIST: DHAKA  
(23.939178 N, 90.298774 E)

1<sup>st</sup> November 2015

# Observations

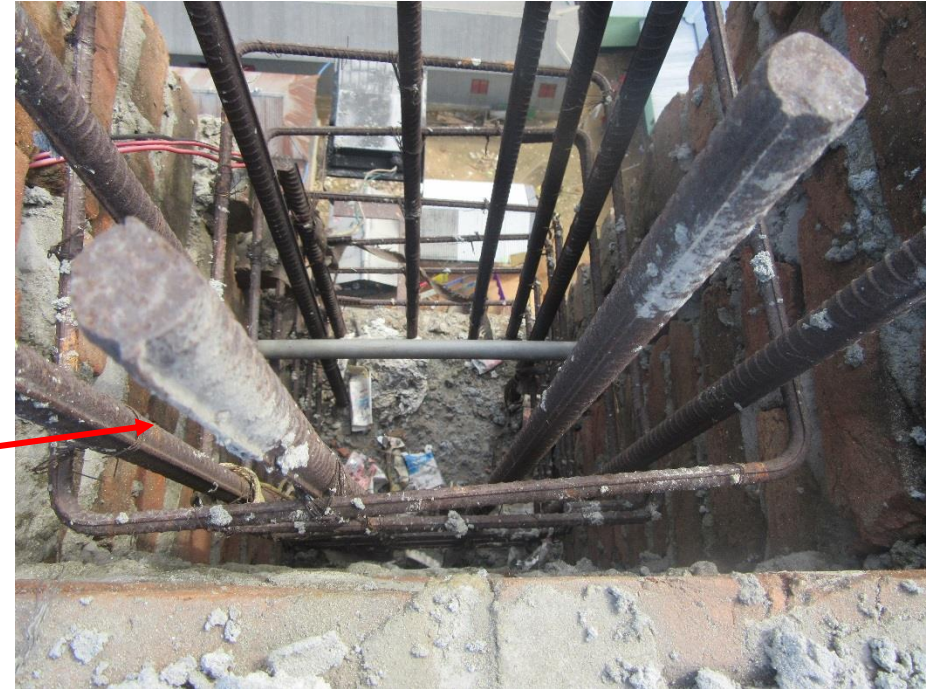
Some of the column rebars were exposed at roof level. Some of them were not matching with the design drawings. Approximately two bars were less.

| Item No. | Observation | Recommended Action Plan | Recommended Timeline |
|---|---|---|---|
| 9 | Discrepancies between Design Drawings and Observations | Column dimensions and reinforcement ratios are found not to be matching with the design drawings. As-built drawings should be prepared by the Building Engineer. | 6-weeks |

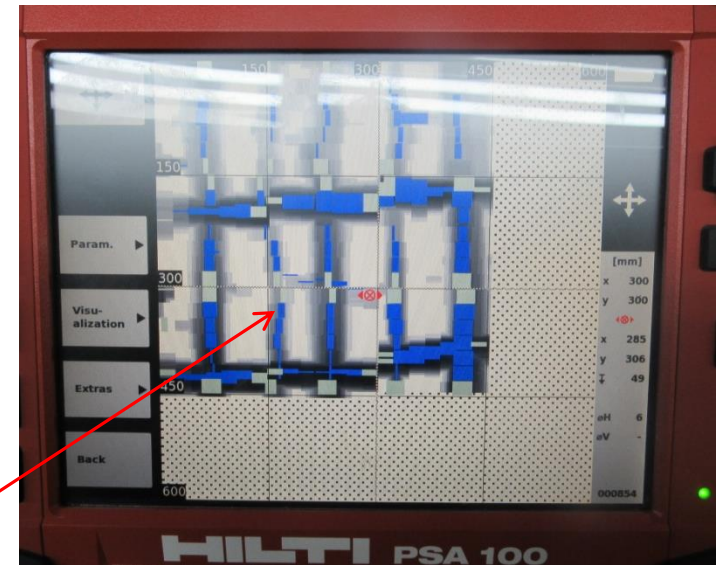
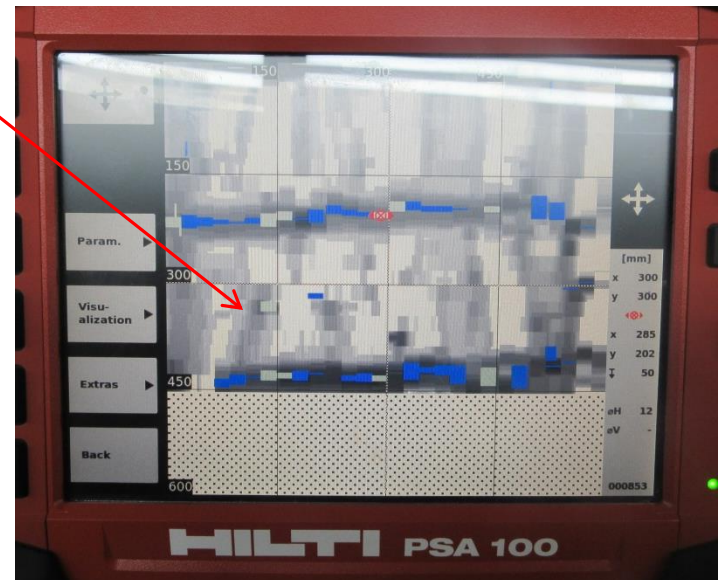
Typical C3 column reinforcement was found to be 18no. 22mm bars instead of 22no.

| Item No. | Observation | Recommended Action Plan | Recommended Timeline |
|---|---|---|---|
| 10 | Discrepancies between Design Drawings and Observations | Information on the as-built drawings should be compared with the data used for the detailed assessment and necessary further studies to be carried out. | 6-months |

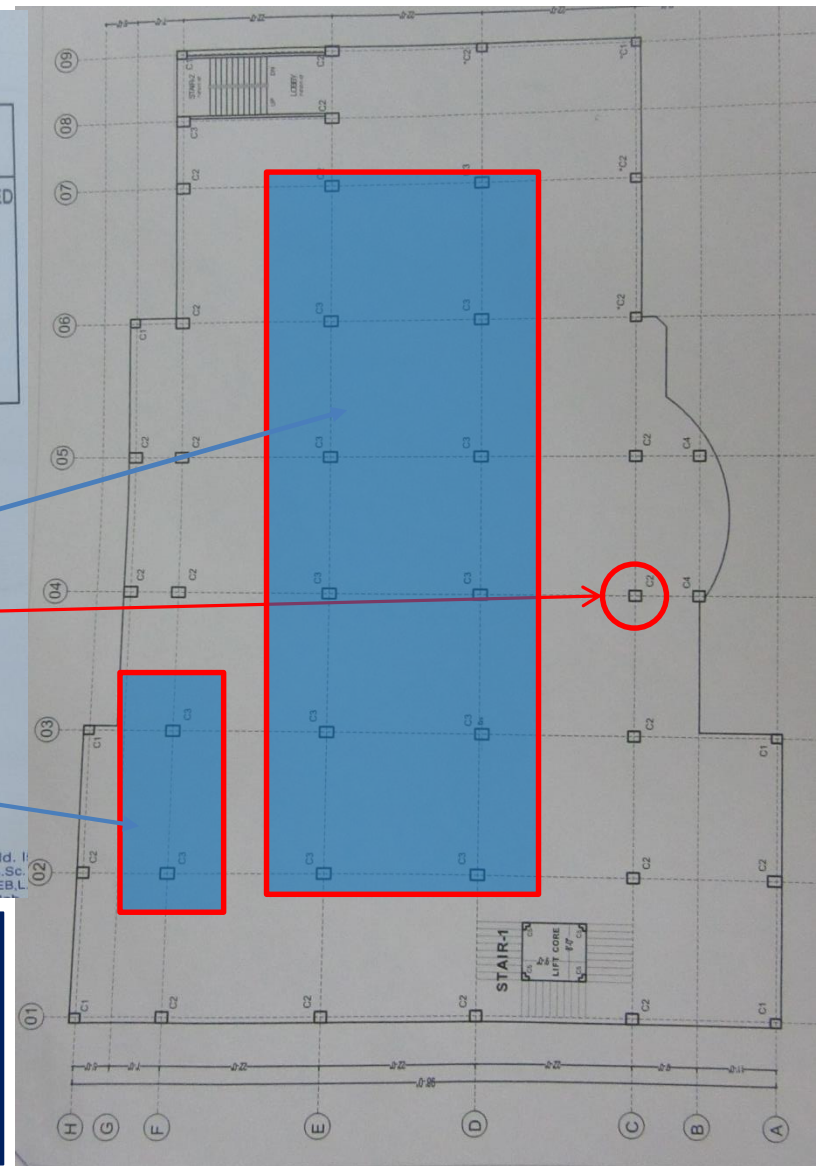
Typical C3 column dimension is measured as 18" by 24" where as it is shown as 20" by 24" on the design drawings. One of the C2 type column dimension also not matching with the design.

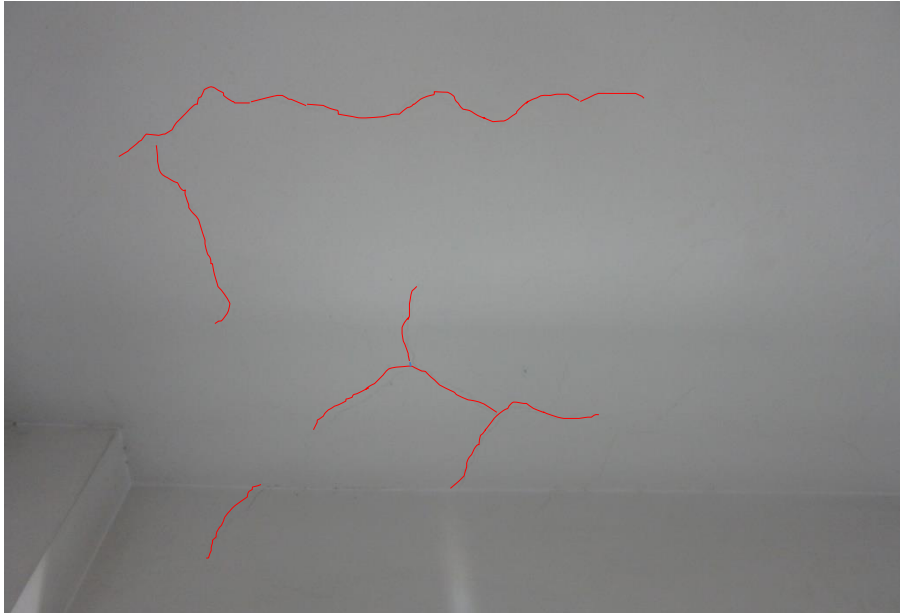
Cracks observed at some slabs.

| Item No. | Observation | Recommended Action Plan | Recommended Timeline |
|---|---|---|---|
| 5 | Hairline Cracks at Beams and Slabs | Monitoring should be done to observe propagation and changes in the width/length of the cracks. | 6-weeks |
| 6 | Hairline Cracks at Beams and Slabs | Cracks to be checked for any structural damage. | 6-weeks |
| 8 | Hairline Cracks at Beams and Slabs | Necessary structural alterations should be done based on the outcome of the investigations. | 6-months |

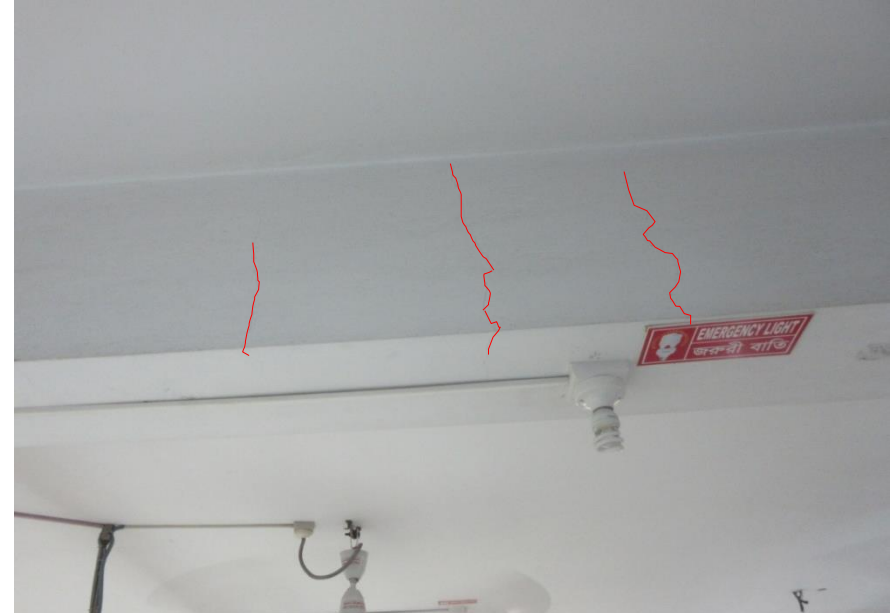
Cracks observed at almost all beams.

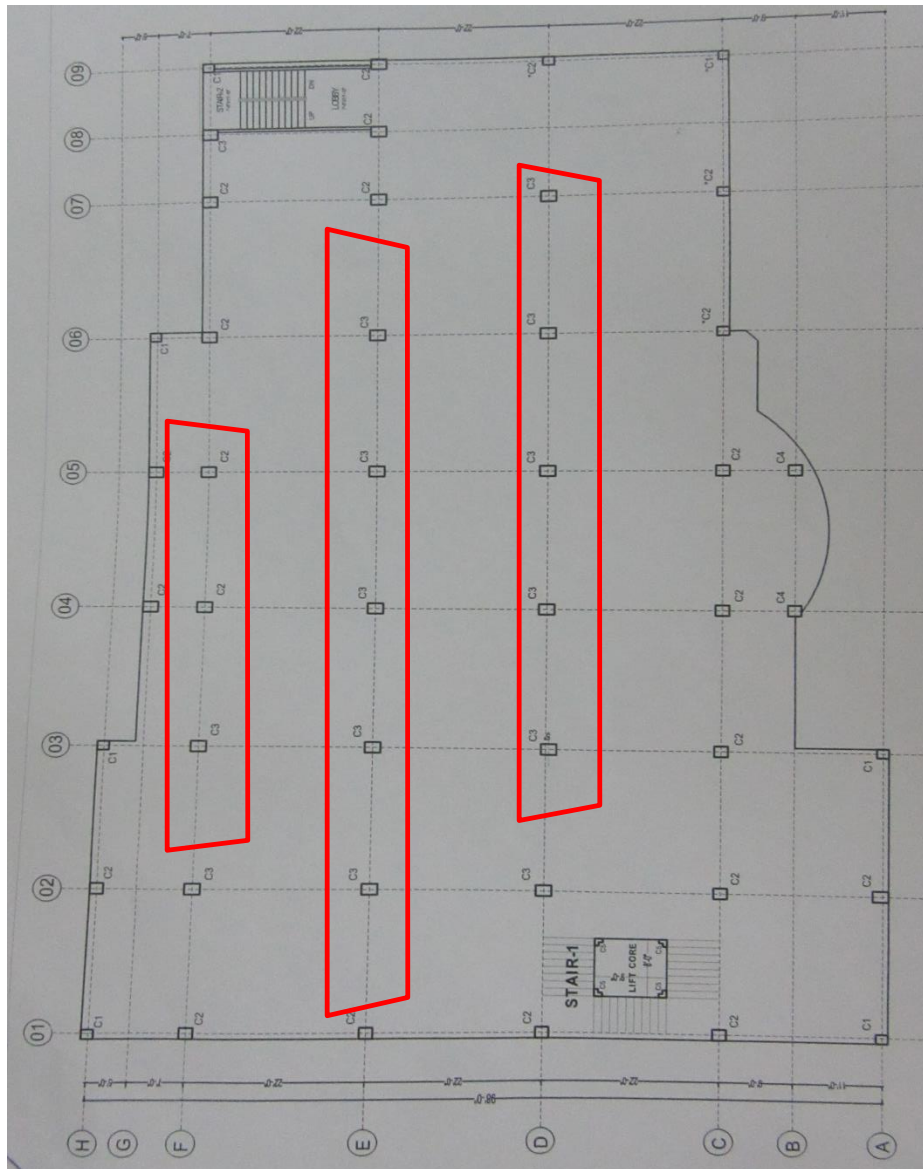
Columns at marked areas  
have found to have high  
stress levels.

| Item No. | Observation | Recommended Action Plan | Recommended Timeline |
|---|---|---|---|
| 1 | Stress Level at Columns | Building Engineer to review design, loads and stresses in columns in the area noted. | 6-weeks |
| 2 | Stress Level at Columns | Building Engineer to verify in-situ concrete strength by taking 100mm diameter cores from 4 columns. | 6-weeks |
| 3 | Stress Level at Columns | Building Engineer to verify grade of steel reinforcement and no. and diameter of main column bars. | 6-weeks |
| 4 | Stress Level at Columns | Make structural alterations if required as advised by Engineer. | 6-months |

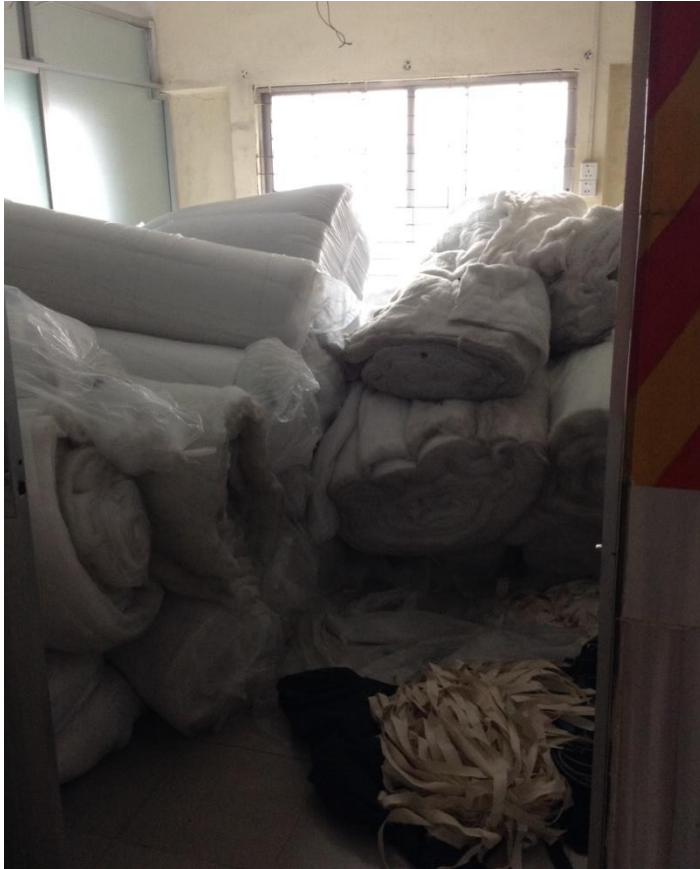
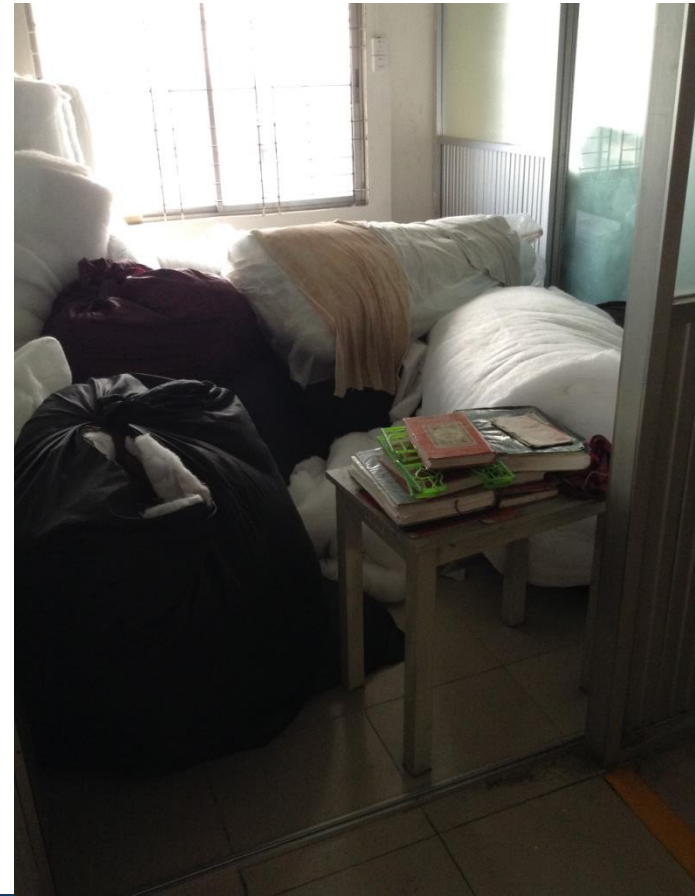
No load plan for storage area in different floors

| Item No. | Observation | Recommended Action Plan | Recommended Timeline |
|---|---|---|---|
| 7 | Hairline Cracks at Beams and Slabs | Loading plan to be prepared for warehouse and accessory store at the first floor to control the loading limits. | 6-weeks |

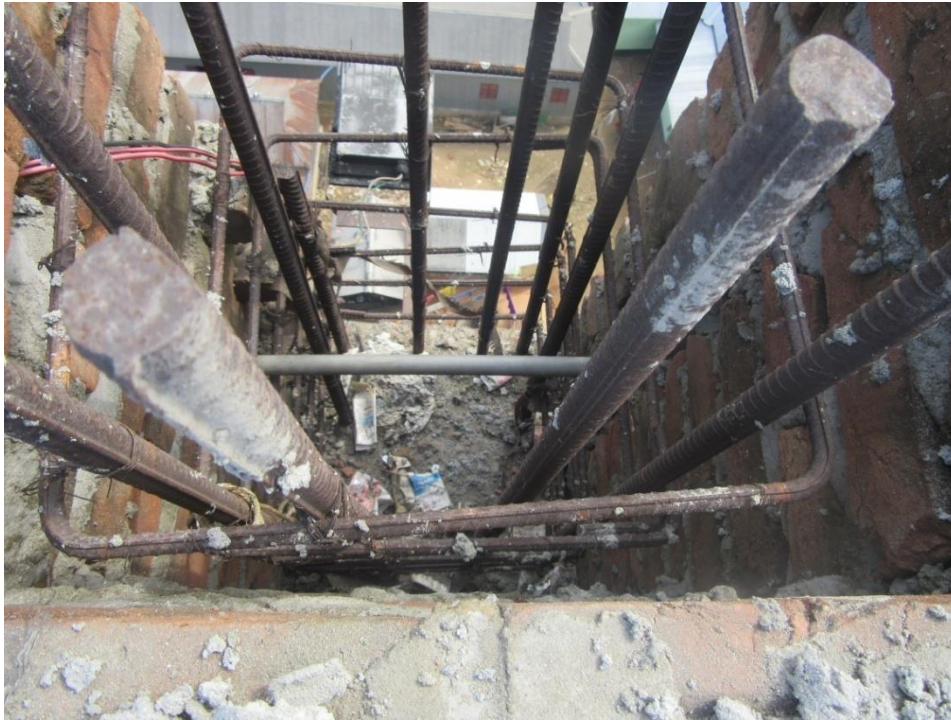
Rebars were exposed at roof level.

No water insulation observed above roof slab.

| Item No. | Observation | Recommended Action Plan | Recommended Timeline |
|---|---|---|---|
| 12 | Exposed Column Rebars and Ponding at Roof Level | The construction have been completed however some of the column rebars are still exposed. | 6-weeks |
| 13 | Exposed Column Rebars and Ponding at Roof Level | Ponding have been observed at roof. | 6-weeks |

| Item No. | Observation | Recommended Action Plan | Recommended Timeline |
|---|---|---|---|
| 14 | Exposed Column Rebars and Ponding at Roof Level | Building engineer to take necessary actions to close the exposed rebars, prevent ponding and apply proper water insulation at roof level. | 6-weeks |
