# Executive Hi-Fashions LTD (Extension)

Sreechala, Bagerbazar, Joydebpur, Gazipur.

15 January 2024

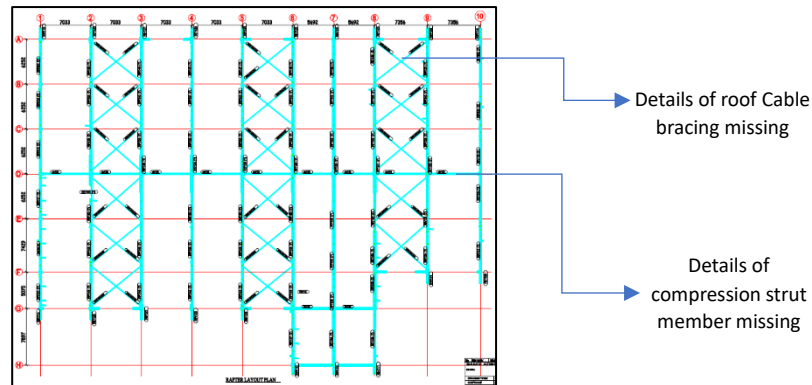
**Observation 1:** Lack of information in as-built drawings and missing Architectural drawings (Shed 1-Cutting Shed).

**Description:** During the inspection, cable bracing and compression strut member details information was missing in the as-built drawings. The building engineer is required to survey the full structure and produce accurate as-built drawings with full information on cable bracing and compression strut members.

| Observation | Action Plan | Timeline |
|---|---|---|
| Lack of information in as-built drawings.<br>(Shed 1-Cutting Shed) | The building engineer is required to survey the full structure and produce accurate as-built drawings with full information on cable bracing and compression strut members. | within 6 weeks |

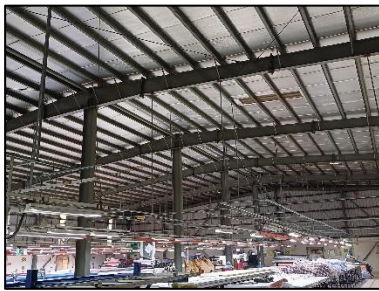
**Observation 2:** The design report needs to be reviewed (Shed 1-Cutting Shed).

**Description:** The design report needs to be reviewed by RSC for lateral forces. The building engineer is required to submit the design report and necessary documents to RSC for review.

| Observation | Action Plan | Timeline |
|---|---|---|
| The design report needs to be reviewed.<br>(Shed 1-Cutting Shed) | The building engineer is required to submit the design report and necessary documents to RSC for review. | within 6 weeks |
| The design report needs to be reviewed.<br>(Shed 1-Cutting Shed) | Carry out remedial work if required. | within 6 months |

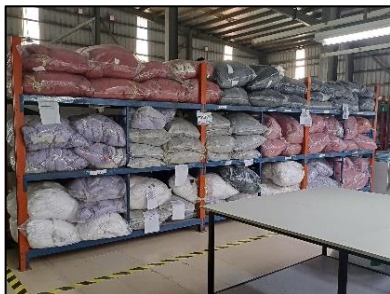
Shed 1-Cutting Shed

**Observation-3:** Storage rack without anchorage (Shed 1-Cutting Shed & Shed 3-Dining Shed).

**Description:** Racks on ground floors are not adequately anchored or braced to resist lateral (earthquake) forces. The building engineer is required to adequately anchor and brace all non-structural elements to resist earthquake forces to comply with the BNBC.

| Observation | Action Plan | Timeline |
|---|---|---|
| Storage rack without anchorage.<br>(Shed 1-Cutting Shed) | Factory is required to adequately anchor and brace all non-structural elements to resist earthquake forces to comply with the BNBC. | within 6 months |

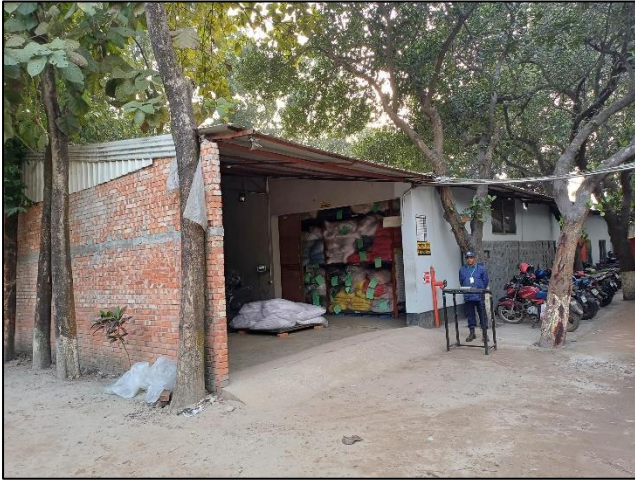
Shed 3-Dinning Shed

**Observation-4:** Lack of drawings design (Shed 3-Dinning Shed & Building 2-Generator Building).

**Description:** As per BNBC, every building or structure designed shall have its design documents prepared following the provision of Section 1.9.1. The design document shall include a design report, and a set of structural drawings, which shall be prepared in compliance with section 1.9.1.1 and section 1.9.1.2, part 6 of BNBC. At the time of inspection, as-built drawings, and design reports were not available which are required to be prepared in compliance with section 1.9.1.1 (part-6, BNBC) and submitted to RSC for detailed review for lateral forces.

| Observation | Action Plan | Timeline |
|---|---|---|
| Lack of drawings design.<br>(Shed 3-Dinning Shed) | The building engineer is required to prepare a set of as-built drawings and design reports as per 1.9.1 of BNBC. | within 6 weeks |
| Lack of drawings design.<br>(Shed 3-Dinning Shed) | Carry out remedial work if required. | within 6 months |

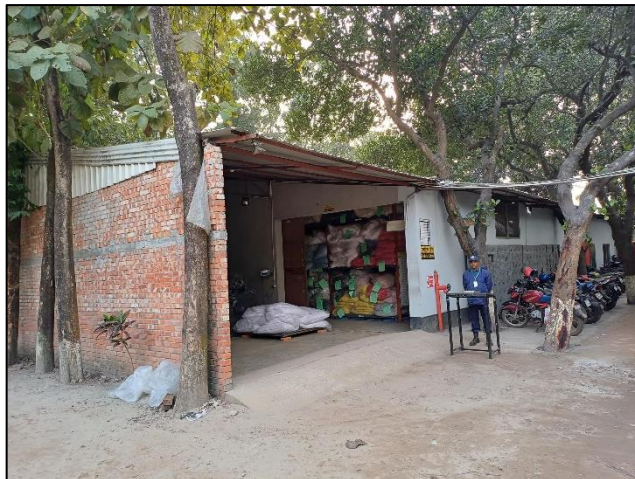
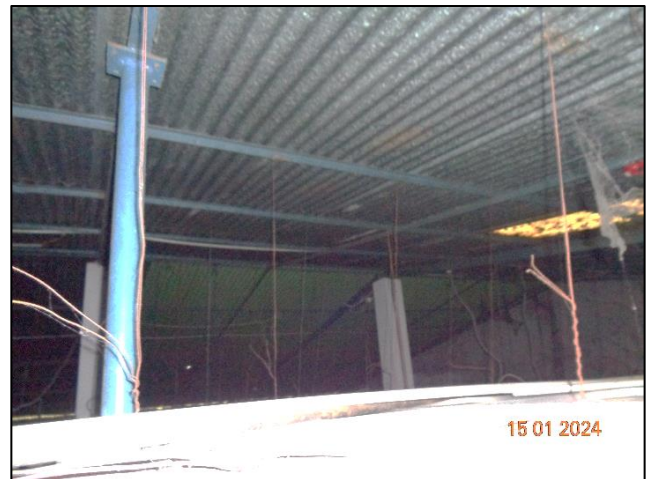
Shed 3-Dinning Shed

**Observation-5:** Lack of lateral stability (Shed 3-Dinning Shed).

**Description:** Lack of stability against lateral load, apparent inadequate members and non-engineered connection were observed at the roof. The building engineer is required to check the member, connection & stability system of the structure and suggest proper alternatives accordingly.

| Observation | Action Plan | Timeline |
|---|---|---|
| Lack of lateral stability.<br>(Shed 3-Dinning Shed) | The building engineer is required to check the lateral stability system of the structure. | within 6 weeks |
| Lack of lateral stability.<br>(Shed 3-Dinning Shed) | Carry out remedial work if required. | within 6 months |

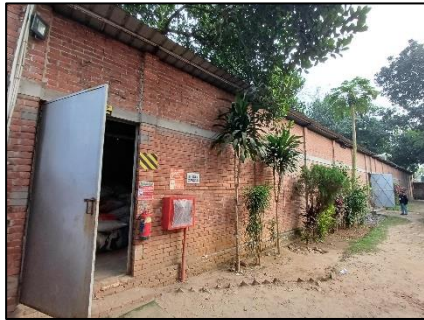
Shed 4-Wastage Shed

**Observation-6:** Lack of as-built drawings (Shed 4-Wastage Shed, Shed 5-Substation Shed, Shed 6-Compressor Shed, Shed 7-Fire Control & Security Shed, Shed 8-Fire Pump Shed, Building 3-RMS room).

**Description:** During inspection, there is no drawings were available for the above-mentioned structures. The building engineer is required to survey those structures and prepare accurate as built drawings for each structure separately.

| Observation | Action Plan | Timeline |
|---|---|---|
| Lack of as-built drawings<br>(Shed 4-Wastage Shed) | The building engineer is required to survey the structures and prepare accurate as-built drawings. | within 6 weeks |

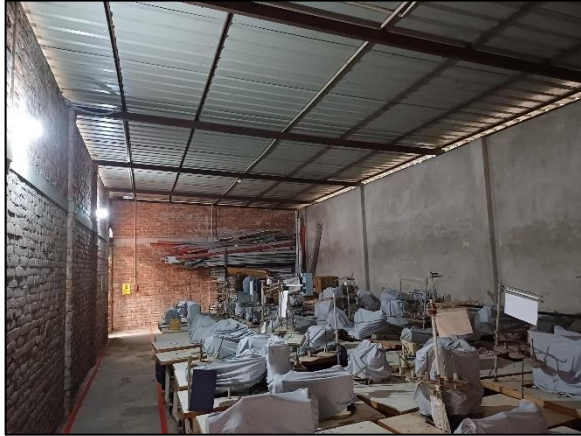
Shed 4-Wastage Shed

**Observation-7:** Connection adequacy check for the lightweight roof (Shed 4-Wastage Shed, Shed 5-Substation Shed, Shed 6-Compressor Shed, Shed 7-Fire Control & Security Shed).

**Description:** Lack of stability against lateral load, apparent inadequate members and non engineered connection were observed at the roof. The building engineer is required to check the member, connection & stability system of the structure and suggest proper alternatives accordingly.

| Observation | Action Plan | Timeline |
|---|---|---|
| Connection adequacy check for lightweight roof<br>(Shed 4-Wastage Shed) | The building engineer is required to check the member, connection, and stability system of the structure. | within 6 weeks |
| Connection adequacy check for lightweight roof<br>(Shed 4-Wastage Shed) | Carry out remedial work if required. | within 6 months |

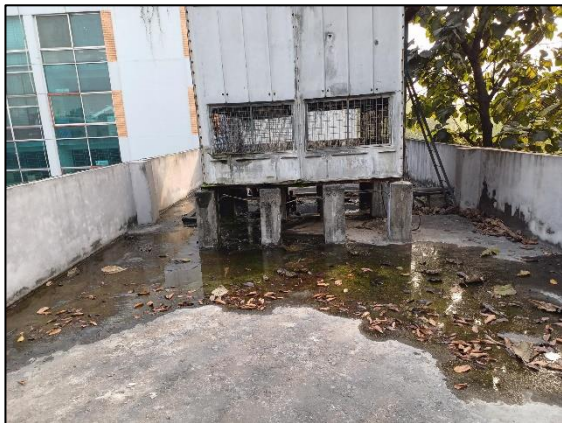
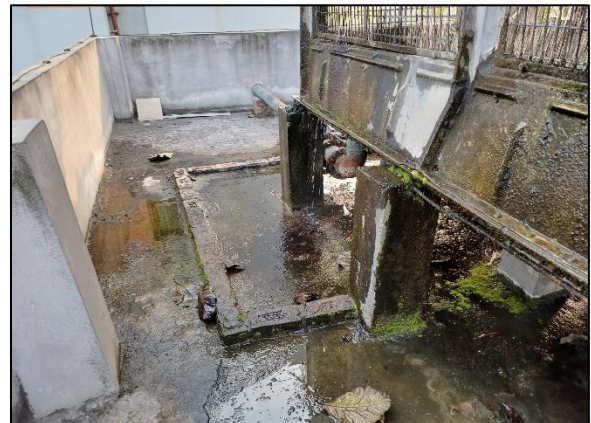
**Observation-8:** Dampness and water ponding on roof slab (Building 2-Generator Building)

**Description:** Dampness and water ponding were found on the roof slab. The factory is required to repair the damp areas and improve the drainage system on the roof slab.

| Dampness and Water ponding on the roof slab.<br>(Building 2-Generator Building) | The factory is required to repair the damp areas and improve the drainage system on the roof slab. | within 6 weeks |

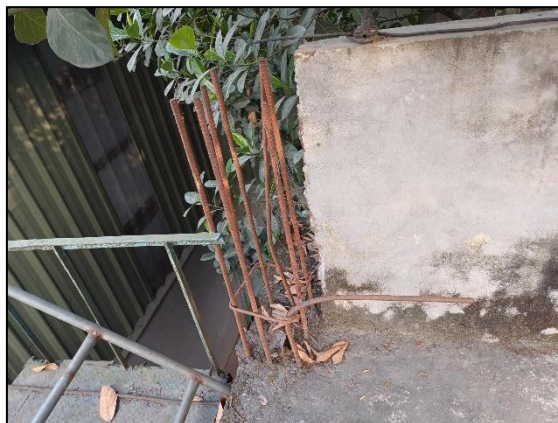
**Observation-9:** Exposed and corroded rebar at roof (Building 2-Generator Building)

**Description:** During inspection, an exposed & and corroded re-bar was found at the roof of the Generator Building. The factory is required to take necessary action to protect exposed re-bar from corrosion.

| Exposed and corroded rebar at the roof.<br>(Building 2-Generator Building) | The factory is required to repair the damp areas and improve the drainage system on the roof slab. | within 6 weeks |

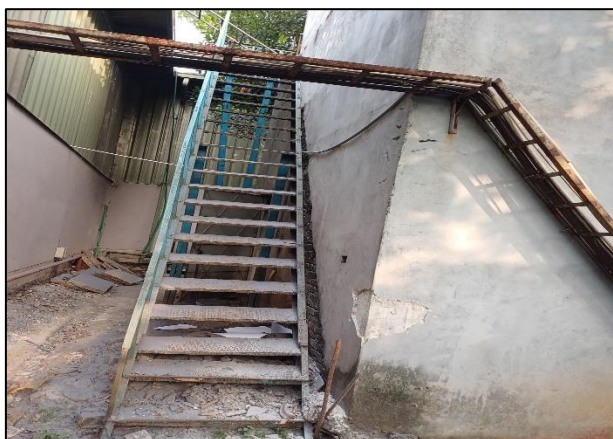
**Observation-10:** Falling hazard at adjacent stair (Building 2-Generator Building).

**Description:** A falling hazard was observed at the adjacent steel stair due to the sharp inclination of the stair tread. Factory is required to repair the stairs or suggest proper alternatives accordingly.

| Falling hazard at the adjacent stair. (Building 2-Generator Building) | The factory is required to repair the stairs to prevent falling hazards. | within 6 months |
