# Kenpark Bangladesh (Pvt) Ltd. (Extension)

Plot # 31-42, Sector # 08, Chittagong EPZ, Chittagong.

13 December 2023

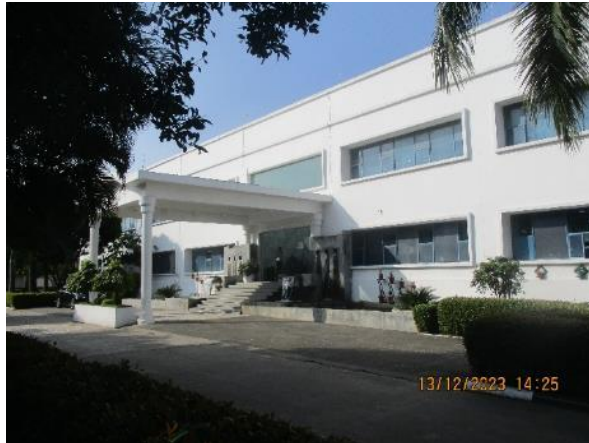
**Observation-1:** Lack of design documents. (Main factory building)

**Description:** As per BNBC, every building or structure designed shall have its design documents prepared in accordance with the provision of Section 1.9.1. The design document shall include a design report, and a set of structural drawings, which shall be prepared in compliance with section 1.9.1.1 and section 1.9.1.2 as per BNBC.

At the time of inspection, design documents (including as-built drawings, design report, load plan and material test reports) were not available which are required to be prepared in compliance with section 1.9.1 (part-6, BNBC).

| Observation | Action Plan | Timeline |
|---|---|---|
| Lack of design documents.<br>(Main factory building) | Building engineer is required to prepare design documents (including as-built drawings, design report, load plan and material test reports) in compliance with section 1.9.1 (part-6, BNBC). | within 6 weeks |
| Lack of design documents.<br>(Main factory building) | Carry out suggested remedial works. | within 6 months |

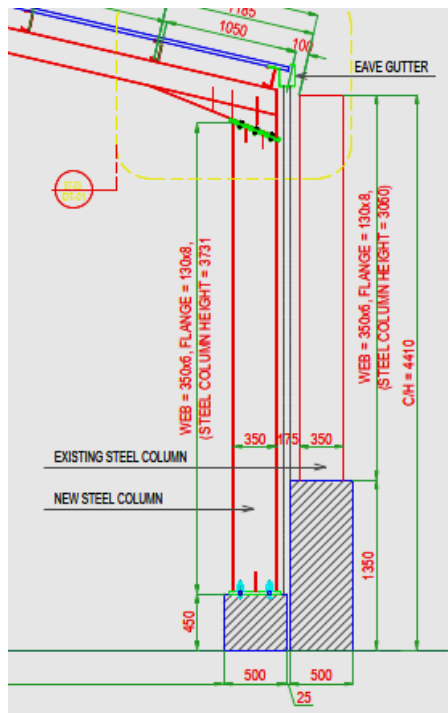
Schedule of Steel Column  
(Rain Protection Shed)

**Observation-2:** Incomplete as-built drawing (Canteen building and rain protection shed)

**Description:** Flange thickness of steel column for Rain Protection Shed was found 7.1 mm instead of 8 mm. Also, the flange thickness of several columns and rafters of Canteen Building were found 5 to 8 mm instead of 10 mm. Details of compression strut, roof bracing, connection was not found in as-built drawing. Building engineer is required to survey whole structure and prepare accurate as-built drawings as per site condition.

| Observation | Action Plan | Timeline |
|---|---|---|
| Incomplete as-built drawing<br>(Canteen Building and Rain Protection Shed) | Building engineer is required to survey whole structure and prepare accurate as-built drawings as per site condition. | within 6 weeks |

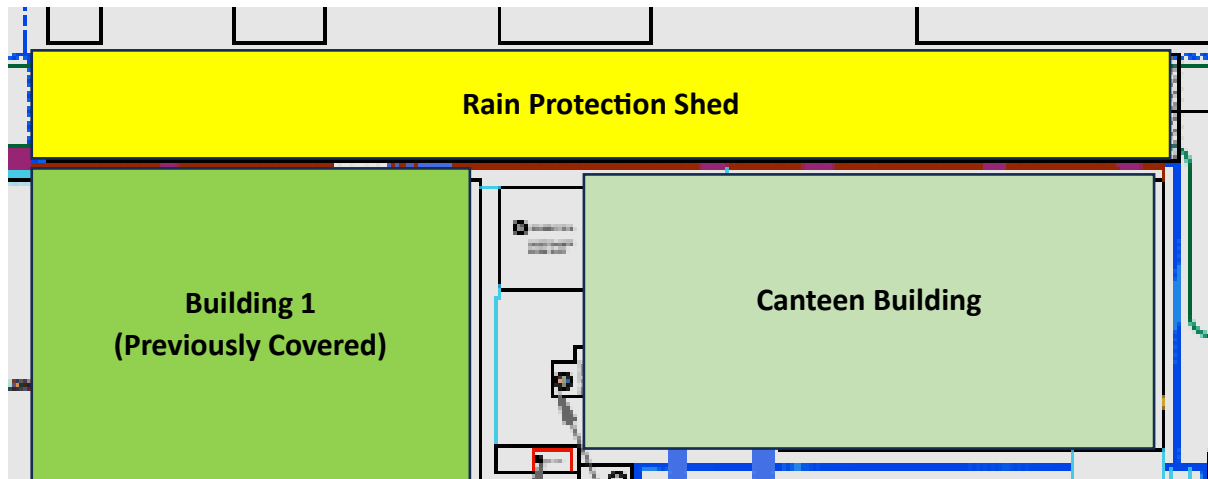
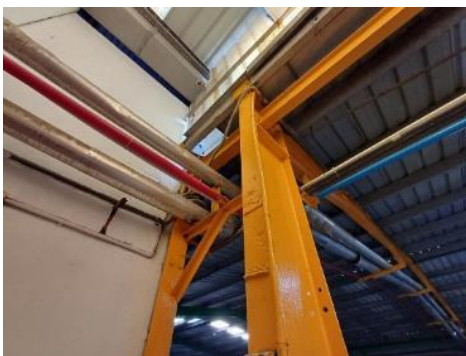
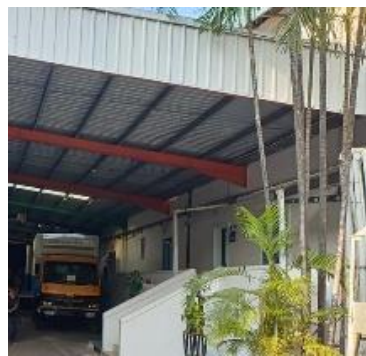
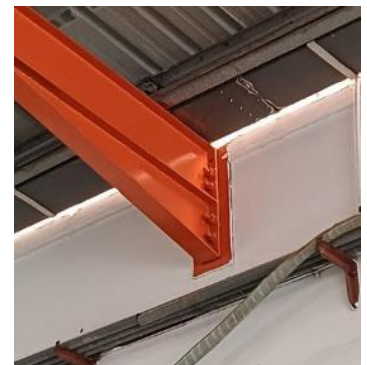
Connection between Rain Protection Shed and Building 1

**Observation-3:** Lack of lateral stability (Canteen building and Rain protection shed)

**Description:** Rain Protection Shed is partially connected with Canteen Building and partially connected with Building 1. Besides, no compression strut at ridgeline and vertical bracing in north-south direction. Building engineer is required to check the stability system & adequacy of all structural element, connection etc. and submit to RSC for review.

| Observation | Action Plan | Timeline |
|---|---|---|
| Lack of lateral stability system<br>(Canteen Building and Rain Protection Shed) | Building engineer is required to check the stability system & adequacy of all structural element, connection etc. and submit to RSC for review. | within 6 weeks |
| Lack of lateral stability system<br>(Canteen Building and Rain Protection Shed) | Carry out suggested remedial works if required. | within 6 months |

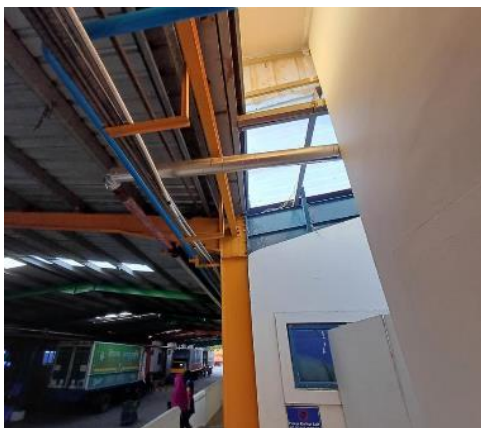
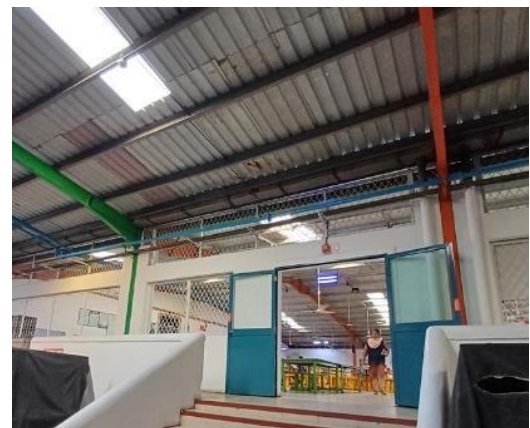
Canteen Building and Rain Protection shed – Structurally Connected

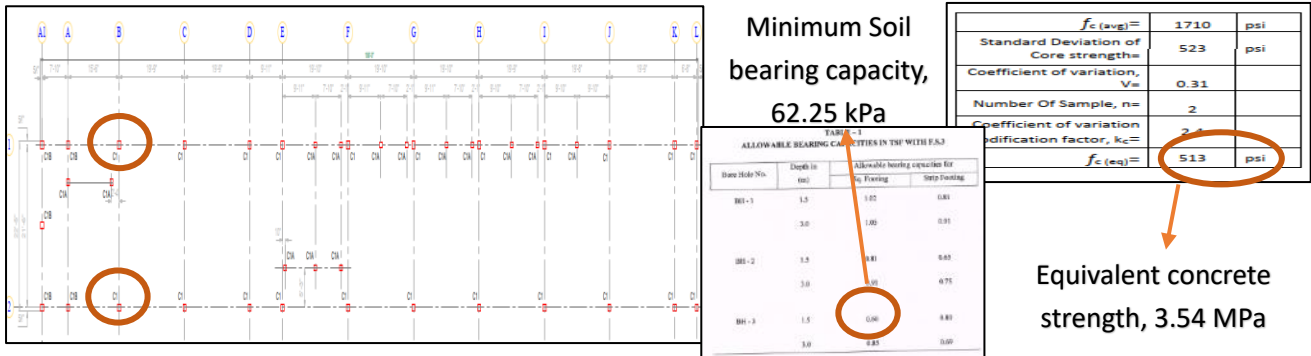
**Observation-4: High stress in Column and Footing (3D Building).**

**Description:** Cursors calculation indicates high stress in the marked columns and footings based on live load (3kPa for typical floor, 1.5 kPa for Roof), dead load (including wall load) and 62.25 kPa for foundation capacity & 3.54 Mpa concrete strength for column as per core test report. The source of loading is minimum live load as per load plan and partition wall. The building engineer is required to carry out Detail Engineering Assessment (DEA) to review the design, loads, column capacity and foundation stress based on in-situ material strength, and minimum floor live loads.

| Observation | Action Plan | Timeline |
|---|---|---|
| High stress in Column and Footing (3D Building). | Building engineer is required to carry out Detail Engineering Assessment (DEA) to review the design, loads, column capacity and foundation stress based on material strength, and minimum floor live loads. | within 6 weeks |
| High stress in Column and Footing (3D Building). | Carry out suggested remedial works if required. | within 6 months |

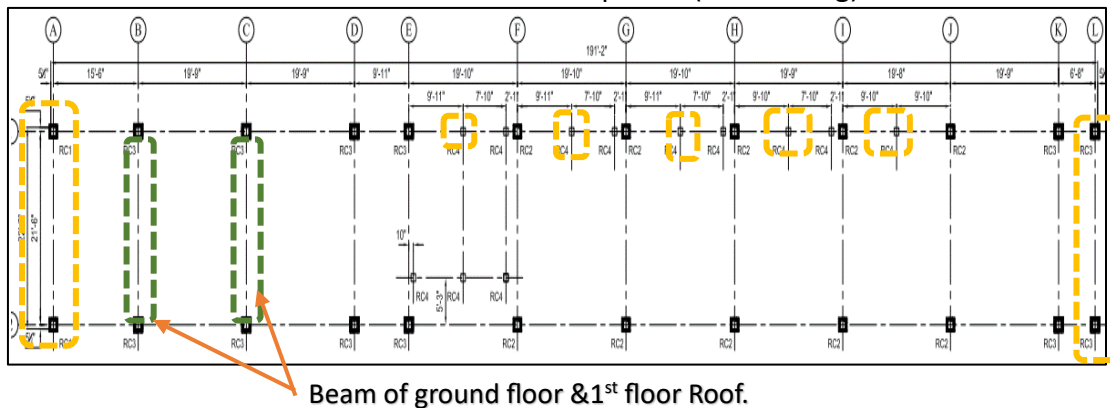
**Observation-5: Remediation works needs to be completed (3D Building).**

**Description:** Marked columns and beam were required to retrofit as per retrofitting drawing. However, during inspection remediation works were found incomplete for these columns and beam. Factory is required to complete the remediation works as per retrofitting drawing.

| Observation | Action Plan | Timeline |
|---|---|---|
| Remediation works needs to be completed (3D Building). | Factory is required to complete the remediation works as per retrofitting drawing. | within 6 months |

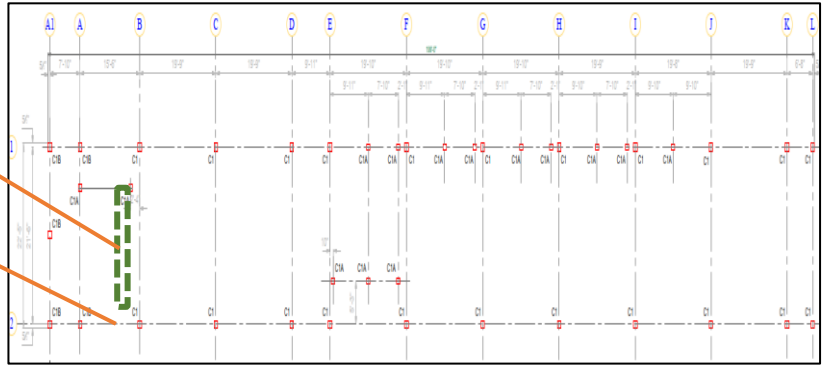
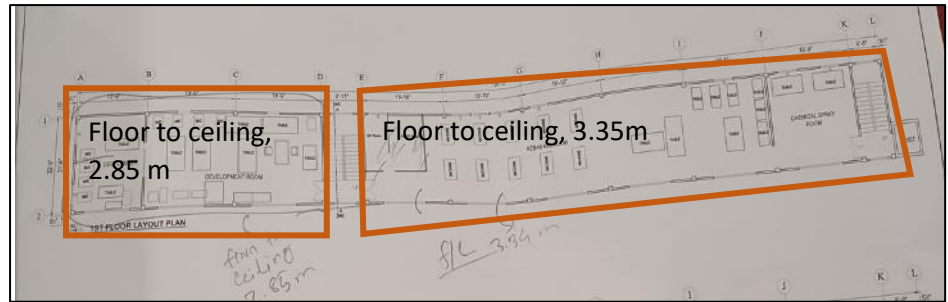
**Observation-6: Mismatch in as built drawings (3D Building).**

This Beam & Column not shown in drawings.

Different level was observed between these two parts at 1<sup>st</sup> floor level.

**Description:** During inspection, mismatches were found between onsite condition and as-built drawing. Some column and beam are not shown up to 1<sup>st</sup> floor roof. Also, different floor to ceiling height was observed on 1<sup>st</sup> floor level. The building engineer is required to survey the full structure and produce accurate as-built drawings.

| Observation | Action Plan | Timeline |
|---|---|---|
| Mismatch in as built drawings<br>(3D Building). | The building engineer is required to survey the full structure and produce accurate as-built drawings. | within 6 weeks |

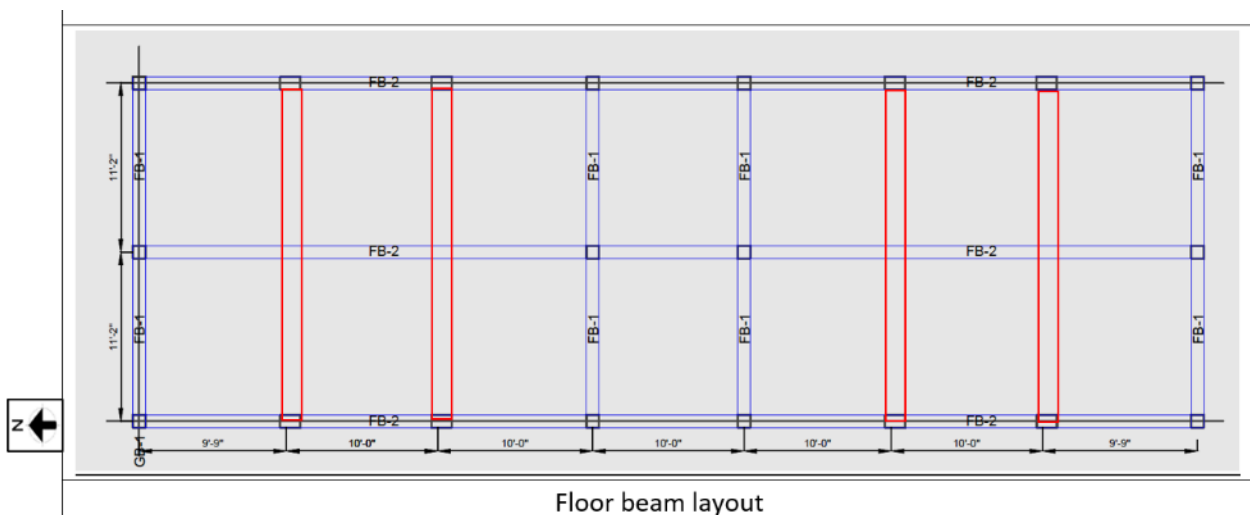
**Observation 7: Mismatches in as built drawings (Prayer & locker building)**

**Description:** Red marked beams were found onsite but not shown in drawing.

Building engineer is required to update the as-built drawing.

| Observation | Action Plan | Timeline |
|---|---|---|
| Mismatches in as built drawings<br>(Prayer & locker building) | The building engineer is required to survey the full structure and produce accurate as-built drawings. | within 6 weeks |

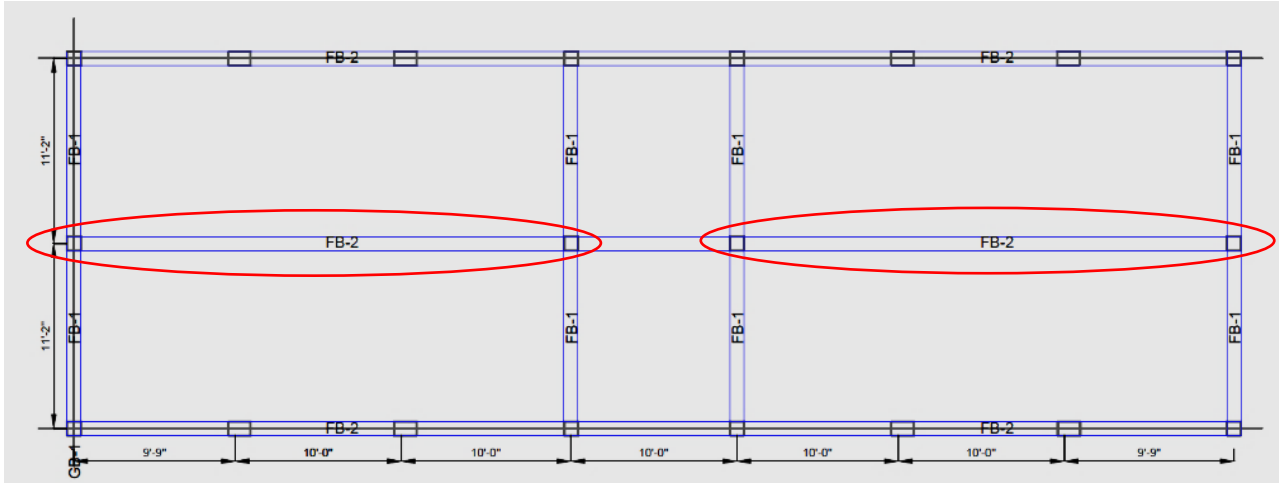
**Description:** Marked beams were not found onsite. Moreover, foundation and slab details are not shown in as-built drawings.

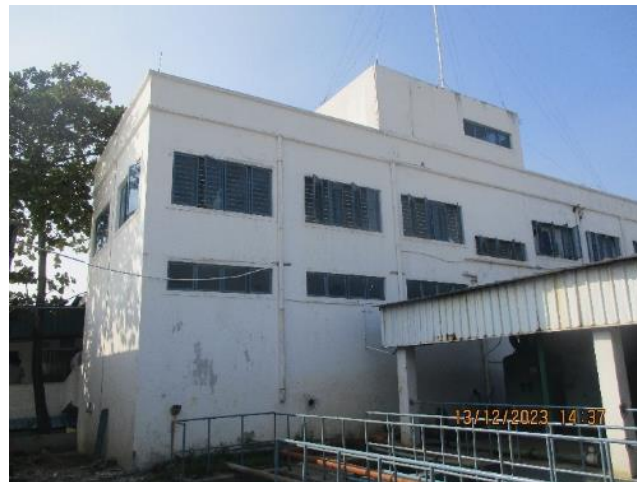
**Observation 8:** Lack of design documents. (Prayer & locker building)

**Description:** As per BNBC, every building or structure designed shall have its design documents prepared in accordance with the provision of Section 1.9.1. The design document shall include a design report, and a set of structural drawings, which shall be prepared in compliance with section 1.9.1.1 and section 1.9.1.2 as per BNBC.

At the time of inspection, design documents (including design report, load plan and material test reports) were not available which are required to be prepared in compliance with section 1.9.1 (part-6, BNBC).

| Observation | Action Plan | Timeline |
|---|---|---|
| Lack of design documents.<br>(Prayer & locker building) | Building engineer is required to prepare design documents (including design report, load plan and material test reports) in compliance with section 1.9.1 (part-6, BNBC). | within 6 weeks |
| Lack of design documents.<br>(Prayer & locker building) | Carry out suggested remedial works. | within 6 months |

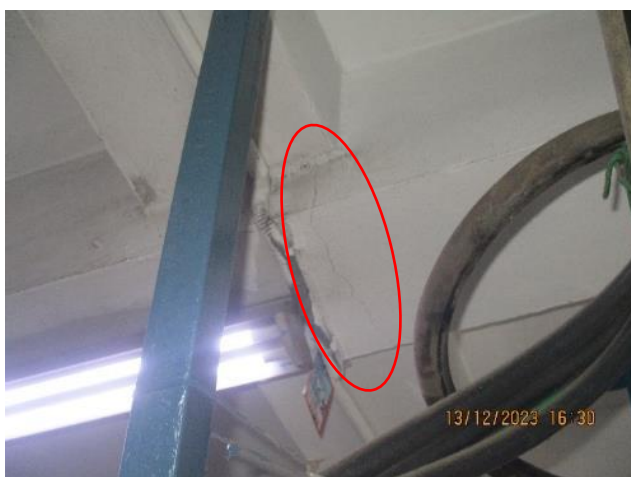
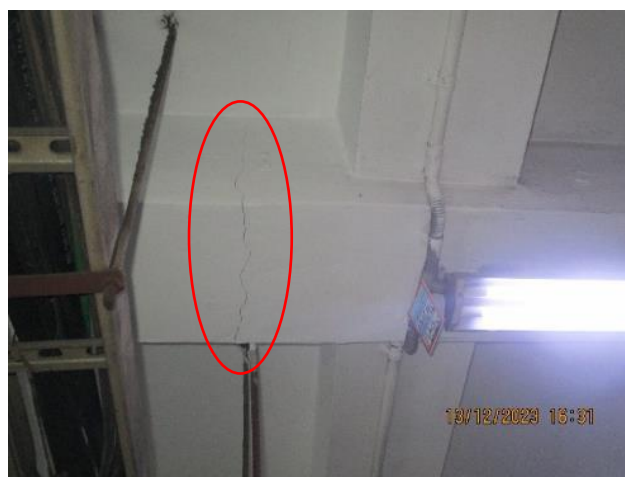
**Observation 9: Crack on beams (Compressor Room 1)**

**Description:** Crack was observed on beam surface. The building engineer is required to check the extent of crack and prepare an investigation report with necessary remedial measure.

| Observation | Action Plan | Timeline |
|---|---|---|
| Crack on beams (Compressor room-1) | Building engineer is required to check the extent of crack and prepare an investigation report with necessary remedial measure. | within 6 weeks |
| Crack on beams (Compressor | Carry out remedial works as per investigation | within 6 months |

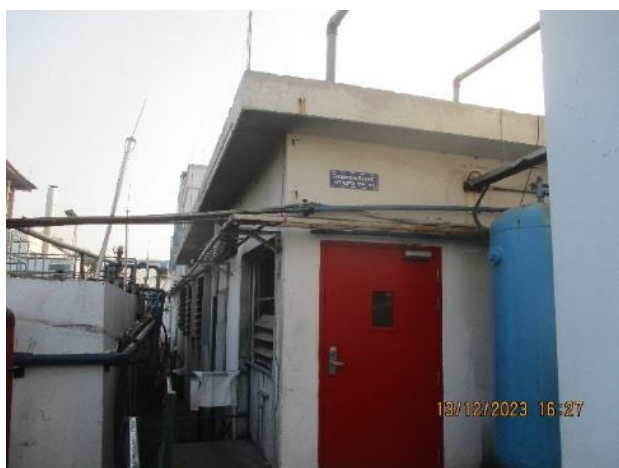
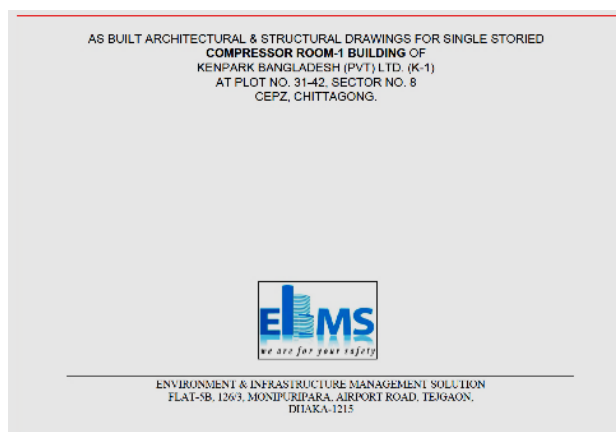
**Observation 10: Lack of information in as built drawings. (Compressor room 1)**

**Description:** During the inspection, the factory provided a set of as-built drawing. But foundation and slab details are not shown in as-built drawings. The building engineer is required to update the as-built drawing.

| Lack of information in as built drawings. (Compressor room-1) | The building engineer is required to survey the whole structure and update the as-built drawing as per actual site condition. | within 6 weeks |

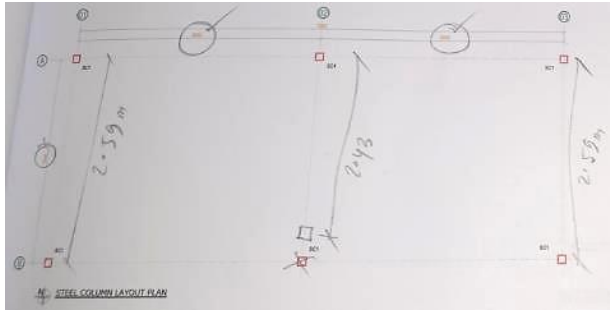
On-site grid spacing

### Observation 11: Discrepancies in as-built drawing (CMS Shed)

**Description:** On-site grid spacing, and location of column did not match with as-built drawing. Also, steel column size found 100X100 box section instead of 150X150 box and C-channel found 150X38X4 instead of 38X38X4. The building engineer is required to survey the whole structure and revise the as-built drawing as per actual site condition.

| Discrepancies in As-built drawing (CMS Shed) | The building engineer is required to survey the whole structure and revise the as-built drawing as per actual site condition. | within 6 weeks |

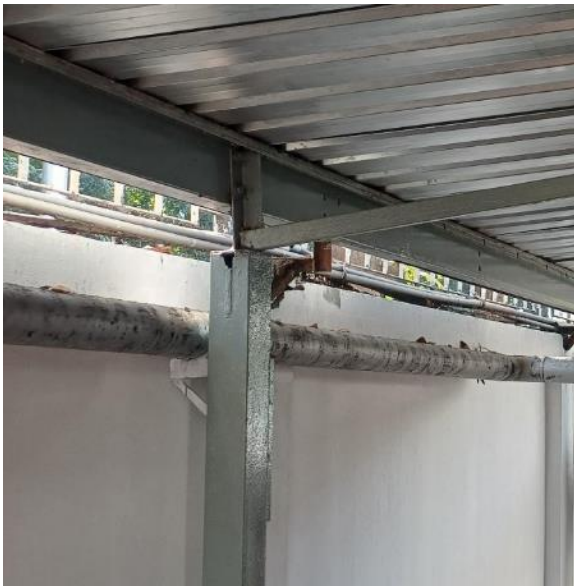
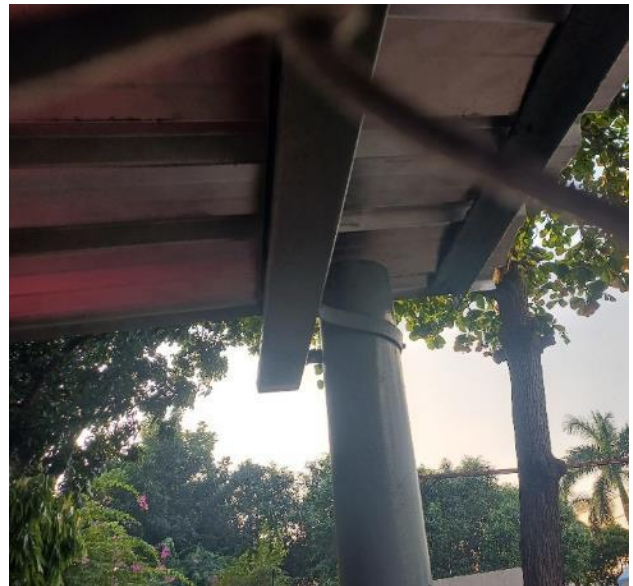
On-site connections

### Observation 12: Apparently inadequate connection (CMS Shed)

**Description:** During inspection, inadequate connections and apparently inadequate member size found. The building engineer is required to check the connection adequacy against the uplift force.

| Apparently inadequate connection (CMS Shed) | The building engineer is required to check the connection adequacy against the uplift force. | within 6 weeks |
| Apparently inadequate connection (CMS Shed) | Carry out the suggested remedial works if required. | within 6 months |

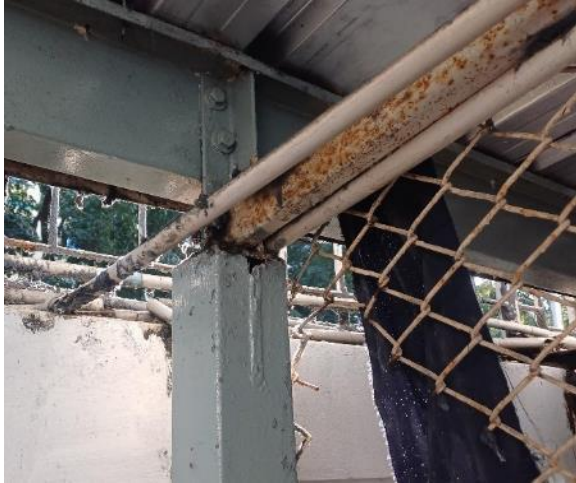
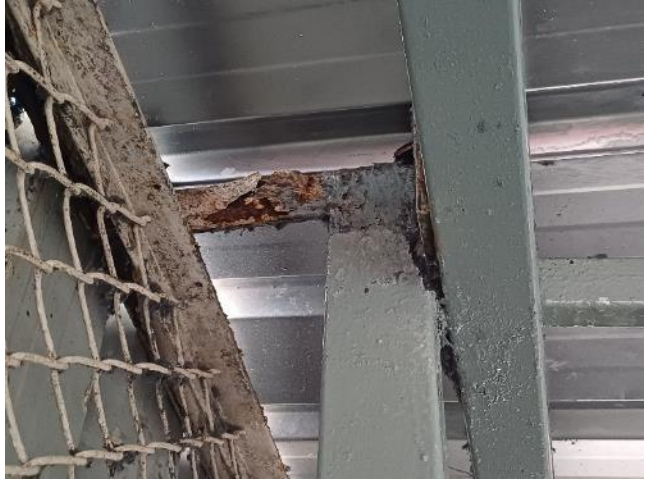
**Observation 13:** Corrosion observed at steel member (CMS Shed)

Severe corrosion at steel member

**Description:** During inspection, severe corrosion was observed at several steel members. The building engineer is required to remove the corrosion and provide rust proof coating.

| Corrosion observed at steel member (CMS Shed) | The building engineer is required to remove the corrosion and provide rust proof coating. | within 6 weeks |
| Corrosion observed at steel member (CMS Shed) | Carry out suggested remedial works if required. | within 6 months |

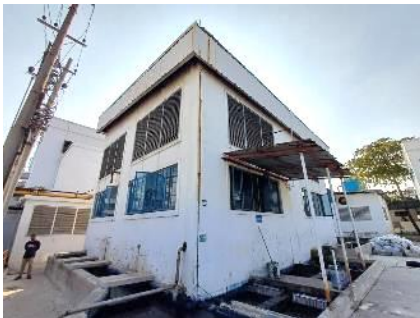
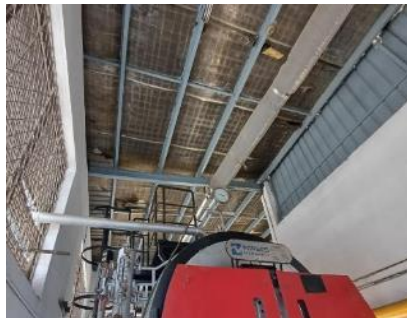
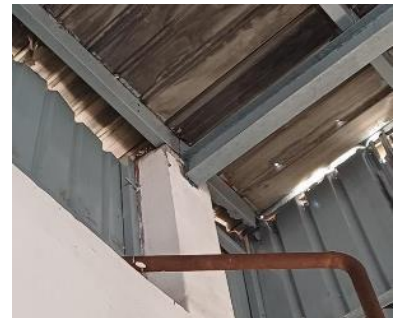
**Observation-14:** Lack of design documents (Boiler Room (6 Ton))

**Description:** As per BNBC, every building or structure designed shall have its design documents prepared in accordance with the provision of Section 1.9.1. The design documents shall include as built drawings and a design report which shall be prepared in compliance with section 1.9.1, part-6 of BNBC. During inspection, the design report was not available on site. The building engineer is required to prepare a design report in compliance with BNBC 1.9.1.

| Lack of design documents (Boiler Room (6 Ton)) | Building engineer is required to prepare a design report in compliance with section 1.9.1, part 6 of BNBC. | within 6 weeks |
| Lack of design documents (Boiler Room (6 Ton)) | Carry out suggested remedial works if required. | within 6 months |

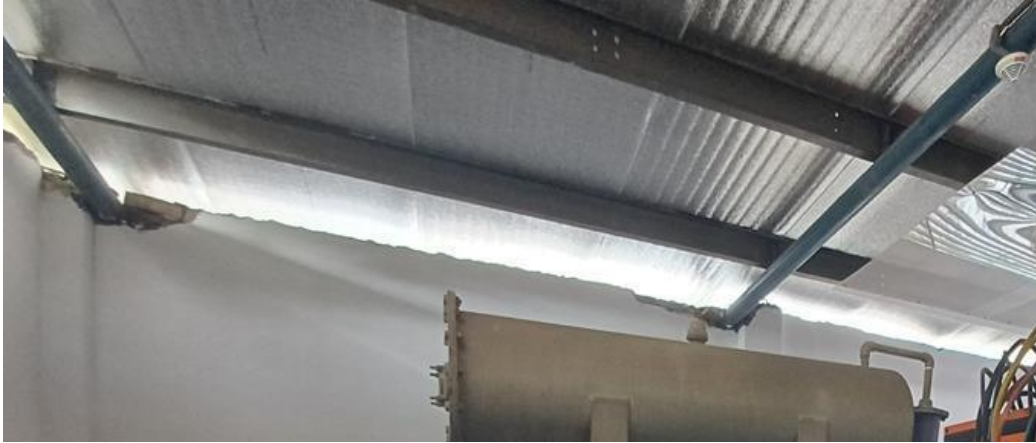
**Observation-15:** Apparently inadequate connection (Transformer room-1)

Connection between pipe and brick wall

**Description:** The steel pipe is inserted into the brick wall poorly without any proper connection. The building engineer is required to check the connection adequacy of the steel members.

| Apparently inadequate connection (Transformer Room-1). | Building engineer is required to check the connection adequacy of the steel members. | within 6 weeks |
| Apparently inadequate connection (Transformer Room-1). | Carry out remedial work if required. | within 6 months |

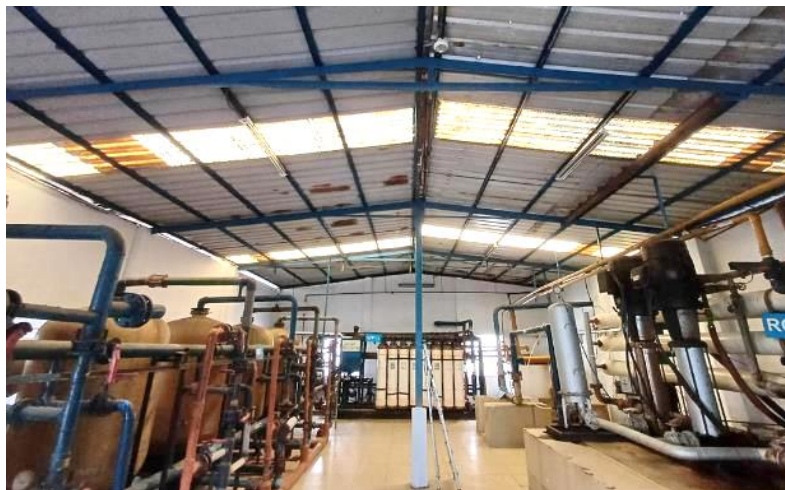
**Observation-16:** Lack of lateral stability system (RWTP Shed - 1)

**Description:** Lack of lateral stability system, apparent inadequate members and non-engineered connection were observed. The building engineer is required to check the member, connection & stability system of the structure and suggest proper remediation accordingly.

| Lack of lateral stability system (RWTP Shed - 1) | Building engineer is required to check the stability system & adequacy of all structural element, connection etc. and submit to RSC for review. | within 6 weeks |
| Lack of lateral stability system (RWTP Shed - 1) | Carry out suggested remedial works if required. | within 6 months |

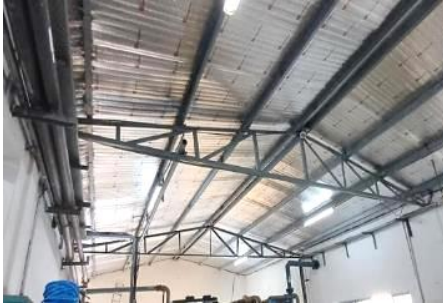
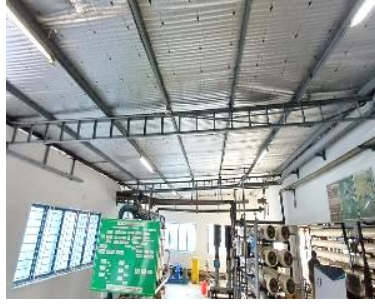
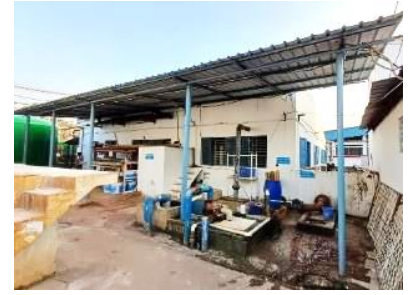
Lightweight Steel Roof

**Observation-17: Lack of lateral stability (RWTP Shed - 2)**

**Description:** Lack of lateral stability system, apparently inadequate members and non-engineered connection were observed. The building engineer is required to check the member, connection & stability system of the structure and suggest proper remediation accordingly.

| Lack of lateral stability system (RWTP Shed - 2) | Building engineer is required to check the stability system & adequacy of all structural element, connection etc. and submit to RSC for review. | within 6 weeks |
| Lack of lateral stability system (RWTP Shed - 2) | Carry out suggested remedial works if required. | within 6 months |

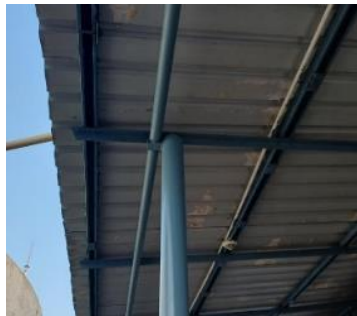
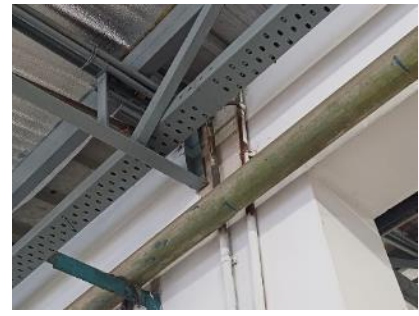
Poor Connection

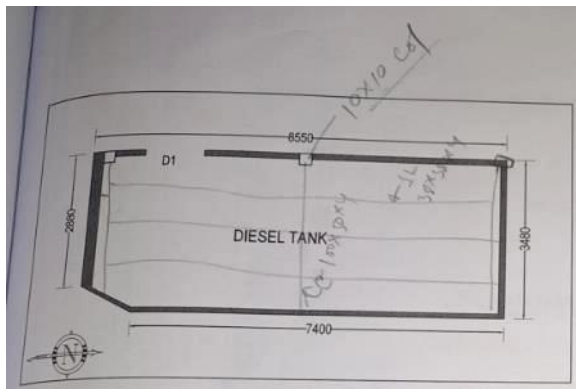
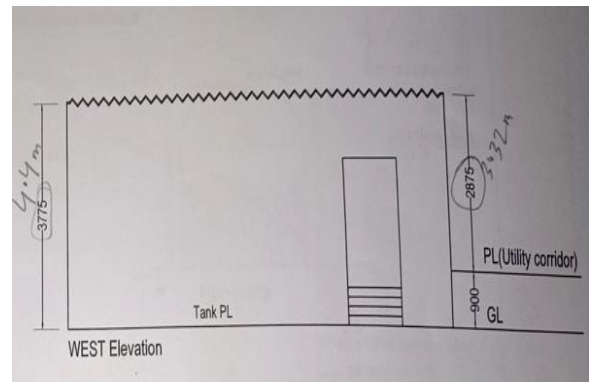
**Observation 18: Lack of as-built drawing (Diesel tank shed)**

Steel member, Column and Foundation details not available

**Description:** Details of steel members, columns and foundations were not available, only architectural plan was available. The building engineer is required to prepare a complete set of drawings as per actual site condition.

| Lack of As-built drawing (Diesel tank shed) | The building engineer is required to prepare a complete set of as-built drawings as per actual site condition. | within 6 weeks |

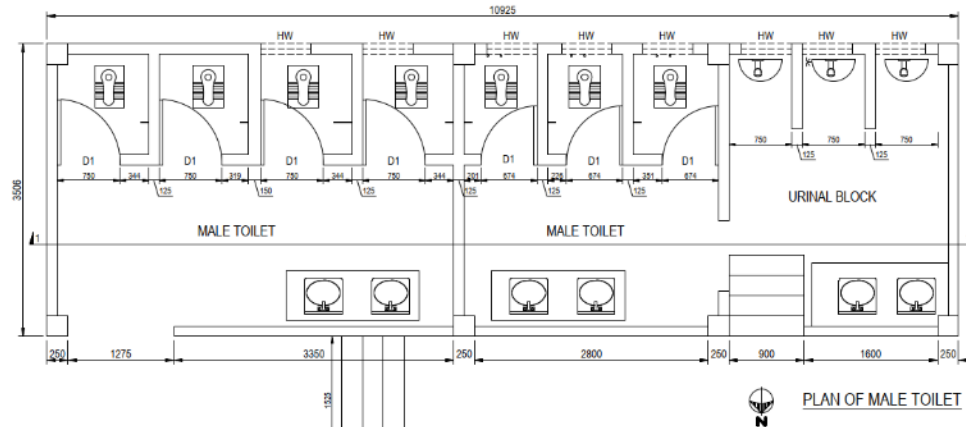
**Observation 19: Lack of As-built drawing (Male toilet block)**

Beam, Column and Foundation details not available

**Description:** Details of beams, Columns and Foundations were not available, only an architectural plan was available. The building engineer is required to prepare a complete set of as-built drawings as per actual site condition.

| Lack of As-built drawing (Male toilet block) | The building engineer is required to prepare a complete set of as-built drawings as per actual site condition. | within 6 weeks |

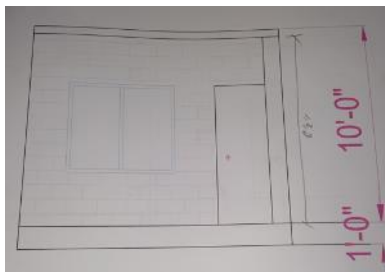
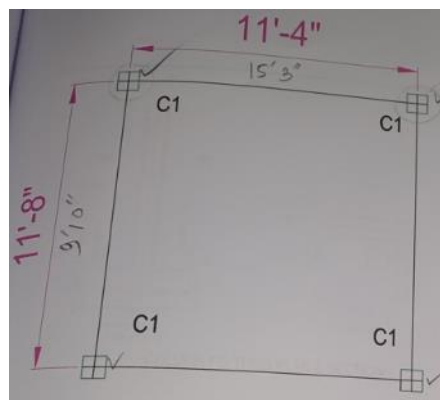
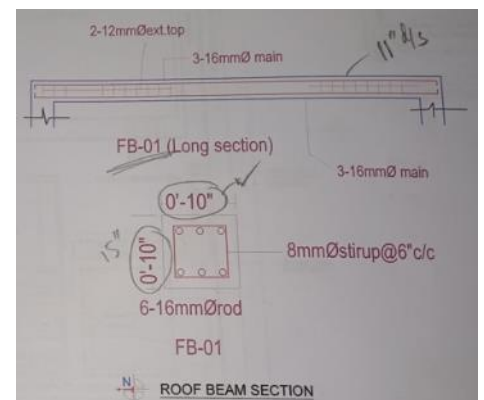
On-site conditions

**Observation 20: Discrepancies in As-built drawing (Driver's waiting room)**

**Description:** On-site grid spacing, height, beam section did not match with as-built drawing. A details were not available. The building engineer is required to survey the whole structure and re as-built drawing as per actual site condition.

| Discrepancies in As-built drawing (Driver's waiting room) | The building engineer is required to survey the whole structure and revise the as-built drawing as per actual site condition. | within 6 weeks |

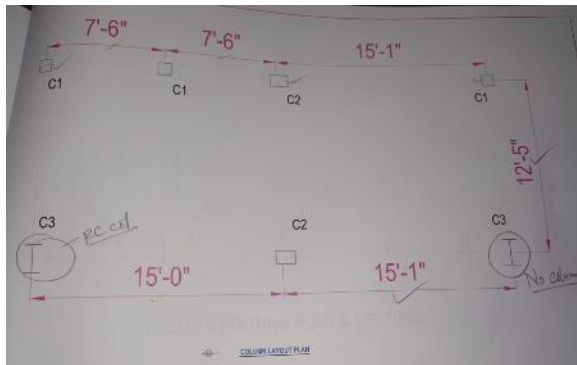
**Observation 21:** Discrepancies in As-built drawing (Chemical issue room)

Mismatch in Column

**Description:** Column layout and beam layout did not match with as-built drawing. The building engineer is required to survey the whole structure and revise the as-built drawing as per actual site condition.

| Discrepancies in As-built drawing (Chemical issue room) | The building engineer is required to survey the whole structure and revise the as-built drawing as per actual site condition. | within 6 weeks |

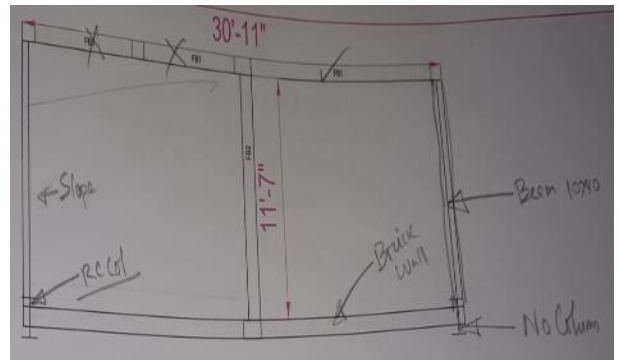
Beam Layout not matched

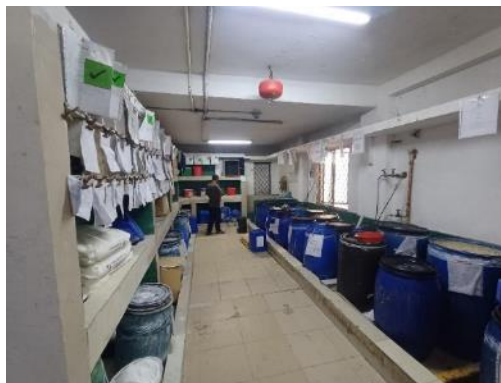
**Observation 22:** Lack of design documents (Chemical issue room)

Design documents not available

**Description:** As per BNBC (part-6), every building or structure designed shall have its design documents prepared in accordance with the provision of Section 1.9.1. The design document shall include a design report, and a set of structural drawings, which shall be prepared in compliance with section 1.9.1.1 & section 1.9.1.2 of BNBC (part-6).

At the time of inspection, design report was not available for this structure. The building engineer is required to prepare a set of design documents in compliance with BNBC.

| Lack of design documents (Chemical issue room) | The building engineer is required to prepare a set of design documents in compliance with BNBC. | within 6 weeks |
| Lack of design documents (Chemical issue room) | Carry out the suggested remedial works if required. | within 6 months |

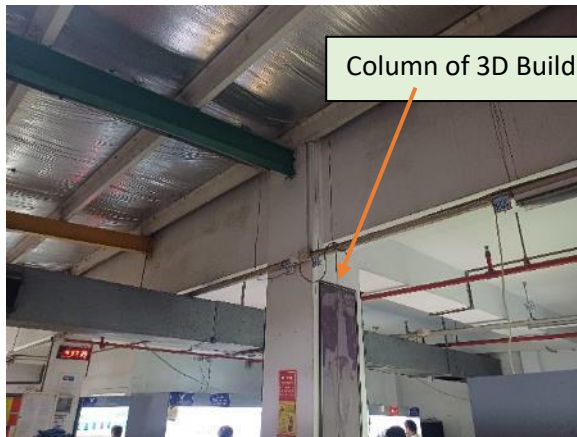
**Observation 23:** Structurally connected with 3D Building (WP QC area shed)

Structurally Connected Column

**Description:** Columns of this structure found connected with 3D Building. The building engineer is required to analysis the structure with 3D building otherwise separate the structure.

| Structurally connected with 3D Building (WP QC area shed) | The building engineer is required to analysis the structure with 3D building otherwise separate the structure. | within 6 weeks |
| Structurally connected with 3D Building (WP QC area shed) | Carry out the suggested remedial works if required. | within 6 months |

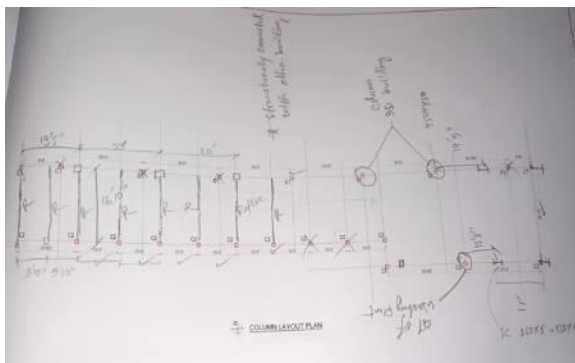
**Observation 24:** Discrepancies in As-built drawing (WP QC area shed)

Mismatch in Column & Rafter

**Description:** Column layout and Rafter layout in as-built drawing did not match with actual site condition. The building engineer is required to survey the whole structure and revise the as-built drawing as per actual site condition.

| Discrepancies in As-built drawing (WP QC area shed) | The building engineer is required to survey the whole structure and revise the as-built drawing as per actual site condition. | within 6 weeks |

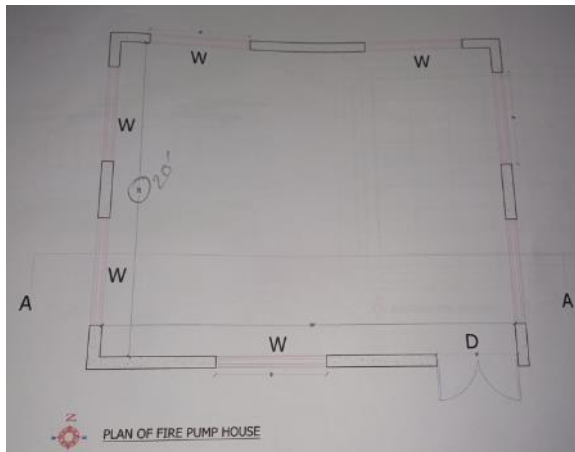
**Observation 25: Discrepancies in As-built drawing (Fire pump room)**

**Description:** On-site grid spacing did not match with as-built drawing. Also, steel column size found 100X100 box section instead of 75X50 box. The building engineer is required to survey the whole structure and revise the as-built drawing as per actual site condition.

| Discrepancies in As-built drawing (Fire pump room) | The building engineer is required to survey the whole structure and revise the as-built drawing as per actual site condition. | within 6 weeks |

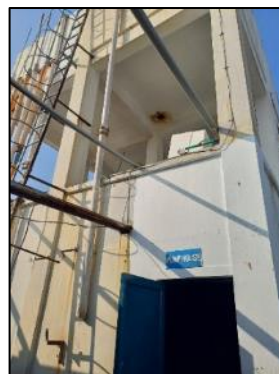
**Observation-26: Lack of design documents (Overhead pump room).**

**Description:** As per BNBC, every building or structure designed shall have its design documents prepared in accordance with the provision of Section 1.9.1. The design documents shall include as built drawings and a design report which shall be prepared in compliance with section 1.9.1, part-6 of BNBC.

During inspection, the design documents (as-built structural drawings, design report) were not available on site. The building engineer is required to prepare a design document based on in-situ material strength & software-based analysis and submit it to RSC for review.

| Lack of design documents (Overhead pump room). | The building engineer is required to prepare a design document based on in-situ material strength & software-based analysis and submit it to RSC for review. | within 6 weeks |
| Lack of design documents (Overhead pump room). | Carry out suggested remedial works if required. | within 6 months |

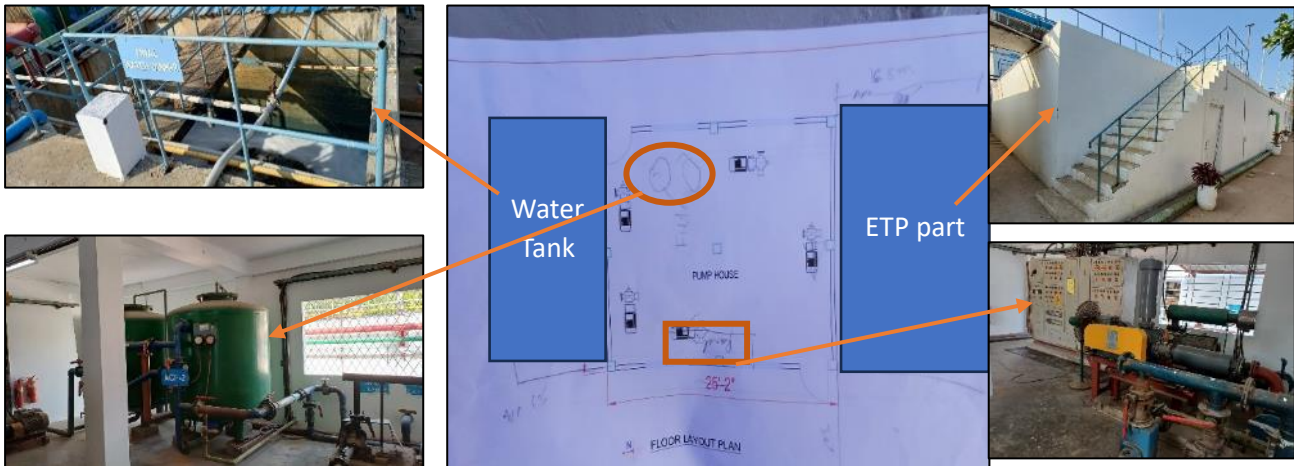
**Observation-27:** Discrepancies in as built drawings (ETP pump room).

**Description:** During inspection, mismatches were found between onsite condition and as-built drawing. Water tank and ETP process part were not shown in as built drawings. Also, mis match was observed in pump room foot layout. The building engineer is required to survey the full structure and produce accurate as-built drawings.

| Discrepancies in as built drawings (ETP pump room). | The building engineer is required to survey the full structure and produce accurate as-built drawings. | within 6 weeks |

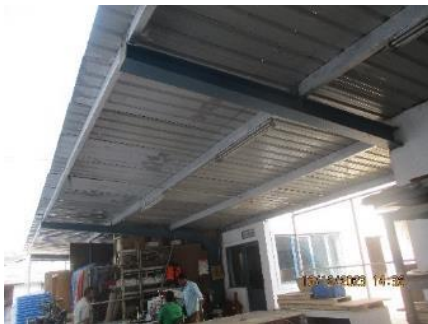
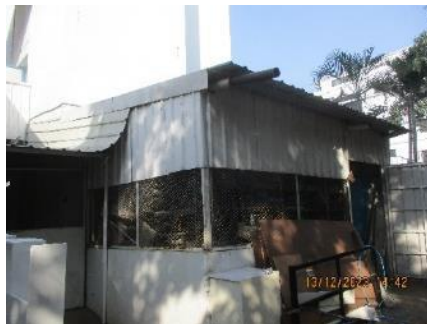
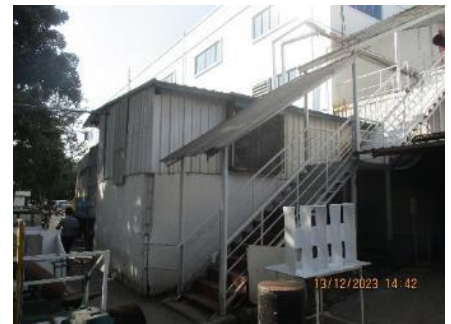
**Observation-28:** Lack of information in as built drawings. (Maintenance workshop shed, WP maintenance workshop shed and loading & unloading shed of WP)

**Description:** During the inspection factory provided a set of as-built drawings for maintenance workshop shed, WP maintenance workshop shed and loading & unloading shed of WP. But foundation details are not shown for maintenance workshop shed and WP maintenance workshop shed. Also, connection details are not found for maintenance workshop shed, WP maintenance workshop shed and loading & unloading shed of WP in as-built drawings.

Building engineer is required to update the as-built drawing as per on site condition.

| Lack of information in as built drawings. (Maintenance workshop shed, WP maintenance workshop shed and loading & unloading shed of WP) | The building engineer is required to survey the whole structure and update the as-built drawing as per actual site condition. | within 6 weeks |

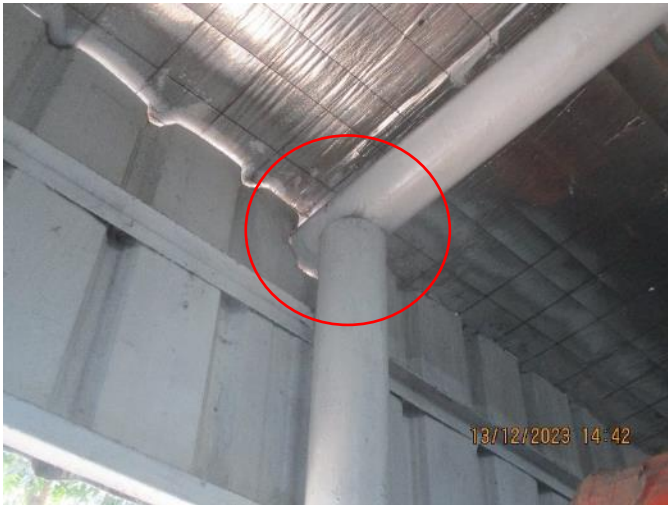
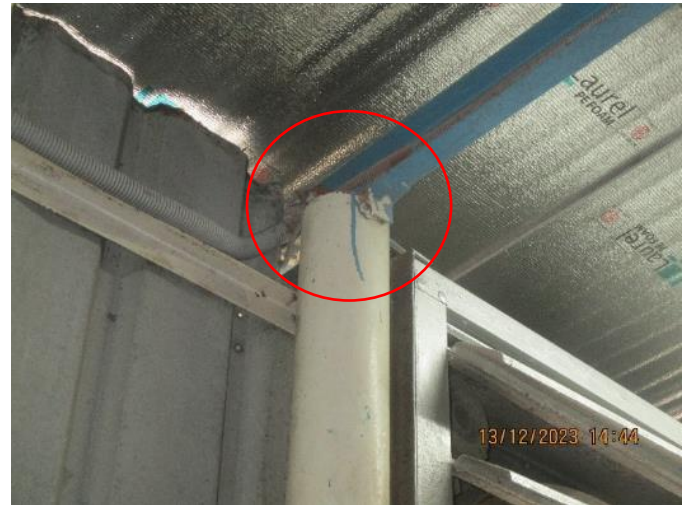
**Observation-29:** Apparently inadequate connection. (WP maintenance workshop shed and loading & unloading shed of WP)

**Description:** During inspection poor connections were observed. The building engineer is required to check the connection adequacy of the structures and suggest proper remediation accordingly.

| Apparently inadequate connection. (WP maintenance workshop shed and loading & unloading shed of WP) | The building engineer is required to check the connection adequacy against the uplift force. | within 6 weeks |
| Apparently inadequate connection. (WP maintenance workshop shed and loading & unloading shed of WP) | Carry out the suggested remedial works if required. | within 6 months |

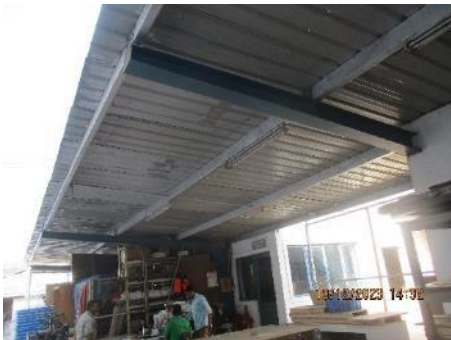
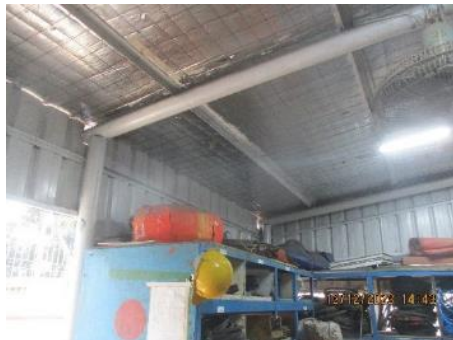
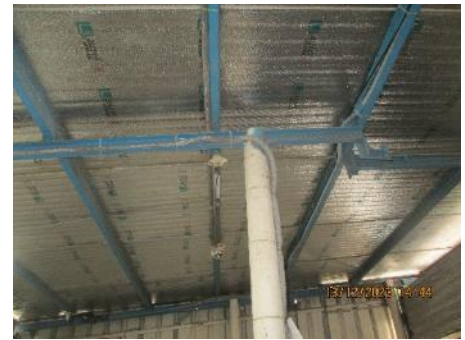
**Observation-30:** Lack of lateral stability system. (Maintenance workshop shed, WP maintenance workshop shed and loading & unloading shed of WP)

**Description:** Lack of lateral stability system (horizontal and vertical bracing etc.) and apparently inadequate members were observed. The building engineer is required to check adequacy of the member & stability system of the structure and suggest proper remediation accordingly.

| Lack of lateral stability system.<br>(Maintenance workshop shed,<br>WP maintenance workshop<br>shed and loading & unloading<br>shed of WP) | Building engineer is required to check the<br>stability system & adequacy of all structural<br>element and submit to RSC for review. | within 6 weeks |
| Lack of lateral stability system.<br>(Maintenance workshop shed,<br>WP maintenance workshop<br>shed and loading & unloading<br>shed of WP) | Carry out the suggested remedial works if<br>required. | within 6 months |

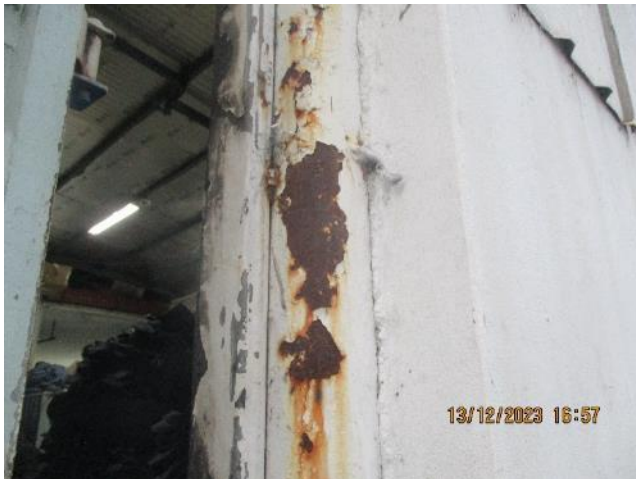
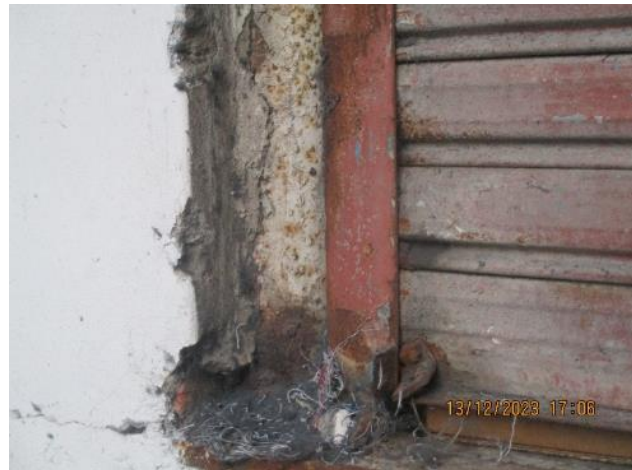
**Observation-31:** Corrosion on steel columns. (Loading & unloading shed of WP)

**Description:** During inspection corrosion was found to steel pipe columns. The building engineer is required to identify all corroded members, remove the corrosion and apply suitable anti-corrosive coating to the affected steel members.

| Corrosion on steel columns.<br>(Loading & unloading shed of<br>WP) | Building Engineer is required to identify all<br>corroded members, remove the corrosion,<br>and apply suitable anti-corrosive coating to<br>the affected steel members. | within 6 weeks |
