# Big Boss Corporation Ltd. (Extension)

Holding#30 Sharabo, Kasimpur, Gazipur  
(23.985604, 90.284023)  
25 September 2023

# Observations

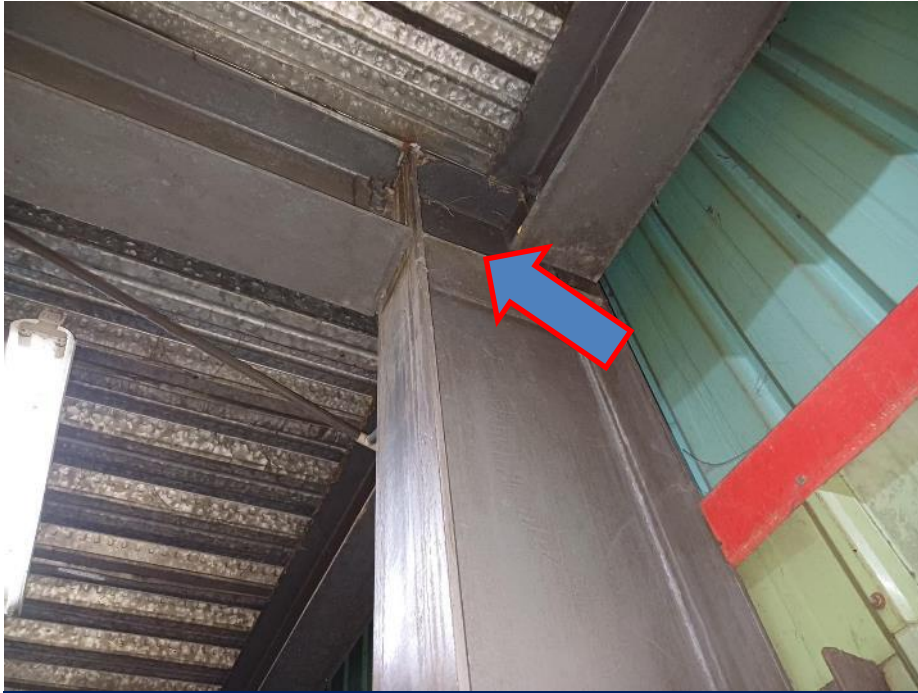
Shear connection in floor beam in both direction

Roof bracing and compression strut on roof and shear connection in both direction of 1<sup>st</sup> floor was observed . No vertical bracing was observed under floor or wall. Hence load transfer media from roof to foundation is incomplete. The building engineer is required to check the lateral stability of the structure as part of EA and suggest proper remedial actions accordingly.

| Item No. | Observation | Recommended Action Plan | Recommended Timeline |
|---|---|---|---|
| 01 | Lack of Lateral Stability (Canteen Building) . | Building engineer is required to check the lateral stability of the structure as part of EA and suggest proper remedial actions accordingly. | 6-weeks |

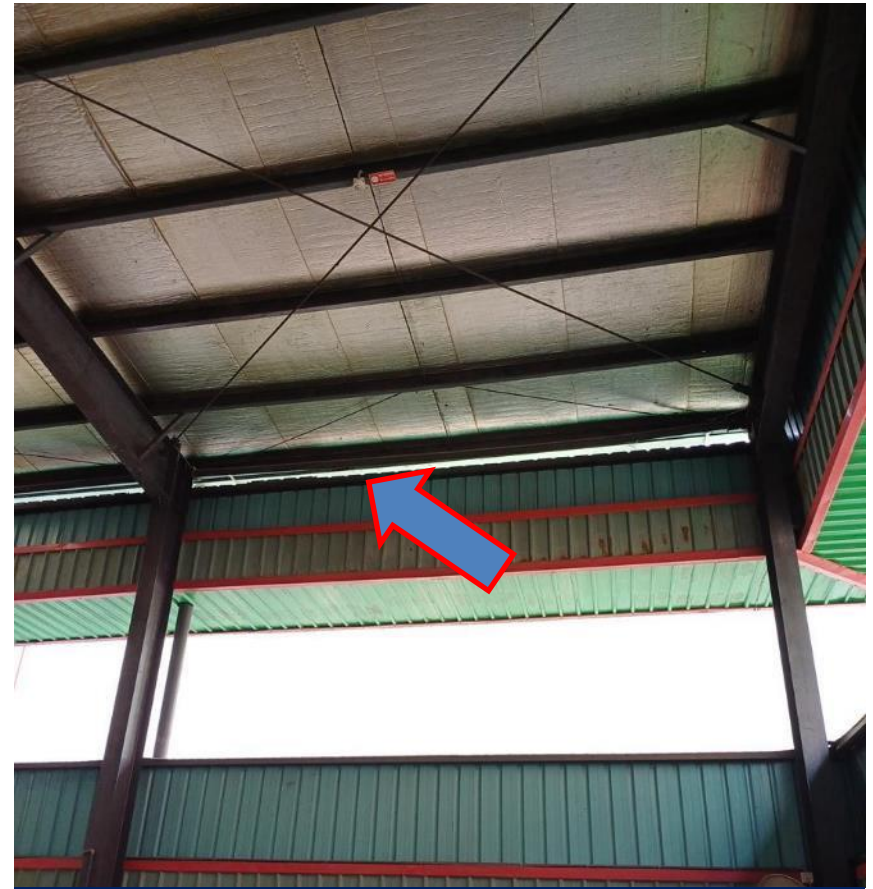
Only roof bracing and compression member

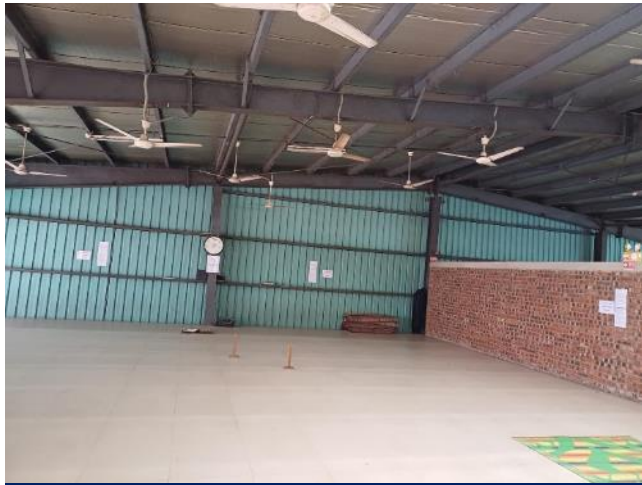
Min. 105 psf L.L . for prayer room.

Prayer room in 1<sup>st</sup> floor

The design live load considered for 1<sup>st</sup> floor is 63 psf. Building engineer is required revised load plan as per BNBC Table 6.2.3 and revise the design report as well.

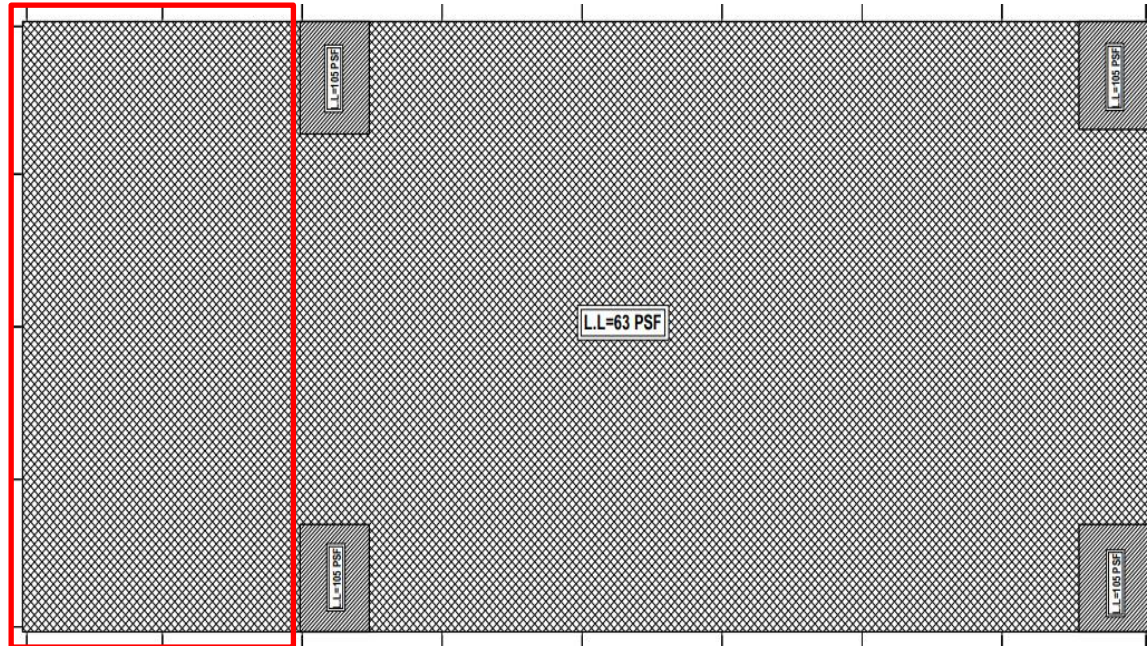
Considered live load is 63 psf for prayer room on 1<sup>st</sup> floor in load plan

| Item No. | Observation | Recommended Action Plan | Recommended Timeline |
|---|---|---|---|
| 03 | Load plan doesn't comply with BNBC (Canteen Building). | Building engineer is required to revise the load plan as per BNBC Table 6.2.3 and revise the design report as well. | 6-weeks |

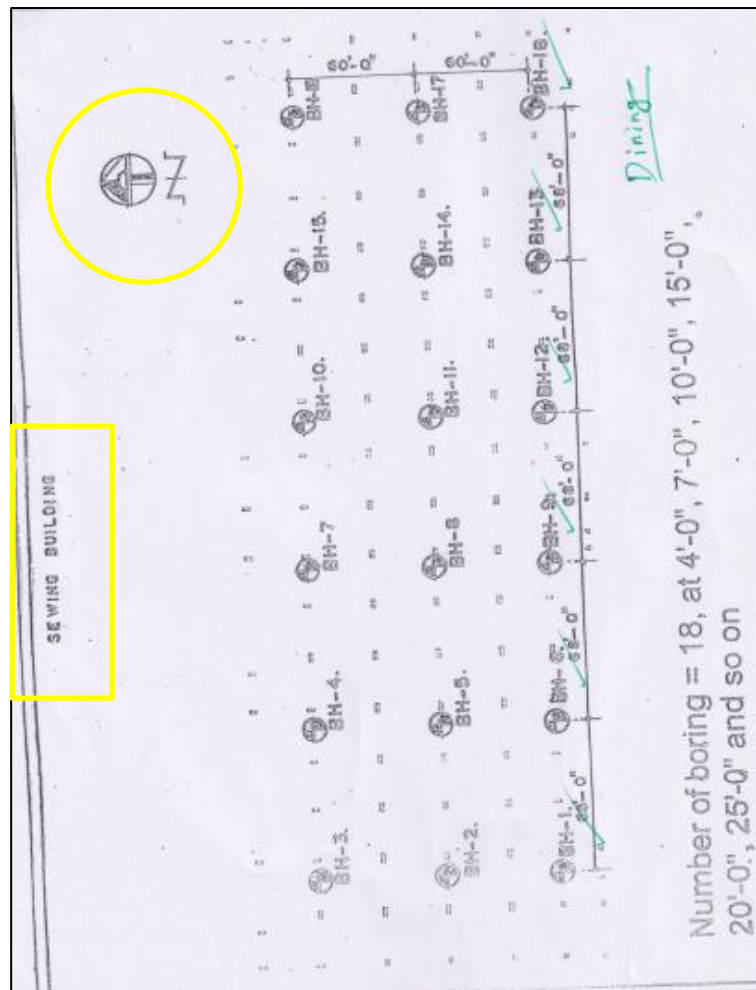
Bore hole location are for Sewing Building

The foundation adequacy check of this structure was done by using the data from different structures. Building engineer is required to check the foundation adequacy as per in-situ soil-bearing capacity.

| Item No. | Observation | Recommended Action Plan | Recommended Timeline |
|---|---|---|---|
| 05 | Soil-bearing capacity consideration (Canteen Building) . | Building engineer is required to check the foundation adequacy as per in-situ soil bearing capacity.. | 6-weeks |

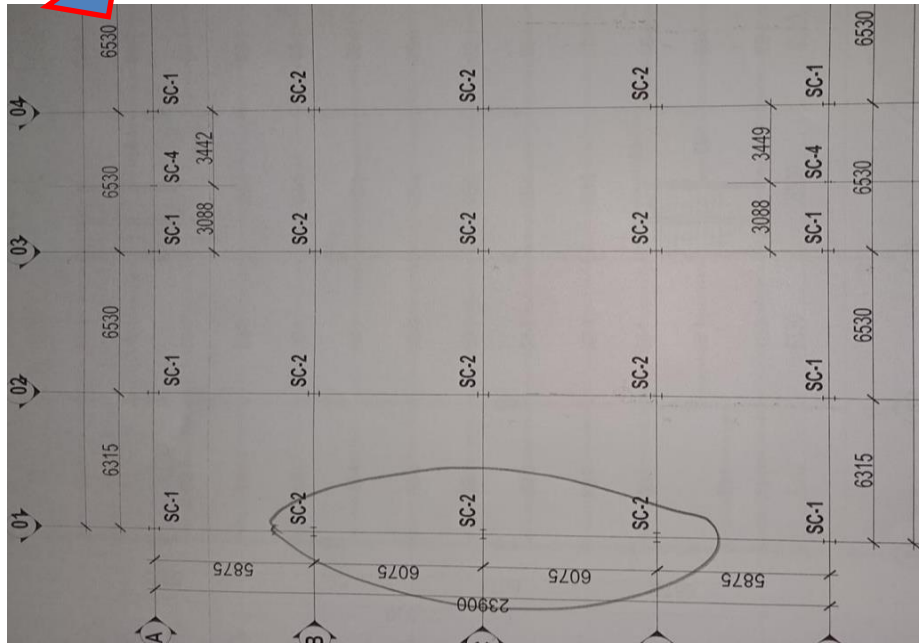
Columns shown in longitudinal direction

Columns orientation were not matched with as built drawing. The building engineer is required to check the column orientation and update the as-built drawing accordingly.

| Item No. | Observation | Recommended Action Plan | Recommended Timeline |
|---|---|---|---|
| 07 | Mismatch in as built drawing (Canteen Building). | The building engineer is required to check the column orientation and update the as-built drawing accordingly. | 6-weeks |

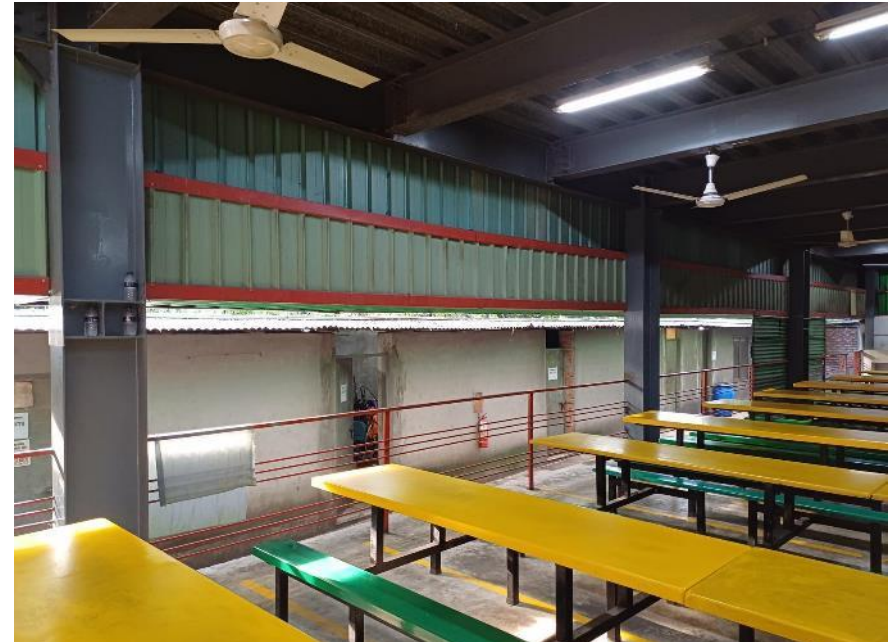
Columns found in transverse direction

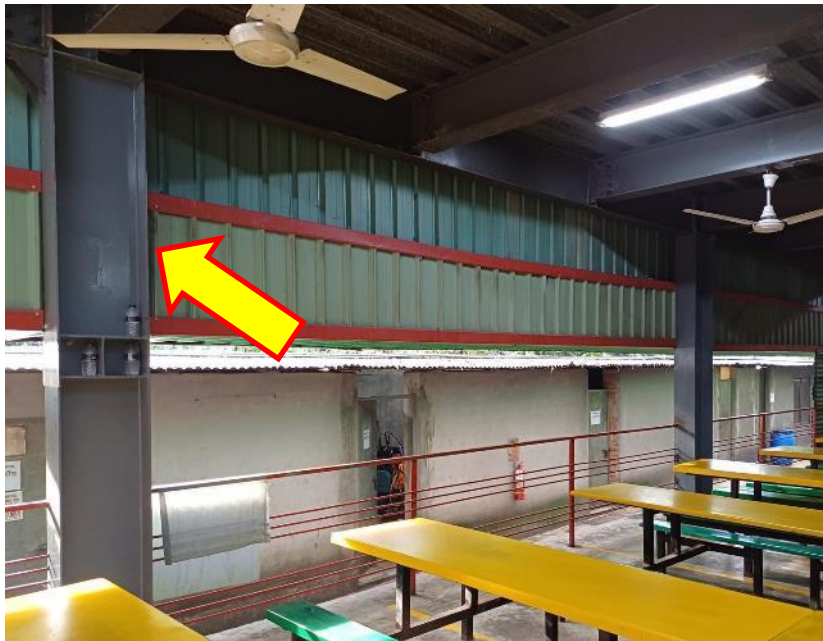
Column orientation below floor

During inspection, column above floor was observed in different orientation than column below floor. The building engineer is required to update the FEM model, check the vertical load transfer adequacy of the joint, and suggest proper remedial actions accordingly.

| Item No. | Observation | Recommended Action Plan | Recommended Timeline |
|---|---|---|---|
| 08 | Mismatch in as built drawing (Canteen Building). | The building engineer is required to the update the FEM model, check the vertical load transfer adequacy of the joint, and suggest proper remedial actions accordingly. | 6-weeks |

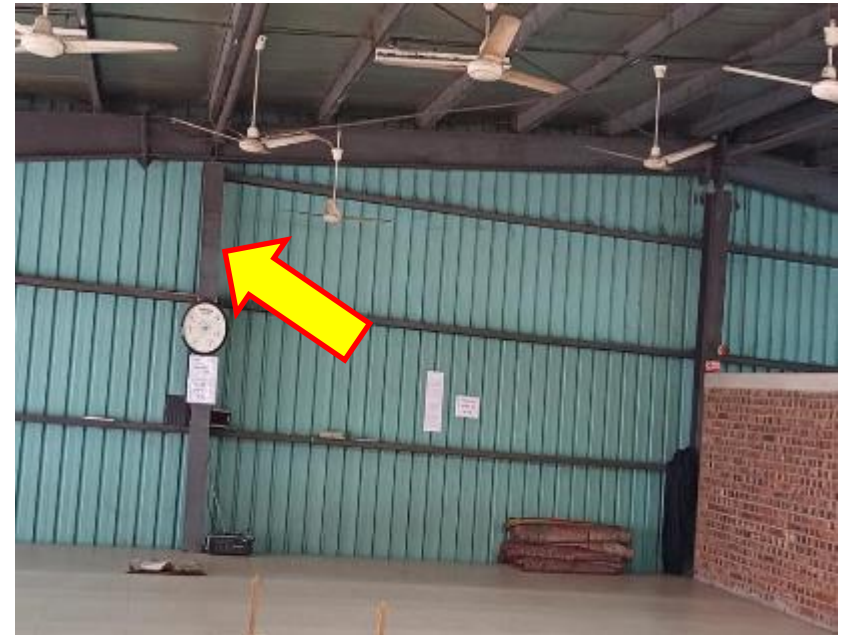
Rotated column above floor

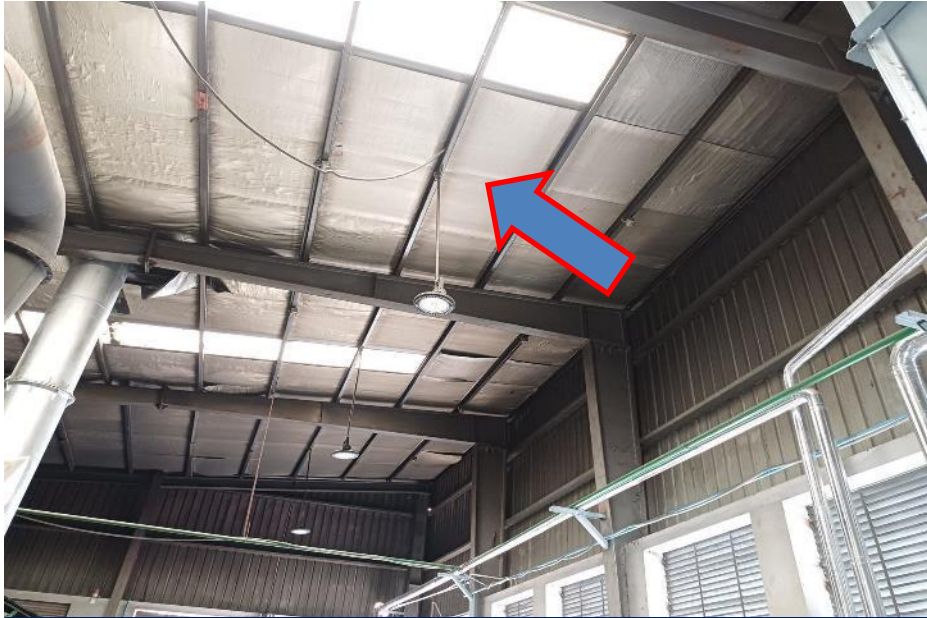
Compression member, wall & roof bracing missing

No roof and wall bracing was observed as shown in the as-built drawing. Hence, the lateral stability system structure is absent. The building engineer is required to update the as-built drawing check the lateral stability of the structure as part of EA and suggest proper remedial actions accordingly.

| Item No. | Observation | Recommended Action Plan | Recommended Timeline |
|---|---|---|---|
| 10 | Lack of Lateral Stability (Boiler shed). | The building engineer is required to update the as built drawing, check the lateral stability of the structure as part of EA and suggest proper remedial actions accordingly | 6-weeks |

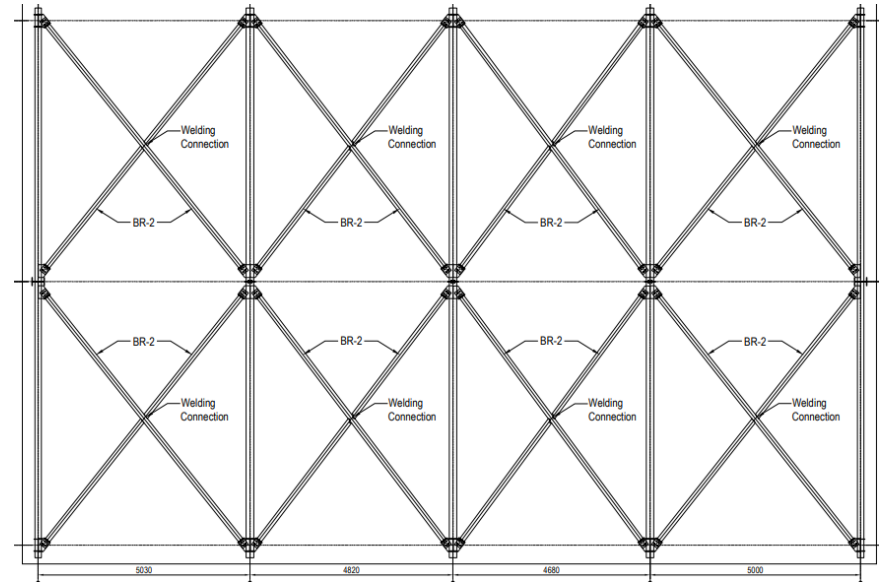
Roof bracing in as built drawing

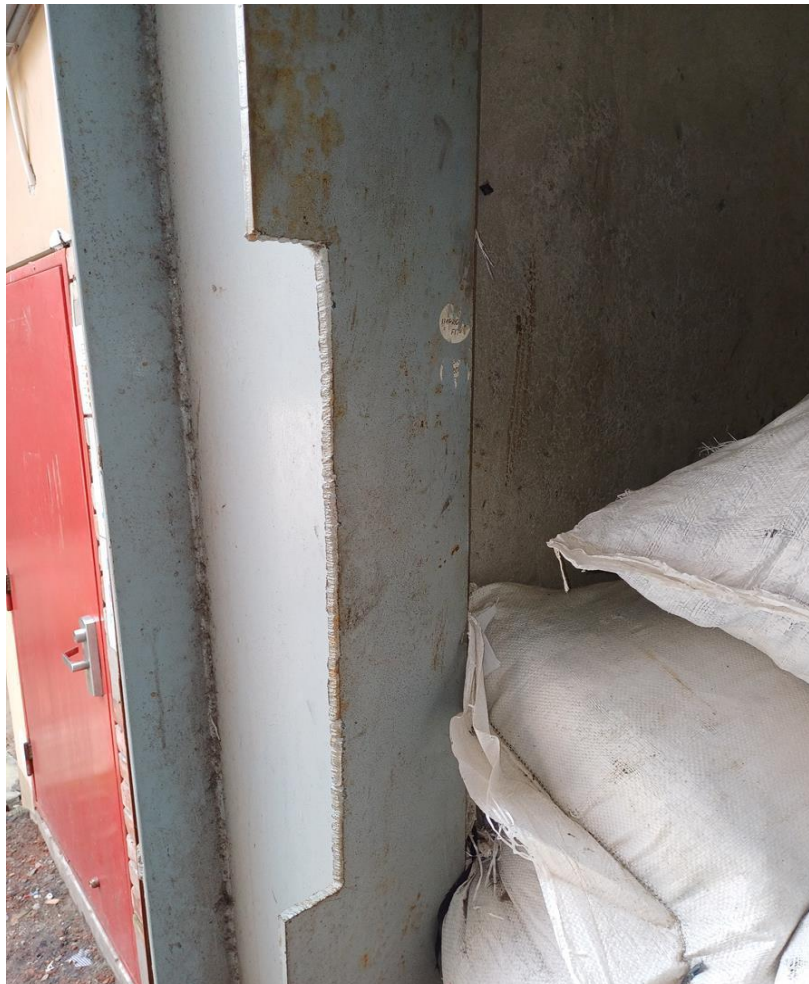
Sample has been taken from Column Flange

The factory has taken samples from steel member for plate tests. Building engineer is required to fill the sample location with adequate measures.

| Item No. | Observation | Recommended Action Plan | Recommended Timeline |
|---|---|---|---|
| 12 | Plate sample location need to be filled (Boiler shed). | Building engineer is required to fill the sample location with adequate measures. | 6-weeks |

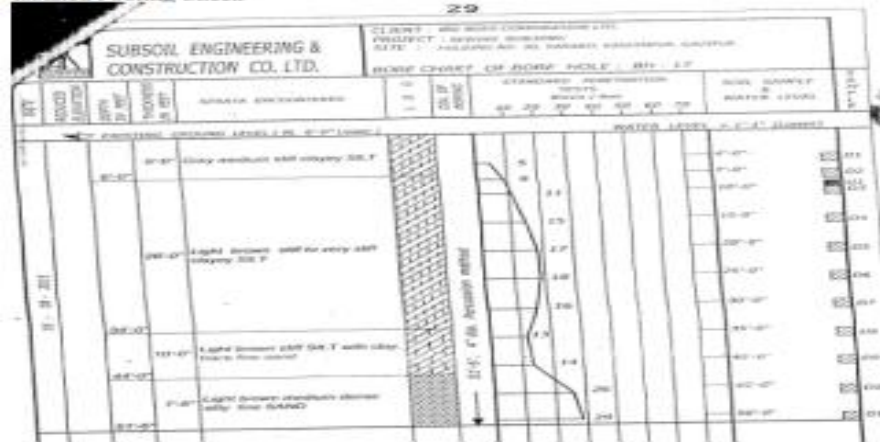
Foundation adequacy check from different soil test data

The foundation adequacy check of this structure was done by using the data from different structure. Building engineer is required to check the foundation adequacy as per in-situ soil bearing capacity.

| Item No. | Observation | Recommended Action Plan | Recommended Timeline |
|---|---|---|---|
| 13 | Design report needs to be updated (Boiler shed). | Building engineer is required to check the foundation adequacy as per in-situ soil-bearing capacity. | 6-weeks |

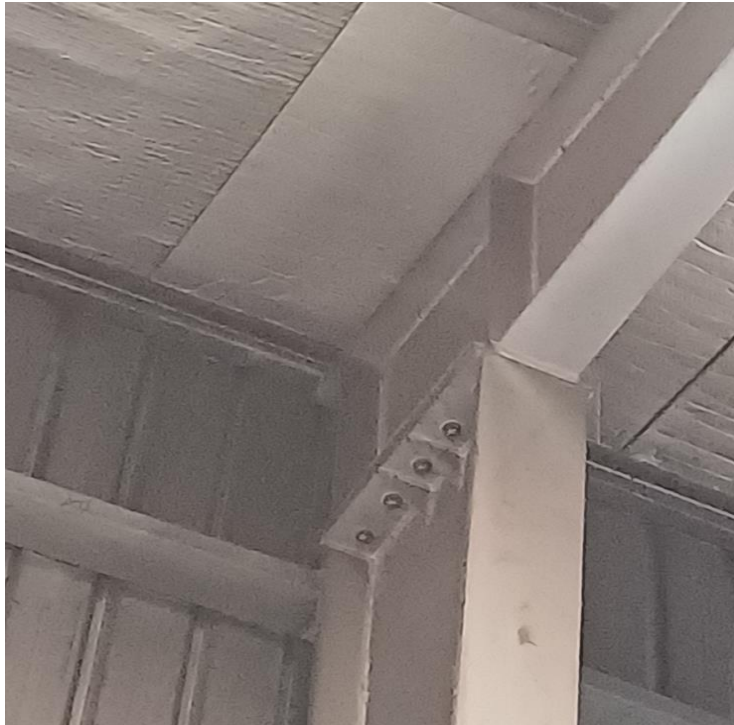
column-rafter connection

The column rafter connection design as a moment resisting connection. However, the bolt arrangement in connection is not suitable for resisting moment. Building engineer is required to check the joint adequacy as per in-situ built condition and revise the design report as well.

| Item No. | Observation | Recommended Action Plan | Recommended Timeline |
|---|---|---|---|
| 14 | Design report needs to be updated (Boiler shed). | Building engineer is required to check the joint adequacy as per as-built condition and revise the design report as well. | 6-weeks |

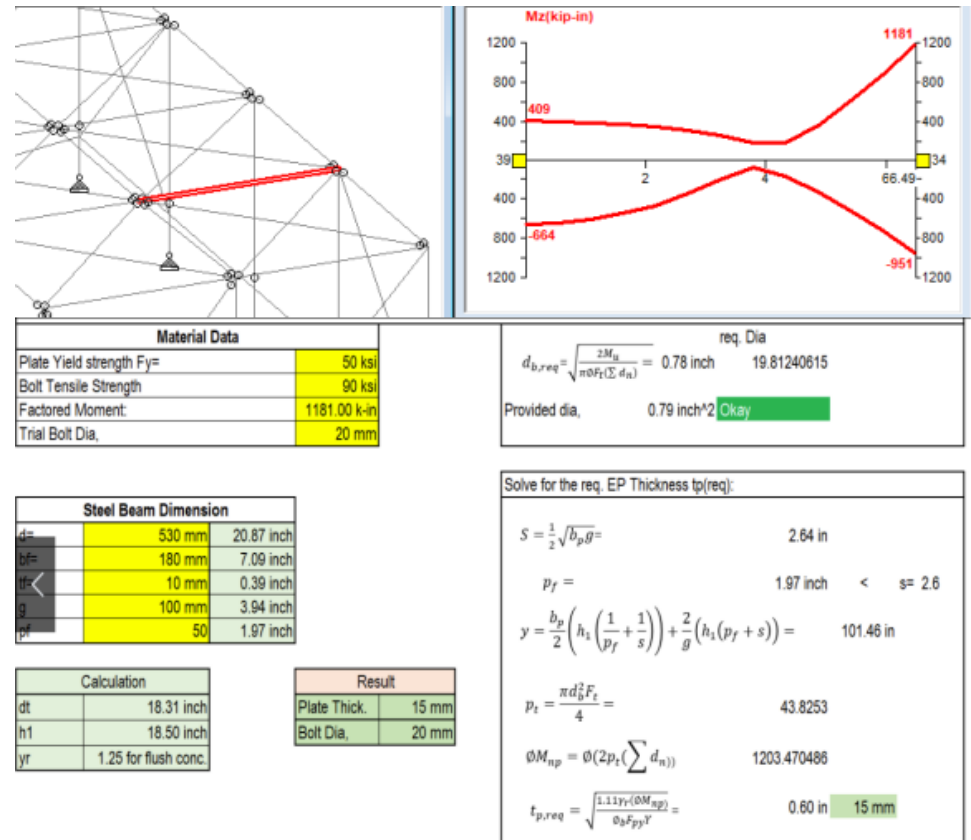
Joint design as rigid moment connection

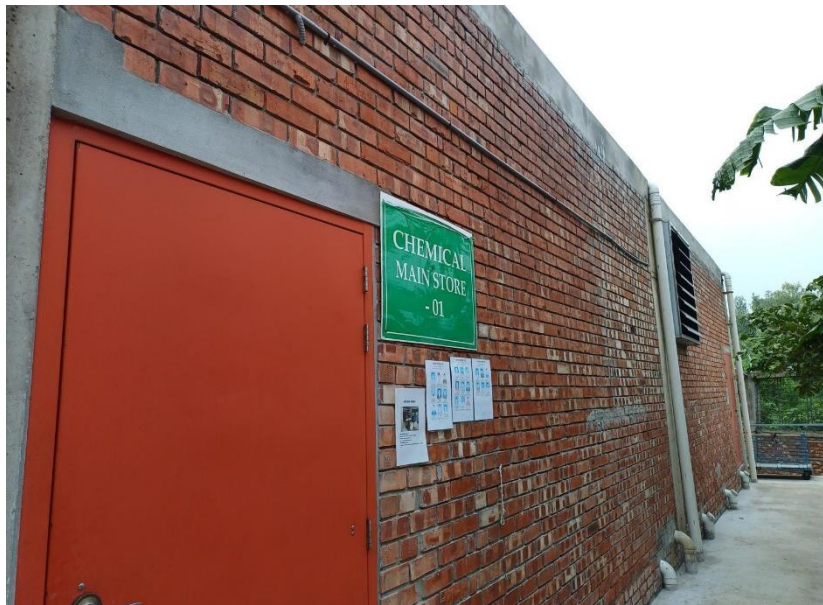
Single storey structure

As built drawing was found for two storied structure with a stair. During inspection single story structure was observed with no stair. Building engineer is required to survey the structures thoroughly and update the as-built drawing.

| Item No. | Observation | Recommended Action Plan | Recommended Timeline |
|---|---|---|---|
| 16 | As built drawing need to be revised (Chemical Store). | Building engineer is required to survey the structures thoroughly and update the as-built drawing. | 6-weeks |

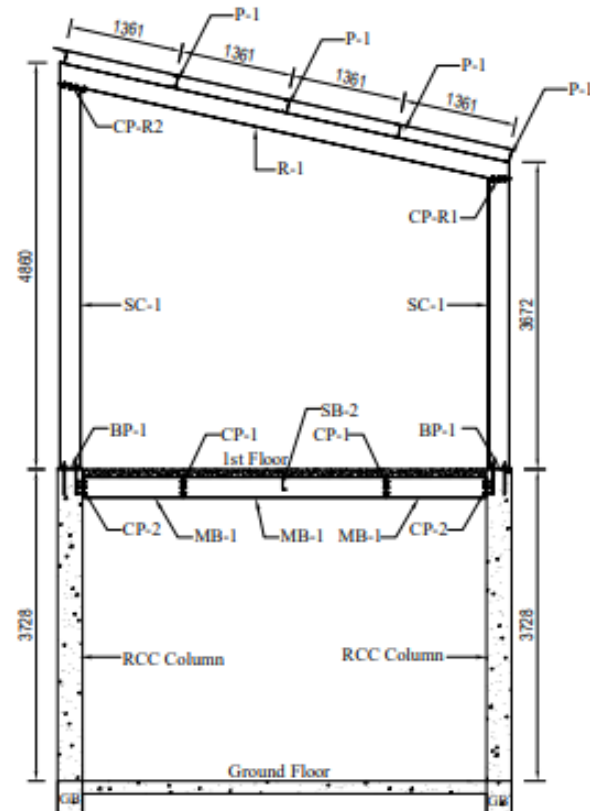
Two storied structure in as built drawing

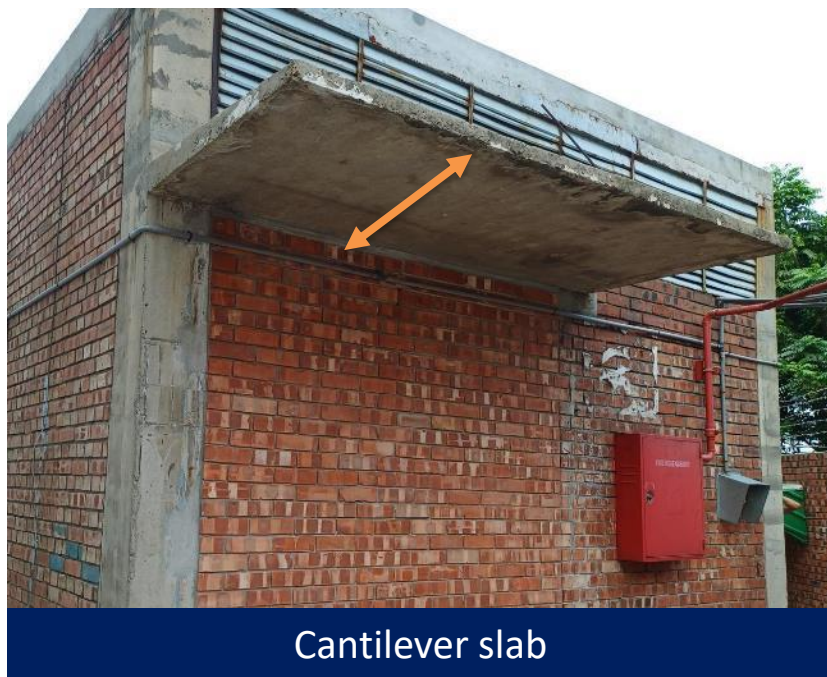
Cantilever slab

The cantilever slab apparently unstable as it is supported on masonry column. Building engineer is required to check the stability and deflection of the slab and update the design report as well.

| Item No. | Observation | Recommended Action Plan | Recommended Timeline |
|---|---|---|---|
| 17 | Apparently unstable cantilever slab (Chemical Store). | Building engineer is required to check the stability and deflection of the slab and update the design report as well. | 6-weeks |

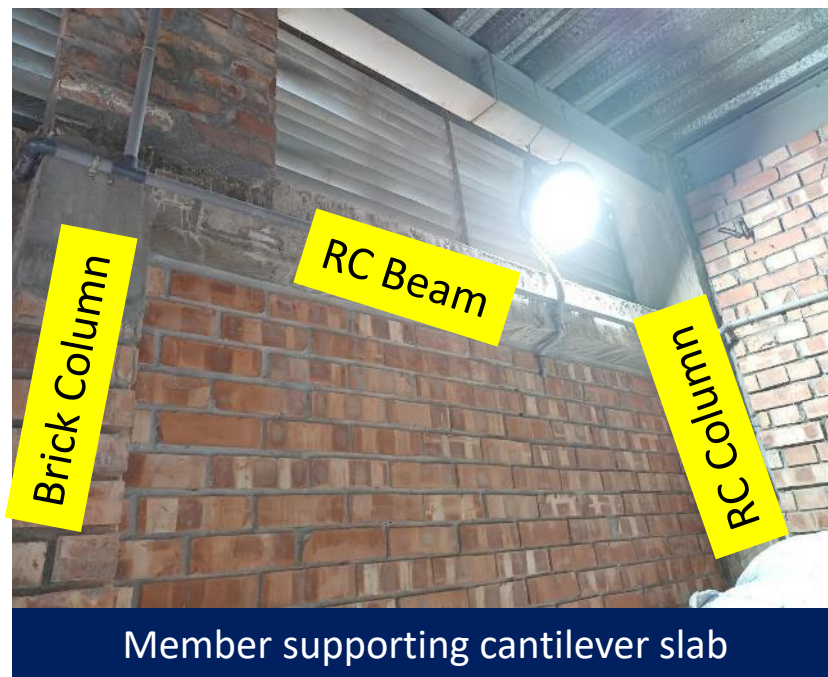
Member supporting cantilever slab

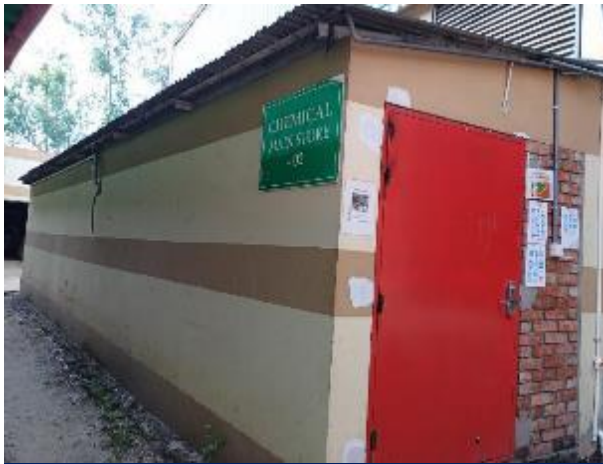
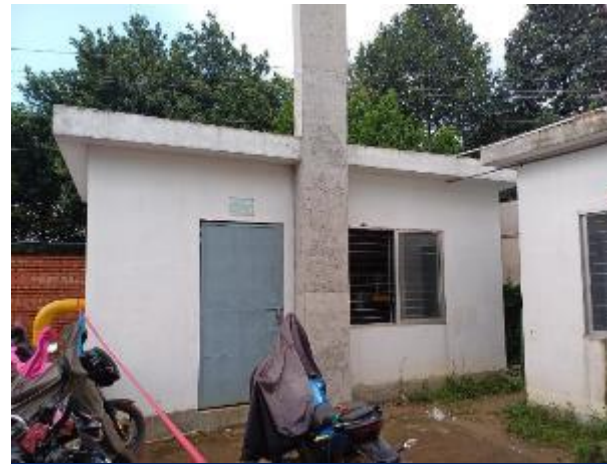
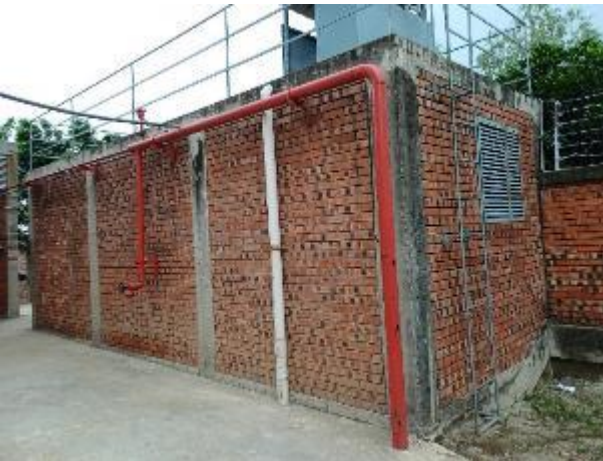
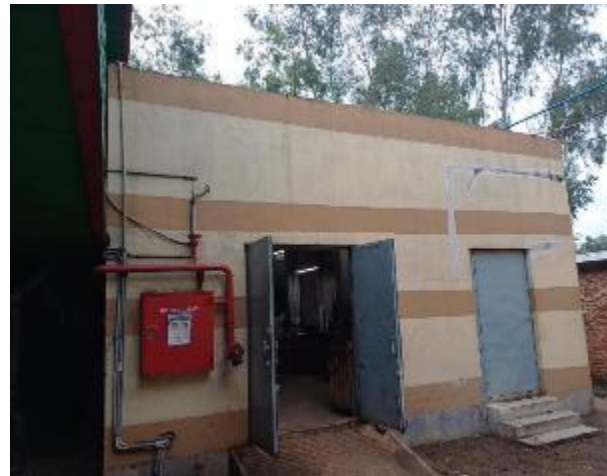
As-built drawing was not available for these structure. Building engineer is required to produce as-built drawing for the structures.

| Item No. | Observation | Recommended Action Plan | Recommended Timeline |
|---|---|---|---|
| 20 | Lack of as built drawing (Chemical Store-2, Chemical Store-3, RMS Room, Workshop & Kitchen) | Building is required to produce as-built drawing for the structures | 6-weeks |
