# Yasin Knittex Ind. Ltd. (Extended Building)

South Panishail zerani bazar, BKSP, Gazipur, Dhaka

23 January 2024

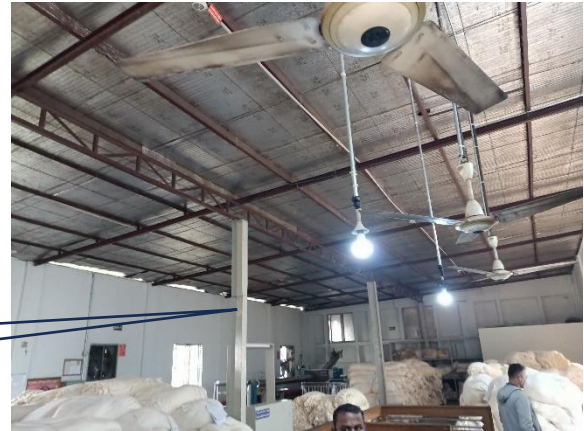
### Observation-1: Inconsistencies in as-built drawings. (Batch Shed)

Column schedule

Steel column (I joist)

**Description:** Structural sectional details and connection details were not found in the provided as-built drawings. Moreover, steel pipe has been shown instead of I joist.

| Observation | Action Plan | Timeline |
|---|---|---|
| Inconsistencies in as-built drawings. (Batch Shed) | The building engineer is required to prepare the as-built drawings with complete structural details. | within 6 weeks |

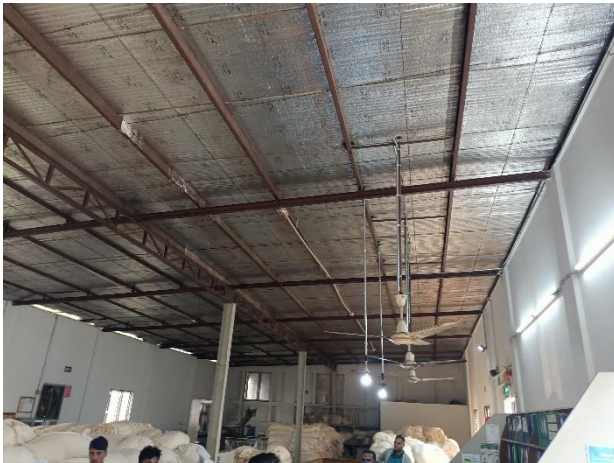
Roof truss and column connection

**Description:** Lack of lateral stability system (strut and bracing), apparent inadequate members and non-engineered connection was observed. The building engineer is required to check the member, connection & stability system of the structure and suggest proper alternatives accordingly.

| Observation | Action Plan | Timeline |
|---|---|---|
| Lack of lateral stability and connection adequacy. (Batch Shed) | The building engineer is required to check the member, connection & stability system of the structure and suggest proper alternatives accordingly. | within 6 weeks |
| Lack of lateral stability and connection adequacy. (Batch Shed) | Implement remediation work if required. | within 6 months |

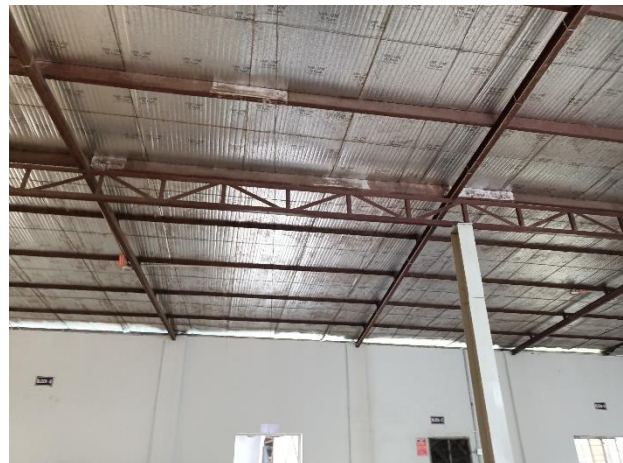
Steel angle connected with brick walls

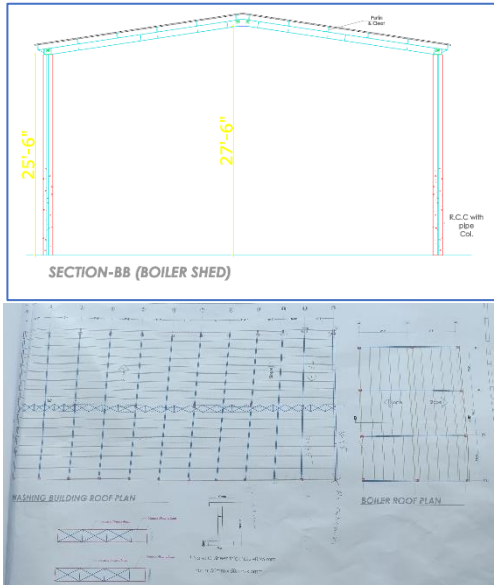
Roof layout and section

**Description:** Structural sectional details and connection details were not found in the provided as-built drawings. Also, column and truss layout not fully matched. Rafter sizes (boiler) were not mentioned.

| Observation | Action Plan | Timeline |
|---|---|---|
| Lack of information and mismatches in as-built drawings. (Washing and Boiler Shed) | The building engineer is required to prepare accurate as-built drawings with complete structural details. | within 6 weeks |

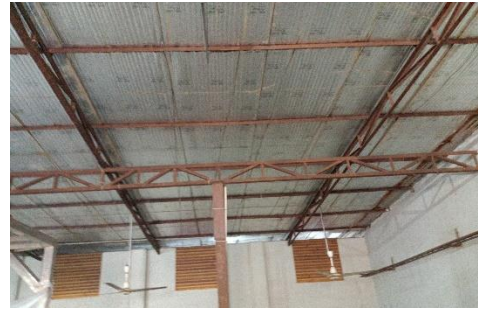
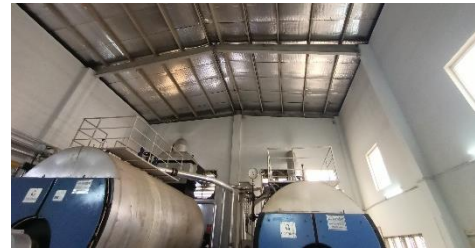
Steel framing

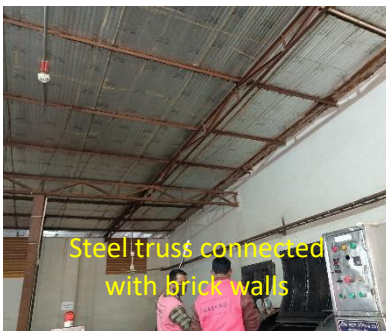
Connection

**Description:** Lack of lateral stability system (strut and bracing), apparent inadequate members and non-engineered connection was observed. The building engineer is required to check the member, connection & stability system of the structure and suggest proper alternatives accordingly.

| Observation | Action Plan | Timeline |
|---|---|---|
| Lack of lateral stability and connection adequacy. (Washing and boiler Shed) | The building engineer is required to check the member, connection & stability system of the structure and suggest proper alternatives accordingly. | within 6 weeks |
| Lack of lateral stability and connection adequacy. (Batch Shed) | Implement remediation work if required. | within 6 months |

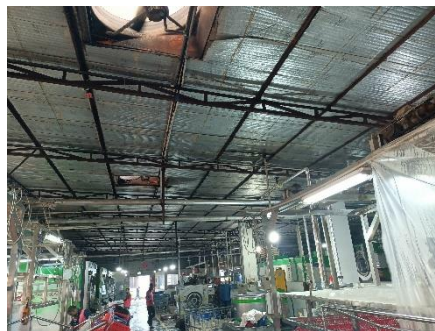
Truss and rafter frame

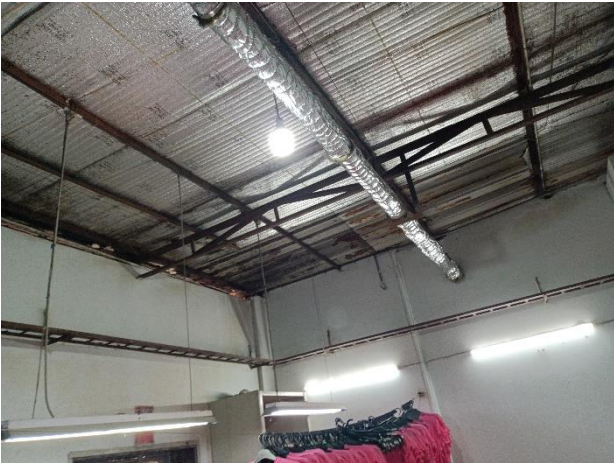
Corrossion on steel truss

**Description:** Severe corrosion was observed on steel members (steel truss). The building engineer is required to remove the corrosion and provide rust-proof coating on all steel members to protect from corrosion.

| Observation | Action Plan | Timeline |
|---|---|---|
| Corrosion on steel section. (Washing and Boiler Shed) | The factory is required to remove the corrosion and provide rust-proof coating on all steel members to protect from corrosion. | within 6 weeks |

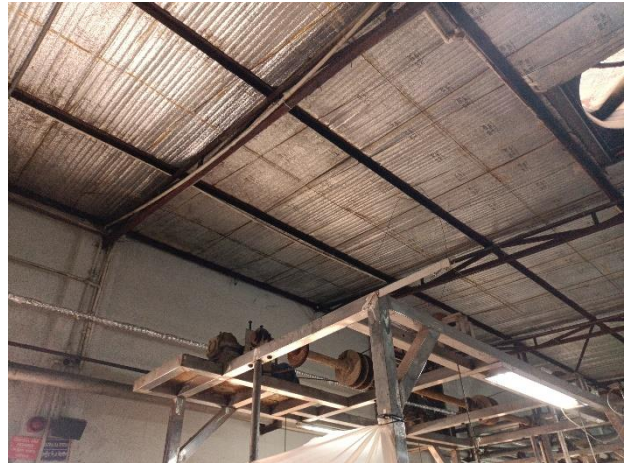
Corrossion on steel truss

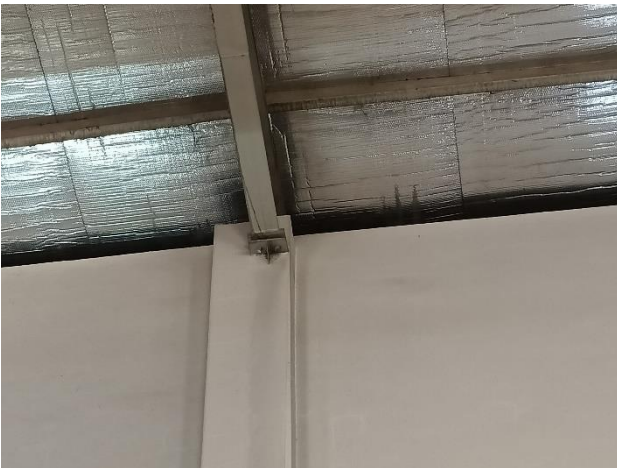
Connection gap

**Description:** Building engineer is required to survey the whole structure and identify the locations of the connection gaps and suggest proper remediation. Also, install the missing bolts where necessary.

| Observation | Action Plan | Timeline |
|---|---|---|
| Connection gap and bolt missing in baseplate. (Washing and Boiler Shed) | The building engineer is required to survey the whole structure and identify the locations of the connection gaps and suggest proper remediation.<br><br>Also, install missing bolts where necessary. | within 6 weeks |

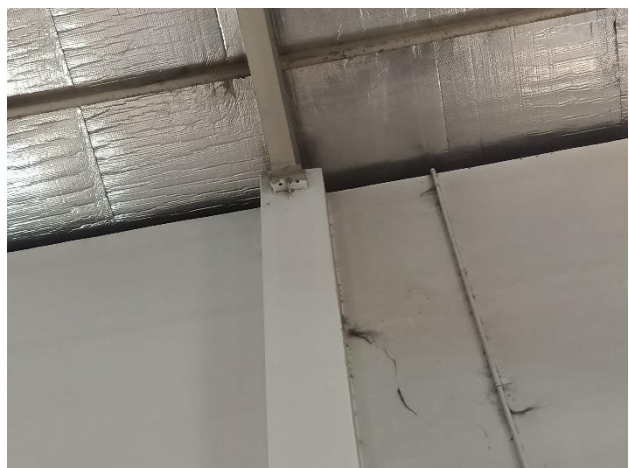
Bolt missing
