FCI (BD) Ltd -Extended New Warehouse Building

Plot No: 83-84, DEPZ (Old Zone), Ashulia, Savar, Dhaka-1349.

24 January 2024

2. Observations:

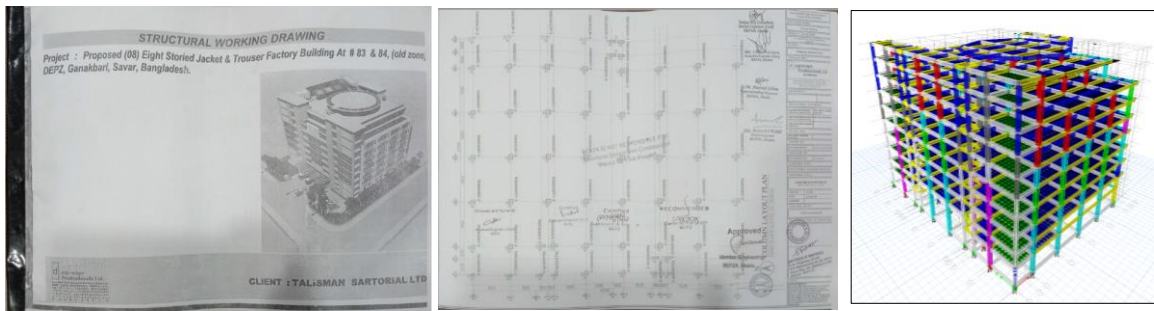
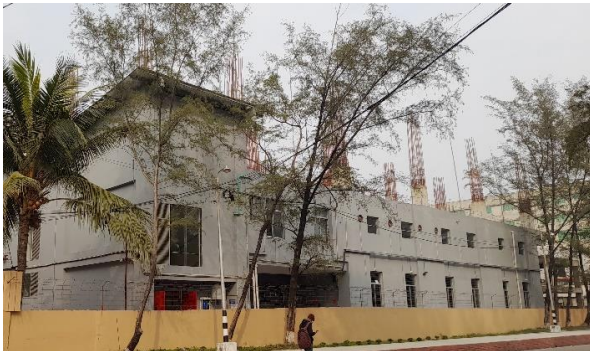
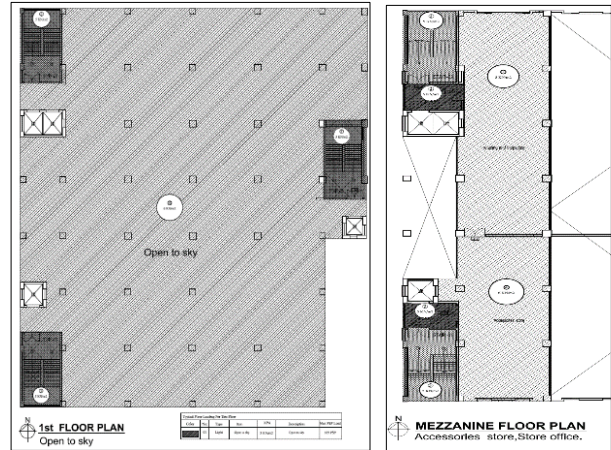
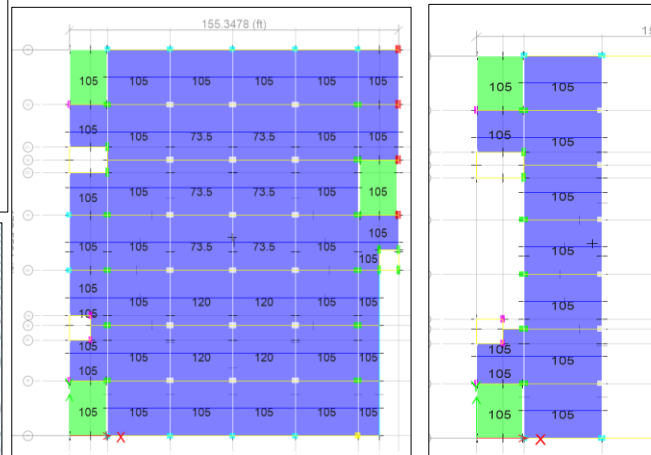
Observation-1: Possibility of Vertical Extension. Building-1 (Factory Building)

Description: The building permission layout is for eight storied structures approved by BEPZA. The construction of the building started in February 2019 and completed up-to 1st floor level in January 2023. Extended columns were observed on the roof. So, there is a possibility of future vertical extension. The building engineer is required to conduct Detail Engineering Assessment (DEA) for the eight storied structure prior to commencement of further extension work and submit to RSC for further review.

In the provided load plan, 6kPa has been considered at 1st floor (existing roof) and partial area of the mezzanine. But in FEA model, the floor loading has been assigned less than 6kPa.

In design report, design concrete strength has been considered 5000psi for the column, beam and slab as well as assigned in FEA model. During inspection, Nineteen sets of concrete cylinder test reports from BUET where ten sets for Column, three sets for slab, three sets for pile cap & three sets for pile. The average cylinder strength of a ground floor lift column was found less then the design strength. Building engineers is required to verify the in-situ concrete strength for the column.

Serial No	Observation	Action Plan	Timeline
1	Possibility of Vertical Extension. Building-1 (Factory Building)	Prior to the vertical extension, the building engineer is required to conduct a Detailed Engineering Assessment (DEA) of the structure according to BNBC. Submit DEA to RSC for review.	within 6 months
2	Possibility of Vertical Extension. Building-1 (Factory Building)	Carry out remedial work if required.	within 6 months
3	Implement load management programs properly. Building-1 (Factory Building)	Post the load plan and maintain loading accordingly.	within 6 weeks
4	Hairline cracks in brick wall. Building-1 (Factory Building)	The building engineer is required to investigate the reason of crack, extend of crack and suggest proper remedial action.	within 6 weeks
5	Non-structural elements not anchored or braced. Building-1 (Factory Building)	Building engineer is required to adequately anchor and brace all non-structural elements to resist earthquake forces to comply with the BNBC.	within 6 months

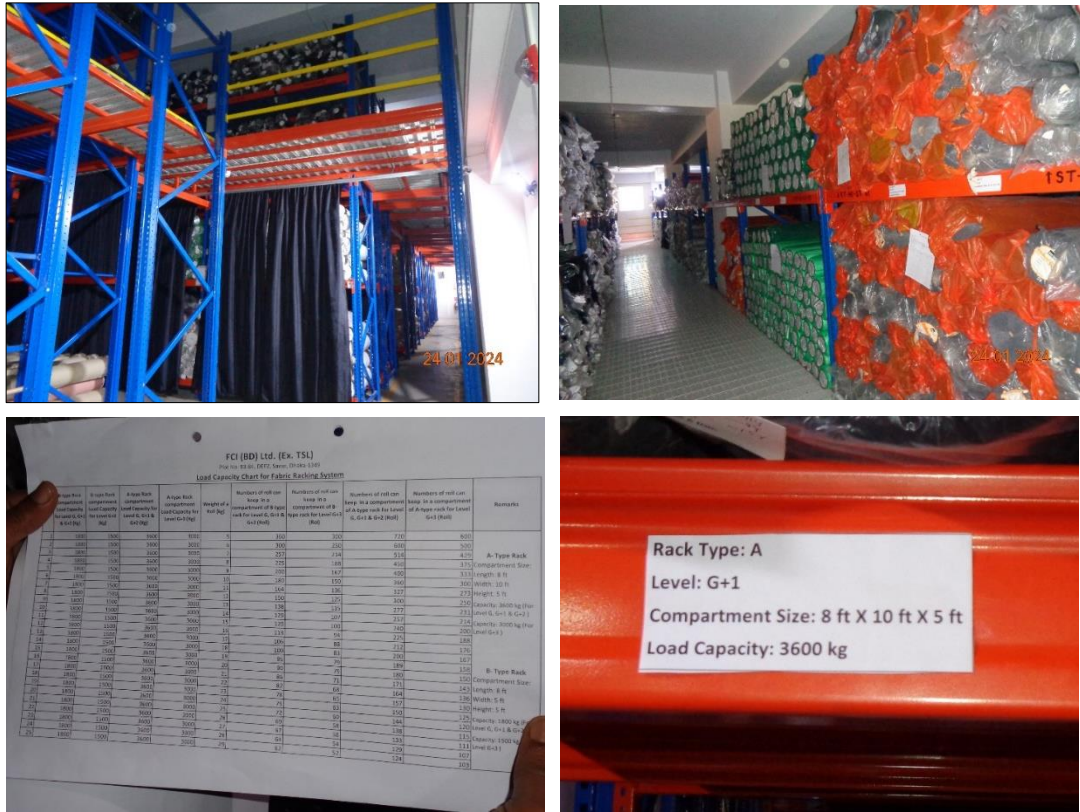
Observation-2: Implement load management programs properly. Building-1 (Factory Building)

Description: During the inspection, two storage racks were found on ground floor. Load plan or loading capacity has been provided by the manufacturer of racks. But the load management program was not found as per the capacity. The building engineer is required to post load plan for racks all around the floors and maintain the loading in rack as per the capacity.

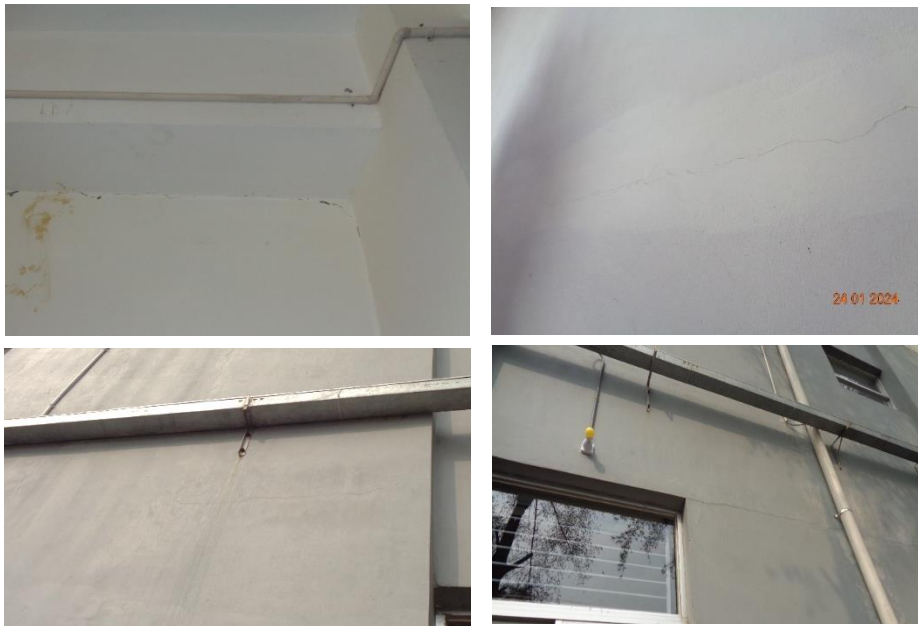
Observation-3: Hairline cracks in brick wall. Building-1 (Factory Building)

Description: During inspection, hairline cracks were found in the brick wall. Building engineer is required to investigate the reasons of the cracks, extend of the cracks and suggest proper remedial action.

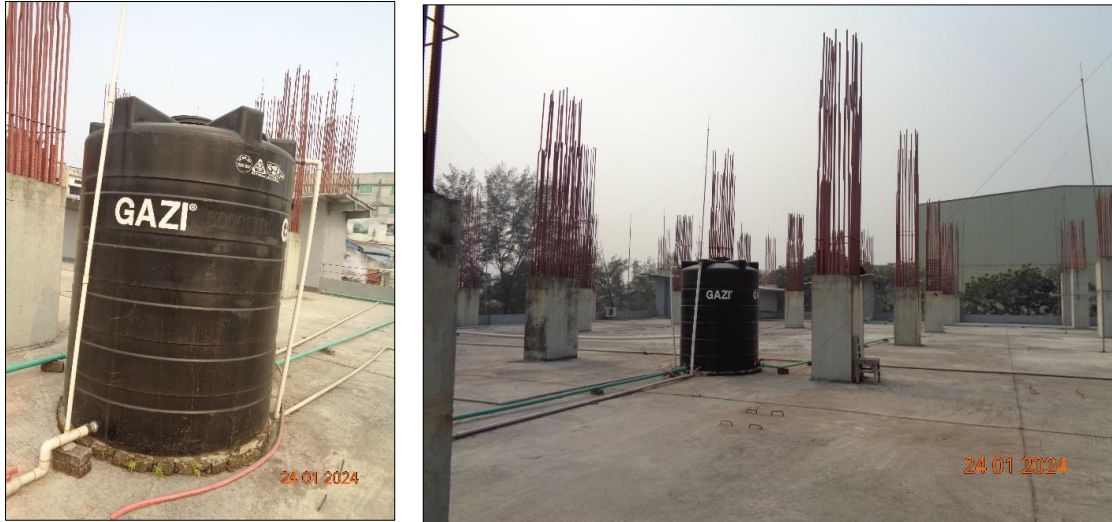
Observation-4: Non-structural elements not anchored or braced. Building-1 (Factory Building).

Description: PVC water tank at roof is not adequately anchored or braced to resist lateral (earthquake) forces. Building is required to adequately anchor and brace all non-structural elements to resist earthquake forces to comply with the BNBC.

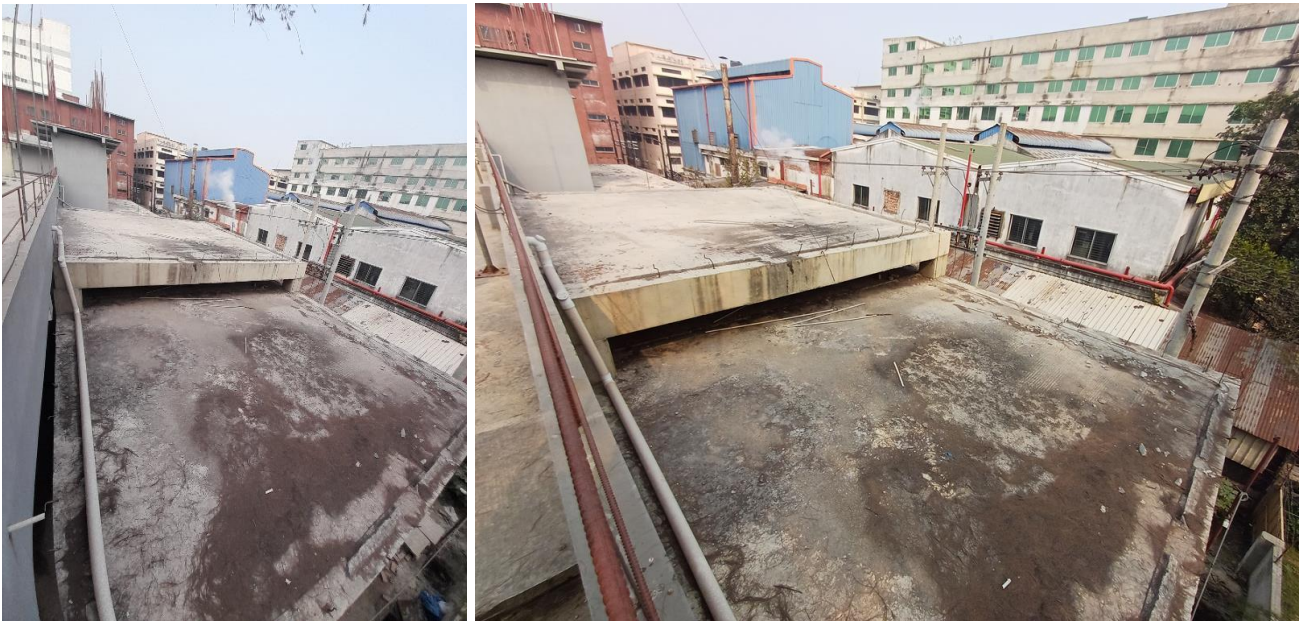
Observation-5: Water dampness at roof. Building 2 (Utility Building)

Description: Water ponding was found on the roof slab due to inadequate slope. The factory is required to develop proper drainage system with adequate slope and water outlet on the roof.

6	Water dampness at roof. Building 2 (Utility Building)	The building engineer to develop proper drainage system with adequate slope to resist water ponding on the roof.	within 6 months
