L'esquire Limited

Jamirdia, Valuka, Mymensingh.

25 January 2024

2. Observations

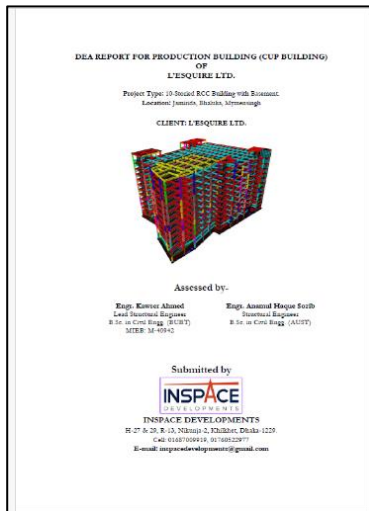
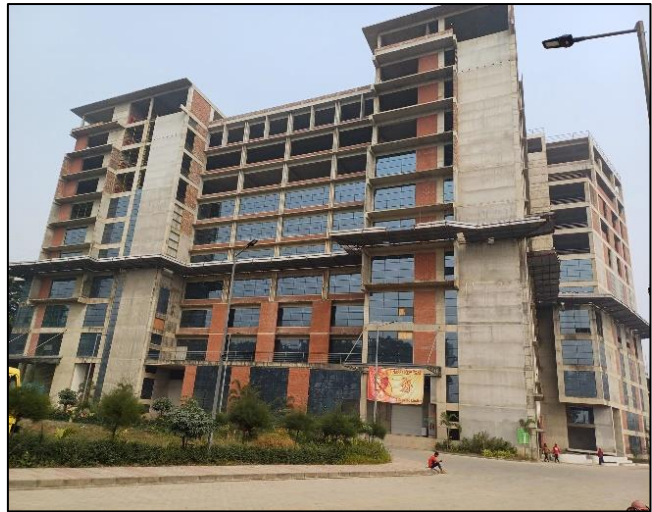
Observation 1: Design check against lateral loading needs to be reviewed in depth (Production Building).

Description: During the inspection, a detailed engineering assessment report and as-built drawings were available on site which need to be reviewed by RSC in depth for lateral forces. The building engineer is required to submit the design documents to RSC for review and implement remedial works if required.

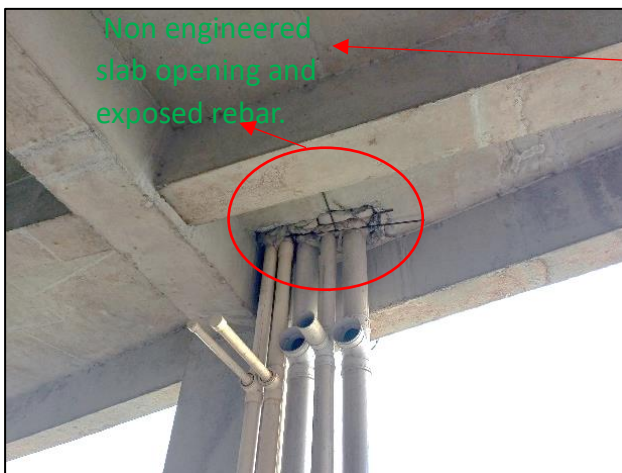
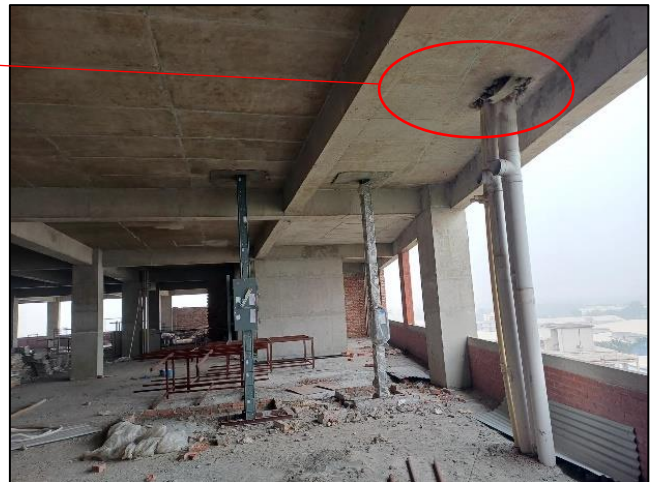
Observation-2: Non-engineered slab opening and exposed rebar (Production Building).

Description: During inspection, a non-engineered slab opening is observed on every floor. The building engineer is required to check the slab adequacy for the non-engineered opening at every floor and factory is required to take remedial measures for exposed rebar at slab openings.

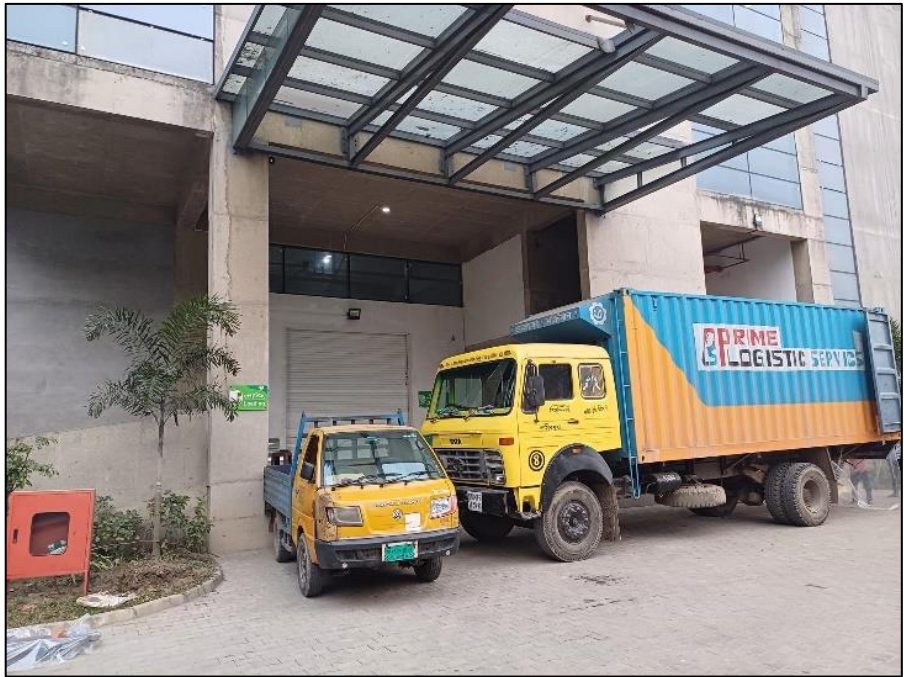
Observation-3: Column at ground floor at loading unloading area susceptible to vehicular impact (Production Building).

Description: During inspection, it was found that ground floor columns of Production Building at loading unloading area are susceptible to vehicular impact. Factory is required to provide adequate barriers around column at ground floor to prevent vehicular impact.

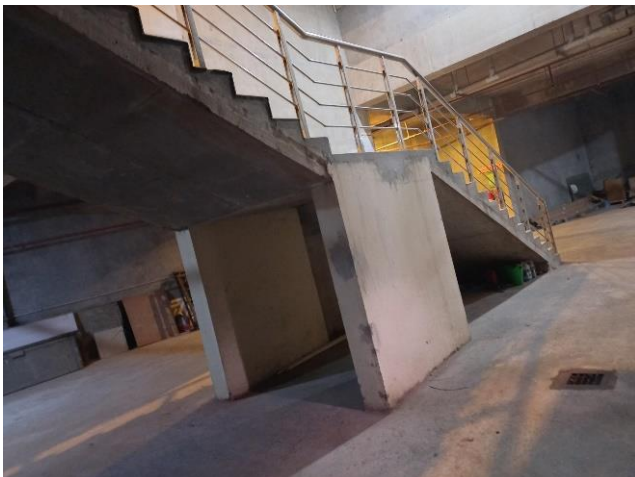
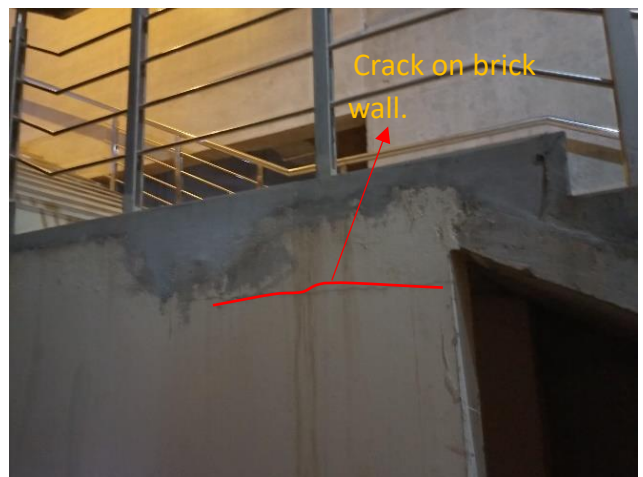
Observation-4: Crack on brick wall supporting the stairs from basement to ground floor (Production Building).

Description: During the inspection, cracks were observed on the brick wall which supports the stairs from the basement to the ground floor. The building engineer is required to investigate the reason for the crack of the load-bearing wall, check the stability of the stairs and implement remedial works if required.

Carry out remedial works as per the crack investigation report.	within 6 months
Design check against lateral loading needs to be reviewed in-depth (Utility Building)	The building engineer is required to submit DEA documents to RSC for review.	within 6 weeks
	Carry out remedial work (if required).	within 6 months
Improper water drainage system (Utility Building)	The building engineer is required to provide a roof drainage system.	within 6 weeks
Dampness at the exterior wall (Utility Building)	The building engineer is required to remove dampness and take remedial actions against dampness.	within 6 months
Design documents need to be reviewed by RSC for lateral forces. (RMS Room & ATM Booth)	The building engineer is required to submit the design documents to RSC for review.	within 6 weeks
	Implement remediation work if required.	within 6 months
Exposed re-bar at the roof. (RMS Room & ATM Booth).	Building engineer is required to provide an anti-corrosive coating to avoid corrosion.	within 6 months

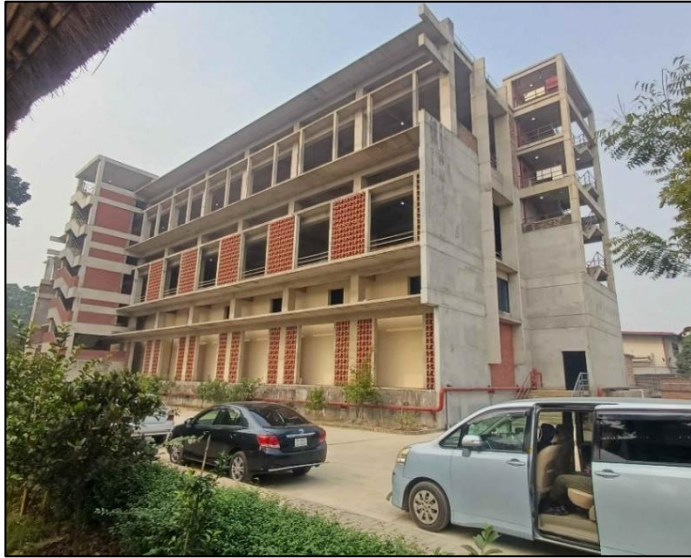
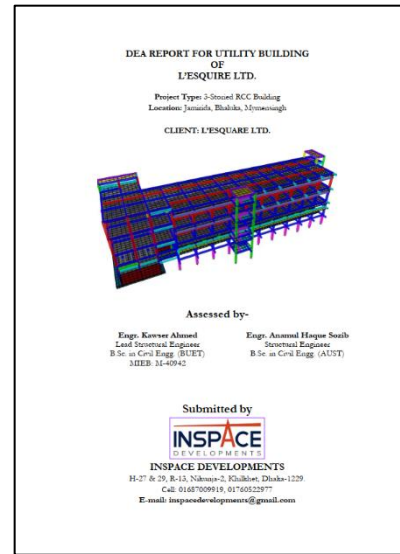
Observation-5: Design check against lateral loading needs to be reviewed in-depth (Utility Building).

Description: Design check against lateral loading needs to be reviewed in-depth by RSC. The building engineer is required to submit DEA documents to RSC for review.

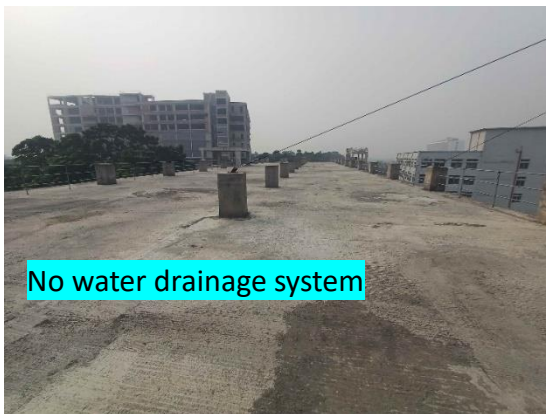
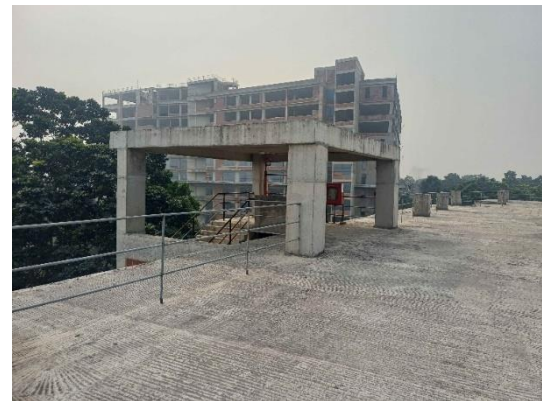
Observation-6: Improper water drainage system (Utility Building).

Description: During inspection, no water drainage system was observed on the roof. The building engineer is required to provide roof drainage system.

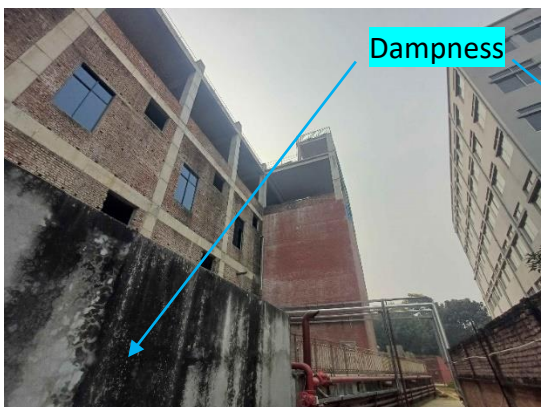
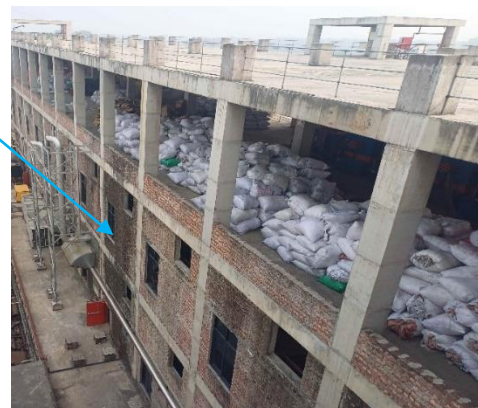
Observation-7: Dampness at the exterior wall (Utility Building).

Description: During the inspection, dampness was observed on the exterior wall. The building engineer is required to remove dampness and take remedial actions against dampness.

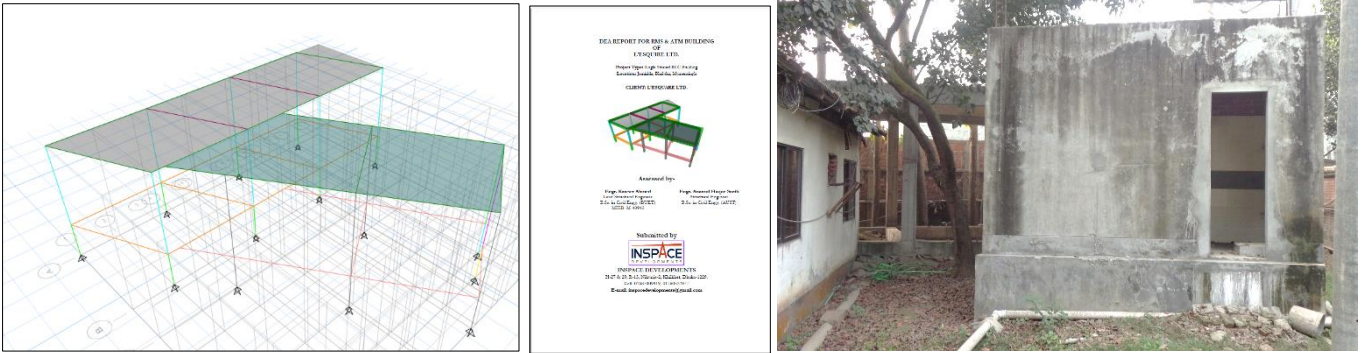
Observation-8: Design documents need to be reviewed by RSC for lateral forces (RMS Room & ATM Booth).

Description: DEA documents of the building need to be reviewed in-depth against lateral forces by RSC. The building engineer is required to submit DEA documents to RSC for review.

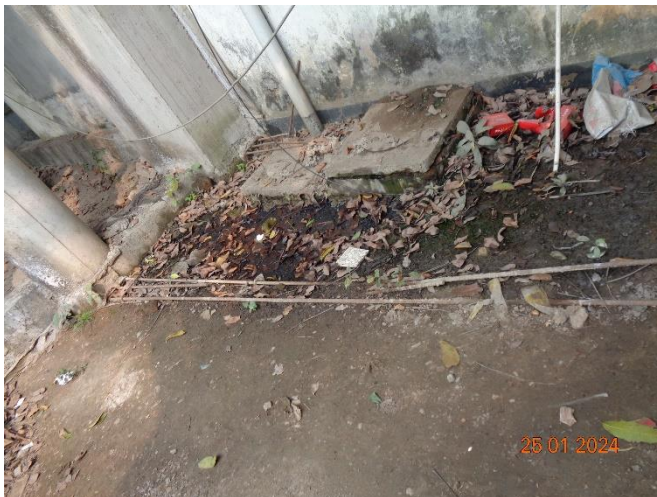
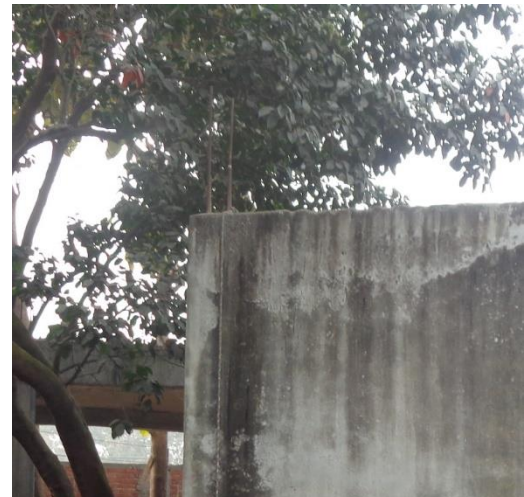
Observation-9: Exposed re-bar at the roof. (RMS Room & ATM Booth).

Description: Exposed reinforcement was found on columns and rebar. Building engineer is required to provide an anti-corrosive coating to avoid corrosion.
