# Meghna Knit Composite Ltd (Extension)

Gilarchala, Sreepur, Gazipur  
(24.186253N, 90.425741E)

28 November 2023

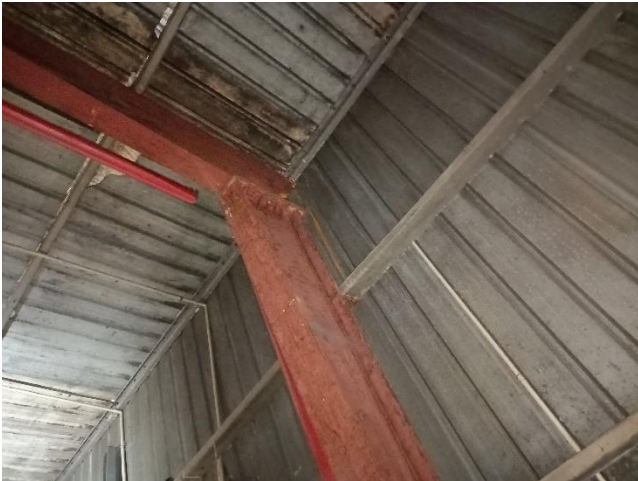
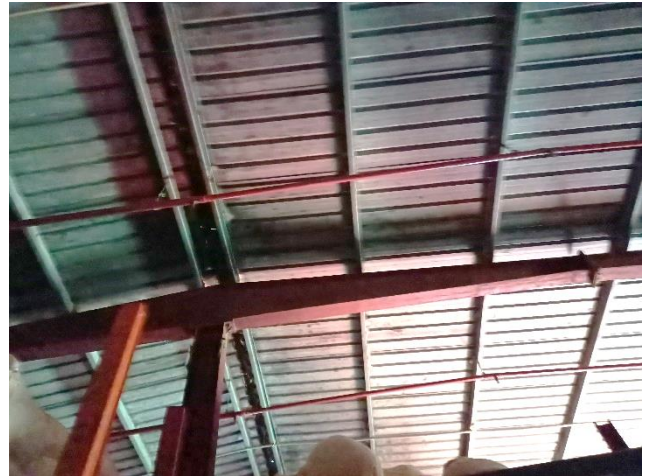
**Observation-1:** Lack of lateral Stability. (Dyeing Building-2).

**Description:** Load transfer media is not provided along the long direction for the 1<sup>st</sup> floor shed. Therefore, the lateral stability system of the shed is apparently incomplete. Building engineer is required to check the lateral stability of the structure.

| Observation | Action Plan | Timeline |
|---|---|---|
| Lack of lateral Stability. (Dyeing Building-2). | Building engineer is required to check the lateral stability of the structure as per of Engineering Assessment (EA). | within 6 weeks |
| Lack of lateral Stability. (Dyeing Building-2). | Carry out remediation work where required. | within 6 months |

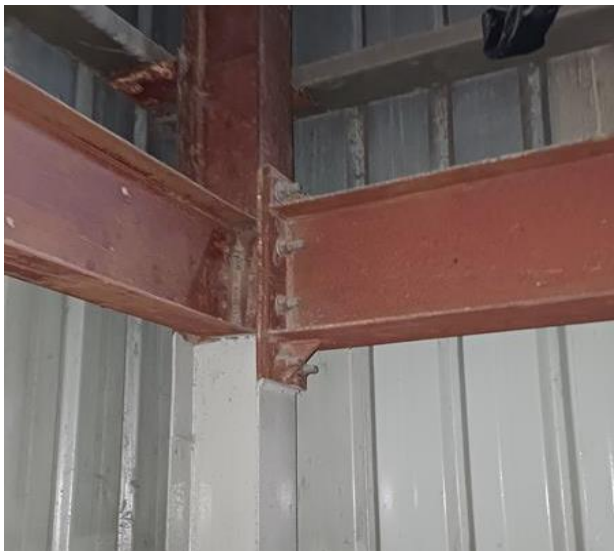
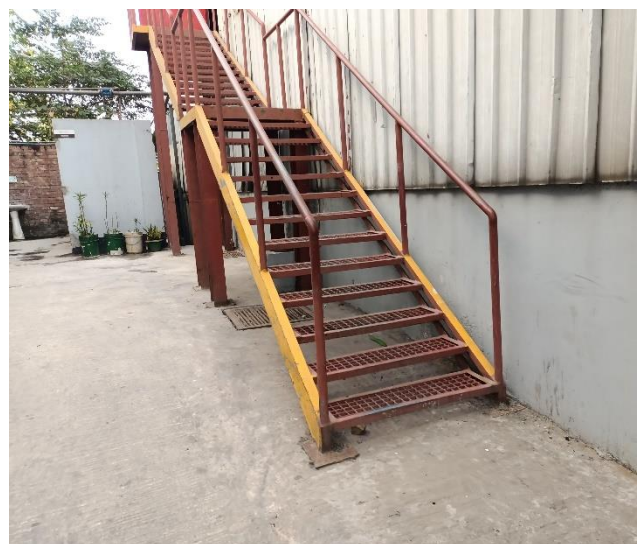
**Observation-2:** Lack of information in as-built drawings. (Dyeing Building-2).

**Description:** All sectional details and connection details were not available in the provided as-built drawings. Moreover, no drawing details were found for the external steel stair. The building engineer is required to survey the full structure and produce a full set of as-built drawings.

| Observation | Action Plan | Timeline |
|---|---|---|
| Lack of information in as-built drawings (Dyeing Building-2). | The building engineer is required to survey the structure and prepare a full set of as-built drawings. | within 6 weeks |

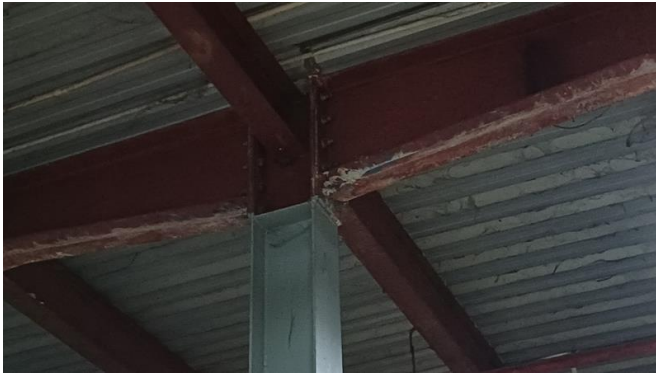
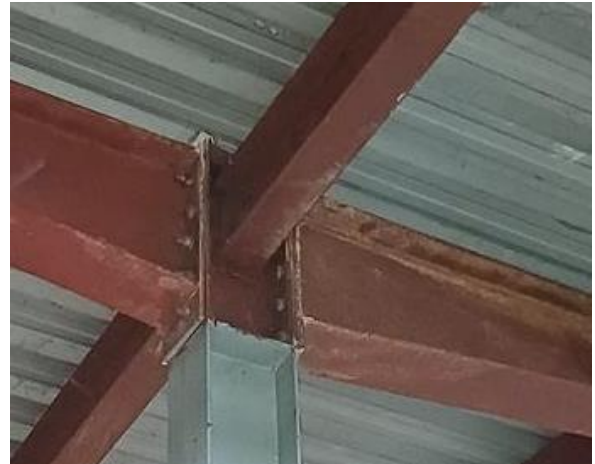
**Observation-3:** Corrosion in steel member. (Dyeing Building-2).

**Description:** Corrosion in steel member was observed in the several locations. The building engineer is required to suggest proper remedial measures accordingly.

| Observation | Action Plan | Timeline |
|---|---|---|
| Corrosion in steel member. (Dyeing Building-2). | Building engineer to remove the corrosion and apply suitable corrosion resistance coating. | within 6 weeks |

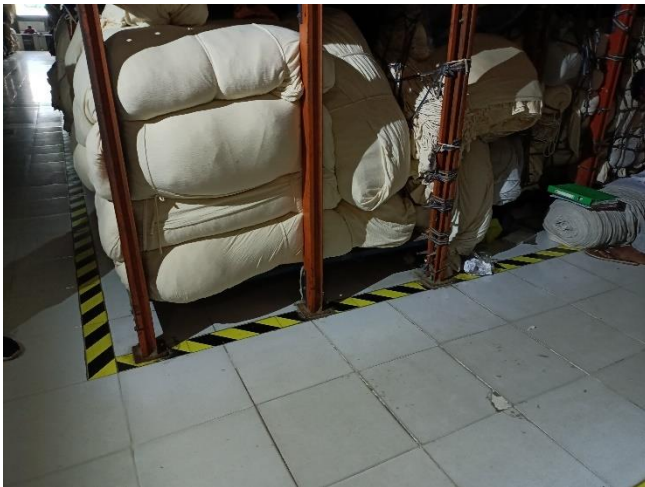
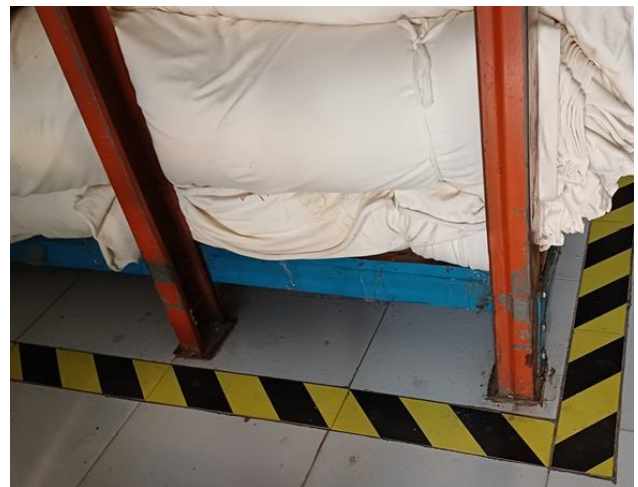
**Observation-4:** Non-structural elements not anchored or braced. (Dyeing Building-2)

**Description:** Some racks on floors are not anchored or braced to resist lateral (earthquake) forces. The factory is required to anchor/brace all non-structural elements adequately to resist earthquake forces.

| Observation | Action Plan | Timeline |
|---|---|---|
| Non-structural elements not anchored or braced. (Dyeing Building-2) | Building engineer is required to check the lateral stability of the structure as per of Engineering Assessment (EA). | within 6 weeks |

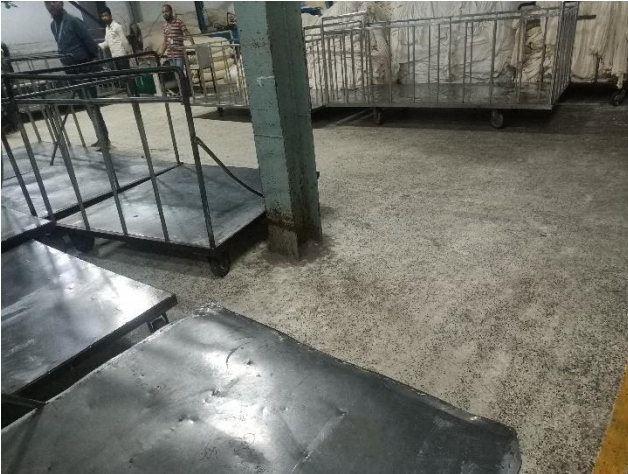
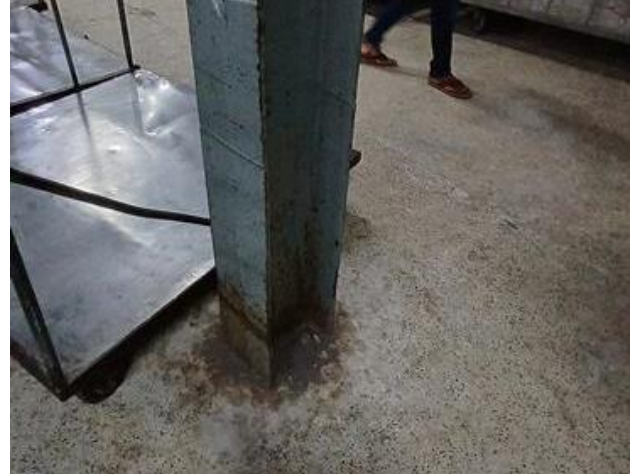
**Observation-5:** Column susceptible to trolley impact. (Dyeing Building-2).

**Description:** Columns on the ground floor are prone to trolley impact. The factory is required to provide barriers for all exposed columns on the ground floor to avoid possible trolley impact on the column.

| Observation | Action Plan | Timeline |
|---|---|---|
| Columns susceptible to trolley impact. (Dyeing Building-2). | The building engineer is required to provide barriers for all exposed columns on the ground floor to avoid possible trolley impact on the columns. | within 6 weeks |

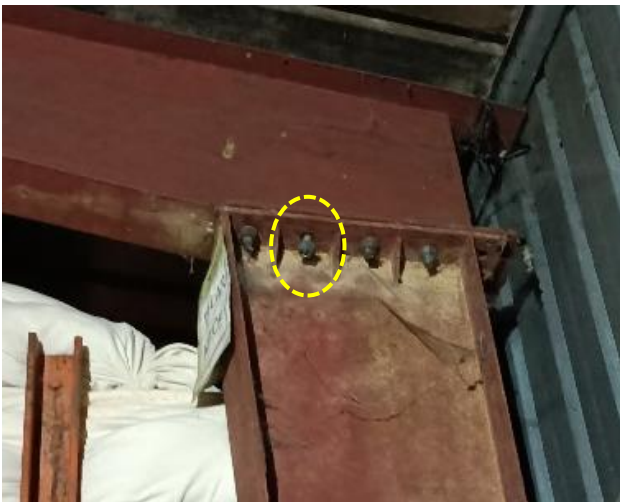
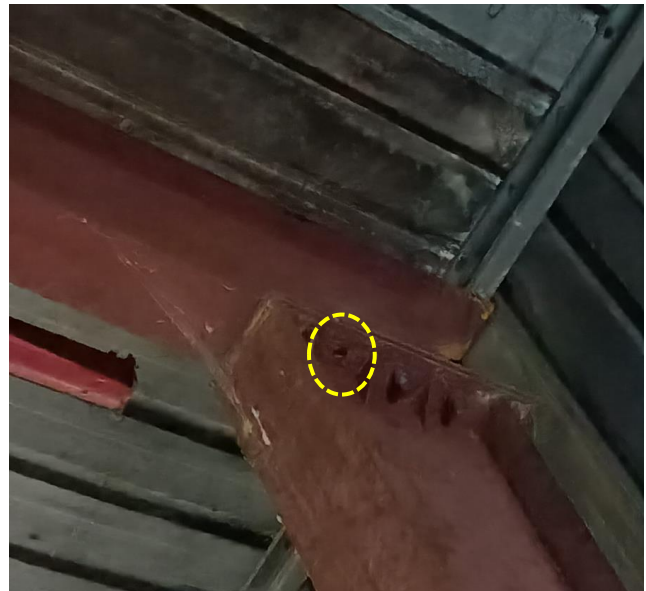
**Observation-6:** Bolts missing and loose nuts. (Dyeing Building-2).

**Description:** Missing bolts and loose nuts were found in the column-rafter joint. Building engineer is required to install the missing bolts and tighten the loose nut where necessary.

| Observation | Action Plan | Timeline |
|---|---|---|
| Bolts missing and loose nuts. (Dyeing Building-2). | Building engineer is required to install the missing bolts and tighten the loose nut where necessary. | within 6 weeks |

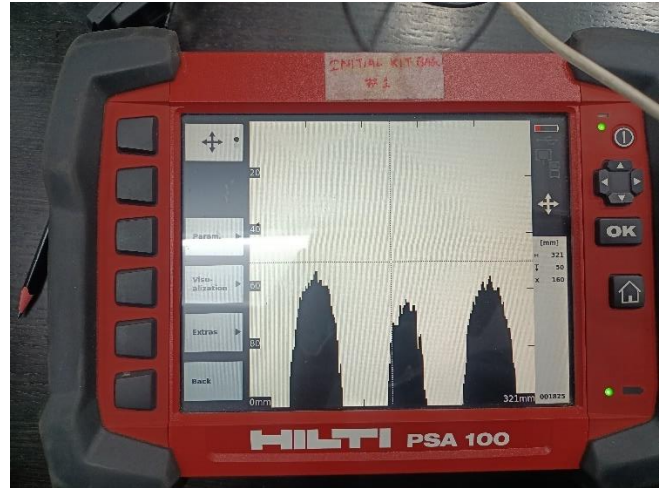
### Observation-7: Mismatches in as-built drawings. (Store Building).

**Description:** Amount of rebar in C-3 Type column at first floor was found 10 nos instead of 12 nos. Building engineer is required to update the as-built drawings as per on site condition and submit to RSC.

| Observation | Action Plan | Timeline |
|---|---|---|
| Mismatches in as-built drawings. (Store Building). | Building engineer is required to update the as-built drawings as per on-site conditions and submit to RSC. | within 6 weeks |

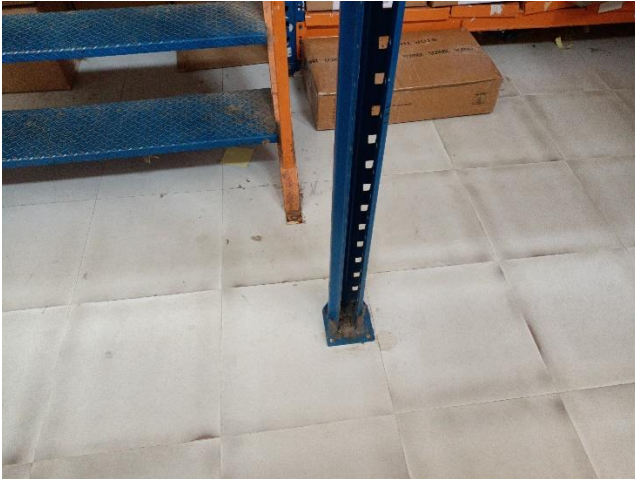
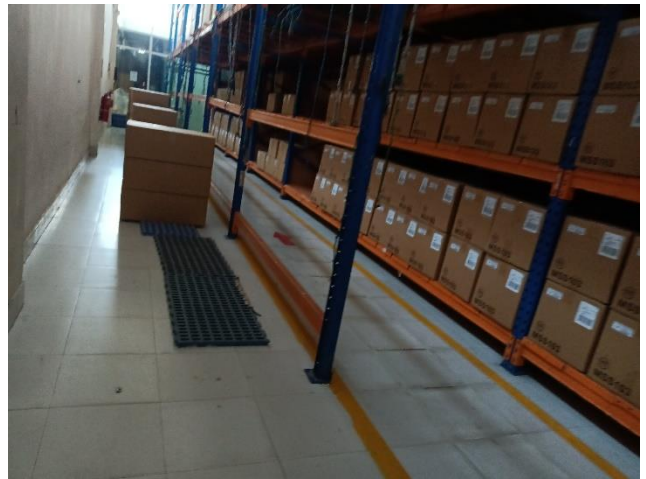
**Observation-09:** Non-structural elements not anchored or braced. (Store Building).

**Description:** Some racks on floors are not anchored or braced to resist lateral (earthquake) forces. The factory is required to anchor/brace all non-structural elements adequately to resist earthquake forces.

| Observation | Action Plan | Timeline |
|---|---|---|
| Non-structural elements not anchored or braced. (Store Building). | Building engineer is required to check the lateral stability of the structure. | within 6 weeks |

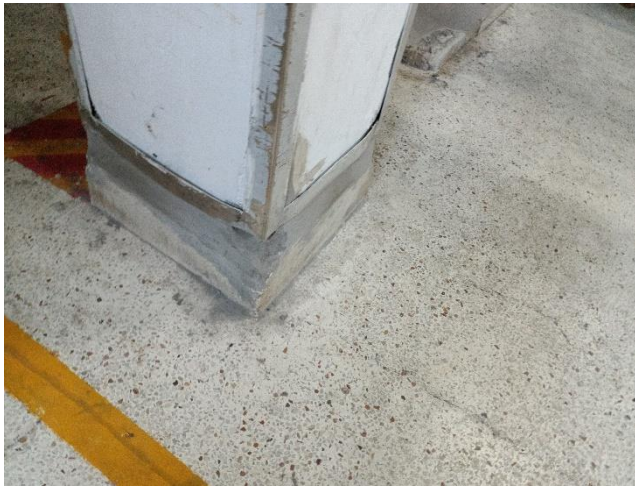
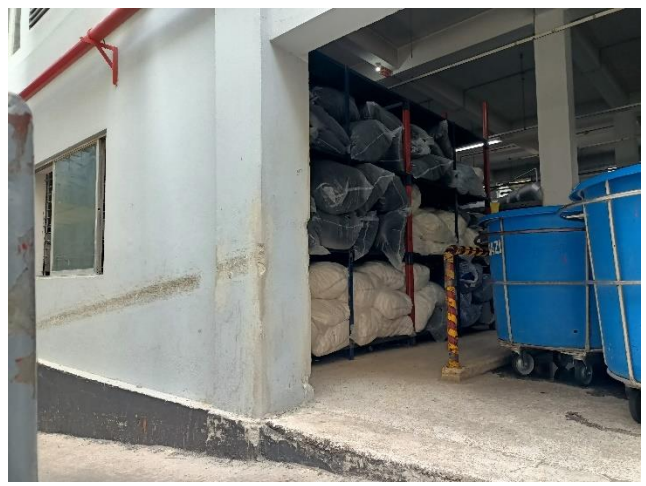
**Observation-10:** Trolley impact risk on the column and improper column guards. (Store Building).

**Description:** Columns on the ground floor are prone to trolley impact. And few column guards are found inactive. The factory is required to provide proper barriers for all exposed columns on the ground floor to avoid possible trolley impact on the column.

| Observation | Action Plan | Timeline |
|---|---|---|
| Trolley impact risk on the column and improper column guards. (Store Building). | The building engineer is required to provide proper barriers for all exposed columns at the ground floor to avoid possible trolley impact on the column. | within 6 weeks |

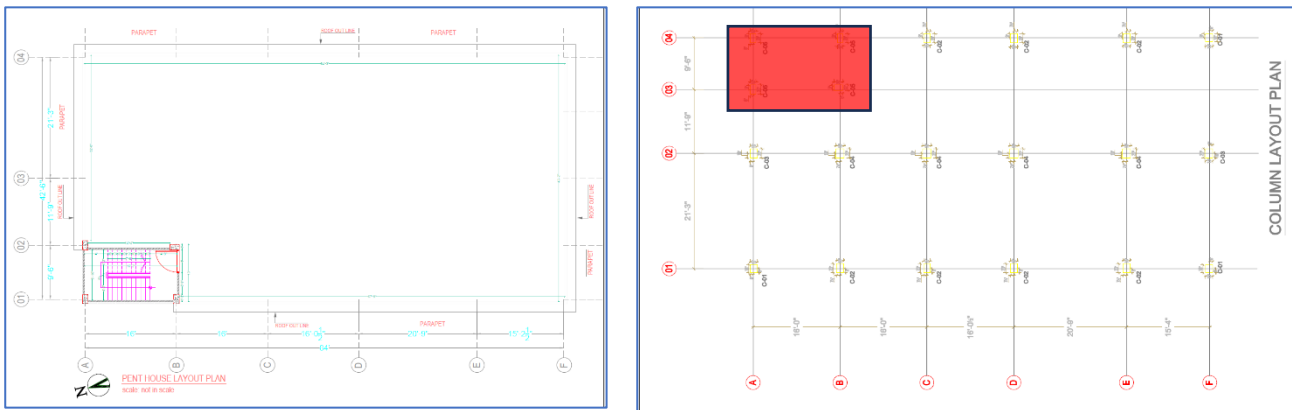
### Observation-11: Mismatches in as-built drawings. (Utility Building).

**Description:** Floor and column layout in structural drawings does not match with the as-built condition. Building engineer is required to survey the full structure and revise the as-built drawing as per the on-site condition.

| Mismatches in as-built drawings. (Utility Building). | Building engineer is required to survey the full structure and revise the as-built drawing as per on-site conditions. | within 6 weeks |

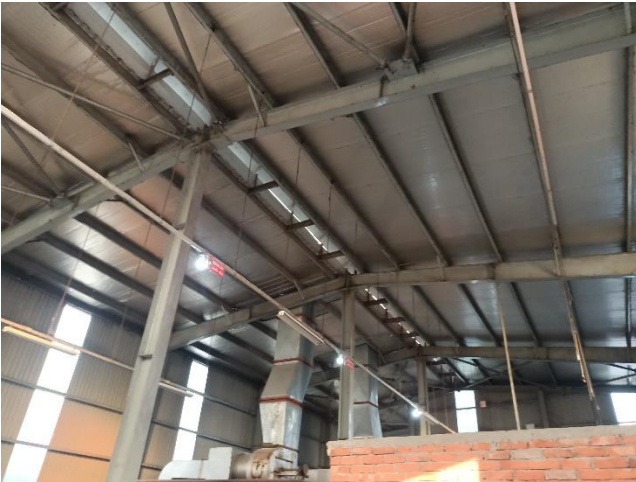
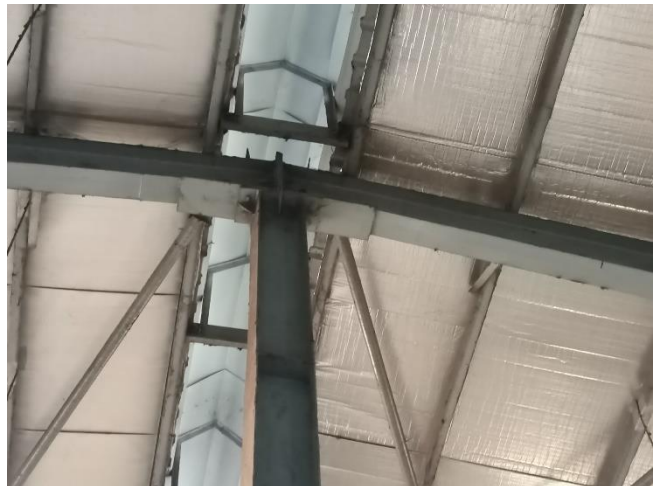
**Observation 13:** Mismatches in as-built drawings. (New LK Dryer Shed).

**Description:** Column schedule and all sectional details were not available in the provided as-built drawings. The building engineer is required to survey the full structure and produce a full set of as-built drawings.

| Mismatches in as-built drawings. (New LK Dryer Shed). | The building engineer is required to survey the full structure and produce a full set of as-built drawings. | within 6 weeks |

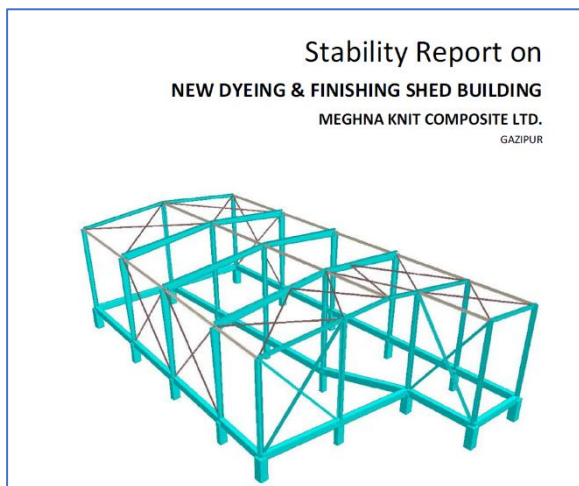
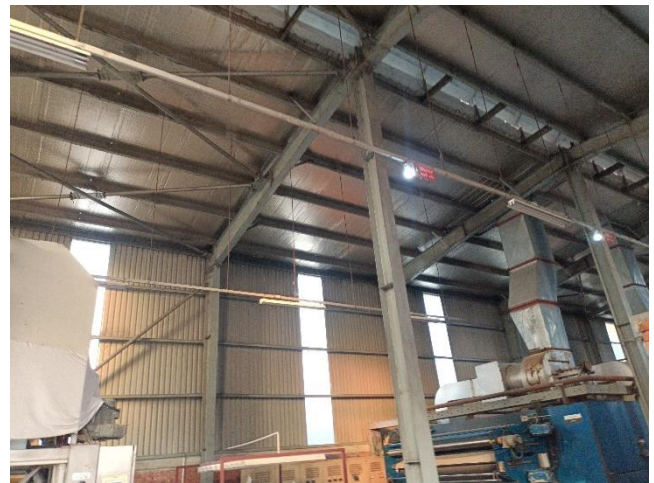
**Observation-14:** Incomplete lateral stability system. (New LK Dryer Shed).

**Description:** Though compression struts were shown in the design report, no compression strut was found on-site along the long direction. Only cable bracings were found onsite. So, lateral stability in the long direction is incomplete. The building engineer is required to check the stability system of the existing structure.

| Incomplete lateral stability system. (New LK Dryer Shed). | The building engineer is required to check the stability system of the existing structure. | within 6 weeks |
| Incomplete lateral stability system. (New LK Dryer Shed). | Implement remediation work if required. | within 6 months |

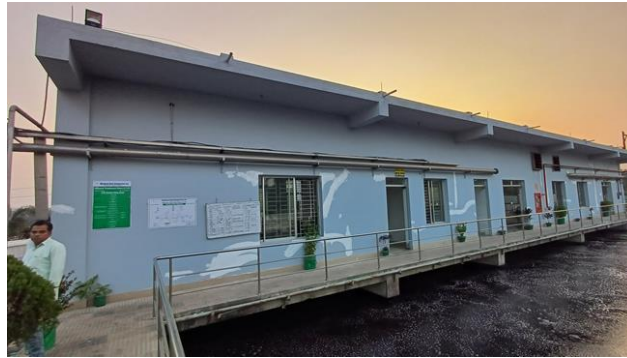
**Observation-15:** Lack of drawings for ETP Lab Room. (ETP).

**Description:** As-built drawings were not available for the ETP Lab Room. The building engineer is required to survey the full structure and produce a full set of as-built drawings.

| Lack of drawings for ETP Lab Room. (ETP). | The building engineer is required to survey the full structure and produce a full set of as-built drawings. | within 6 weeks |

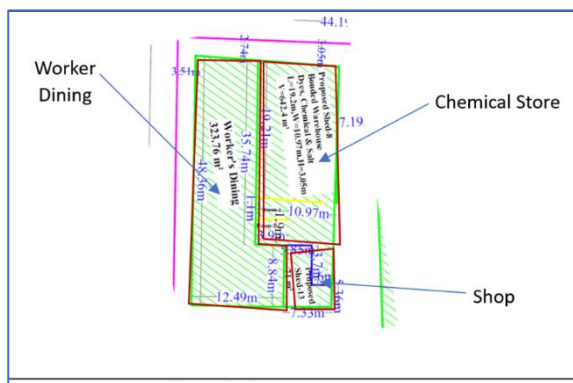
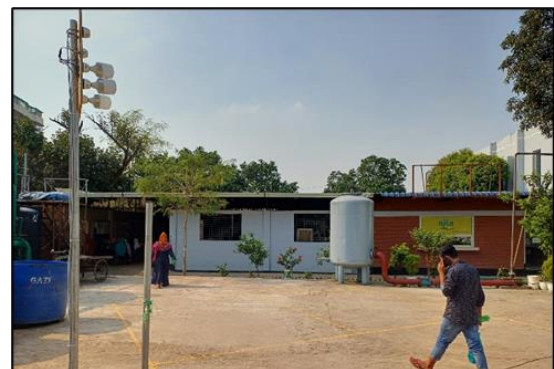
**Observation-16:** Lack of drawings details. (Worker Dining).

**Description:** As-built drawings were not available for the Worker Dining. The building engineer is required to survey the full structure and produce a full set of as-built drawings.

| Lack of drawing details. (Worker Dining). | The building engineer is required to survey the full structure and produce a full set of as-built drawings. | within 6 weeks |

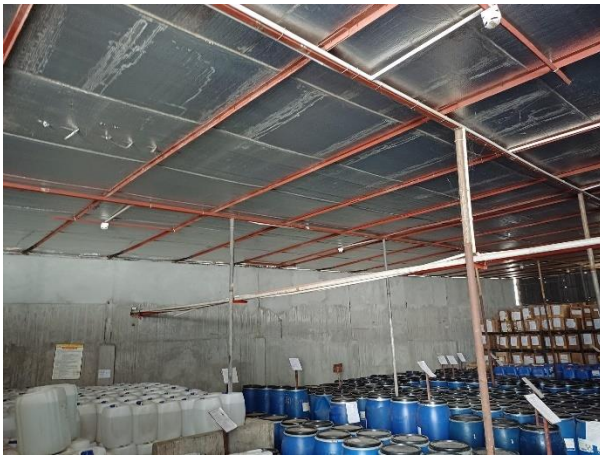
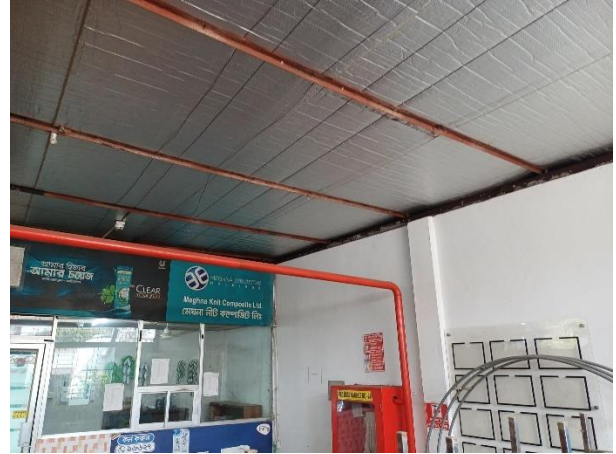
**Observation 17:** Lack of lateral stability and connection adequacy. (Worker Dining).

**Description:** Lateral load transfer media was not available along the long direction. Also, some connection was found to be apparently inadequate. The building engineer is required to check the lateral stability and connection adequacy of the shed.

| Lack of lateral stability and connection adequacy. (Worker Dining). | The building engineer is required to check the lateral stability and connection adequacy of the shed. | within 6 weeks |
| Lack of lateral stability and connection adequacy. (Worker Dining). | Implement remediation work if required. | within 6 months |

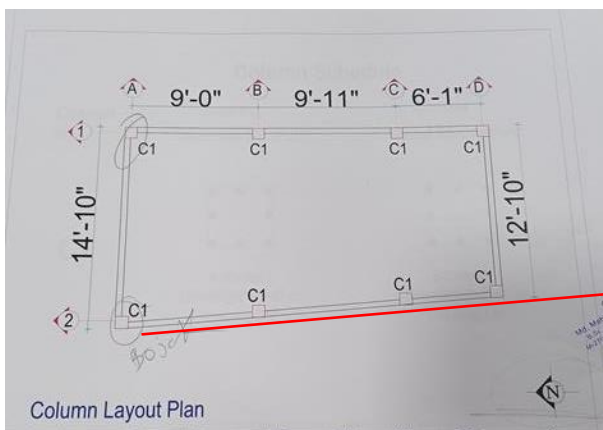
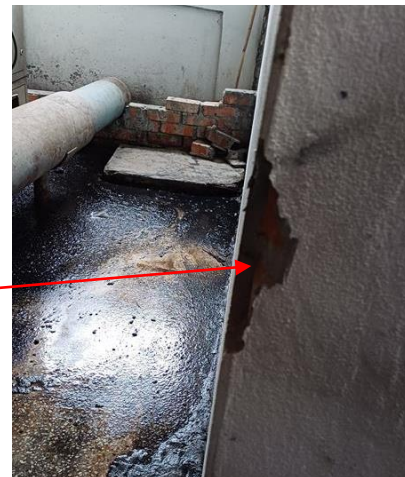
**Observation-18:** Discrepancies in as-built drawings. (RMS Room).

**Description:** Beam layouts did not match with as-built condition. Also, brick pier was found instead of RC column. Building engineer is required to update the as-built drawings as per on site condition and submit to RSC.

| Discrepancies in as-built drawings. (RMS Room). | Building engineer is required to update the as-built drawings as per on-site conditions and submit to RSC. | within 6 weeks |

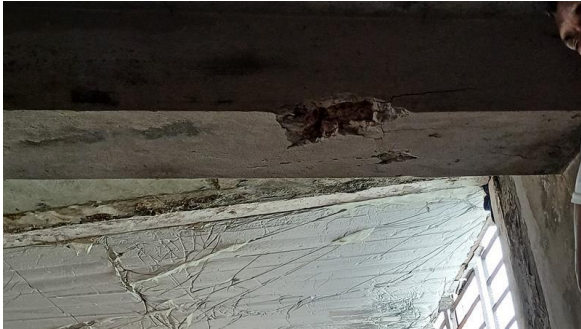
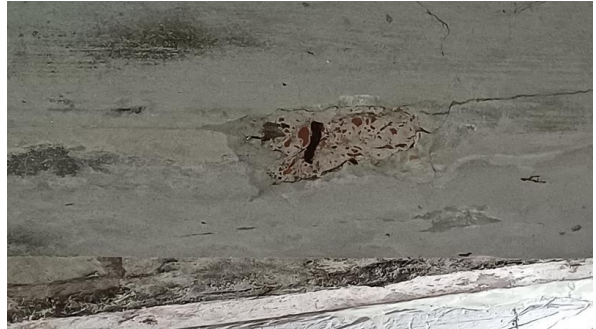
**Observation-19:** Cracks under beam soffit. (RMS Room).

**Description:** Crack found under beam soffit at North side of cooling tower. Building engineer is required to investigate the extent of crack and repair with a suitable method.

| Cracks under beam soffit. (RMS Room). | Building engineer is required to investigate the extent of the crack and repair it with a suitable method. | within 6 weeks |

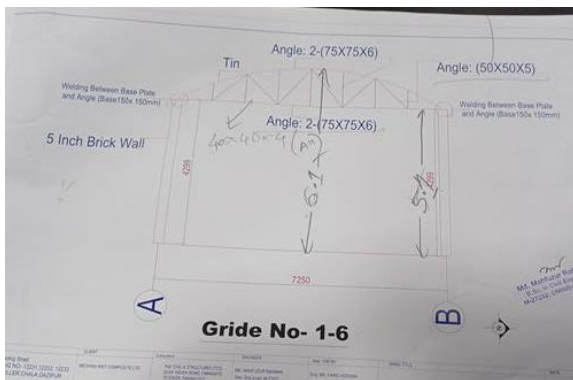
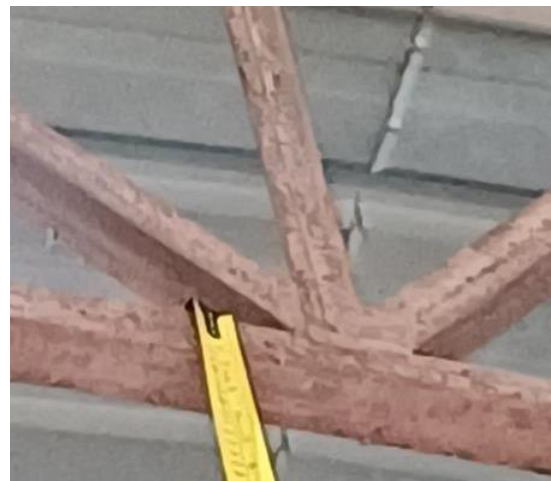
**Observation-20:** Discrepancies in as-built drawings. (Loading & Unloading Shed).

**Description:** Truss angle sizes were found 40x40x4 mm instead of 2-75x75x6 mm. Also, undocumented canopy was found at front. Building engineer is required to update the as-built drawings as per on site condition and submit to RSC.

| Discrepancies in as-built drawings. (Loading & Unloading Shed). | Building engineer is required to update the as-built drawings as per on-site conditions and submit to RSC. | within 6 weeks |

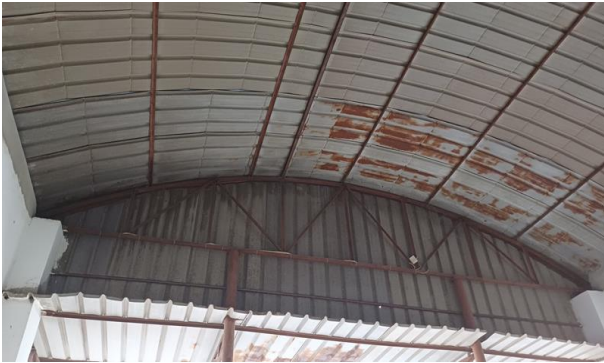
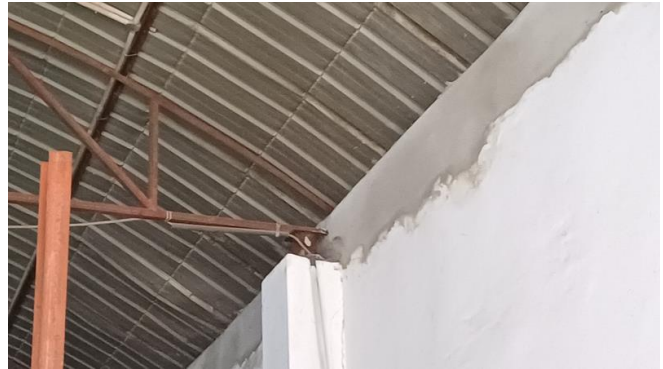
**Observation-21:** lack of lateral stability. (Loading & Unloading Shed).

**Description:** Lateral load transfer media was not available along the long direction. The building engineer is required to check the lateral stability and connection adequacy of the shed.

| lack of lateral stability.<br>(Loading & Unloading Shed). | The building engineer is required to check the lateral stability and connection adequacy of the shed. | within 6 weeks |
| lack of lateral stability.<br>(Loading & Unloading Shed). | Implement remediation work if required. | within 6 months |

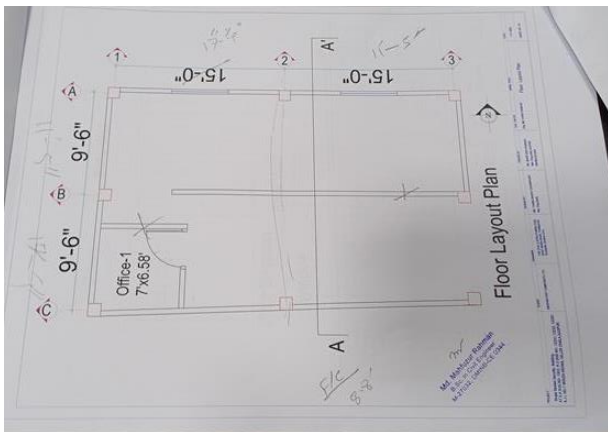
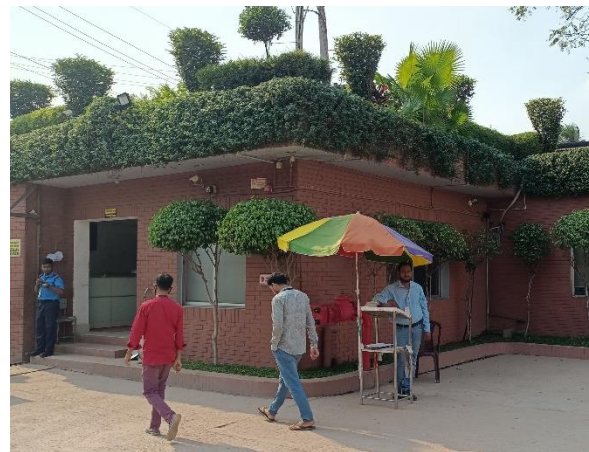
**Observation-22:** Lack of as-built drawings. (Security Building).

**Description:** As-built drawings were not found for the Security Building. A set of drawings were available on site which was totally different from as-built condition. Building engineer is required to survey the full structure and prepare full set of as-built drawings as per on site condition and submit to RSC.

| Lack of as-built drawings.<br>(Security Building). | Building engineer is required to survey the full structure prepare a full set of as-built drawings as per on-site conditions and submit to RSC. | within 6 weeks |

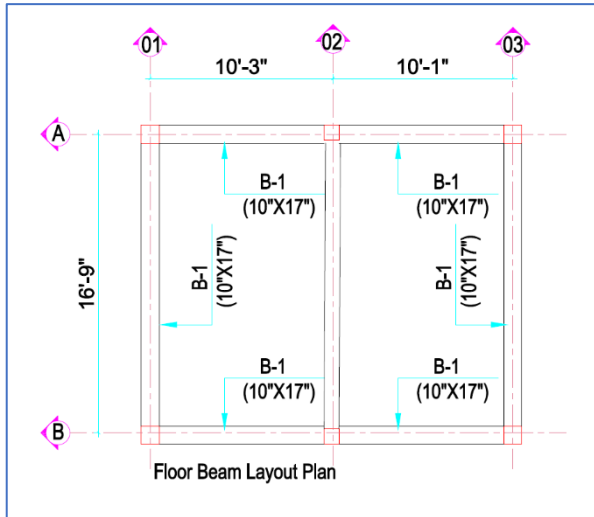
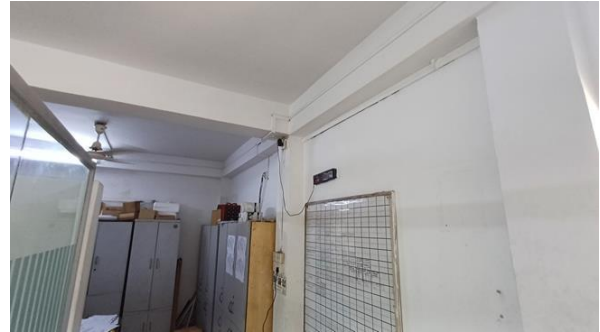
**Observation-23:** Discrepancies in as-built drawings. (Maintenance Room).

**Description:** Number of rebar in columns and beam layout did not match fully with as-built condition. Building engineer is required to update the as-built drawings as per on site condition and submit to RSC.

| Discrepancies in as-built drawings.<br>(Maintenance Room). | Building engineer is required to update the as-built drawings as per on-site conditions and submit to RSC. | within 6 weeks |

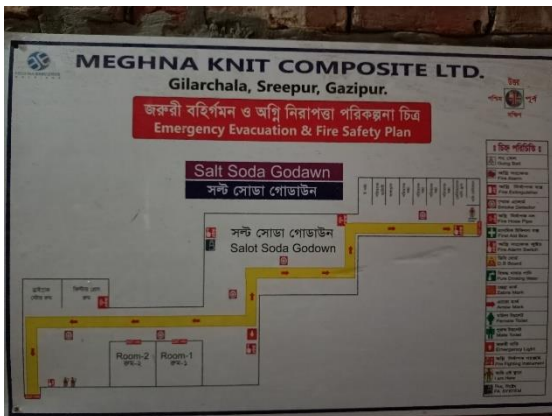
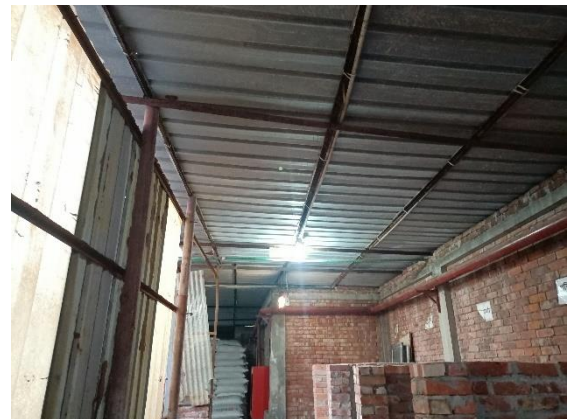
**Observation-24:** Lack of as-built drawings. (Salt Soda Godown).

**Description:** As-built drawings were not found for the Salt Soda Godown. Building engineer is required to survey the full structure and prepare full set of as-built drawings as per on site condition and submit to RSC.

| Lack of as-built drawings.<br>(Salt Soda Godown). | Building engineer is required to survey the full structure prepare a full set of as-built drawings as per on-site conditions and submit to RSC. | within 6 weeks |

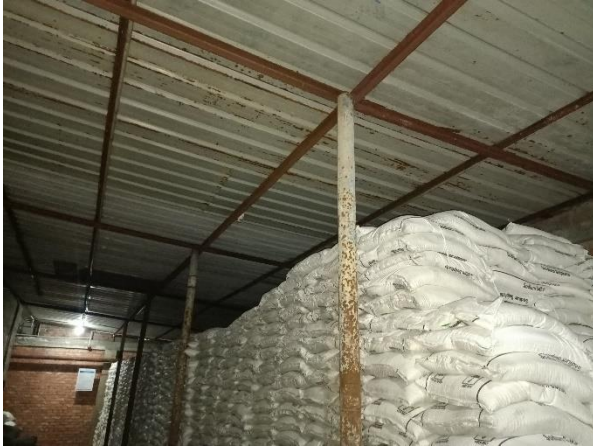
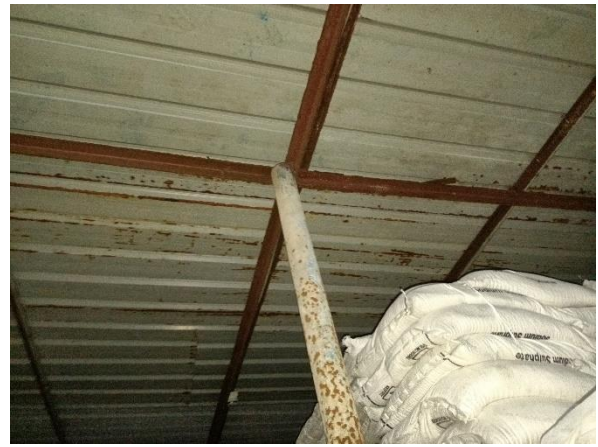
**Observation-25:** Apparently inadequate connection. (Salt Soda Godown).

**Description:** Lack of lateral stability system (strut and bracing), apparent inadequate members and non-engineered connection was observed. The building engineer is required to check the member, connection & stability system of the structure and suggest proper alternatives accordingly.

| Apparently inadequate connection.<br>(Salt Soda Godown). | The building engineer is required to check the members, connection & stability system of the structure and suggest proper alternatives accordingly. | within 6 weeks |
| Apparently inadequate connection.<br>(Salt Soda Godown). | Implement remediation work if required. | within 6 months |
