# Farseeing Knit Composite Limited (Extension)

10 January 2024

## 2. Observations:

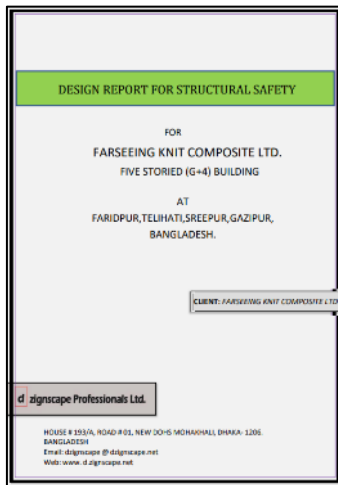
### Observation-1: Inconsistencies in design report. (Building-1 (Production Building))

**Description:** Response modification factor  $R=12$  has been considered in the design report. However no detailed calculation has been provided to support the consideration for the connection details. Also, due to ongoing construction the necessary amount of material testing has not been completed. The building engineer is required to check the framing system, confirm the material strength by necessary testing and revise the design report accordingly. Submit the design documents to the RSC for review.

| Item No. | Observation | Action Plan | Timeline |
|---|---|---|---|
| 1 | Inconsistencies in Design documents. (Building-1 (Production Building)) | The building engineer is required to check the framing system & revise the design parameters, complete the necessary material testing & confirm the material strength and revise the design report accordingly. Submit the design documents to the RSC for review. | within 6 weeks |
| 2 | Inconsistencies in Design documents. (Building-1 (Production Building)) | Implement remediation work if required. | within 6 months |

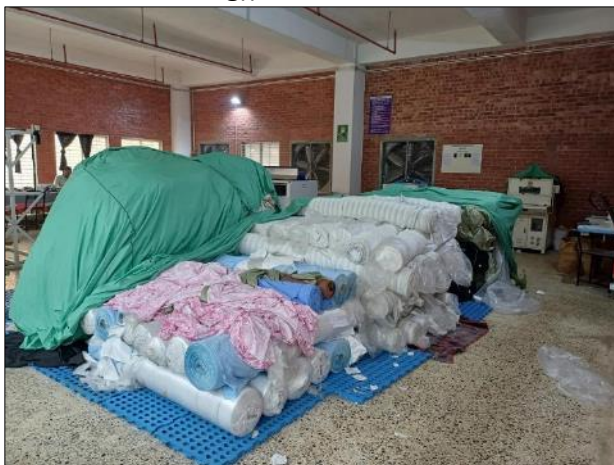
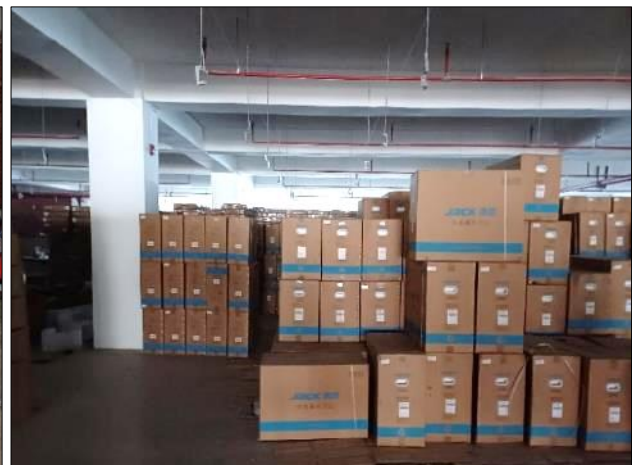
### Observation-2: Undesignated storage on ground level suspended floor and 1st floor. (Building-1 (Production Building))

**Description:** Undesignated storage found on the suspended ground floor (above UGWR) and 1st floor. The building engineer is required to update the load plan considering 6 kPa for storage areas and check the design accordingly.

| Item No. | Observation | Action Plan | Timeline |
|---|---|---|---|
| 3 | Undesignated storage on ground level suspended floor and 1st floor. (Building-1 (Production Building)) | The building engineer is required to update the load plan considering 6 kPa for storage areas and check the design accordingly. | within 6 weeks |

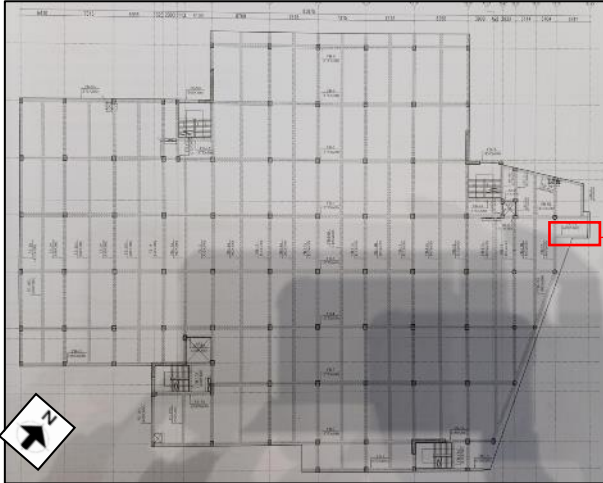
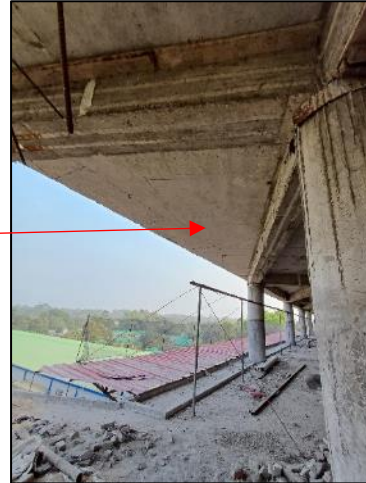
At 4th-floor beam layout, the cantilever beam mentioned in the drawing

Not found in as-built condition

**Description:** During the inspection, a mismatch was found in the 4th-floor beam layout and toilet build-up on the 1<sup>st</sup> floor. The building engineer is required to survey the full structure and produce accurate as-built drawings.

| Item No. | Observation | Action Plan | Timeline |
|---|---|---|---|
| 4 | Discrepancies in as-built structural drawings. (Building-1 (Production Building)) | The building engineer is required to survey the full structure and produce accurate as-built drawings. | within 6 weeks |

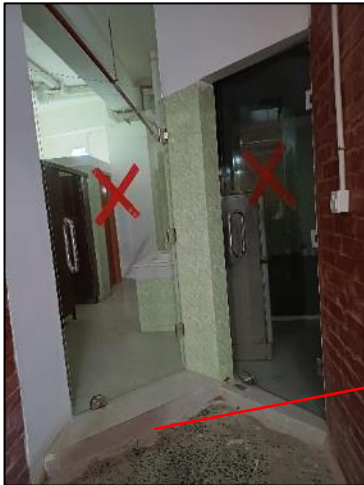
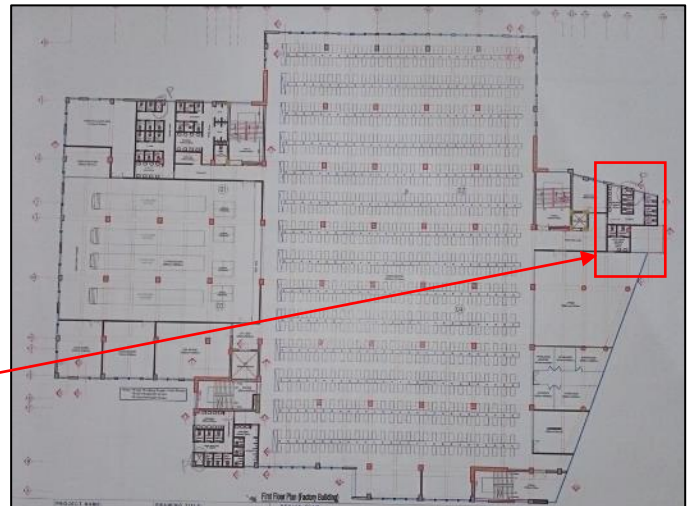
150 mm build-up found at the toilet zone of 1<sup>st</sup> floor which is not mentioned in the drawing.

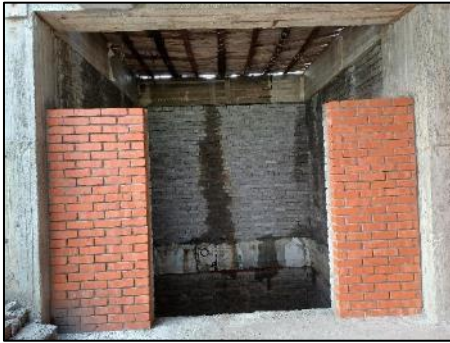
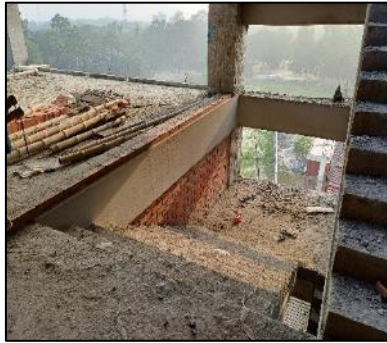
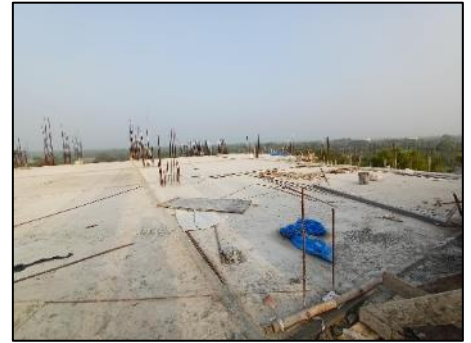
**Observation-4:** Falling hazard at roof, lift and stair. (Building-1 (Production Building))

**Description:** No parapet/railing was found on the roof, lift and stair. The building engineer is required to provide edge protection to all the required areas to avoid potential falling hazards.

| Item No. | Observation | Action Plan | Timeline |
|---|---|---|---|
| 5 | Falling hazard at roof, lift and stair. (Building-1 (Production Building)) | The building engineer is required to provide edge protection to all the required areas to avoid falling hazards. | within 6 weeks |

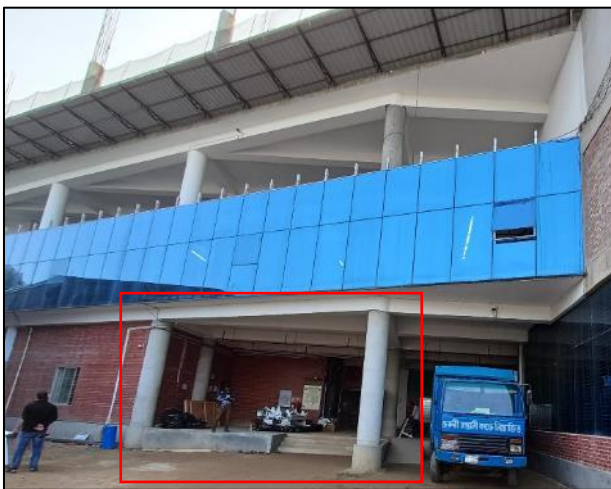
Columns susceptible to vehicle impact.

**Description:** Columns found which are prone to vehicle/trolley impact. The building engineer is required to provide a separate barrier surrounding the exterior columns to avoid vehicle impact and provide a column edge protection guard to prevent trolley impact on the columns.

| Item No. | Observation | Action Plan | Timeline |
|---|---|---|---|
| 6 | Columns susceptible to vehicle & trolley impact. (Building-1 (Production Building)) | The building engineer is required to provide separate barriers surrounding the exterior columns to avoid vehicle impact and provide a column edge protection guard to prevent trolley impact on the columns. | within 6 weeks |

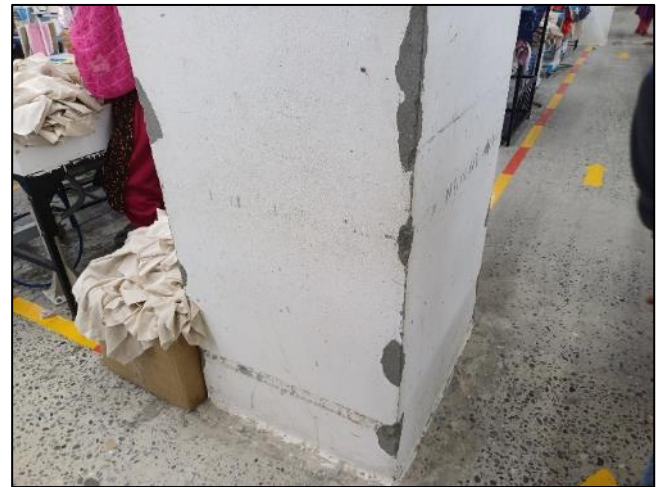
Trolley impact on column

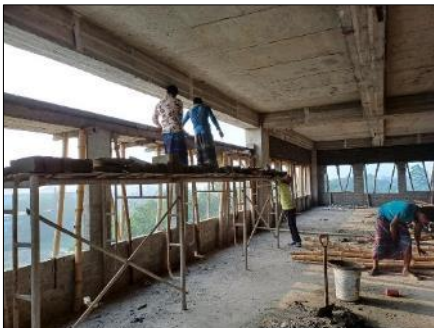
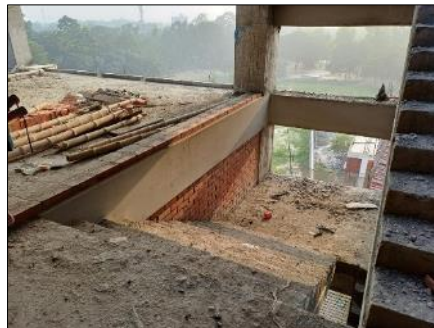
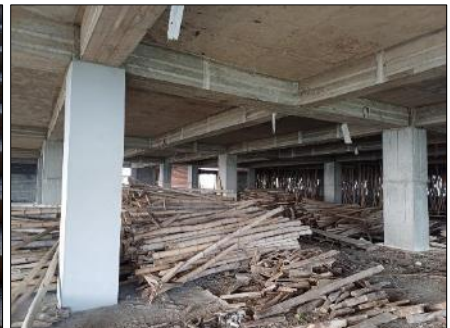
**Observation 6:** Lack of PPE and standard construction safety practices. (Building-1 (Production Building))

**Description:** The construction workers were working without PPEs. A lack of safety barriers was observed (in the stair/lift core/open roof) on the under-construction floors. Also, construction debris was found on the roof. However, the building engineer to ensure necessary safety measures are taken as per BNBC requirements and maintain the standard construction safety practice accordingly.

| Item No. | Observation | Action Plan | Timeline |
|---|---|---|---|
| 7 | Lack of PPE and standard construction safety practices. (Building-1 (Production Building)) | The building engineer to ensure necessary safety measures are taken as per BNBC requirements and maintain the standard construction safety practice accordingly. | within 6 weeks |
