# Tanzila Textile Ltd. (Extension)

Baroypara, Ashulia, Savar-1345, Dhaka, Bangladesh.

22 January 2024

## 2. Observations:

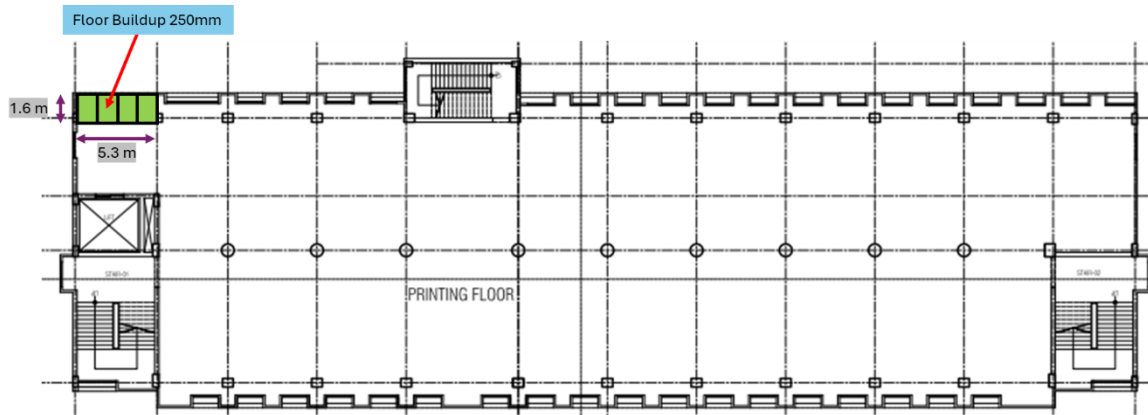
Floor buildup in toilet

**Description:** During inspection, 250mm floor build up found in toilet areas of 1<sup>st</sup> and 2<sup>nd</sup> floor. Mismatch in grid distance was found at GL 1-2, GL 2-4 and GL L-M. In drawing, no cantilever beam is shown but cantilever beams were found on-site at 2<sup>nd</sup>, 4<sup>th</sup> and 5<sup>th</sup> floor. In drawing, no beam is shown offset to columns but during inspection, beams offset to columns were found at ground floor. The building engineer is required to survey the structure, prepare accurate as-built drawings and update the design report and FEM accordingly.

| Serial | Observation | Action Plan | Timeline |
|---|---|---|---|
| 1 | Discrepancy in as-built drawing (Store Building) | The building engineer is required to survey the structure, prepare accurate as-built drawings and update the design report and FEM accordingly. | within 6 weeks |
| 2 | Discrepancy in as-built drawing (Store Building) | Carry out remedial work if required. | within 6 months |

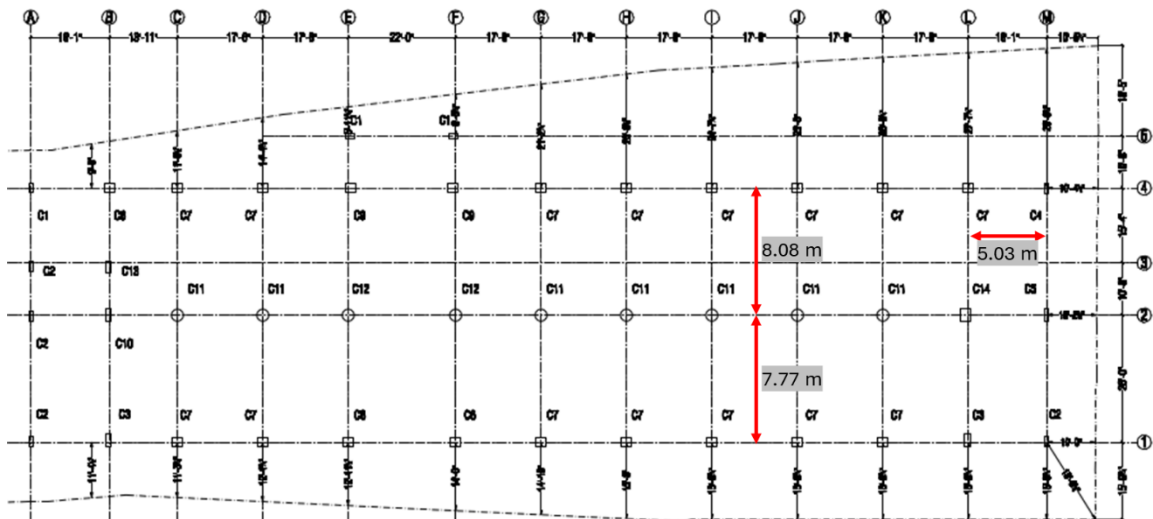
Mismatch in grid distance

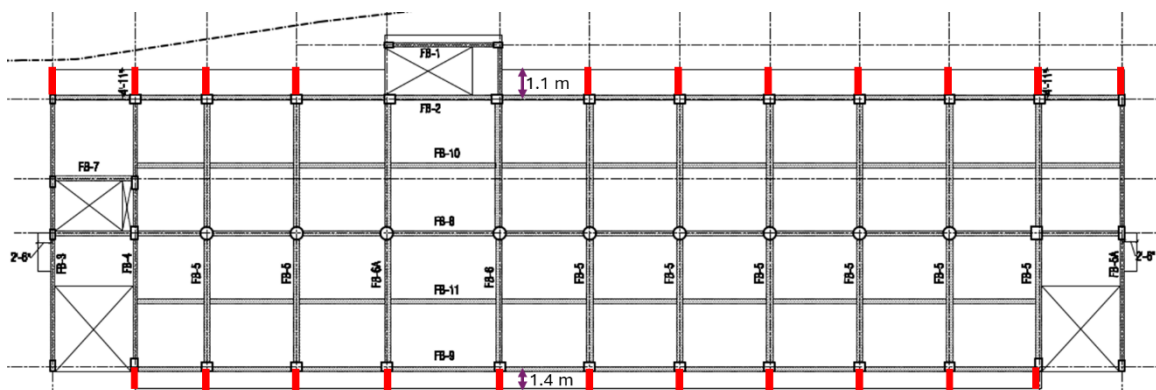
Cantilever beam in 4<sup>th</sup> and 5<sup>th</sup> floor

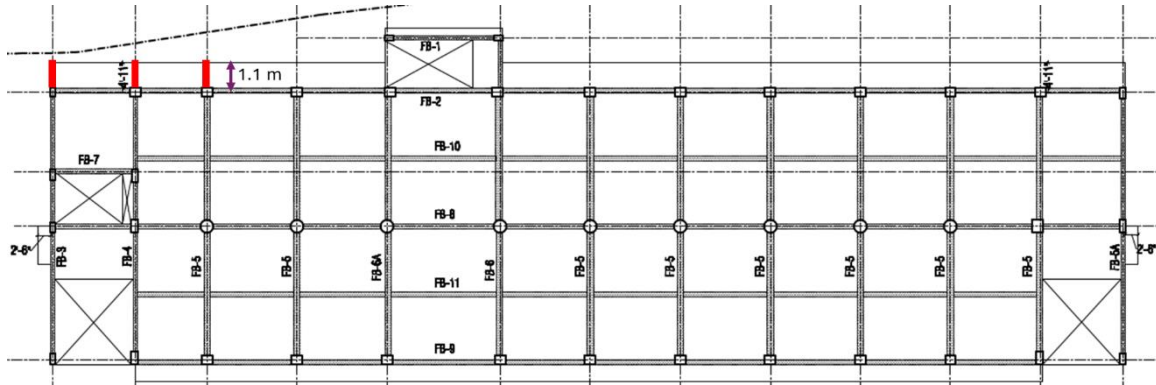
Cantilever beam in 2<sup>nd</sup> floor

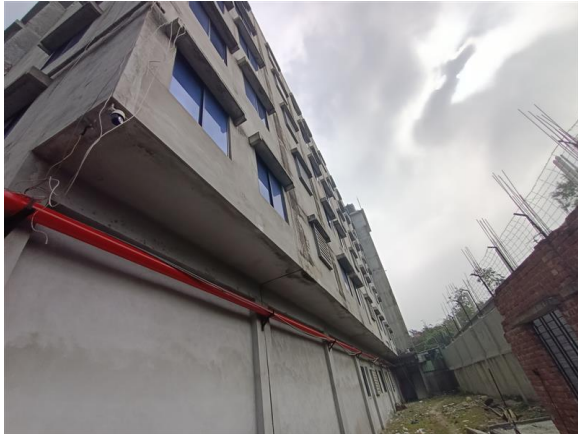
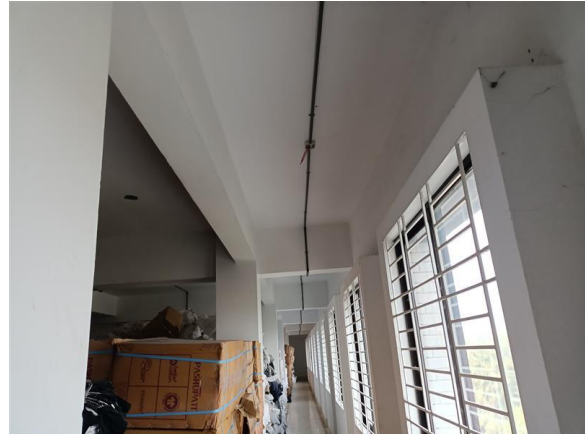
Cantilver portion

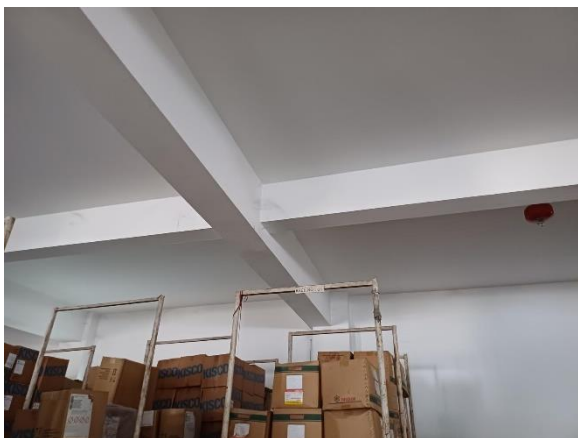
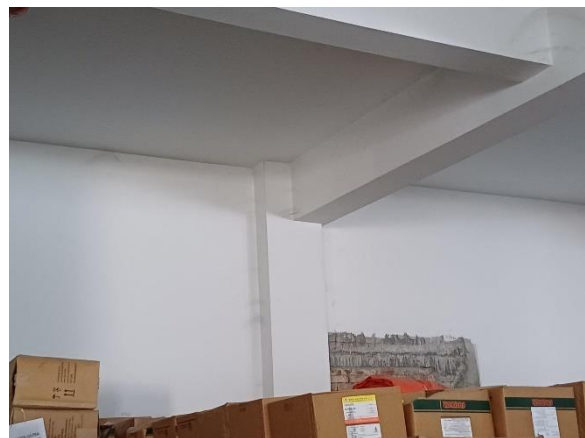
Beam offset from column center

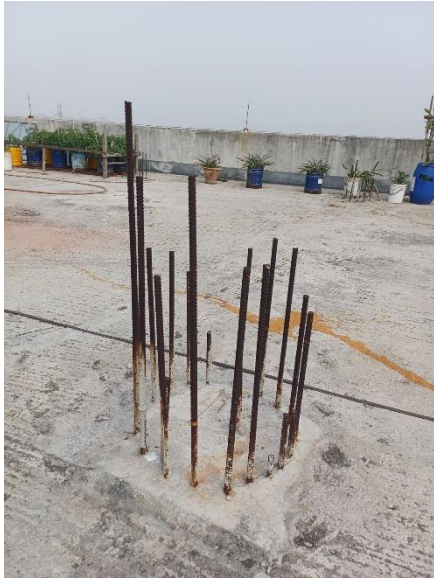
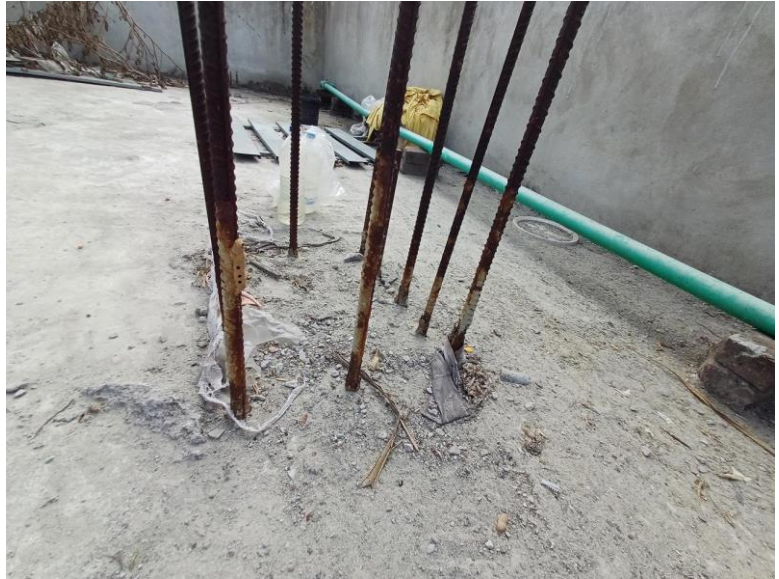
**Observation-2: Corrosion in exposed rebar at roof (Store Building)**

**Description:** Corrosion was observed on exposed rebars at roof. The building engineer is required to remove the corrosion and provide rust-proof coating on all exposed rebars to protect from corrosion.

| Serial | Observation | Action Plan | Timeline |
|---|---|---|---|
| 3 | Corrosion in exposed rebars at roof (Store Building) | The building engineer is required to remove the corrosion and provide rust-proof coating on all exposed rebars to protect from corrosion. | within 6 weeks |

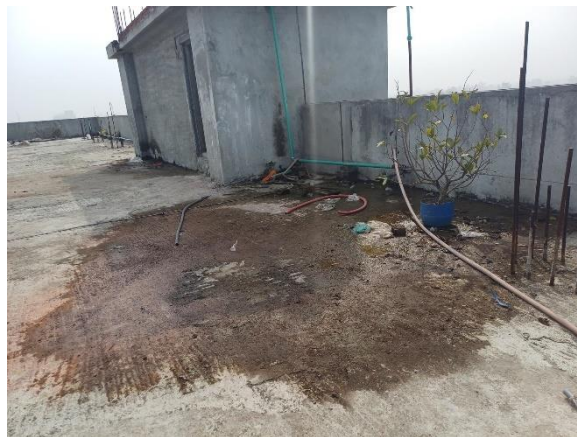
**Observation-3: Water ponding at roof (Store Building)**

**Description:** During inspection, water ponding was found at the roof. The building engineer is required to improve the drainage system by providing adequate slopes and outlets to prevent water ponding.

| Serial | Observation | Action Plan | Timeline |
|---|---|---|---|
| 4 | Water ponding at roof (Store Building) | The building engineer is required to improve the drainage system by providing adequate slope and outlets to prevent water ponding. | within 6 months |

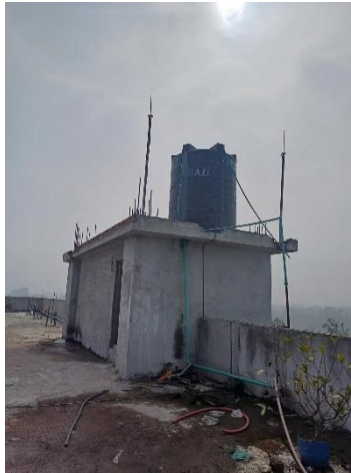
**Observation-4:** Lack of anchorage of plastic water tank (Store Building)

**Observation:** During inspection, plastic water tank at the roof top was found not anchored. The building engineer is required to anchor or laterally brace all non-structural elements including plastic water tanks to resist earthquake force.

| Serial | Observation | Action Plan | Timeline |
|---|---|---|---|
| 5 | Lack of anchorage of plastic water tank (Store Building) | The building engineer is required to anchor or laterally brace all non-structural elements including plastic water tanks to resist earthquake force. | within 6 weeks |

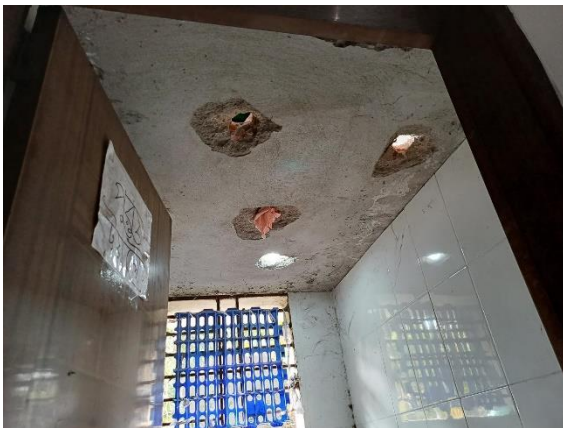
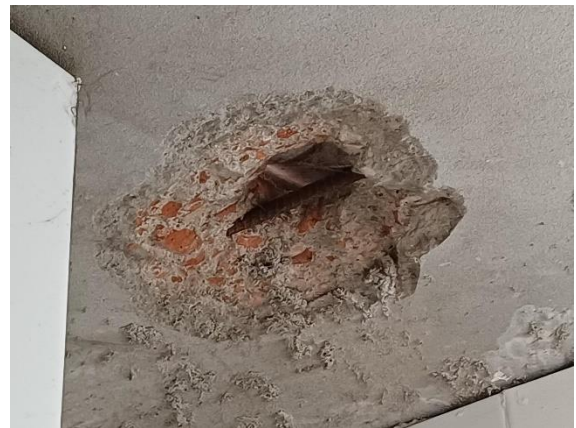
**Observation-5:** Damaged false slab of toilet at 1<sup>st</sup> floor (Store Building)

**Observation:** During inspection, damaged false slab was found at the toilet area of 1<sup>st</sup> floor. Exposed rebar was also found at the affected area of slab. Factory is required to repair the damaged area of the concrete slab as per the suggestion of the building engineer.

| Serial | Observation | Action Plan | Timeline |
|---|---|---|---|
| 6 | Damaged false slab of toilet at 1 <sup>st</sup> floor (Store Building) | Factory is required to repair the damaged area of the concrete slab as per the suggestion of the building engineer. | within 6 weeks |

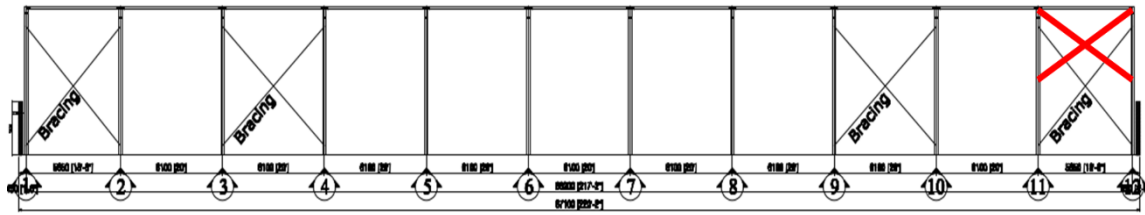
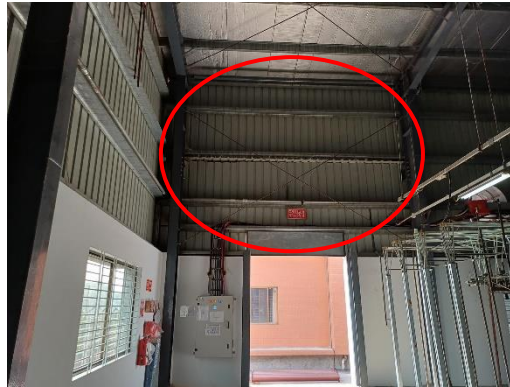
Mismatch in side wall bracing section

**Description:** During inspection, mismatch was found in the side wall bracing section. No canopy is shown in the drawing, but during inspection, two canopies were found on-site. The building engineer is required to survey the structure, prepare accurate as-built drawings and update the design report and FEM accordingly.

| Serial | Observation | Action Plan | Timeline |
|---|---|---|---|
| 7 | Mismatch in as-built drawings (Knitting Shed) | The building engineer is required to survey the structure, prepare accurate as-built drawings and update the design report and FEM accordingly. | within 6 weeks |
| 8 | Mismatch in as-built drawings (Knitting Shed) | Carry out remedial work if required. | within 6 months |

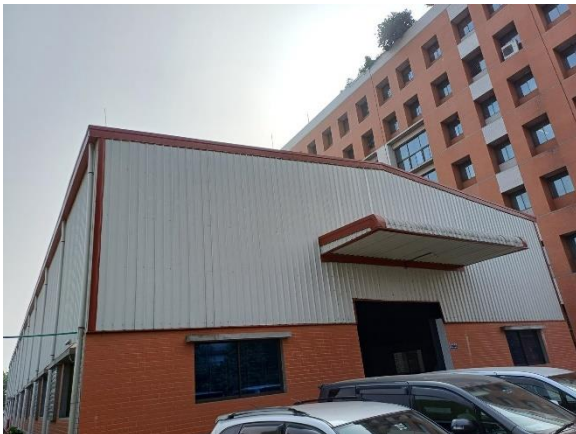
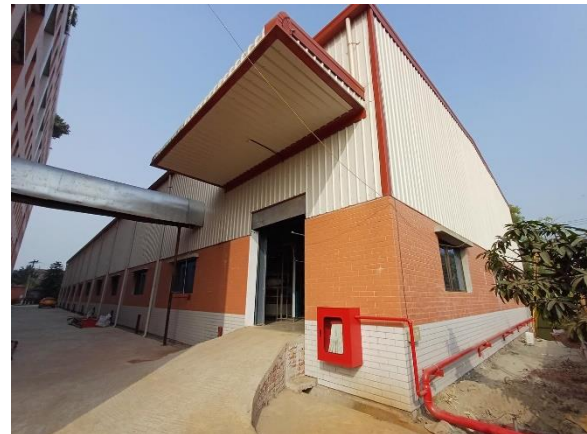
Missing drawing of steel canopies

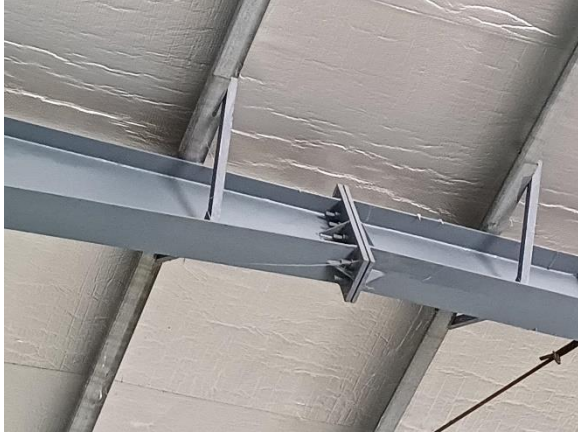
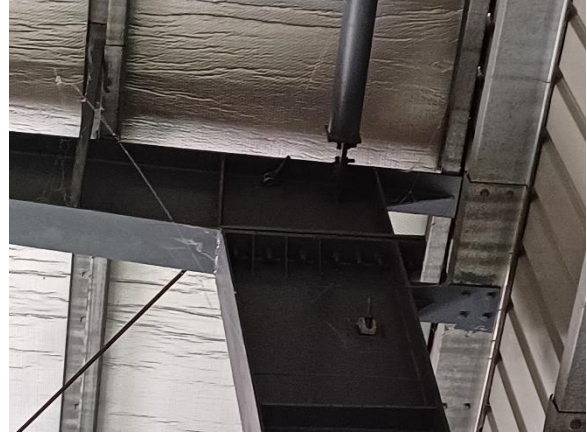
**Observation 7: Significant gap in connection (Knitting Shed)**

**Description:** Significant gaps in the connections of the rafter to the column and rafter to rafter were found. The building engineer is required to identify the locations of the connection gaps, and repair the gaps with a suitable method.

| Serial | Observation | Action Plan | Timeline |
|---|---|---|---|
| 9 | Significant gap in connection (Knitting Shed) | The building engineer is required to identify the locations of the connection gaps and repair the gaps with a suitable method. | within 6 weeks |

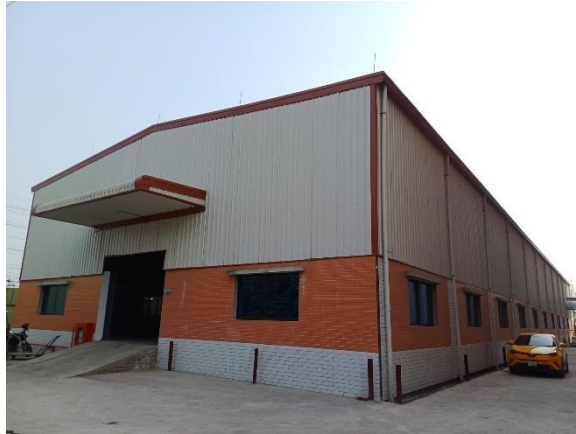
**Observation 8: Lack of building permit from local authority (Knitting Shed)**

**Description:** During inspection, no building permit was found for Knitting Shed. The factory is required to collect building permit from government approved local authority.

| Serial | Observation | Action Plan | Timeline |
|---|---|---|---|
| 10 | Lack of building permit from local authority (Knitting Shed) | The factory is required to collect building permit from government approved local authority. | within 6 months |
