# Far East Knitting & Dyeing Industries Ltd (Extension 2)

Chandona, Thana-Kaliakoir, Gazipur

15 January 2024

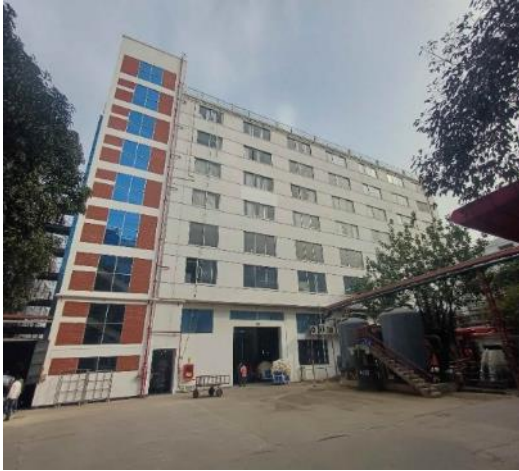
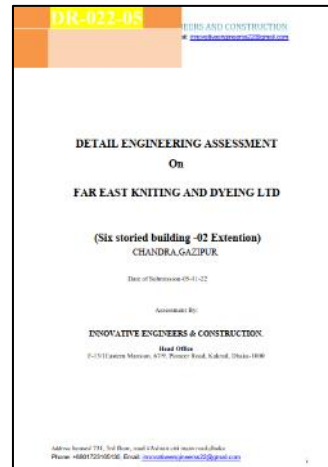
**Observation:** Lateral stability needs to be reviewed (Building-17)

**Description:** DEA documents of the building need to be reviewed against lateral loading by RSC. The building engineer is required to submit DEA documents to RSC for review.

| Serial | Observation | Action Plan | Timeline |
|---|---|---|---|
| 1 | Lateral stability needs to be reviewed (Building-17) | The building engineer is required to submit DEA documents to RSC for review. | within 6 weeks |
| 2 | Lateral stability needs to be reviewed (Building-17) | Carry out remedial work if required. | within 6 months |

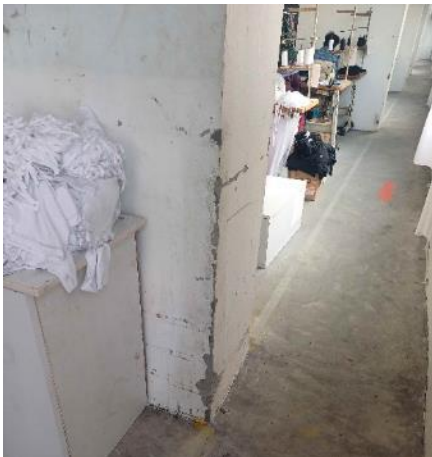
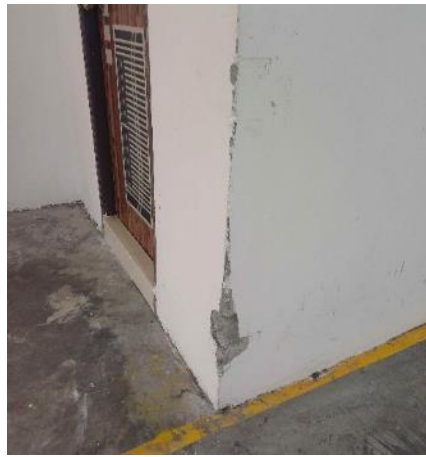
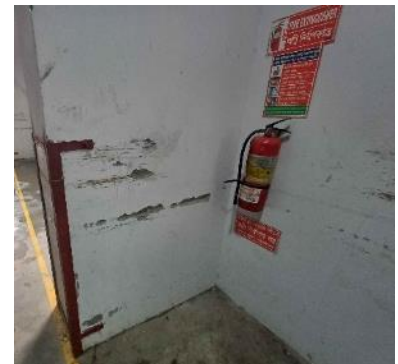
**Observation:** Column and shear wall damage due to Trolley impact (Building-17)

**Description:** During the inspection, damaged column and shear wall were found due to trolley impact load. The building engineer is required to repair the column and provide a safety guard around the column to protect it from trolley impact.

| Serial | Observation | Action Plan | Timeline |
|---|---|---|---|
| 3 | Column and shear wall damage due to Trolley impact (Building-17) | The building engineer is required to repair the column and provide safety guard around the column to protect from trolley impact. | within 6 weeks |

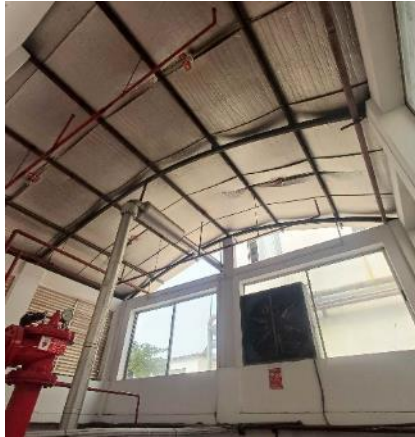
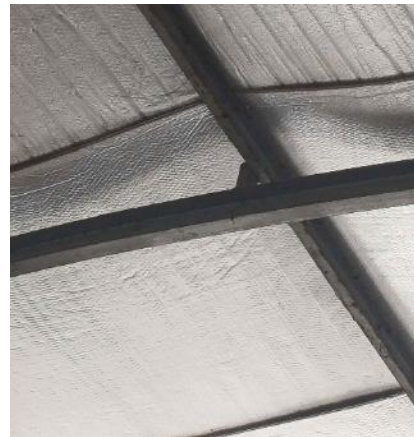
**Observation:** Lack of stability against uplift forces and improper connections. (Building-22)

Severe corrosion on steel members

**Description:** Lack of stability system against uplift force & improper connections were observed in the structure. The building engineer is required to carry out an Engineering Assessment (EA) to check the stability of the structure against uplift force and suggest proper remedial actions accordingly. Submit the EA documents to RSC for review.

| Serial | Observation | Action Plan | Timeline |
|---|---|---|---|
| 4 | Lack of stability against uplift force and improper connections. (Building-22) | The building engineer is required to carry out an Engineering Assessment (EA) to check the stability of the structure against uplift force and suggest proper remedial actions accordingly. Submit the EA documents to RSC for review. | within 6 weeks |
| 5 | Lack of stability against uplift force and improper connections. (Building-22) | Carry out remedial work if required. | within 6 months |

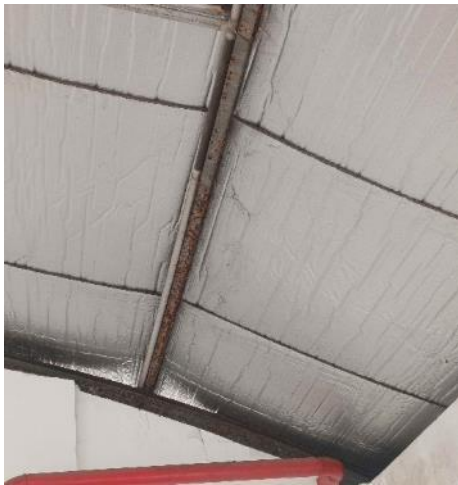
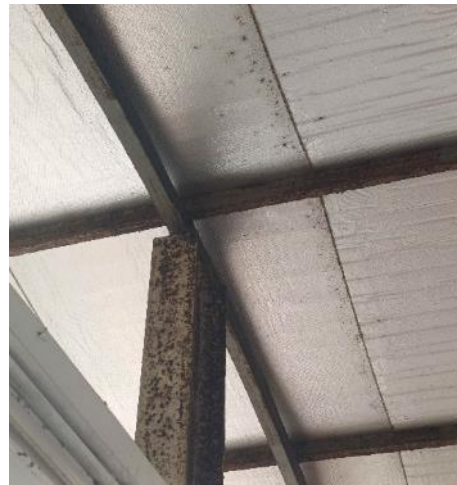
**Observation:** Corrosion on steel member. (Building-22)

Severe corrosion on steel members

**Description:** Severe corrosion was observed on steel members. The building engineer is required to remove the corrosion and provide a rust-proof coating on all steel members to protect from corrosion.

| Serial | Observation | Action Plan | Timeline |
|---|---|---|---|
| 6 | Corrosion on steel member. (Building-22) | The building engineer is required to remove the corrosion and provide rust-proof coating on all steel members to protect from corrosion. | within 6 weeks |

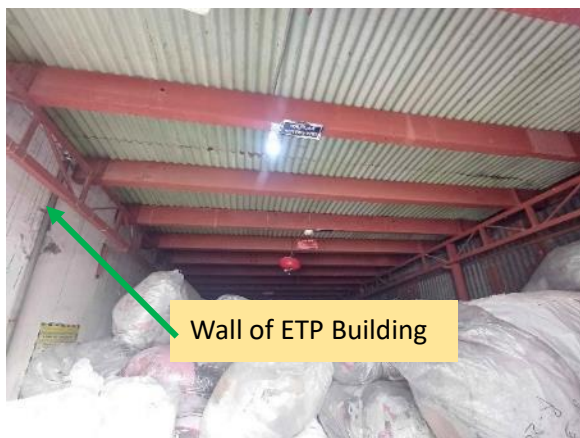
**Observation:** Lack of lateral stability. (Building-23)

No independent support at Northside

**Description:** Lack of lateral stability system (absence of load transfer media) & improper connections were observed in the structure. The building engineer is required to carry out an Engineering Assessment (EA) to check the stability of the structure against uplift force and suggest proper remedial actions accordingly. Submit the EA documents to RSC for review.

| Serial | Observation | Action Plan | Timeline |
|---|---|---|---|
| 7 | Lack of lateral stability. (Building-23) | The building engineer is required to carry out an Engineering Assessment (EA) to check the stability of the structure against uplift force and suggest proper remedial actions accordingly. Submit the EA documents to RSC for review. | within 6 weeks |
| 8 | Lack of lateral stability. (Building-23) | Carry out remedial work if required. | within 6 months |

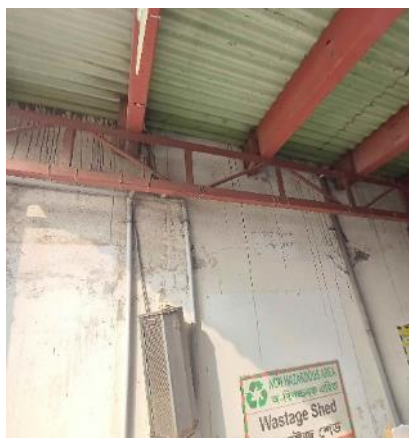
Improper connection

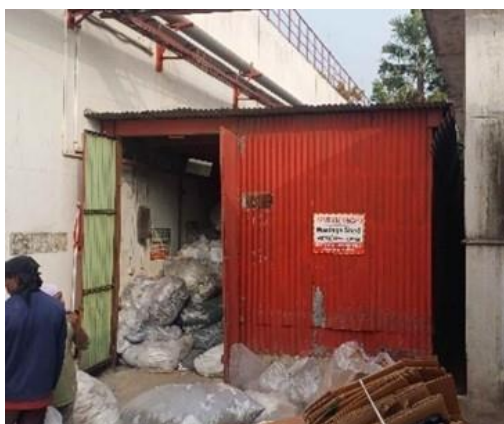
**Observation:** Absence of as-built drawing. (Building-23)

**Description:** As per BNBC, every building or structure designed shall have its design documents prepared following the provision of Section 1.9.1. The design document shall include a design report, a set of as-built drawings and load plans which shall be prepared in compliance with section 1.9.1.1 and section 1.9.1.2, part 6 of BNBC.

The building engineer is required to prepare as-built drawings and submit the documents to RSC.

| Serial | Observation | Action Plan | Timeline |
|---|---|---|---|
| 9 | Absence of as-built drawing. (Building-23) | The building engineer is required to prepare as-built drawings and submit the documents to RSC. | within 6 weeks |

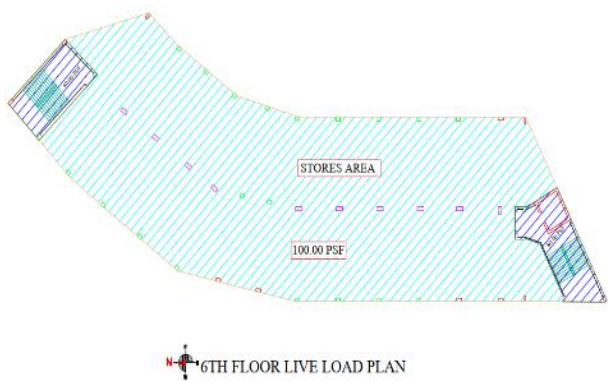
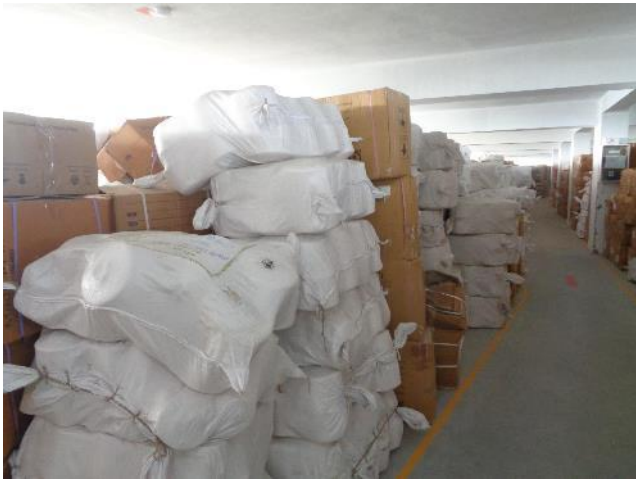
**Observation:** Load plan doesn't comply with BNBC (Building-28)

**Description:** Live load for storage area is considered as 5 kPa at several floors but as per BNBC-2006 live load for storage areas is required to be considered as 6 kPa (minimum). The building engineer is required to revise the load plan as per BNBC requirements and check the design accordingly.

| Serial | Observation | Action Plan | Timeline |
|---|---|---|---|
| 11 | Load plan doesn't comply with BNBC (Building-28) | The building engineer is required to revise the load plan as per BNBC requirements and check the design accordingly. | within 6 weeks |
| 12 | Load plan doesn't comply with BNBC (Building-28) | Implement remediation work if required. | within 6 months |

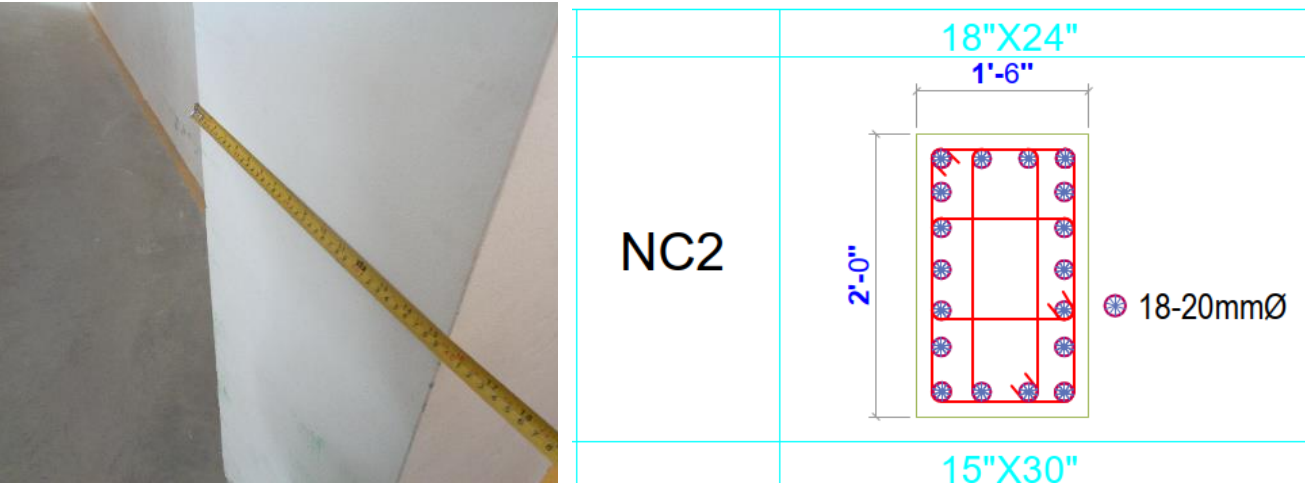
**Observation:** Discrepancy in as-built drawing (Building-28)

**Description:** The dimension of column NC2 was measured as 500 mm X 350 mm instead of 600mm X 450 mm on the 2nd floor. The building engineer is required to update the as-built drawing.

| Serial | Observation | Action Plan | Timeline |
|---|---|---|---|
| 13 | Discrepancy in as-built drawing (Building-28) | The building engineer is required to update the as-built drawing. | within 6 weeks |

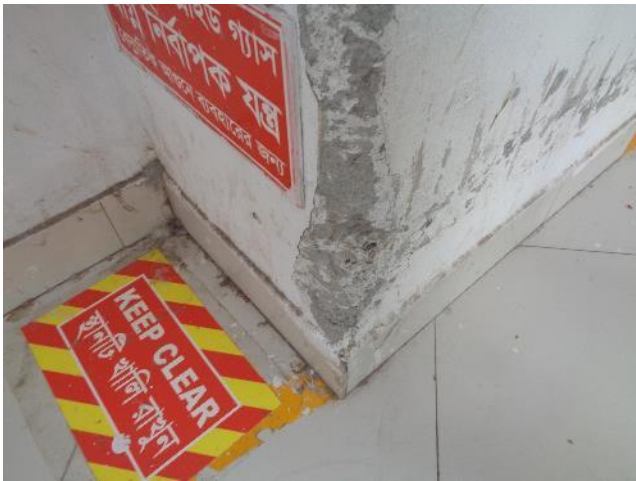
**Observation:** Column plaster damaged due to trolley impact (Building-28)

**Description:** Column plaster was found damaged due to trolley impact at several locations. The building engineer is required to repair the damaged plaster and provide protection to avoid trolley impact.

| 14 | Column plaster damaged due to trolley impact (Building-28) | The building engineer is required to repair the damaged plaster and provide protection to avoid trolley impact. | within 6 weeks |

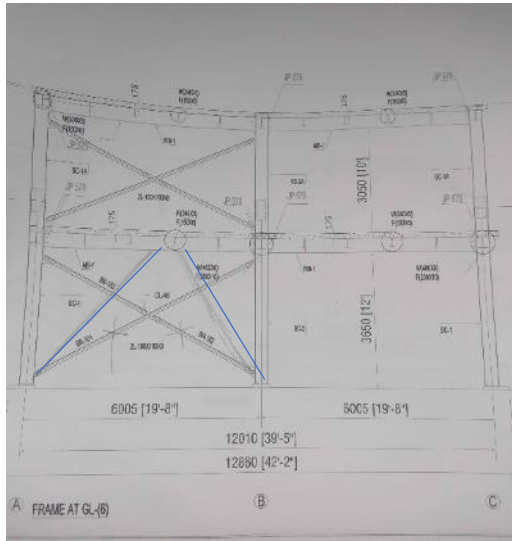
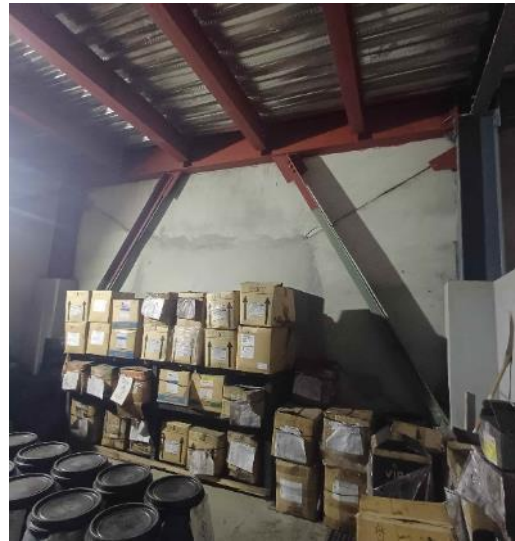
**Observation:** Mismatch in as-built drawings. (Building-29)

**Description:** During the inspection, the mismatch was found in the as-built drawing. The bracing layout of the on-site condition did not match the as-built drawing. The building engineer is required to survey the whole structure and revise the as-built drawing as per actual on-site conditions. Also, submit the design documents to RSC for review.

| 15 | Mismatch in as-built drawings (Building-29) | The building engineer is required to survey the whole structure and revise the as-built drawing as per actual on-site conditions. | within 6 weeks |
| 16 | Mismatch in as-built drawings (Building-29) | The building engineer is required to submit Design documents to RSC for review. | within 6 weeks |
| 17 | Mismatch in as-built drawings (Building-29) | Carry out remedial work if required. | within 6 months |

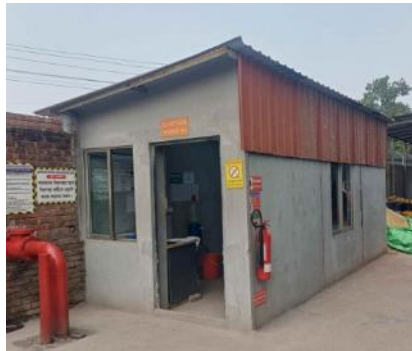
**Observation:** Absence of as-built drawing. (Building-31)

**Description:** As per BNBC, every building or structure designed shall have its design documents prepared following the provision of Section 1.9.1. The design document shall include a design report, a set of as-built drawings and load plans which shall be prepared in compliance with section 1.9.1.1 and section 1.9.1.2, part 6 of BNBC.

The building engineer is required to prepare as-built drawings and keep on-site for verification.

| 18 | Absence of as-built drawing. (Building-31) | The building engineer is required to prepare as-built drawings and keep on-site for verification. | within 6 weeks |

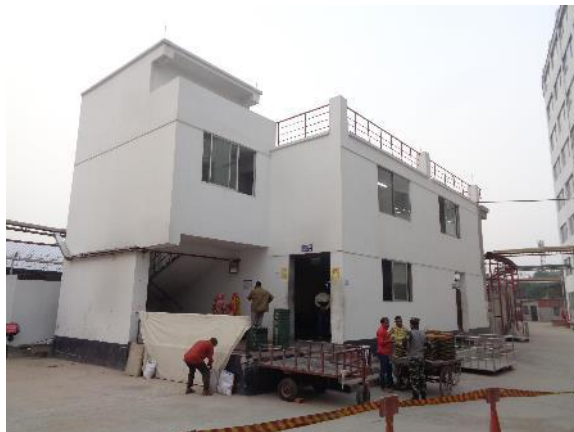
**Observation:** Lack of design report (Building-32)

**Description:** As per BNBC, every building or structure designed shall have its design documents prepared following the provision of Section 1.9.1. The design document shall include a design report, and a set of structural drawings, which shall be prepared in compliance with section 1.9.1.1 and section 1.9.1.2 as per BNBC. At the time of inspection, a design report was not available which is required to be prepared in compliance with section 1.9.1.1 (part 6, BNBC).

| 20 | Lack of design report (Building-32) | Implement remediation work if required. | within 6 months |

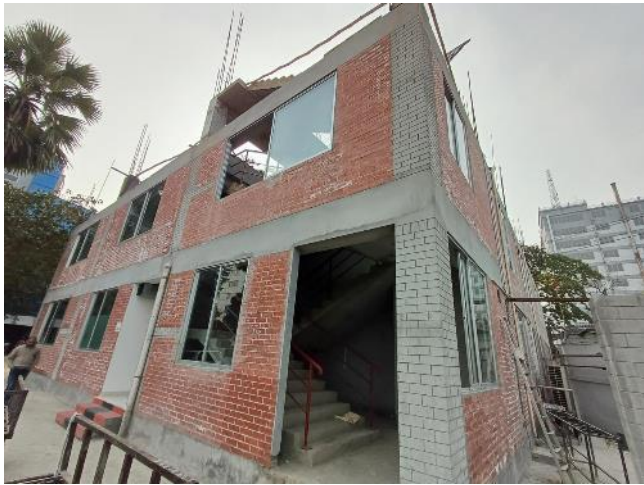
**Observation:** Absence of design report. (Building-3)

**Description:** As per BNBC, every building or structure designed shall have its design documents prepared following the provision of Section 1.9.1. The design document shall include a design report, a set of as-built drawings and load plans which shall be prepared in compliance with section 1.9.1.1 and section 1.9.1.2, part-6 of BNBC.

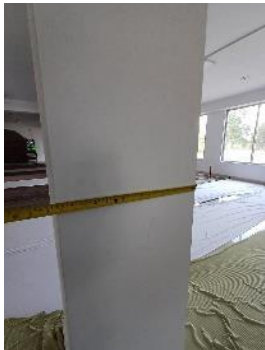
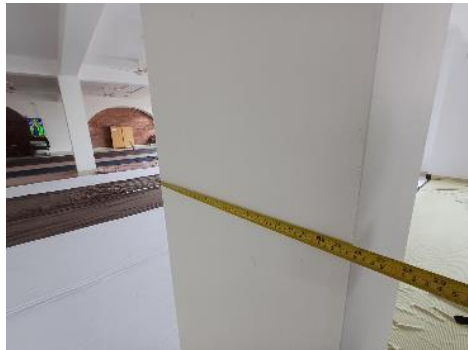
**Observation:** Mismatch in as-built drawings. (Building-3)

Mismatch in column size at column schedule

**Description:** In the as-built structural drawing, the C1 and C2 column sizes don't match with on-site conditions. In the drawing, C1 and C2 column sizes are shown as 400X800 whereas C1 and C2 column sizes were found 400X600 and 400X575 respectively on-site.

| 24 | Mismatch in as-built drawings. (Building-3) | The building engineer is required to revise the as-built drawing as per actual site condition. | within 6 weeks |

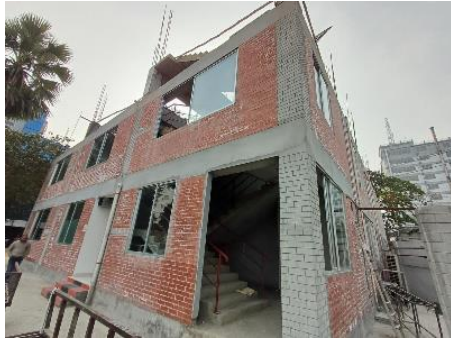
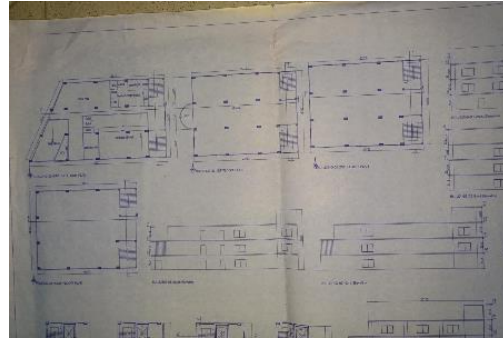
**Observation:** Possible overstress in the column due to vertical extension. (Building-3)

Building 3 constructed up to 2 storey

Local authority permit drawing (Proposed 3 story)

**Description:** The building is permitted for three (G+2) storey from Gazipur City Corporation (local authority). Currently, the building is two (G+1) storied. The factory has a plan to construct six more floors above the current roof. Proposed drawings were available during the inspection for an eight-story building. Considering existing concrete strength from column cores, stress in the column exceeds the normal design limit if the building is vertically extended above 5 storey (G+4). However, the building engineer is required to carry out a Detailed Engineering Assessment (DEA) considering BNBC provision and complete necessary remedial works before the commencement of further construction above 5 storey (G+4). Moreover, the factory is required to take approval from the local authority before constructing the building above 3 storey (G+2).

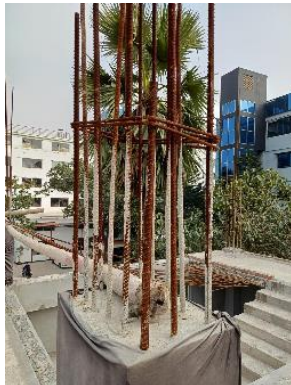
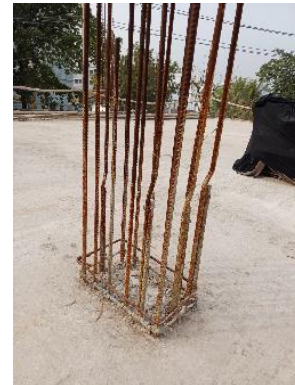
**Observation:** Corrosion in exposed rebar (Building-3)

**Description:** Corrosion was observed on exposed rebars. The building engineer is required to remove the corrosion and provide a rust-proof coating on all exposed rebars to protect from corrosion.

| 27 | Corrosion in exposed rebar (Building-3) | The building engineer is required to remove the corrosion and provide rust-proof coating on all exposed rebars to protect from corrosion. | within 6 weeks |

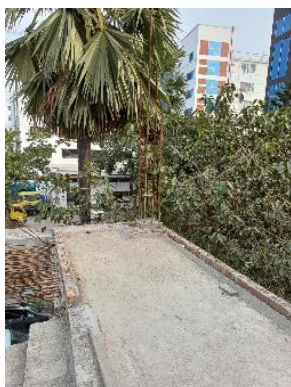
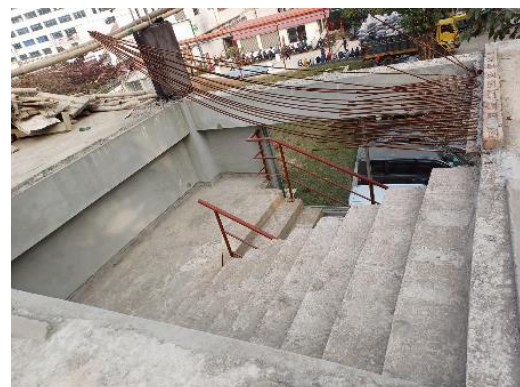
**Observation:** Possible falling hazard (Building-3)

**Description:** During inspection, the railing was found missing at some locations on the roof and the stairs. The factory is required to provide railing to prevent probable falling hazards.

| 28 | Possible falling hazard (Building-3) | The factory is required to provide railing at roof and stairs to prevent probable falling hazard. | within 6 weeks |

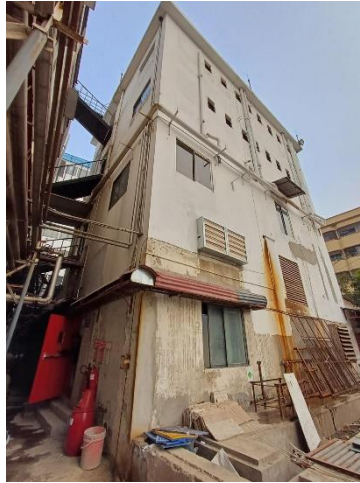
**Observation:** Lack of design documents. (Building-33)

**Description:** As per BNBC, every building or structure designed shall have its design documents prepared following the provision of Section 1.9.1. The design document shall include a design report, a set of as-built drawings, test reports and load plans which shall be prepared in compliance with section 1.9.1.1 and section 1.9.1.2, part-6 of BNBC.

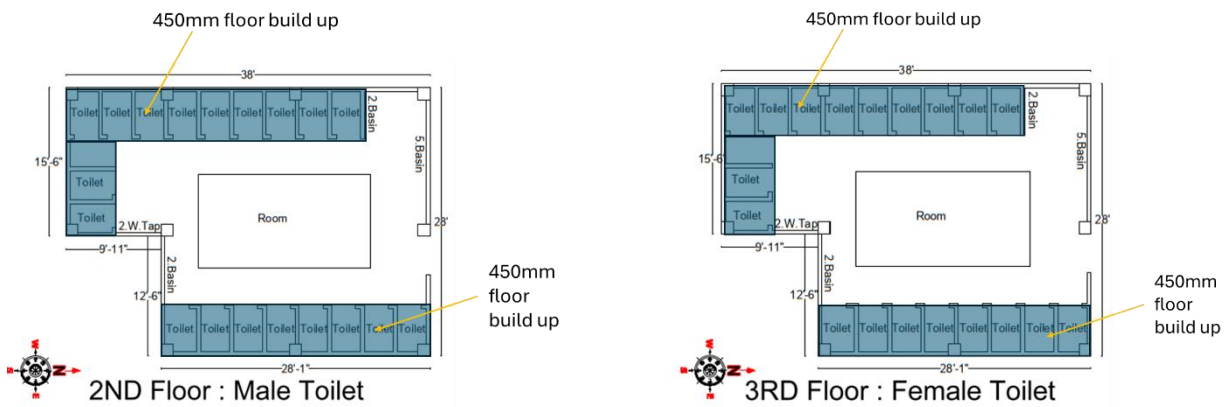
**Observation:** Mismatch in as-built drawing (Building-33)

Floor build-up missing in as-built architectural drawing

**Description:** During the inspection, 450 mm floor build-up was found in the 2<sup>nd</sup> and 3rd-floor toilet areas. The building engineer is required to prepare accurate as-built drawings and submit to the RSC for review.

| 31 | Mismatch in as-built drawing (Building-33) | The building engineer is required to revise the as-built drawing as per actual site condition. | within 6 weeks |

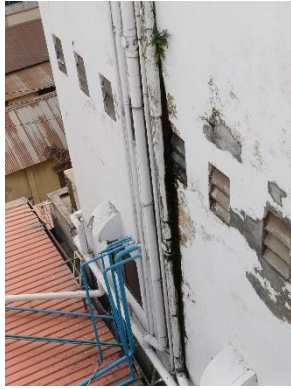
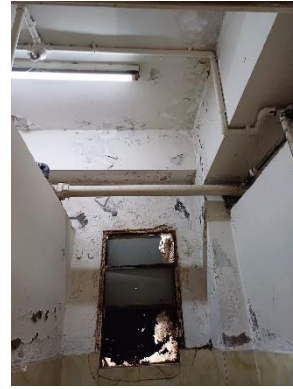
**Observation:** Dampness and vegetation found in the brick wall, beam, column and slab. (Building-33)

**Description:** During the inspection, severe dampness and vegetation were found in the brick wall, beam, column, and slab. The building engineer is required to investigate the cause of dampness, remove vegetation, and repair the dampness accordingly.

| 32 | Dampness and vegetation found in the brick wall, beam, column and slab. (Building-33) | The building engineer is required to investigate the cause of dampness, remove vegetation and repair the dampness accordingly. | within 6 months |

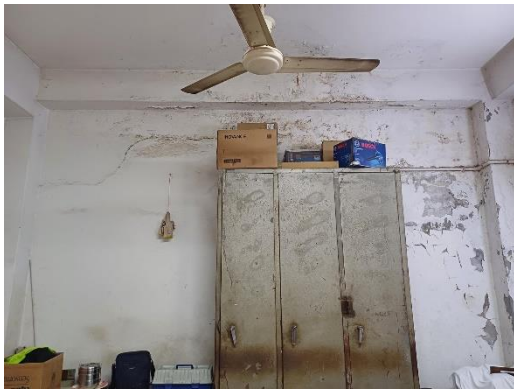
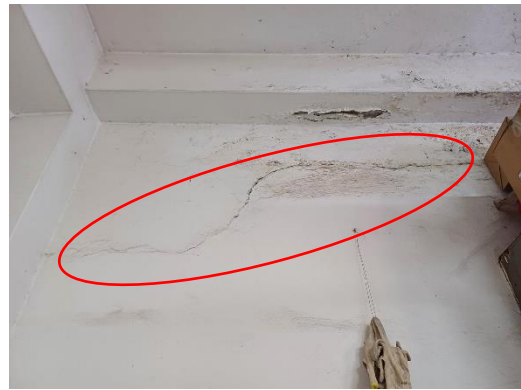
**Observation:** Crack in the brick wall on 1<sup>st</sup> floor. (Building-33)

**Description:** During inspection, a crack was found in the brick wall of the 1<sup>st</sup> floor. The building engineer is required to investigate the cause and extent of the crack, suggest necessary remedial actions, and submit to RSC for review.

| 33 | Crack in brick wall at 1 <sup>st</sup> floor. (Building-33) | The building engineer is required to investigate the cause and extent of the crack, suggest necessary remedial actions and submit to RSC for review. | within 6 weeks |
| 34 | Crack in brick wall at 1 <sup>st</sup> floor. (Building-33) | Carry out remedial work where required. | within 6 months |

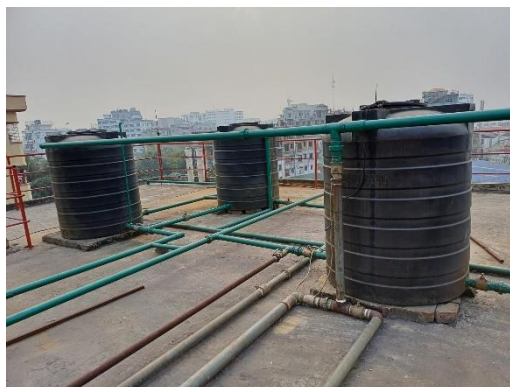
**Observation:** Lack of anchorage of plastic water tanks. (Building-33)

**Description:** During the inspection, plastic water tanks on the roof were found not anchored. The factory is required to anchor or laterally brace all non-structural elements including plastic water tanks to resist earthquake forces.

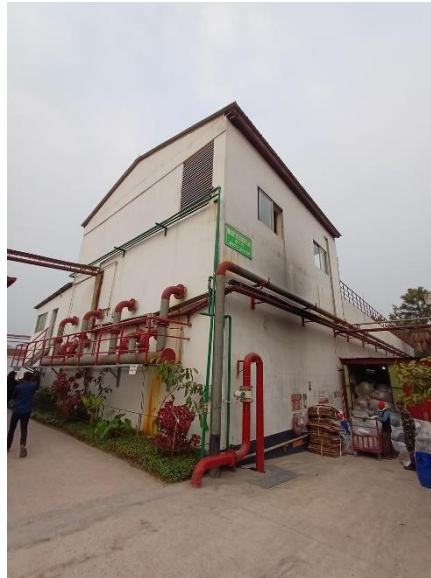
**Observation:** Lack of design documents. (Building-14)

**Description:** As per BNBC, every building or structure designed shall have its design documents prepared following the provision of Section 1.9.1. The design document shall include a design report, a set of as-built drawings and load plans which shall be prepared in compliance with section 1.9.1.1 and section 1.9.1.2, part-6 of BNBC.

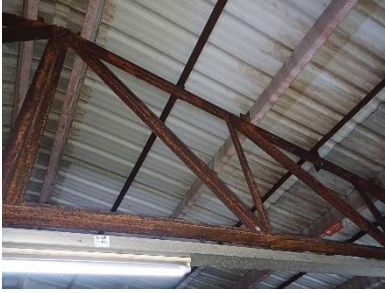
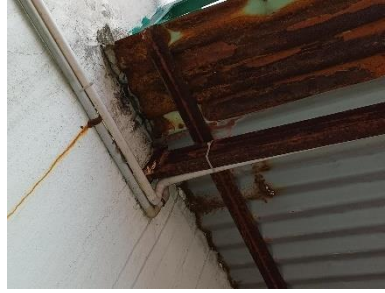
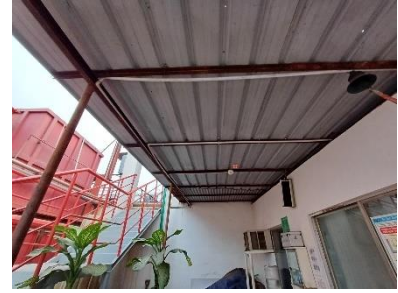
**Observation:** Corrosion in steel section. (Building-14)

**Description:** Severe corrosion was observed on steel members (steel truss and rafter). The building engineer is required to remove the corrosion and provide rust-proof coating on all steel members to protect from corrosion.

| 39 | Corrosion on steel section. (Building-14) | The building engineer is required to remove the corrosion and provide rust-proof coating on all steel members to protect from corrosion. | within 6 weeks |

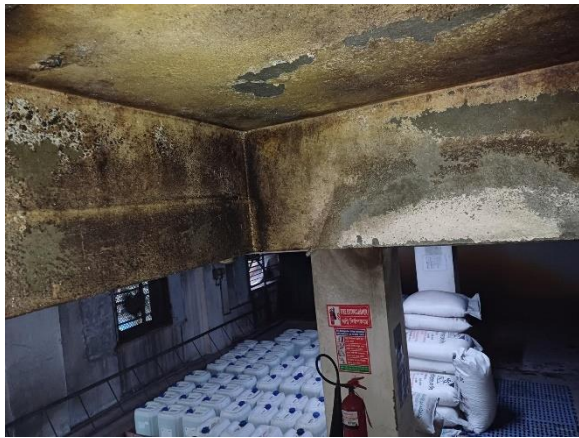
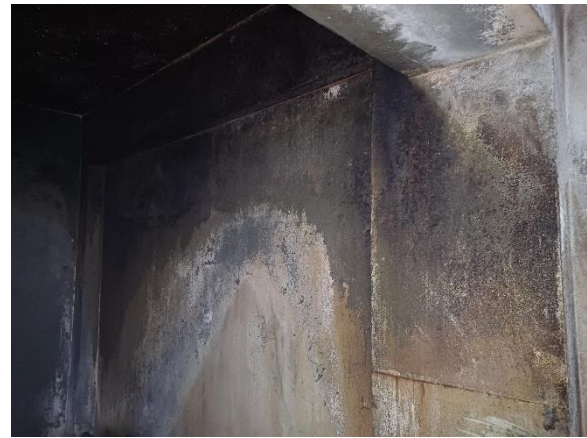
**Observation:** Dampness on 1<sup>st</sup> floor RC beam, column, slab and wall. (Building-14)

**Description:** Dampness was found on the RC beam, column, slab and wall of 1<sup>st</sup> floor at chemical storage area. The building engineer is required to find the source of dampness and take necessary remedial actions to repair the damp areas.

| 40 | Dampness on 1 <sup>st</sup> floor RC beam, column, slab and wall. (Building-14) | The building engineer is required to find the source of dampness and take necessary remedial actions to repair the damp areas. | within 6 months |

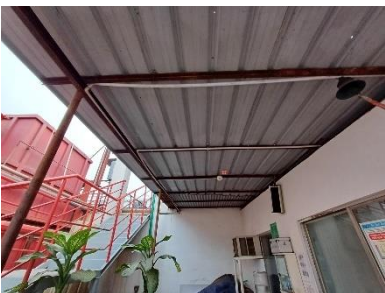
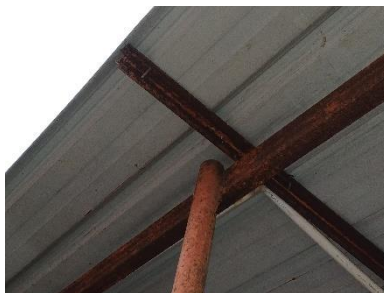
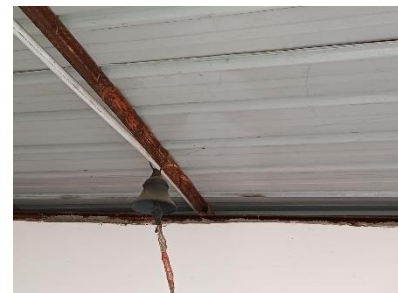
**Observation:** Apparently non-engineered roof shed of the ETP office and lab room. (Building-14)

**Description:** Apparently non-engineered steel roof was observed at the ETP office and lab room. Apparently inadequate members and poor connection between support and rafter. The building engineer is required to check the stability of the lightweight steel roof against uplift force.

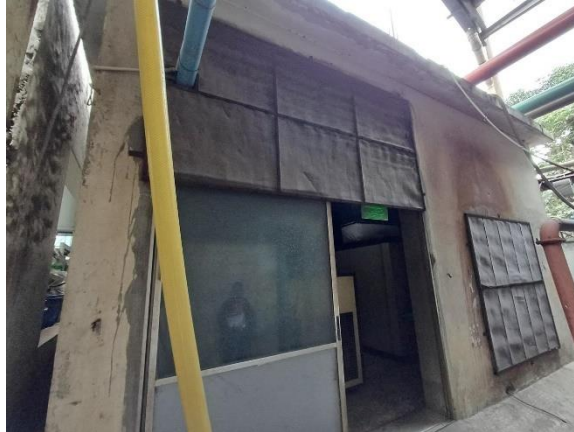
**Observation:** Lack of design report. (Building-7)

**Description:** As per BNBC, every building or structure designed shall have its design documents prepared following the provision of Section 1.9.1. The design document shall include a design report, a set of as-built drawings and load plans which shall be prepared in compliance with section 1.9.1.1 and section 1.9.1.2, part-6 of BNBC.

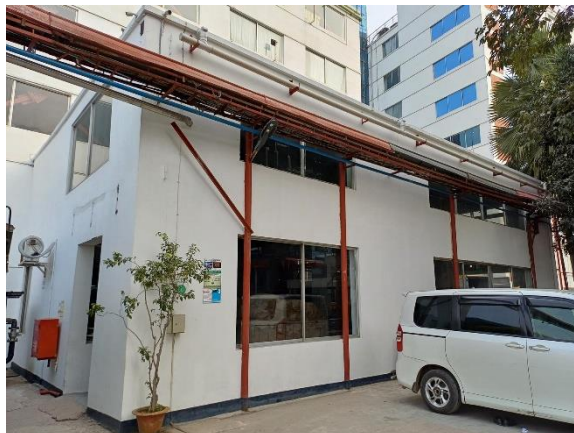
**Observation:** Lack of design report. (Building-24)

**Description:** As per BNBC, every building or structure designed shall have its design documents prepared in accordance with the provision of Section 1.9.1. The design document shall include a design report, a set of as-built drawings and load plans which shall be prepared in compliance with section 1.9.1.1 and section 1.9.1.2, part-6 of BNBC.

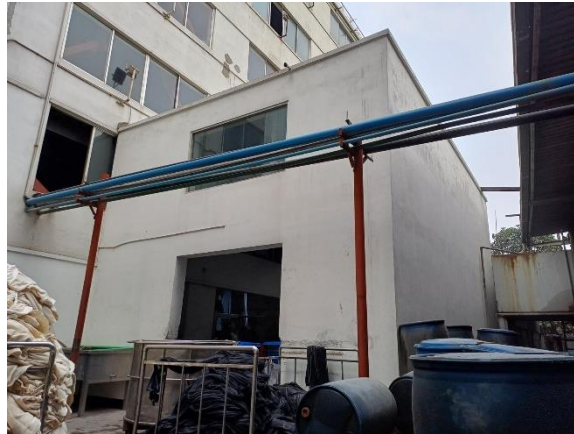
**Observation:** Lack of design report. (Building-21)

**Description:** As per BNBC, every building or structure designed shall have its design documents prepared following the provision of Section 1.9.1. The design document shall include a design report, a set of as-built drawings and load plans which shall be prepared in compliance with section 1.9.1.1 and section 1.9.1.2, part-6 of BNBC.

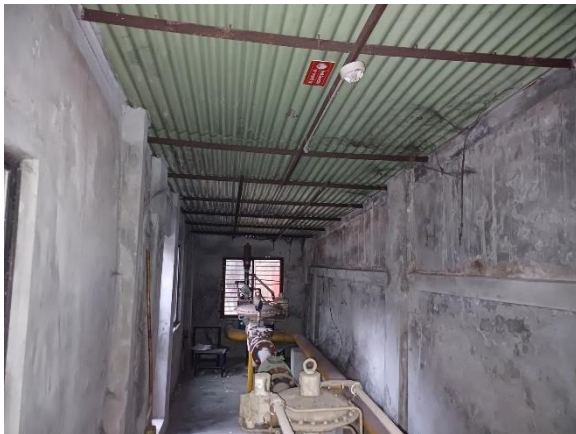
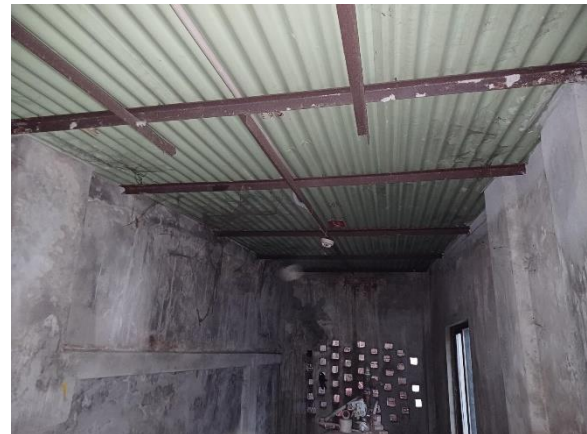
**Observation:** Apparently non-engineered roof shed. (Building-15)

**Description:** Apparently non-engineered lightweight steel roof shed. Apparently inadequate steel rafters and poor connection between support and rafters. Replace the non-engineered shed with a properly engineered structure.

| 49 | Apparently non-engineered roof shed. (Building-15) | Replace the non-engineered shed with a properly engineered structure. | within 6 months |
