# Cortz Apparels Ltd. (Extension)

19 December 2023

## Structural Inspection Report

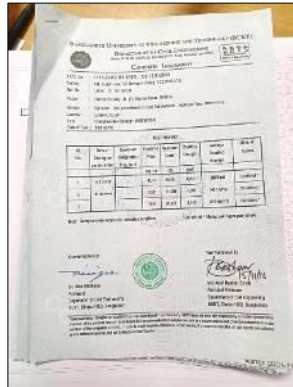
Cylinder test report

### Observation-1: Inadequate number of material test reports (Building-3)

**Description:** 15 sets of cylinder test reports were available for Hamza Clothing Ltd, where only 3 sets were from columns. The number of test reports for the column doesn't meet the frequency of testing requirements of BNBC. Also, the steel rebar test report was not available. The building engineer is required to verify the in-situ material strength of the column by taking the concrete core from the lower tier of the building.

| Item No. | Observation | Action Plan | Timeline |
|---|---|---|---|
| 1. | Inadequate number of material test reports (Building-3) | The building engineer is required to verify the in-situ material strength of the column by taking the concrete core from the lower tier of the building. | within 6 weeks |

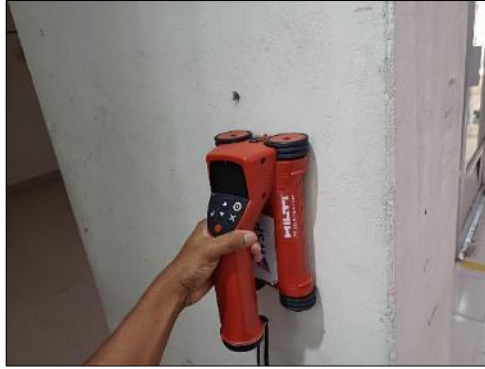
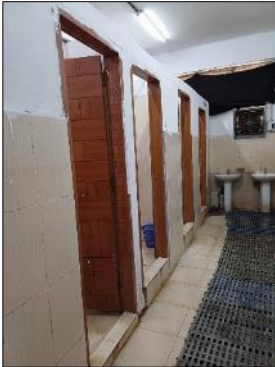
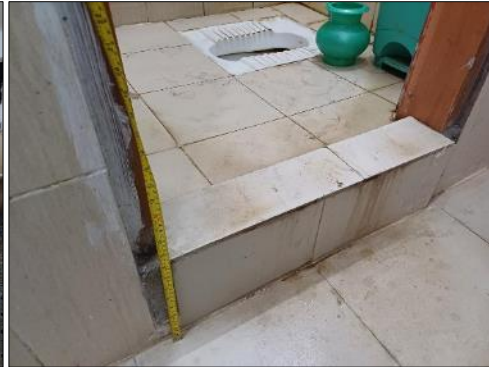
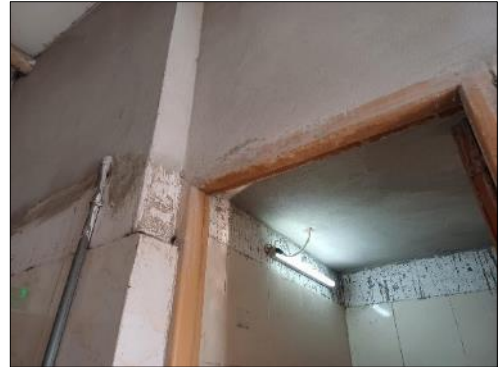
**Observation-3:** Mismatch between drawing and on-site condition. (Building-3)

**Description:** Mismatch rebar in rebar number in some columns (**Specific Columns**). Additional floor-built ups and false ceilings were found on toilet zones which were not shown in the drawings. The building engineer is required to scan the rebar of beams/columns, survey the structure and prepare accurate as-built drawings accordingly.

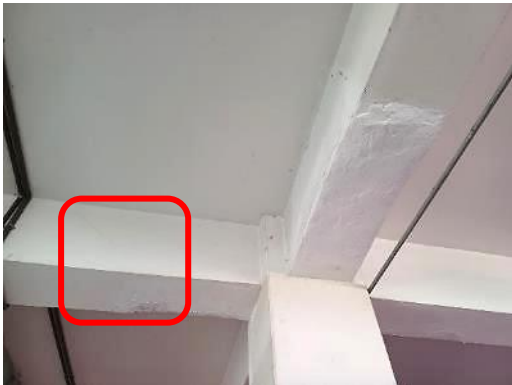
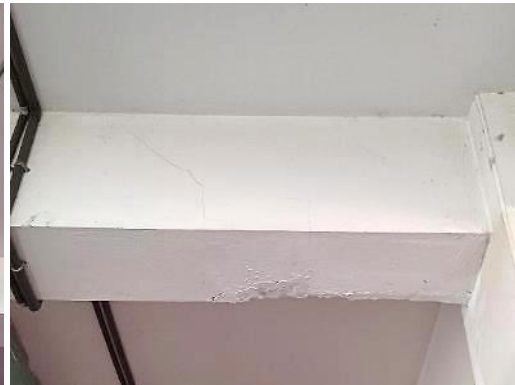
**Observation-4:** Hairline crack in floor beams at 3<sup>rd</sup> floor roof. (Building-3)

**Description:** Hairline cracks were found in the floor beam on the 3<sup>rd</sup> floor. The building engineer is required to check the extent and identify the reason for the crack in the beam and prepare a crack investigation report with proper remedial methodology.

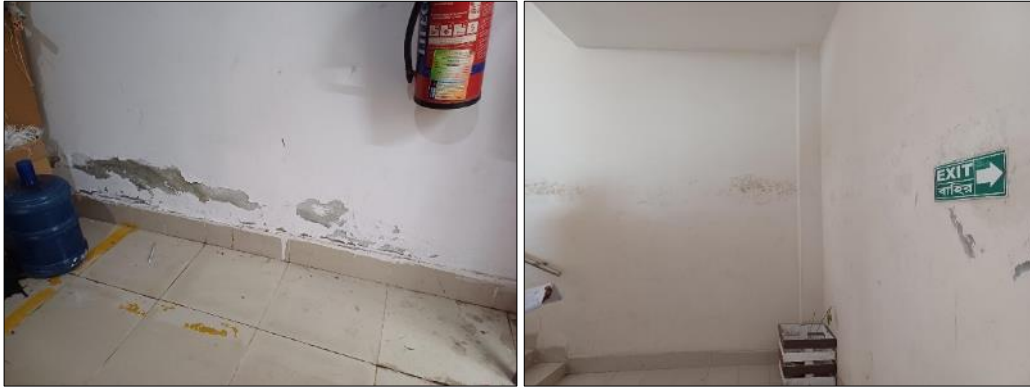
**Observation-5:** Dampness on a brick wall (Building-3)

**Description:** Dampness was observed on the brick wall of toilet zones. The factory is required to seal the source of water and repair the damp area with suitable methods.

| Item No. | Observation | Action Plan | Timeline |
|---|---|---|---|
| 6. | Dampness on a brick wall (Building-3) | The factory is required to seal the source of water and repair the damp area with suitable methods. | within 6 months |

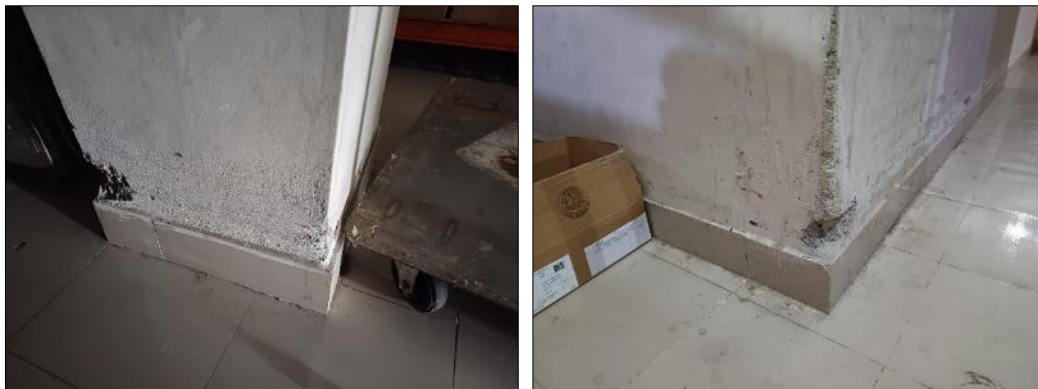
**Observation-6:** Damage on column & wall due to trolley impact (Building-3)

**Description:** Some damage was observed on the edge of the column & and wall due to trolley impact. The factory is required to repair the damage and provide edge protection to the susceptible columns & and walls.

| Item No. | Observation | Action Plan | Timeline |
|---|---|---|---|
| 7. | Damage on column & wall due to trolley impact (Building-3) | The factory is required to repair the damage and provide edge protection to the susceptible columns & walls. | within 6 months |

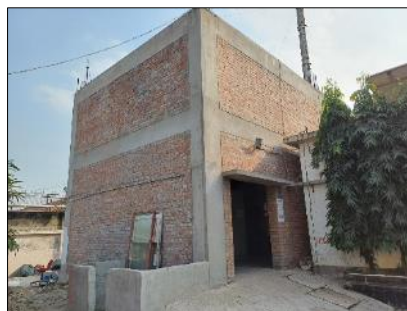
**Observation-7:** Lack of design documents (Boiler Building).

**Description:** As per BNBC, every structure should have design documents in compliance with section 1.9.1. Design documents consist of design reports, drawings, and software-based analysis. During inspection, no design report and as-built drawings were found on-site. The building engineer is required to prepare design documents based on in-situ material strength.

| Item No. | Observation | Action Plan | Timeline |
|---|---|---|---|
| 8. | Lack of design documents (Boiler Building). | The building engineer is required to prepare design documents based on in-situ material strength. Submit the document to the RSC for review. | within 6 weeks |

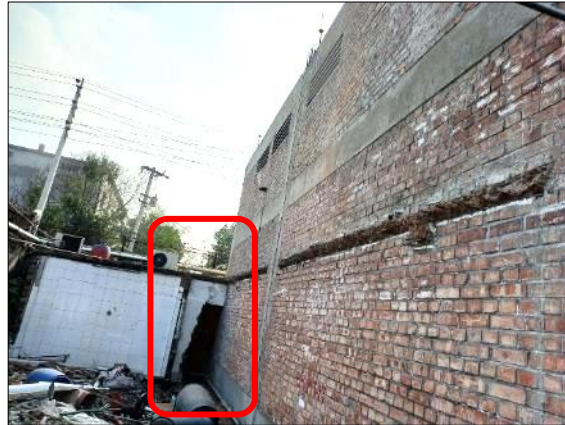
**Observation-8:** Structural Connection between ATM booth and Boiler Building

**Description:** An ATM booth building is structurally connected to the Boiler Building. The engineer is required to separate the structural connection between two connected buildings otherwise considered in the structural analysis & design.

| Item No. | Observation | Action Plan | Timeline |
|---|---|---|---|
| 10. | The structural connection between ATM booth and Boiler Building | The engineer is required to separate the structural connection between two connected buildings otherwise considered in the structural analysis & design. | within 6 months |

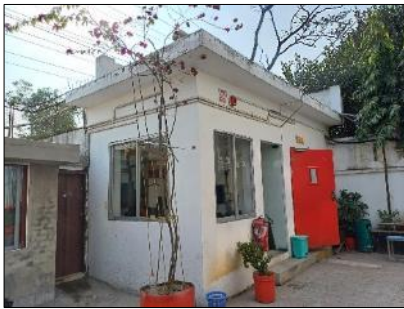
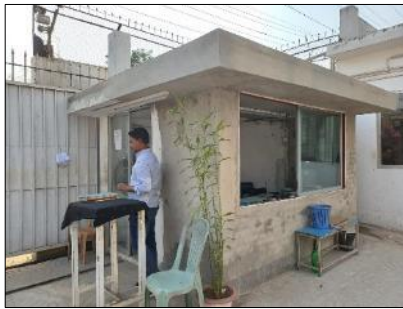
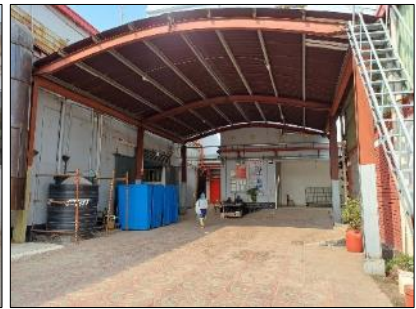
**Observation-9:** Mismatch between drawing and onsite condition for Fire Command Room, Guard Room & Steel Canopy

**Description:** A mismatch was found between the available floor layout and as-built conditions. The building engineer is required to survey the structures and prepare accurate as-built drawings accordingly.

| Item No. | Observation | Action Plan | Timeline |
|---|---|---|---|
| 11. | Mismatch between drawing and onsite condition for Fire Command Room, Guard Room & Steel Canopy | The building engineer is required to survey the structures and prepare accurate as-built drawings accordingly. | within 6 weeks |

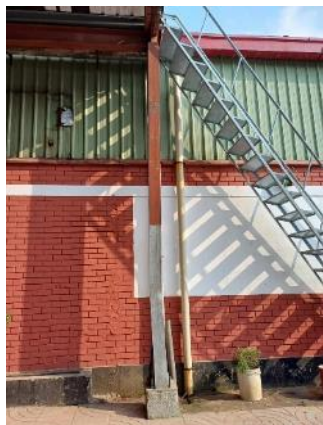
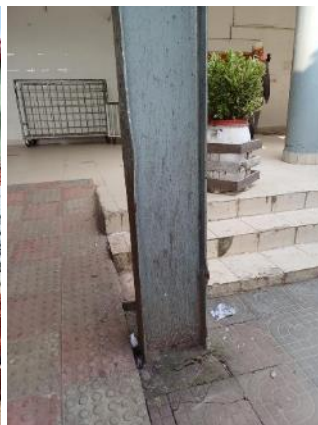
**Observation-10:** Damage due to vehicle impact on steel column (Steel Canopy)

**Description:** Distress in the steel column was found due to the impact of the vehicle. The building engineer is required to repair the distresses and provide barriers surrounding the susceptible columns.

| Item No. | Observation | Action Plan | Timeline |
|---|---|---|---|
| 12. | Damage due to vehicle impact on steel column (Steel Canopy) | The building engineer is required to repair the distresses and provide barriers surrounding the susceptible columns. | within 6 weeks |
