# Soorty Textiles (BD) Ltd. (Extension)

Plot # 12-14 & 21 Cumilla EPZ, Cumilla-3500.

30 November 2023

## Structural Inspection Report

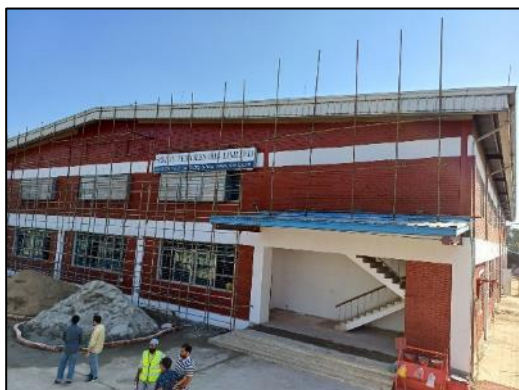
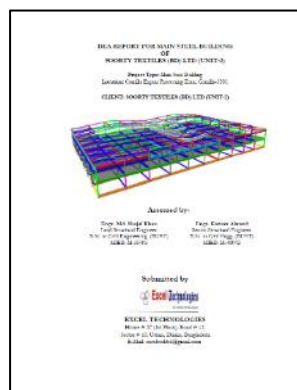
**Observation-1:** Detail review against lateral forces is required for the prepared design documents (design report, floor load plan, retrofitting scheme). (Building-1)

**Description:** A set of design documents was available onsite which are to be submitted to RSC for detailed review against lateral forces. Revise the design documents based on in-situ & retrofitting material strength. Submit to the RSC for review.

| Item No. | Observation | Action Plan | Timeline |
|---|---|---|---|
| 1. | Detail review against lateral forces is required for the prepared design documents (design report, floor load plan, retrofitting scheme). (Building-1) | The building engineer is required to revise the design report based on in-situ/retrofitting material strength & software-based analysis and submit the documents to RSC for review. | within 6 weeks |
| 2. | | Carry out suggested remedial works if required. | within 6 months |

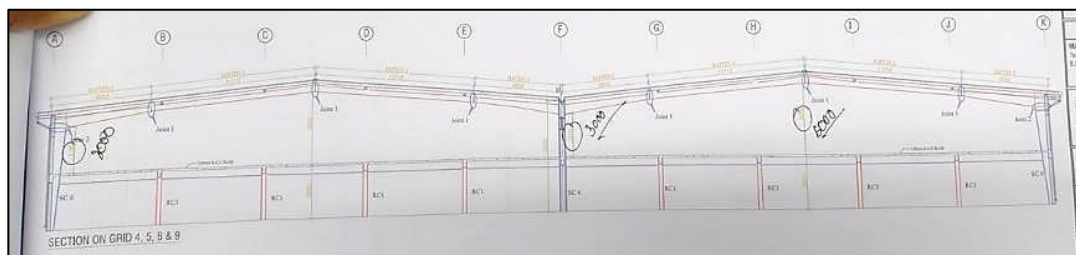
**Observation-2:** Mismatch between drawing & on-site condition. (Building-1)

**Description:** The clear height of the 1<sup>st</sup> floor was found 3 m instead of 3.1m; dissimilarity was found in ridge height. The RC extension portion was suggested demolished in the retrofitting drawing which was found to exist onsite. Also, most of the floor area was unoccupied, after occupancy the drawing needs to be updated accordingly.

| Item No. | Observation | Action Plan | Timeline |
|---|---|---|---|
| 3. | Mismatch between the drawing & on-site condition. (Building-1) | The building engineer is required to survey the full structure and produce accurate as-built drawings. | within 6 weeks |

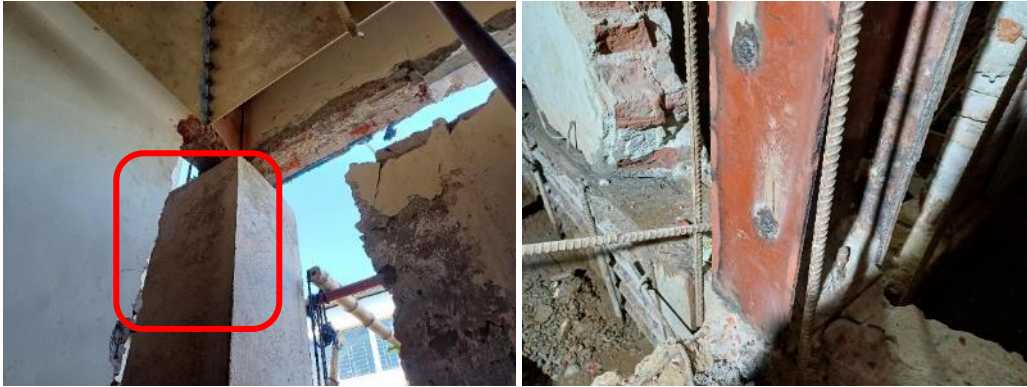
**Observation-3:** Lack of material strength for retrofitting members (concrete & steel). (Building-1)

**Description:** Retrofitting was found in progress. Retrofitting material test report was not found on-site.

| Item No. | Observation | Action Plan | Timeline |
|---|---|---|---|
| 4. | Lack of material strength for retrofitting members (concrete & steel). (Building-1) | The building engineer is required to test the retrofitting material and check with design strength. | within 6 weeks |

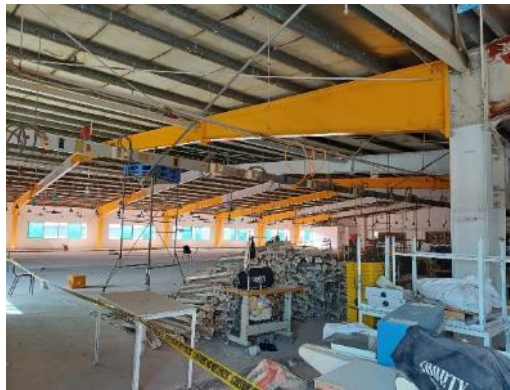
**Observation-4:** Lack of floor load management program (posting load plan, marking area & height, and maintaining floor loading) (Building-1)

**Description:** The load plan was not posted on the suspended floor.

| Item No. | Observation | Action Plan | Timeline |
|---|---|---|---|
| 5. | Lack of floor load management program (posting load plan, marking area & height, and maintaining floor loading) (Building-1) | Implement floor load management program. | within 6 months |

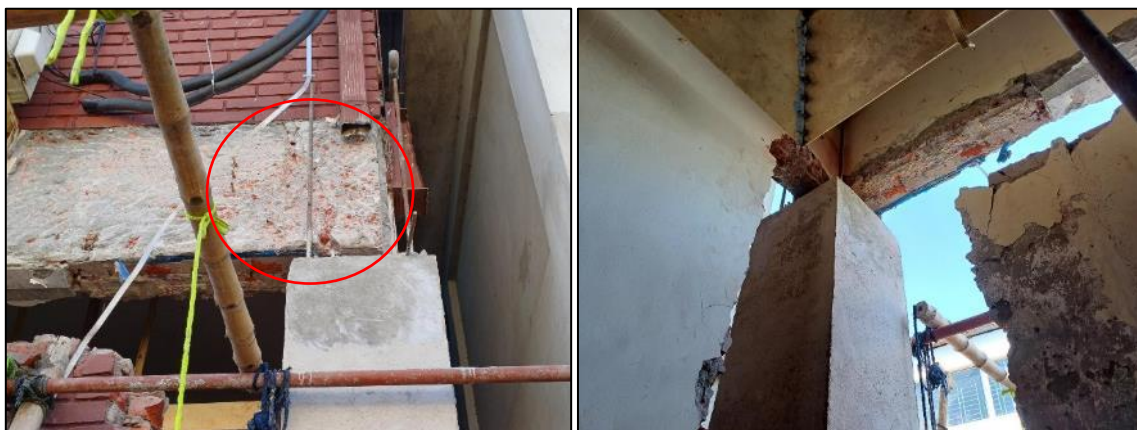
**Observation-5:** Crack in existing beam (Building-1)

**Description:** Crack was found under retrofitting in the existing beam at the North-East corner. The building engineer is required to check the crack and repair it along with retrofitting work.

| Item No. | Observation | Action Plan | Timeline |
|---|---|---|---|
| 6. | Crack in existing beam (Building-1) | The building engineer is required to check the crack and repair it along with retrofitting work. | within 6 weeks |

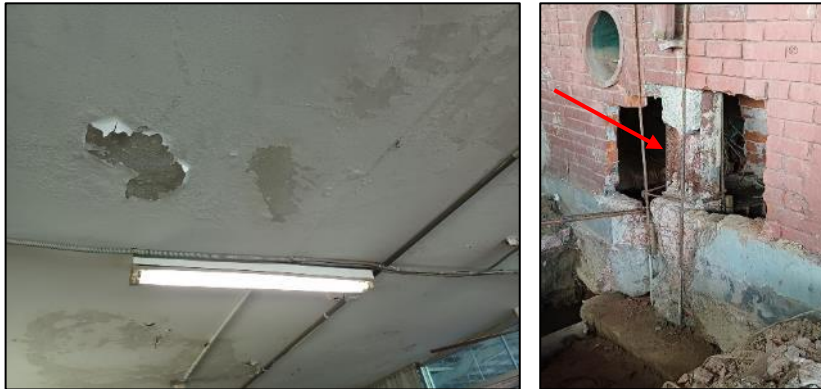
**Observation-6:** Lack of maintenance works (including dampness & corrosion) (Building-1)

**Description:** Dampness was observed in the slab of the RC extension part and corrosion was observed in the steel columns. The factory is required to repair the damp and corroded areas with the proper method.

| Item No. | Observation | Action Plan | Timeline |
|---|---|---|---|
| 7. | Lack of maintenance works (including dampness & corrosion) (Building-1) | The building engineer is required to seal the source of water and repair the damp and corroded areas with suitable methods. | within 6 weeks |

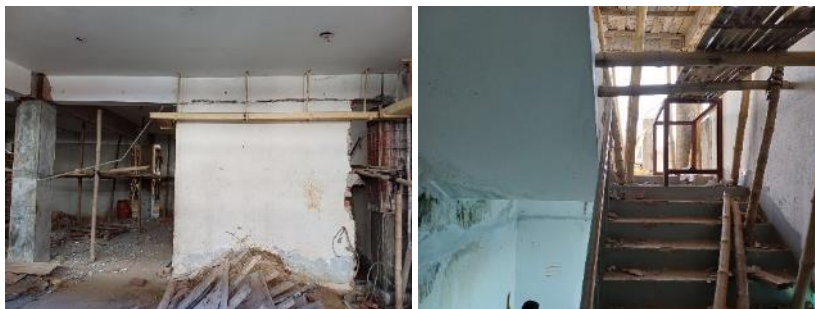
**Observation-7:** Construction safety practice (Building-1,2&3).

**Description:** Retrofitting was found in progress. A lack of PPE was found during the retrofitting/construction works. The factory must follow the proper safety practices as per BNBC.

| Item No. | Observation | Action Plan | Timeline |
|---|---|---|---|
| 8. | Lack of construction safety practice (Building-1,2&3). | The building engineer is required to ensure standard construction safety practices as per BNBC requirements. | within 6 weeks |

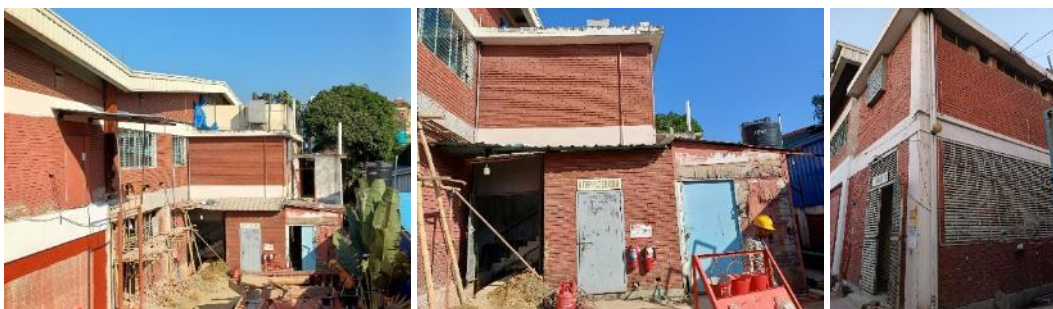
**Observation-8:** Extension next to Building-1 not included in the design report.

**Description:** As per the prepared design report & retrofitting scheme, the RC extension needs to be demolished, which has not been done yet. The factory is required to demolish the RC extensions following proper safety measures.

| Item No. | Observation | Action Plan | Timeline |
|---|---|---|---|
| 9. | The extension next to Building 1 is not included in the design report. | The building engineer is to prepare the design document & carry out necessary remedial works for the extension, otherwise demolish it. | within 6 weeks |

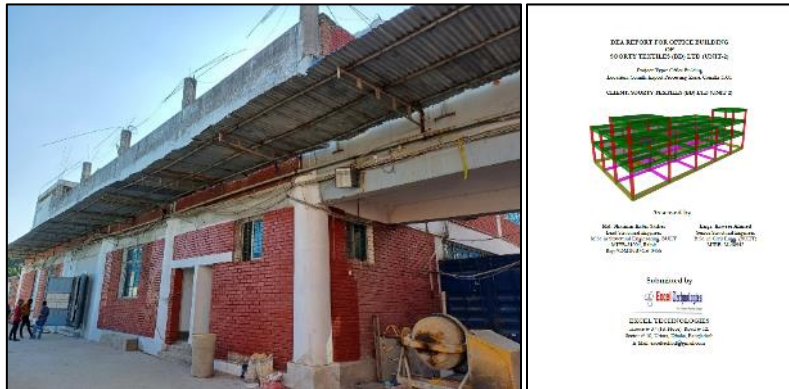
**Observation-9:** Detail review against lateral forces is required for the prepared design documents (design report, floor load plan, retrofitting scheme). (Building-2)

**Description:** A set of design documents was available onsite to be submitted to RSC for detailed review against lateral forces. Revise the design documents based on in-situ & retrofitting material strength. Submit to the RSC for review.

| Item No. | Observation | Action Plan | Timeline |
|---|---|---|---|
| 10. | Detail review against lateral forces is required for the prepared design documents (design report, floor load plan, retrofitting scheme). (Building-2) | The building engineer is required to revise the design report based on in-situ/retrofitting material strength & software-based analysis and submit the documents to RSC for review. | within 6 weeks |
| 11. | | Carry out suggested remedial works if required. | within 6 months |

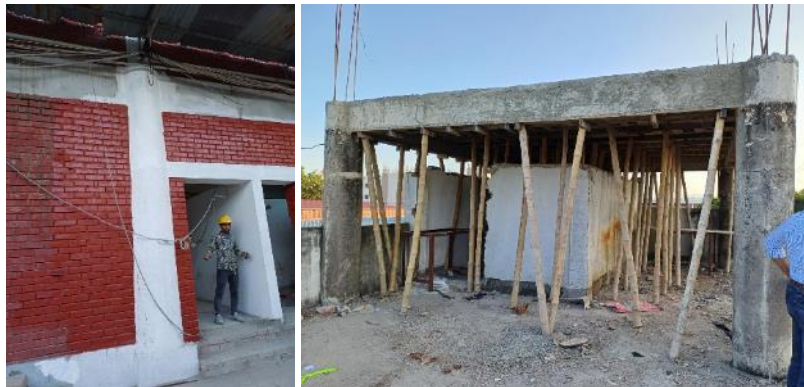
**Observation-10:** Material strength for retrofitting and newly constructed member. (Building-2)

**Description:** New construction was found in progress. Retrofitting and new construction material test reports were not found on-site.

| 12. | Lack of material strength for retrofitting members (concrete & steel). (Building-2) | The building engineer is required to test the retrofitting material and confirm with design strength. | within 6 weeks |

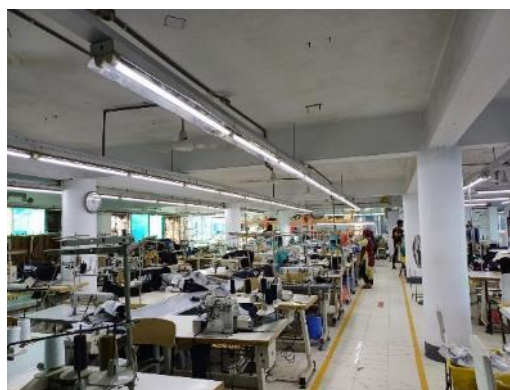
**Observation-11:** Load management (including posting load plan, marking area & height, and maintaining floor loading) (Building-2)

**Description:** The load plan was not posted on the suspended floor.

| 13. | Lack of floor load management program (posting load plan, marking area & height, and maintaining floor loading) (Building-2) | Implement floor load management program. | within 6 months |

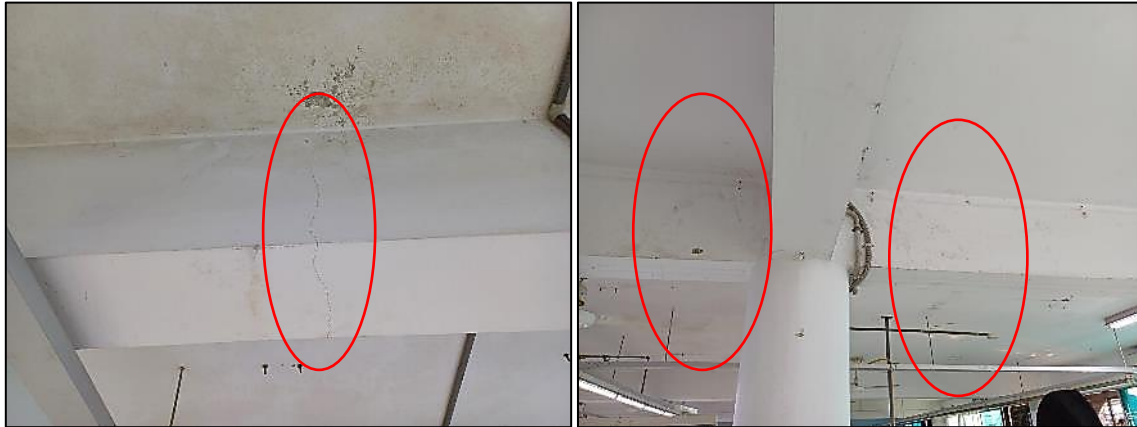
**Observation-12: Hairline crack in existing beam (Building-2)**

**Description:** Hairline cracks were found roof level beam at several locations. The building engineer is required to identify the reason for the crack and prepare an investigation report with the necessary repair method. Repair the crack as per the crack investigation report.

| 14. | Hairline crack in existing beam (Building-2) | The building engineer is required to identify the reason for the crack and prepare an investigation report with the necessary repair method. Repair the crack as per the crack investigation report. | within 6 weeks |

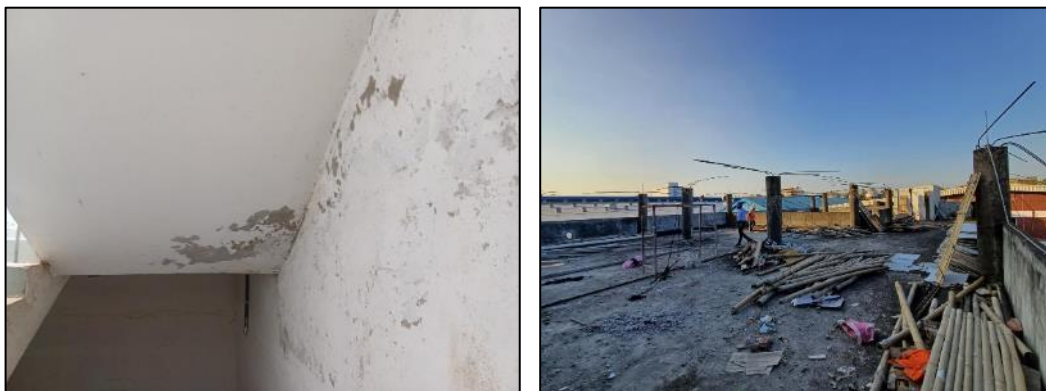
**Observation-13: Dampness on brick walls (Building-2)**

**Description:** Dampness observed on brick walls. The factory is required to repair the damp area with proper methods.

| 15. | Dampness on brick walls (Building-2) | The building engineer is required to seal the source of water and repair the damped areas with suitable methods. | within 6 weeks |

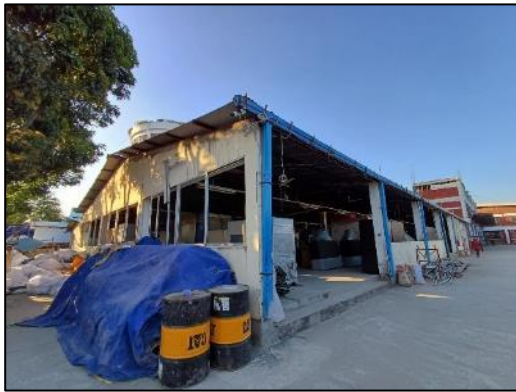
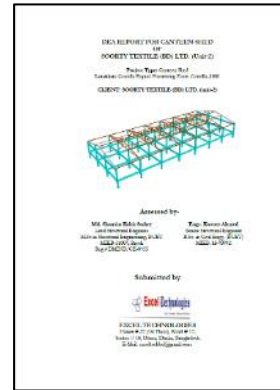
**Observation-15:** Detail review against lateral forces is required for the prepared design documents (design report, & retrofitting scheme). (Building-3)

**Description:** A set of design documents was available onsite which are to be submitted to RSC for detailed review against lateral forces. Revise the design documents based on in-situ & retrofitting material strength. Submit to the RSC for review.

| 17. | Detail review against lateral forces is required for the prepared design documents (design report, floor load plan, retrofitting scheme). (Building-3) | The building engineer is required to revise the design report based on in-situ/retrofitting material strength & software-based analysis and submit the documents to RSC for review. | within 6 weeks |
| 18. | | Carry out suggested remedial works if required. | within 6 months |

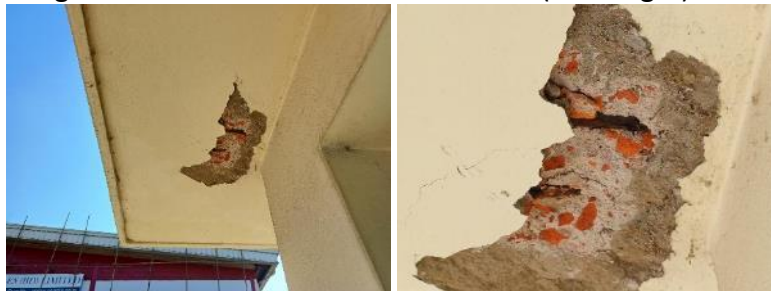
**Observation 17:** Spalling of concrete due to rebar corrosion. (Building-5)

**Description:** Spalling of concrete due to rebar corrosion. The building engineer to remove the corrosion of the rebar and repair it with a suitable method.

| 20. | Spalling of concrete due to rebar corrosion. (Building-5) | The building engineer to remove the corrosion of the rebar and repair it with a suitable method. | within 6 weeks |

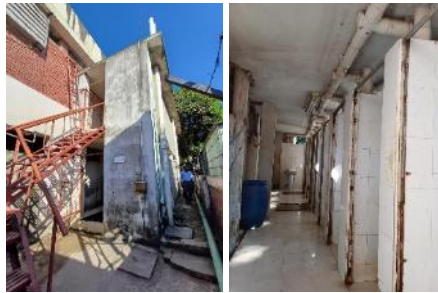
**Observation-18:** Undocumented toilet block. (Toilet Block)

**Description:** Undocumented two-storied toilet block with steel stair observed beside Building-1.

| 21. | Undocumented toilet block (Toilet Block). | The building engineer is to prepare a design document & carry out necessary remedial works for the undocumented toilet block & adjacent steel stair, otherwise demolish it. | within 6 months |
