Kadena Sportswear Limited (Extension)

Standard Factory Building no. 5 & Plot no. 113-121, Comilla EPZ, Comilla

6 & 31 December 2023

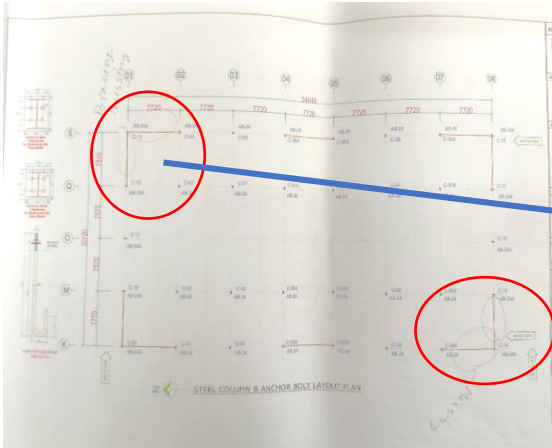
Bracing layout

Observation-01: Mismatch in as-built drawing. (Production Shed-1)

Description: Some bracings were found missing as per bracing layout. Connection details were not available in the provided drawings. Also, no structural details were found for steel stair.

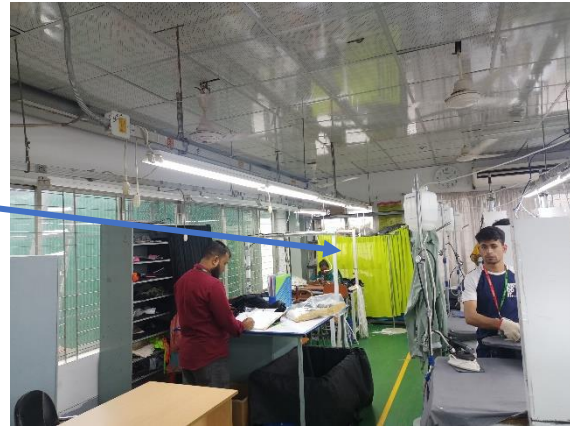
Bracing missing

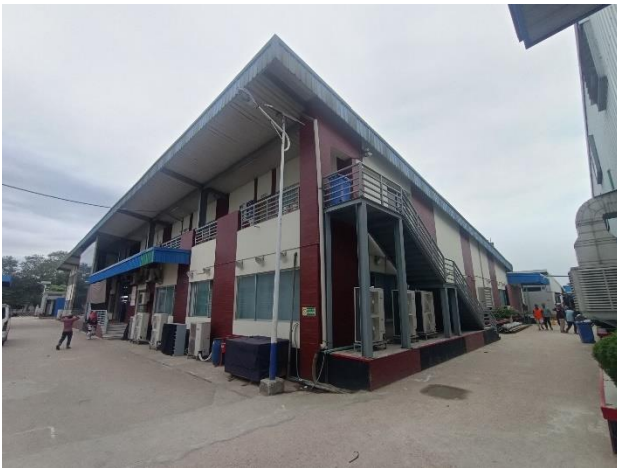
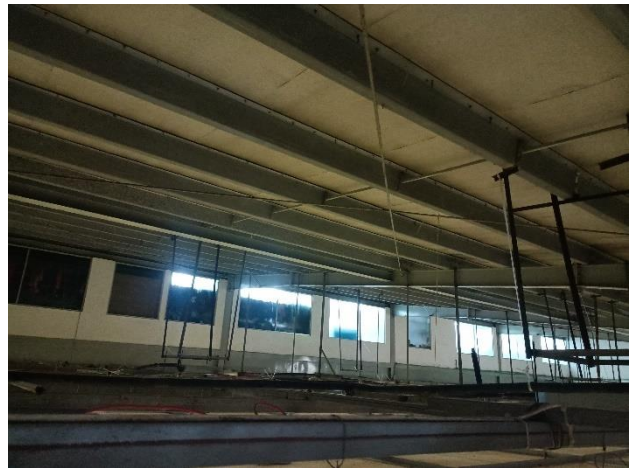
Observation-02: Absence of design documents. (Production Shed-1)

Description: As per BNBC, every building or structure designed shall have its design documents prepared in accordance with the provision of Section 1.9.1. The design document shall include a design report, and a set of structural drawings, which shall be prepared in compliance with section 1.9.1.1 and section 1.9.1.2 as per BNBC. At the time of inspection, a design report was not available which is required to be prepared in compliance with BNBC 2006.

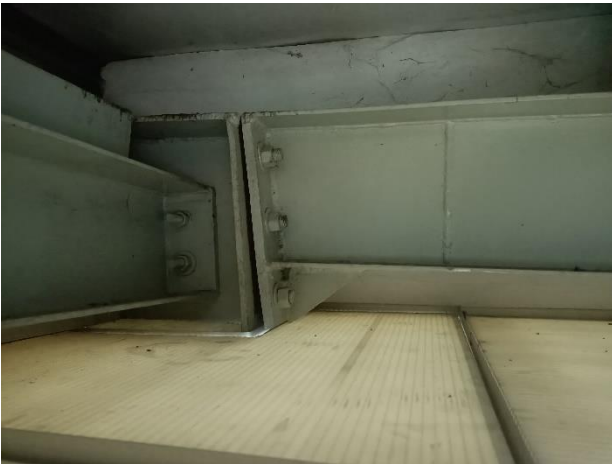
Connection gap

Description: Significant gaps were observed in Rafter-column joint. Also, cable bracings were connected without hillside washer and nuts. Building engineer is required to carry out suitable remedial works for the gap and bracing connection.

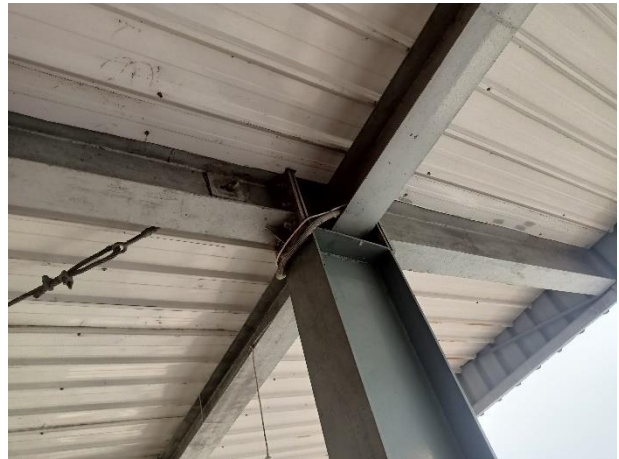
Improper bracing connection

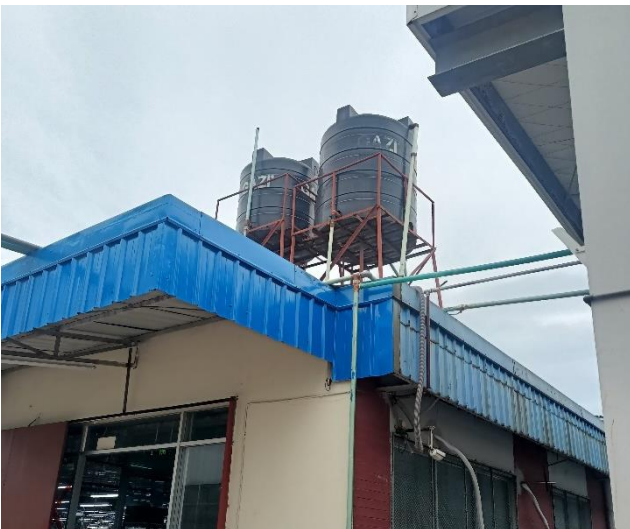
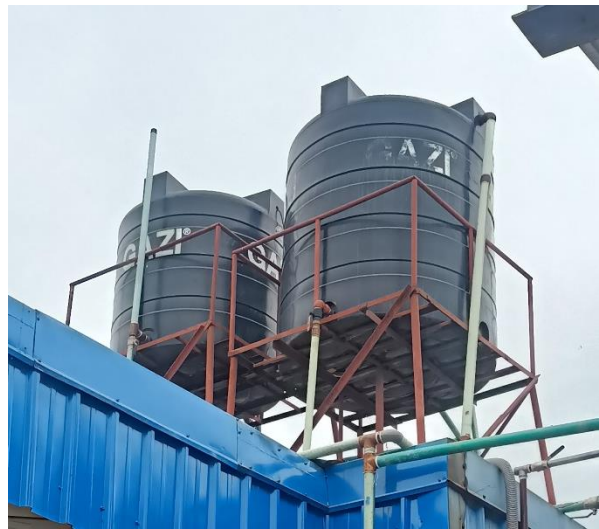
Observation-04: Apparently inadequate platform for plastic water tank. (Production Shed-1)

Plastic water tank on roof

Description: Apparently inadequate platform was found for plastic water tank. The building engineer is required to check the member adequacy of the structure and suggest suitable remedial works.

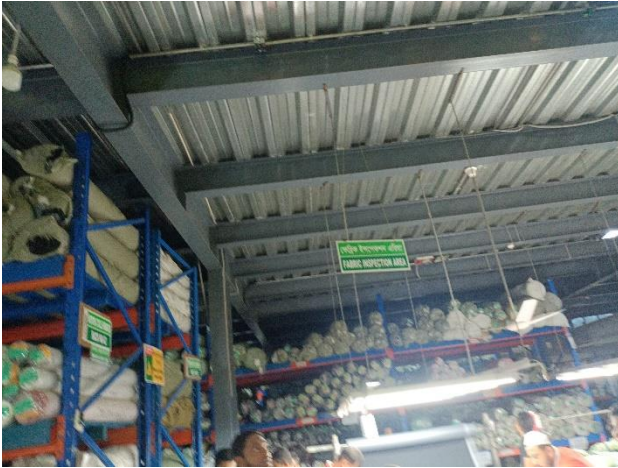
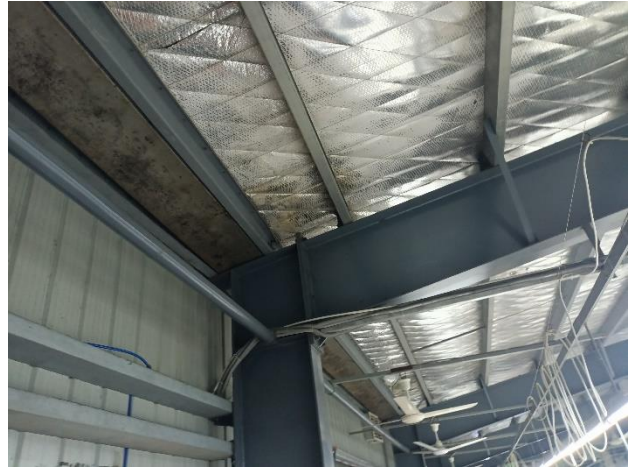
Observation-05: Lack of information in the drawings. (Warehouse and Cutting Shed)

Beam-column of mezzanine

Description: Full set of as-built drawings were not available. Beam layout for mezzanine, bracings, compression strut and connection details were not found in the provided as-built drawings. The building engineer is required to survey the structure and prepare a full set of as-built drawings in compliance with BNBC.

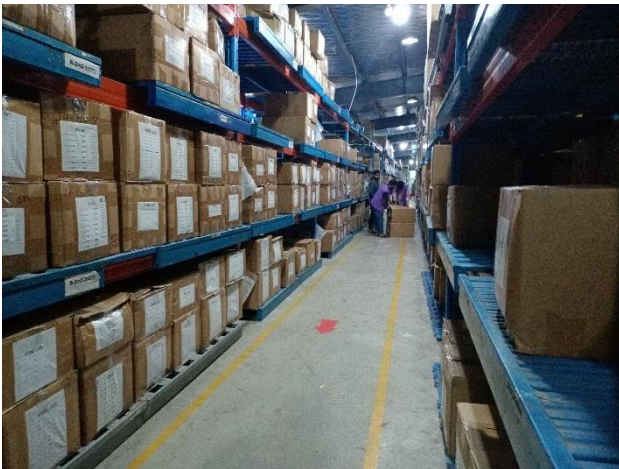
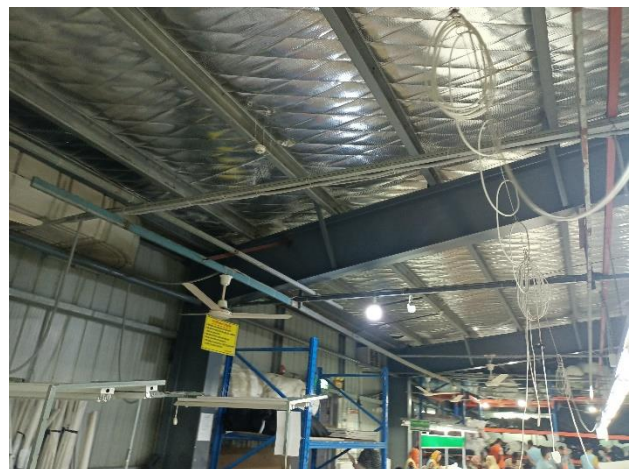
Observation-06: Overloading and absence of design documents. (Warehouse and Cutting Shed)

Loading

Description: As per BNBC, every building or structure designed shall have its design documents prepared in accordance with the provision of Section 1.9.1. The design document shall include a design report, and a set of structural drawings, which shall be prepared in compliance with section 1.9.1.1 and section 1.9.1.2 as per BNBC. At the time of inspection, a design report was not available which is required to be prepared in compliance with BNBC 2006.

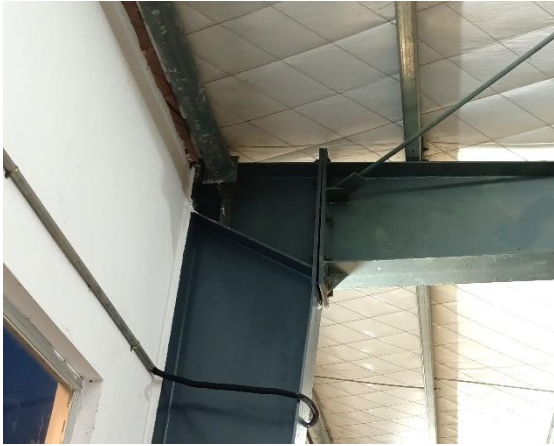
Connection gap

Description: Significant gaps and bolt missing were observed at several joints. Building engineer is required to carry out suitable remedial works for the gap and install the missing bolts.

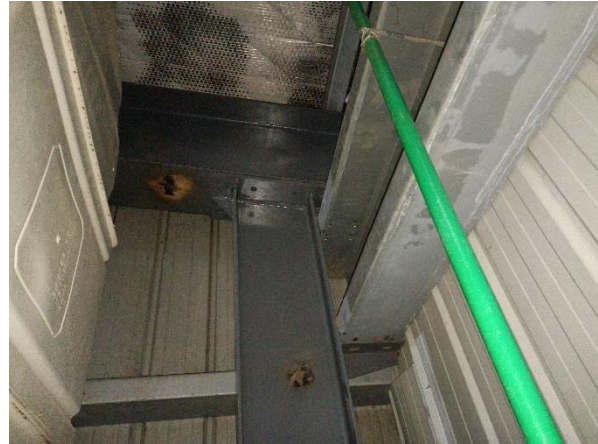
Bolt missing

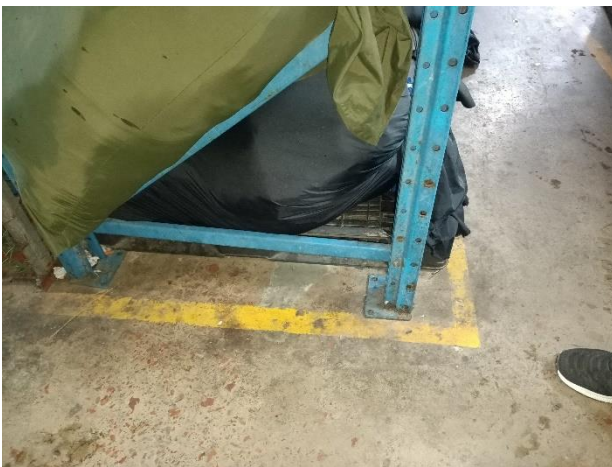
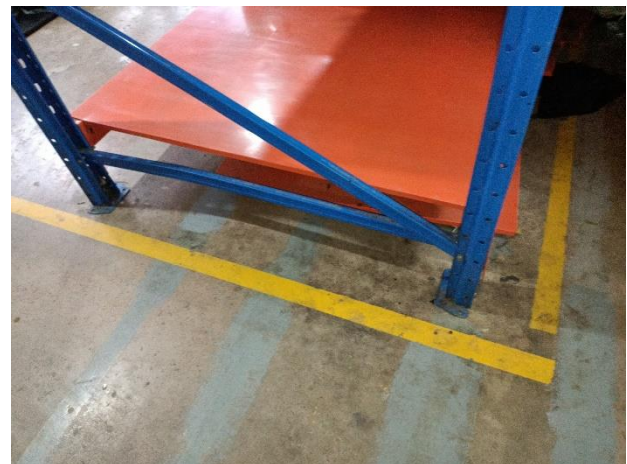
Unbraced racks

Description: Some racks on floors are not anchored or braced to resist lateral (earthquake) forces. The factory is required to anchor/brace all non-structural elements adequately to resist earthquake forces.

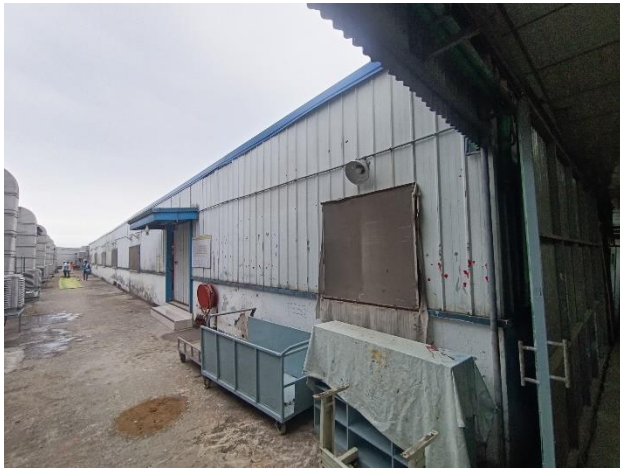
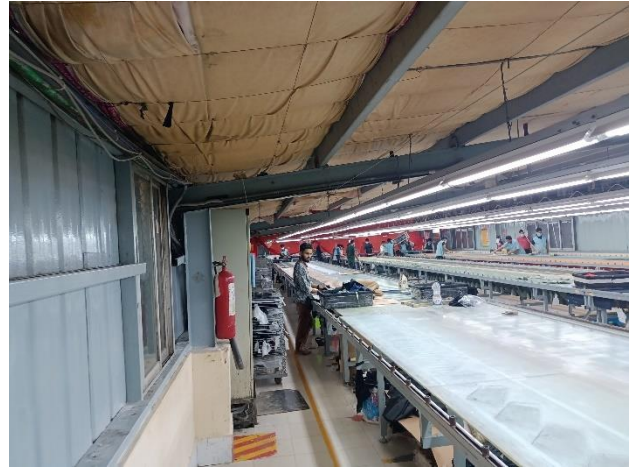
Observation-09: Lack of drawings for steel portion. (Printing Shed)

Description: As-built structural drawings were not found for the steel portion the shed. The building engineer is required to survey the structure and prepare a full set of as-built drawings for steel part.

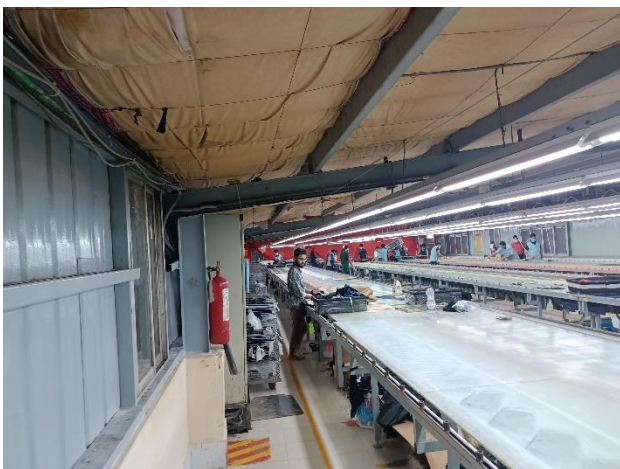
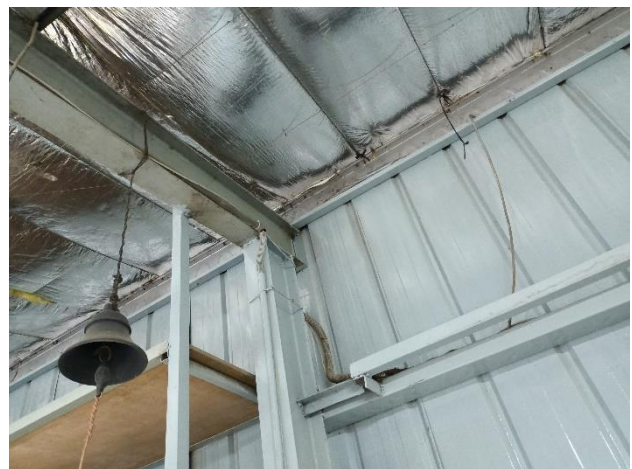
No load transfer media is provided along long direction

Description: Load transfer media is not provided along long direction for this shed. Therefore, lateral stability system of the shed is apparently incomplete. Building engineer is required to check the lateral stability of the structure.

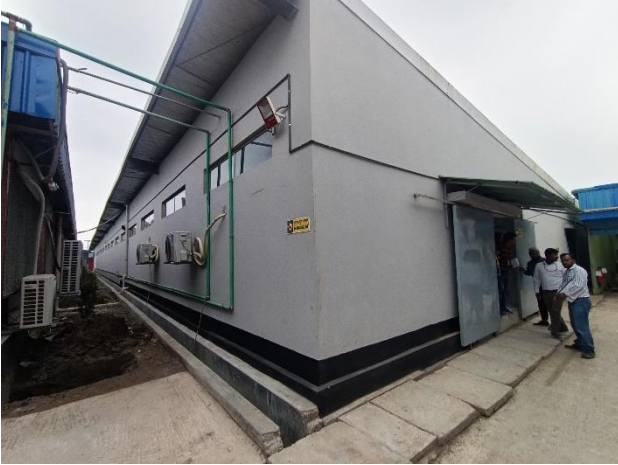
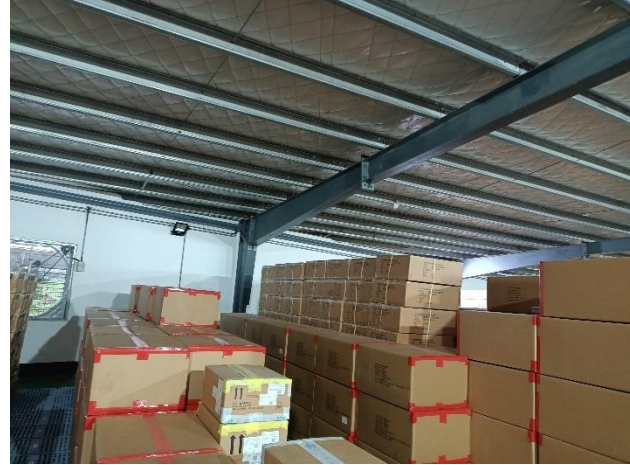
Observation-11: Lack of drawings for steel portion. (116 Finished Goods Shed)

Description: As-built structural and architectural drawings were not found for the steel portion the shed. The building engineer is required to survey the structure and prepare a full set of as-built drawings for steel part.

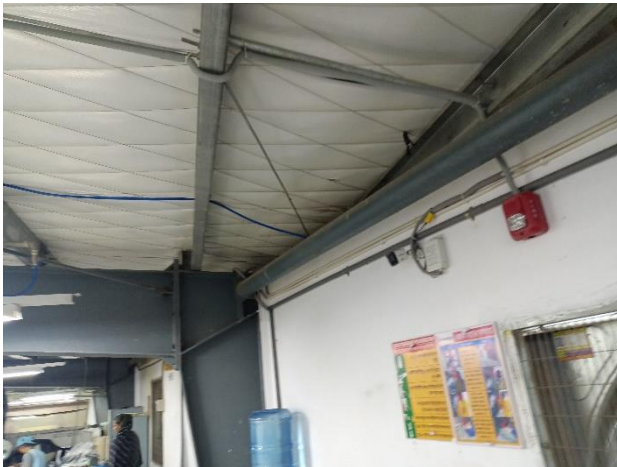
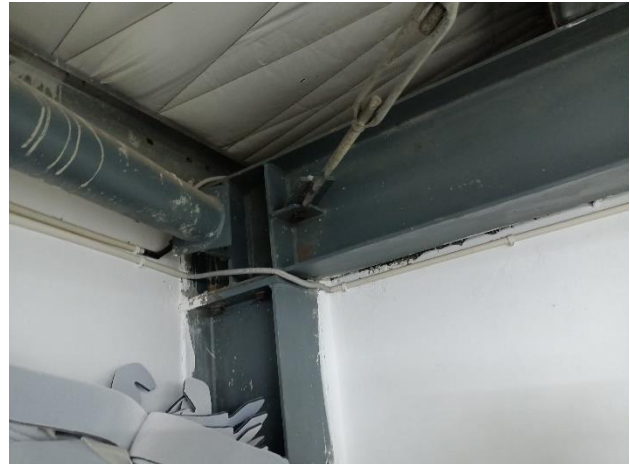
Observation-12: Absence of design report. (116 Finished Goods Shed)

Description: As per BNBC, every building or structure designed shall have its design documents prepared in accordance with the provision of Section 1.9.1. The design document shall include a design report, and a set of structural drawings, which shall be prepared in compliance with section 1.9.1.1 and section 1.9.1.2 as per BNBC. At the time of inspection, a design report was not available which is required to be prepared in compliance with BNBC 2006.

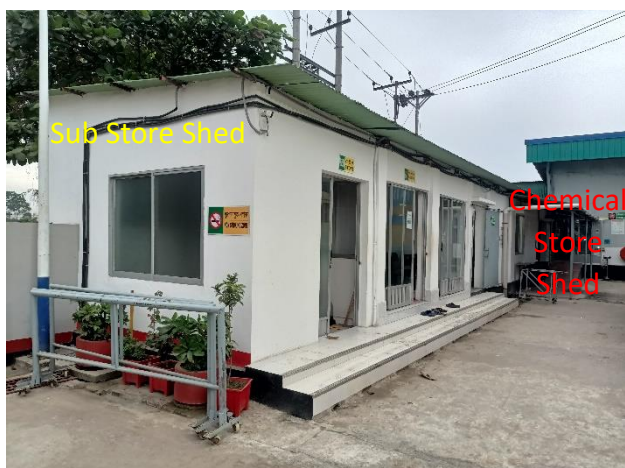
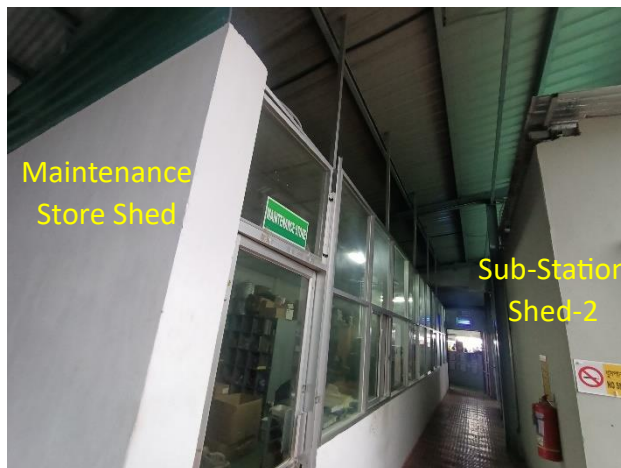
Observation-13: Lack of drawing. (Chemical Store Shed, Sub Store Shed, Maintenance Store Shed, Sub-Station Shed-2)

Description: As-built structural and architectural drawings were not found for these sheds. The building engineer is required to survey the structure and prepare a full set of as-built drawings.

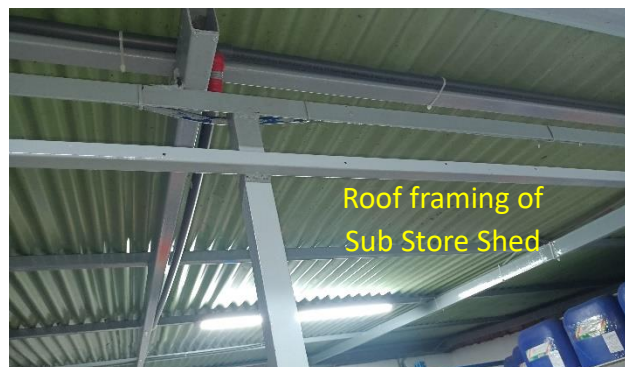
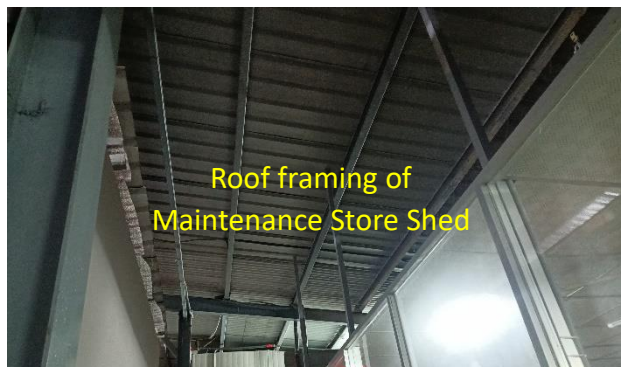
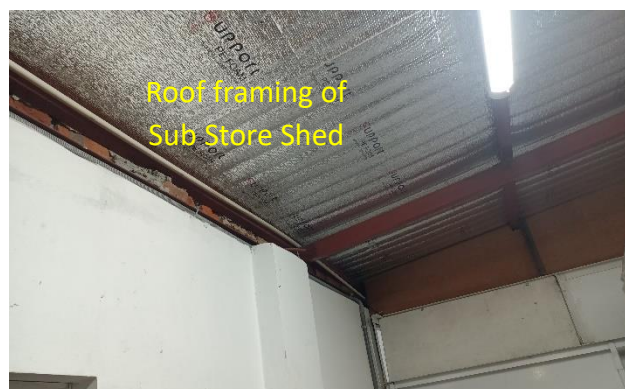
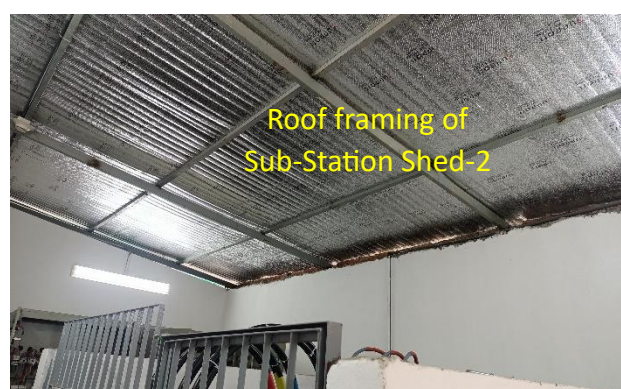
Observation-14: Apparently non-engineered connection. (Chemical Store Shed, Sub Store Shed, Maintenance Store Shed, Sub-Station Shed-2)

Description: Apparently inadequate connections were observed on the lightweight roof of the single storied Sheds. The building engineer is required to check the connection adequacy of the lightweight roof against the uplift pressure of wind.

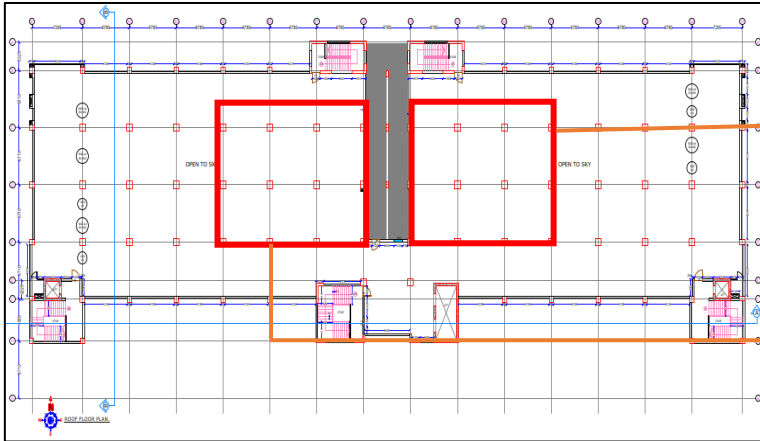
Roof Layout

Observation-15: Discrepancy in as-built drawing. (MS SFB-2)

Undocumented Roof Shed

Description: During inspection, two steel sheds were found on roof of MS SFB-2 building. But in as-built drawing no roof structure was mentioned.

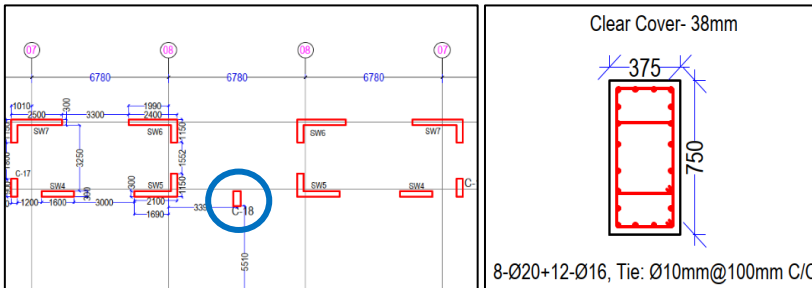
Column Layout & Rebar Details

Description: During inspection, 16 nos. rebar of column C-18 at ramp area in 5th floor were found instead of 20 nos. rebar.

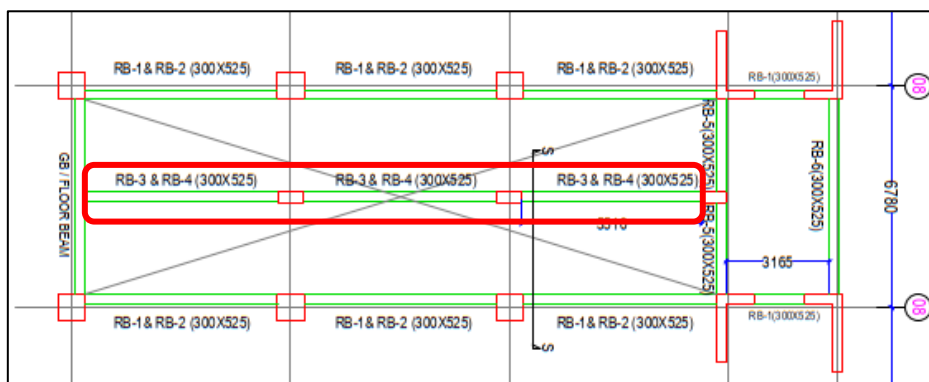
Ramp Beam Layout

Description: During inspection, ramp beam (RB-3 & RB-4) size was found 300X365 instead of 300X525 considering slab thickness 165 mm. The building engineer is required to update the as-built drawing as per actual site condition.

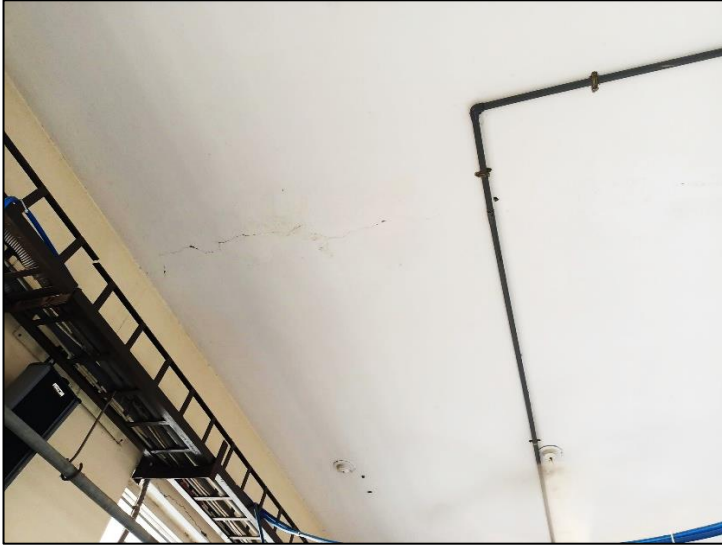
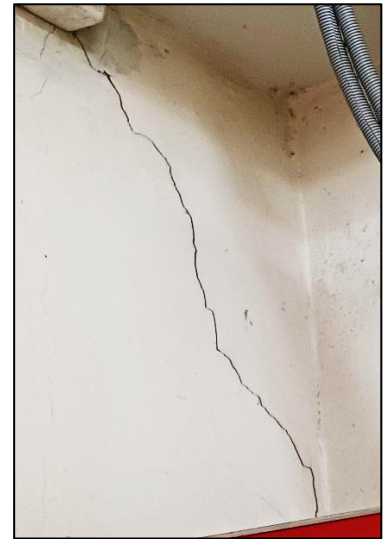
Observation-16: Cracks on slab & brick wall. (MS SFB-2)

Description: During inspection, some cracks were found on brick wall & slab soffit. The building engineer is required to investigate the reason of cracks and carry out remedial works as per investigation report.

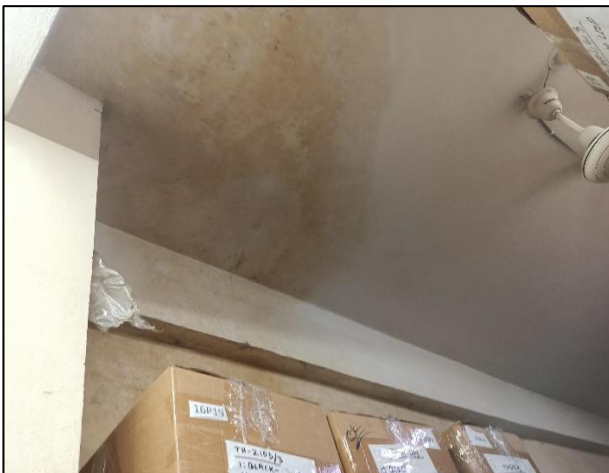
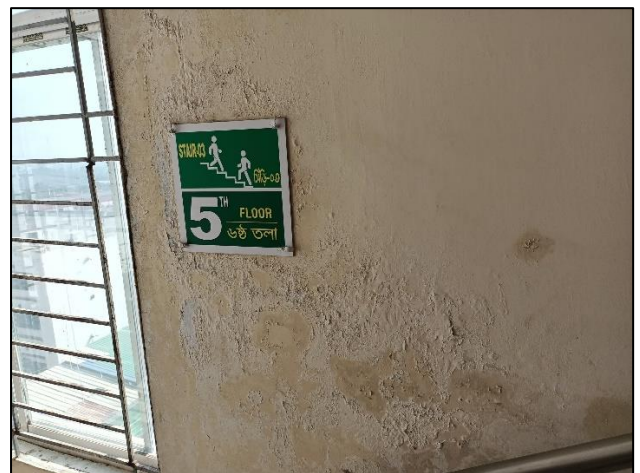
Observation-17: Dampness on brick wall. (MS SFB-2)

Description: During the inspection, dampness was found on brick wall. The building engineer is required to investigate the reason of dampness & repair with suitable method.

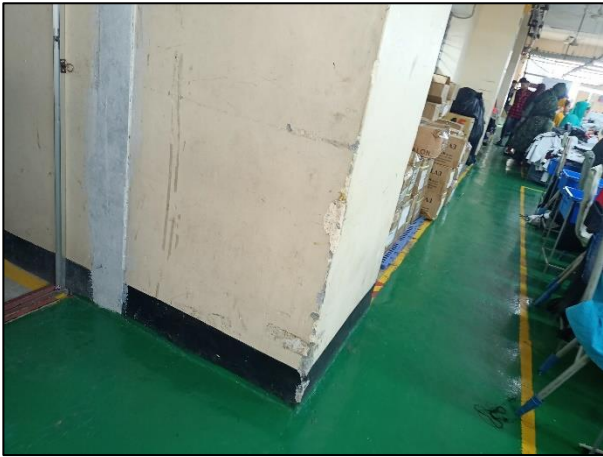
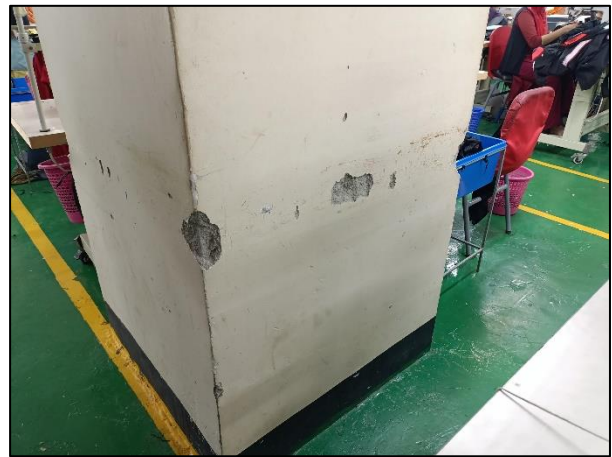
Observation-18: Column susceptible to trolley impact. (MS SFB-2)

Description of observation: During inspection, some column of MS SFB-2 building had the sign of trolley impact. The building engineer is required to provide barriers around the column to avoid trolley impact.

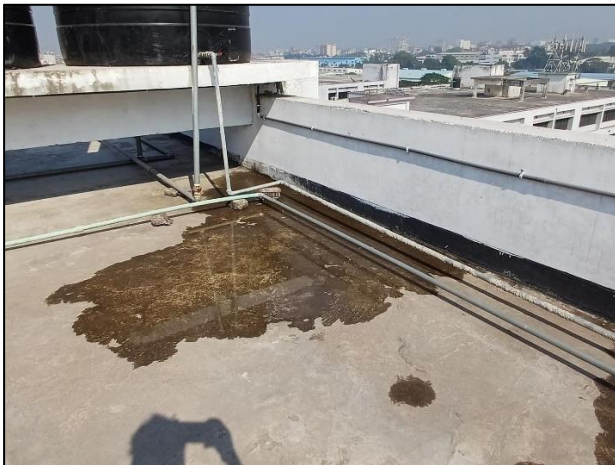
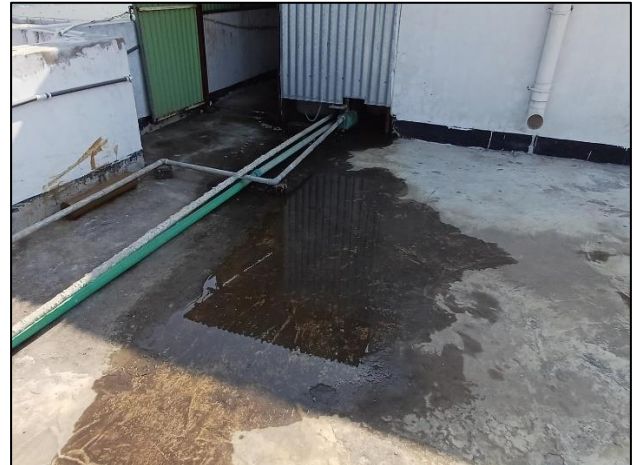
Observation-19: Water ponding on roof. (MS SFB-2)

Description: During inspection, water ponding was found on the roof of MS SFB-2 building. The building engineer is required to develop the drainage system on the roof.

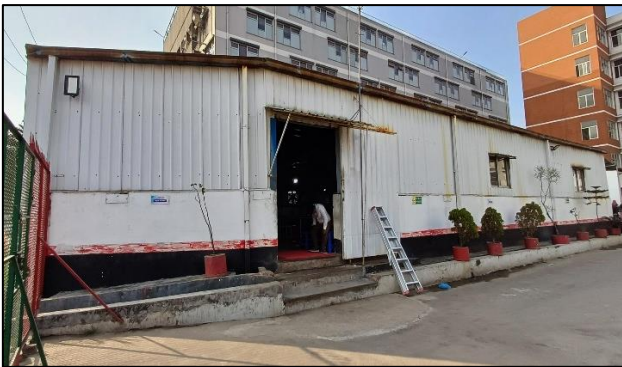
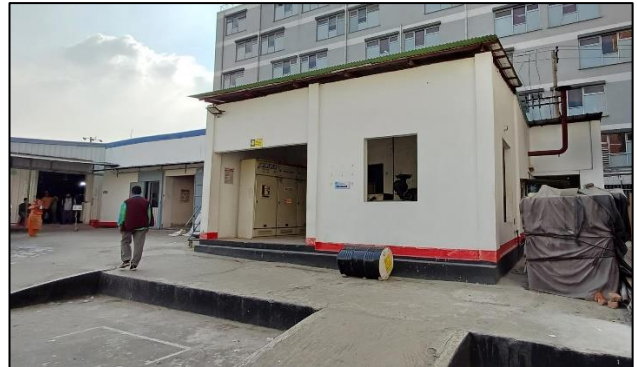
Observation-20: Absence of design document. (Dining Shed & Utility Shed)

Description: As per BNBC, every building or structure designed shall have its design documents prepared in accordance with the provision of Section 1.9.1. The design document shall include a design report, and a set of structural drawings, which shall be prepared in compliance with section 1.9.1.1 and section 1.9.1.2 as per BNBC. At the time of inspection, the design report was not available. The building engineer is required to prepare a design report in compliance with BNBC 1.9.1.

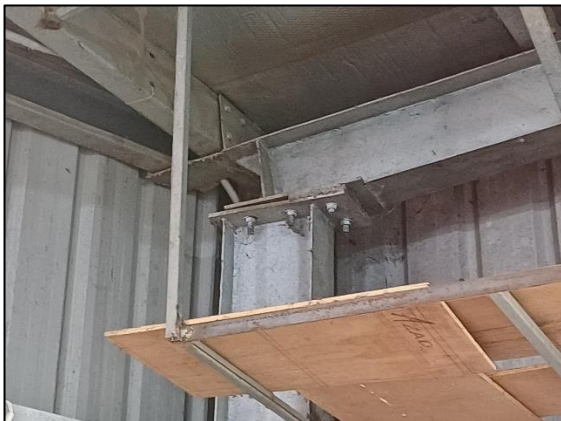
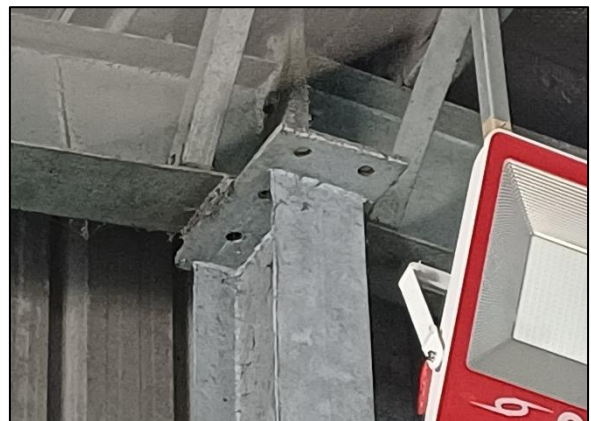
Observation-21: Connection gap & bolt missing in steel members. (Dining Shed)

Description: During inspection, connection gap & bolt missing was found on steel members in Dining Shed. The building engineer is required to repair the connection gap with suitable method & install missing bolts where necessary.

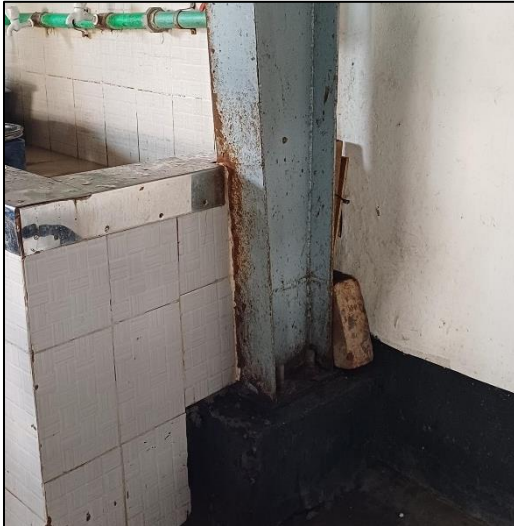
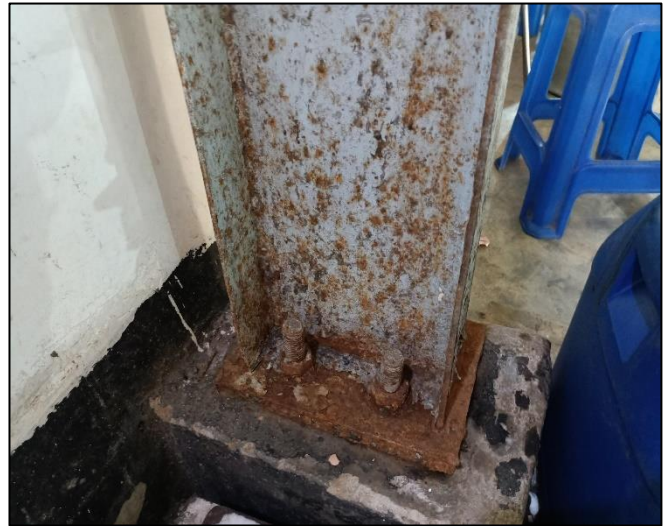
Observation-22: Corrosion on steel members. (Dining Shed)

Description: During inspection, steel members were found corroded in Dining Shed. The building engineer is required to apply rust proof paint on steel members.
