Dhakarea Ltd (Extension)

Plot 23-27, (New) DEPZ Extension Zone, Ganakbari, Ashulia, Savar

22 January 2024

Structural Inspection Report

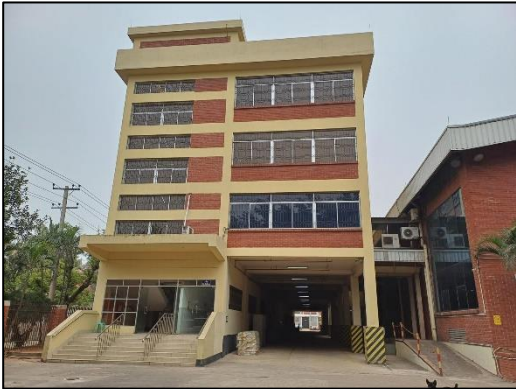
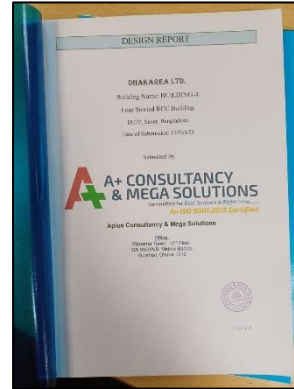
Observation-1: Inadequate number of material test report (Building-4).

Description: 14 sets of concrete cylinder test report were available where 5 sets from columns. Also, out of 14 sets 7 sets have no average results. However, the number of cylinder test reports doesn't satisfy the frequency of testing requirement of BNBC. So, the building engineer is required to verify in-situ material strength of the building by taking minimum 4 number of concrete cores from lower tier columns.

Item No.	Observation	Action Plan	Timeline
1.	Inadequate number of material test report (Building-4)	The building engineer is required to verify in-situ material strength of the building by taking minimum 4 number of concrete cores from lower tier columns. Incorporate the equivalent strength in the design report.	within 6 weeks

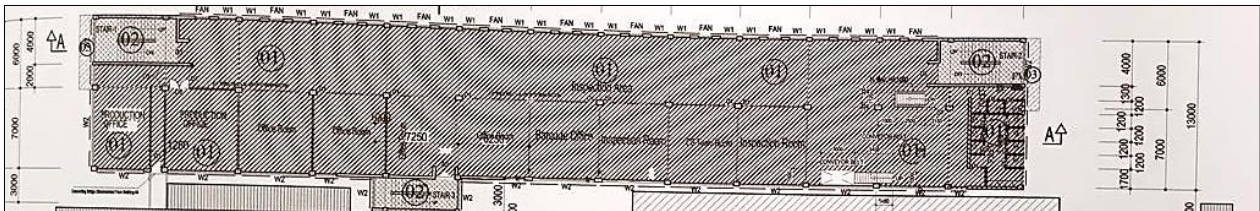
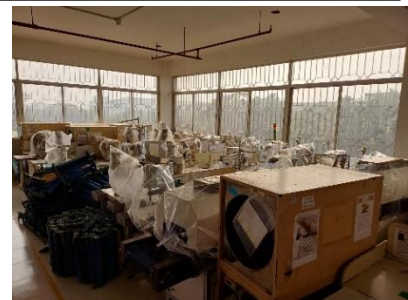
Observation-2: Live load limit doesn't comply with the BNBC requirements. (Building-4)

Description: In the prepared live load plan, 2 kPa (42 psf) live load has been considered for production area where 3 kPa is minimum requirement as per BNBC 2006. The building engineer is required to revise the design report based on updated floor live load plan and in-situ material strength. Submit design documents to the RSC for review.

2.	Live load limit doesn't comply with the BNBC requirements (Building-4)	The building engineer is required to update the floor live load plan and revise the design report based on in-situ material strength. Submit design documents to the RSC for review.	within 6 weeks

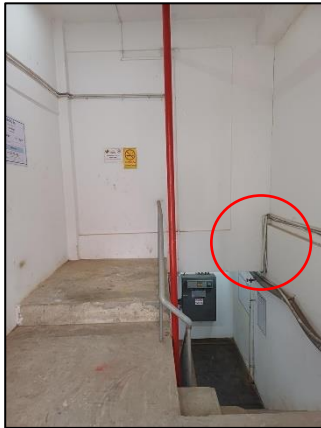
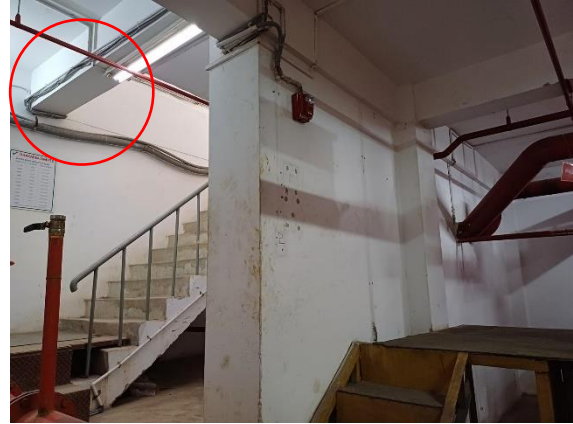
Description: Structural connection between Building-4 and Fire Pump room is found at ground level. The building engineer is required to consider the connection in the design documents.

3.		Carry out suggested remedial works if required.	within 6 months
4.	Structural Connection between Building-4 & Fire Pump Room	The building engineer is required to consider the structural connection in the design. Otherwise, separate the structures	within 6 weeks

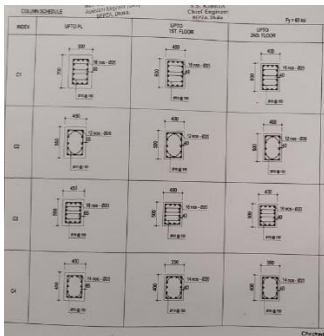
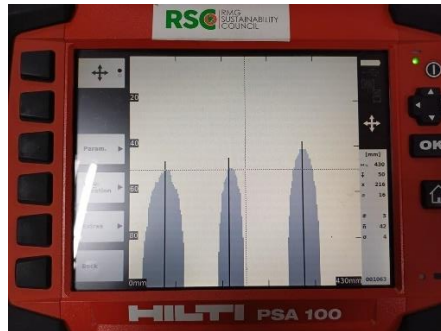
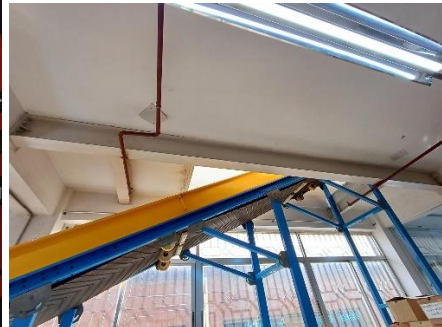
Observation-4: Mismatch between drawing & on-site condition. (Building-4)

Description: During inspection, 3 rebars were found by ferro-scanning in one face of C4 type column instead of 4 rebars. Also, a steel conveyor belt was found in the building which has no design documents. The building engineer is required to re-check and confirm the rebar number as well as prepare the drawing of steel conveyor belt.

5.	Mismatch between drawing & on-site condition. (Building-4)	The building engineer is required to survey the whole structure including the conveyor belt and update the accurate as-built drawing accordingly.	within 6 weeks

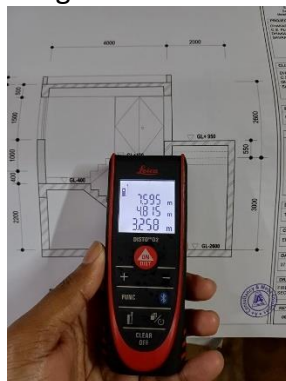
Observation-5: Mismatch between drawing & on-site condition. (Fire Pump Room)

Description: The column grid and floor heights do not match with the prepared drawing. The building engineer is required to survey the structure and prepare as-built drawing accordingly.

6.	Mismatch between drawing & on-site condition. (Fire Pump Room)	The building engineer is required to survey the whole structure and prepare accurate as-built drawing accordingly.	within 6 weeks

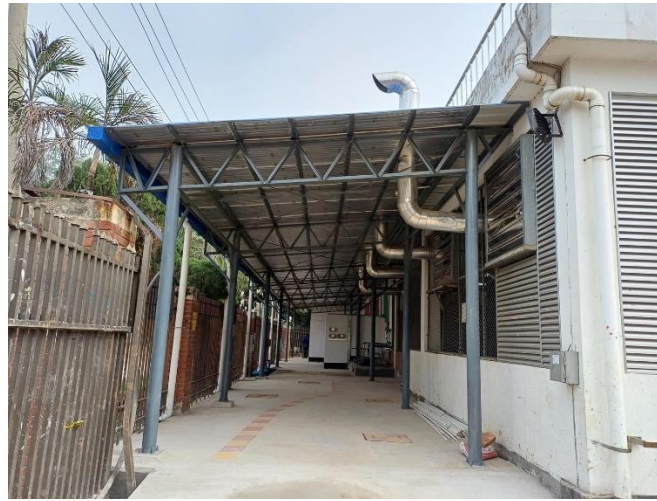
Observation-6: Lack of design documents for Steel Diesel Shed.

Description: The building engineer is required to survey the structure and prepare an accurate as-built drawing as per site condition. Also, prepare a full set of design documents including the adequacy check of the truss and connection. Submit the design documents to the RSC for review.

7.	Lack of design documents for Steel Diesel Shed.	The building engineer is required to survey the structure and prepare as-built drawing accordingly. Also, prepare a full set of design documents. Submit design documents to the RSC for review.	within 6 weeks
