# Ahsan Composite Ltd. (Extension)

Ward no-07, Holding no-99/D, Chandra Pollibidyut Road, Kaliakoir, Gazipur  
(24.044005199, 90.259546481)

30 November 2023

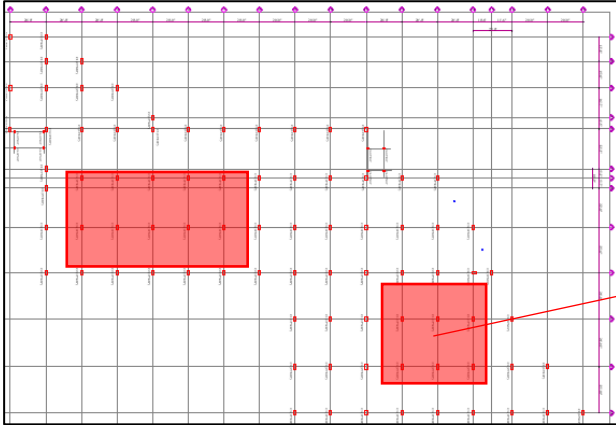
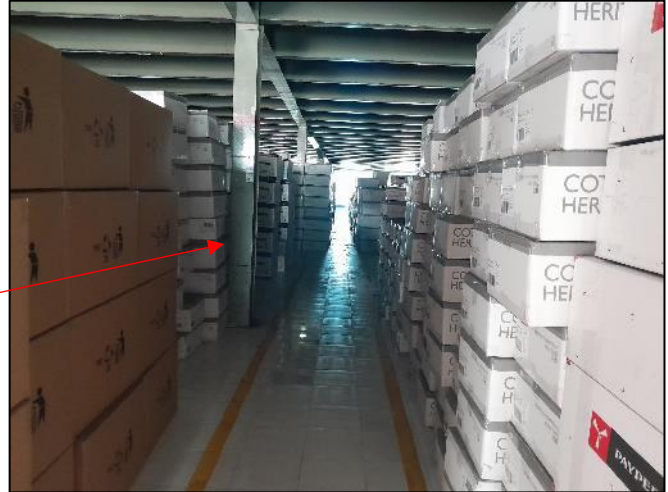
**Observation-1:** Steel columns are stressed above normal design limit. [Building-07 (Production Building)]

**Description:** Cursory calculation indicates that the marked area appears to be stressed above normal design limits based on prepared live load plan (3 kPa for typical and 6 kPa for storage) and minimum steel plate strength (250 MPa). Also, foundation details and geotechnical investigation report were not found onsite. The building engineer is required to carry out Detail Engineering Assessment (DEA) to review the design, loads and column stress based on in-situ material strength and floor live loads.

| Observation | Action Plan | Timeline |
|---|---|---|
| Steel columns are stressed above normal design limit. [Building 07 (Production Building)] | The building engineer is required to carry out Detail Engineering Assessment (DEA) to review the design, loads and column stress based on in-situ material strength and floor live loads. | within 6 weeks |
| Steel columns are stressed above normal design limit. [Building 07 (Production Building)] | Produce and actively manage a floor live load plan for all floors of the building based on floor, column & foundation capacity. The floor load plan must include machinery weight and specifications. | within 6 weeks |
| Steel columns are stressed above normal design limit. [Building 07 (Production Building)] | Carry out suggested remedial works if required. | within 6 months |

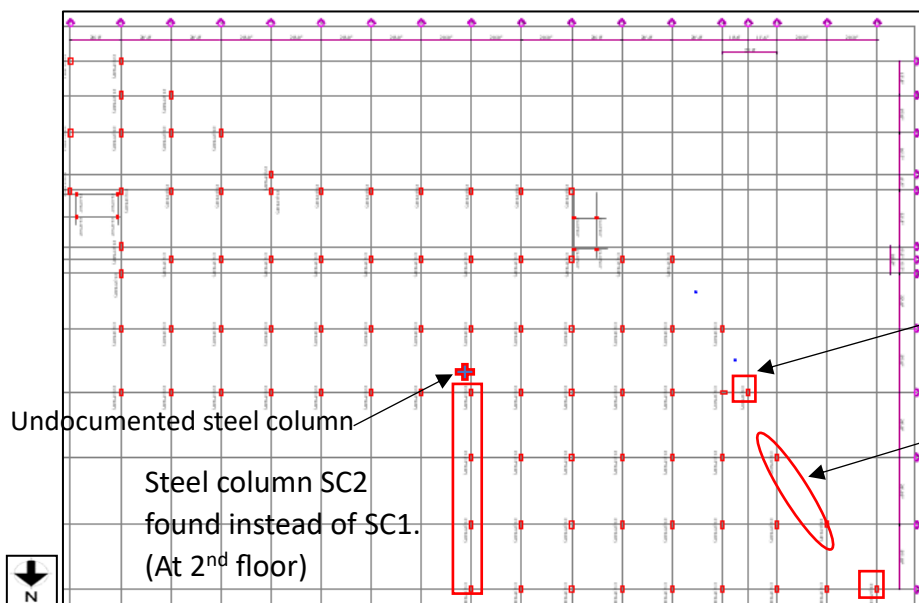
Steel column SC3 found instead of (200x400) mm instead of (200x260) mm. (At 2<sup>nd</sup> floor)

The building engineer is required to survey the full structure and prepare complete as-built drawing.

| Observation | Action Plan | Timeline |
|---|---|---|
| Incomplete drawing. [Building 07 (Production Building)] | The building engineer is required to survey the full structure and prepare complete as-built drawing. | within 6 weeks |

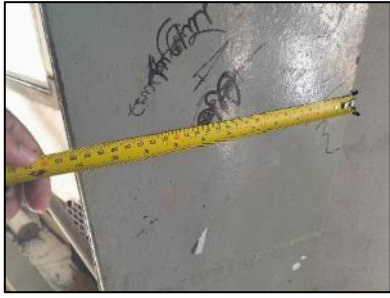
Steel column SC1 found instead of SC3. (At 2<sup>nd</sup> floor)

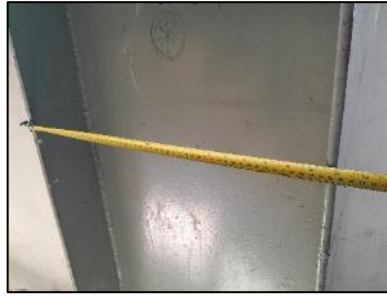
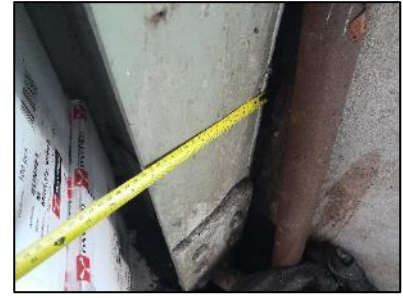
Steel column SC1 found instead of SC3. (At 2<sup>nd</sup> floor)  
(280x550) mm

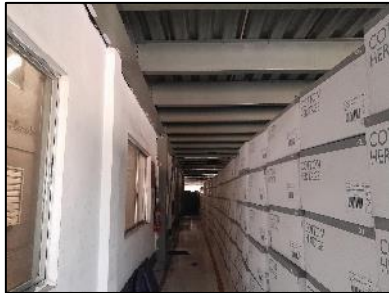
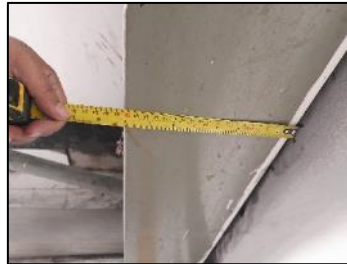
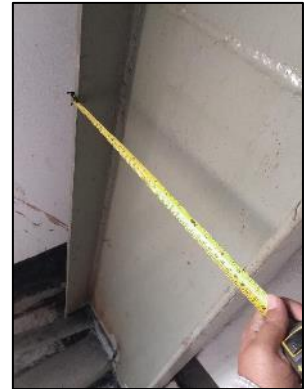
Steel column SC3 found  
(200x400) mm instead of  
(200x260) mm. (At 2<sup>nd</sup> floor)

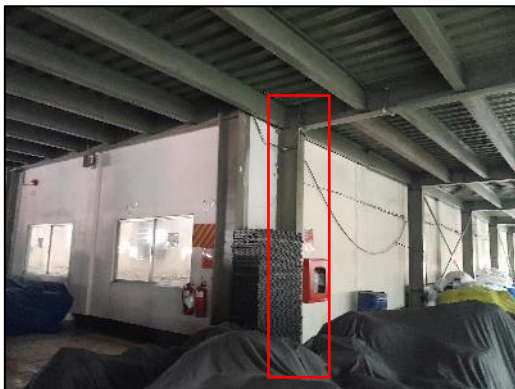
Steel column SC2 found instead of SC1. (At 2<sup>nd</sup> floor)

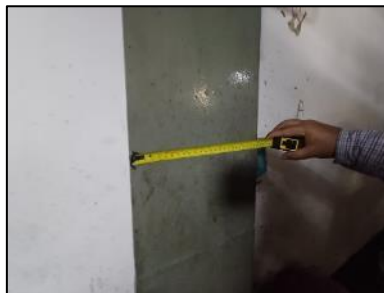
Undocumented steel column

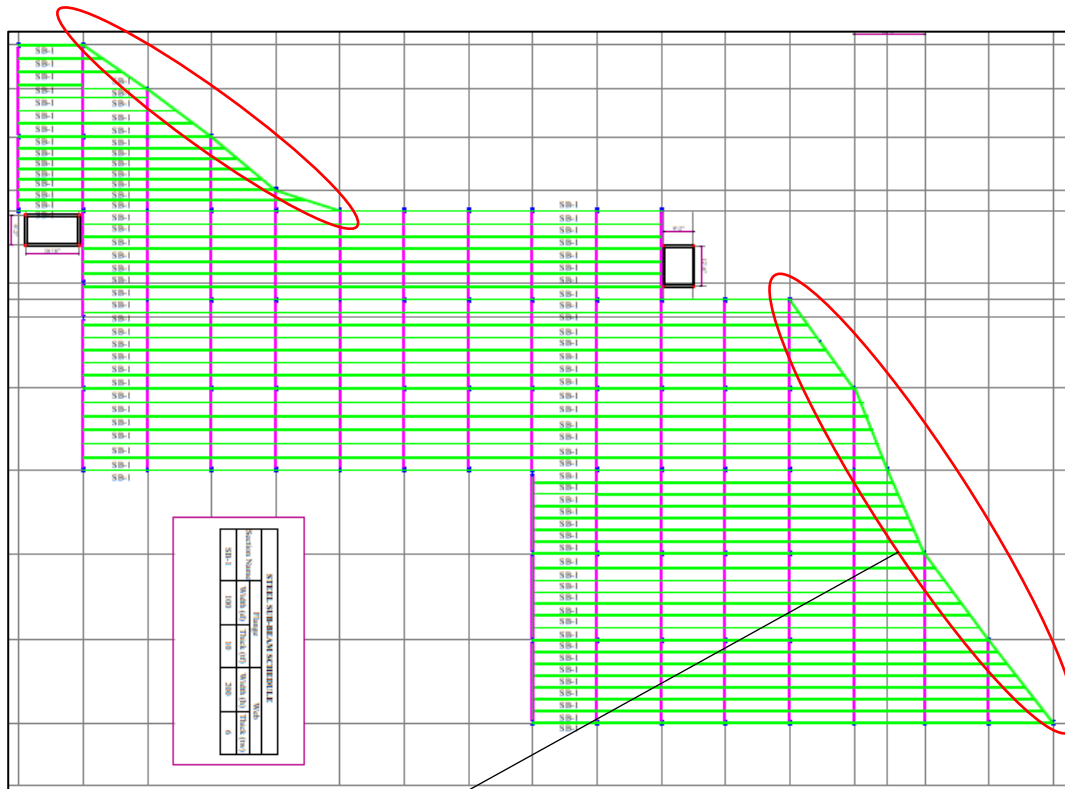
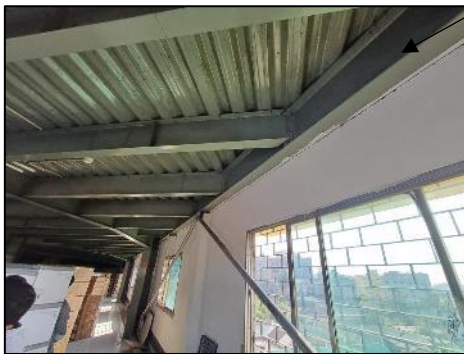
SC3 found 250x360 instead of 200x260. (At ground floor)

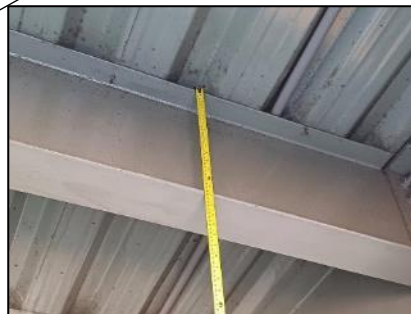
Marked beam details not shown in drawing (180x400) mm

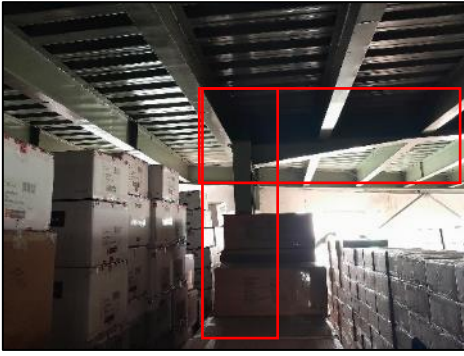
Sub beam size was found (125x350) mm instead of (100x200) mm

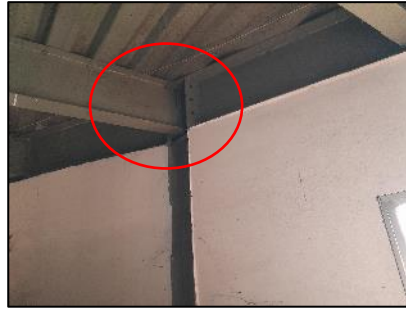
Frame section missing in the prepared drawing

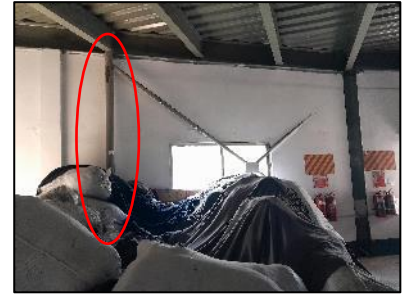
Welding connection

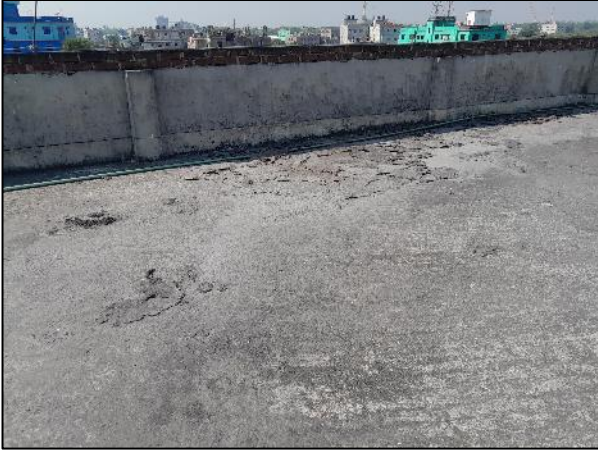
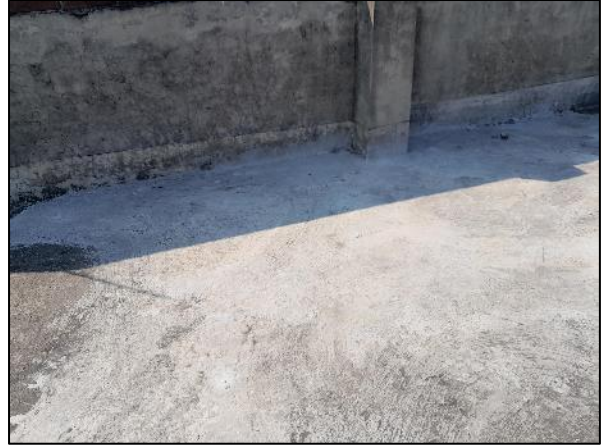
**Observation-3:** Lack of drainage system on roof. [Building 07 (Production Building)]

**Description:** During the inspection, a poor roof drainage system and signs of water stagnant were found on the roof. The building engineer is required to improve the water drainage system on the roof with proper slope & adequate number of water outlets.

| Observation | Action Plan | Timeline |
|---|---|---|
| Lack of drainage system on roof. [Building 07 (Production Building)] | The building engineer is required to improve the water drainage system on the roof with proper slope & adequate number of water outlets. | within 6 months |

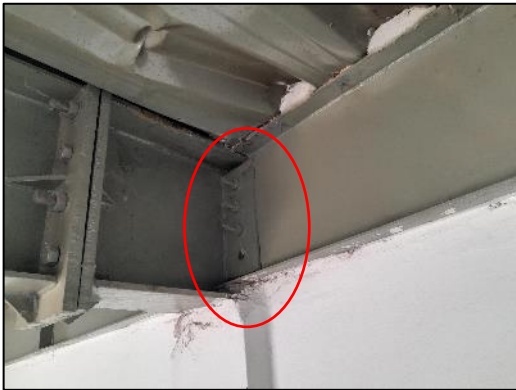
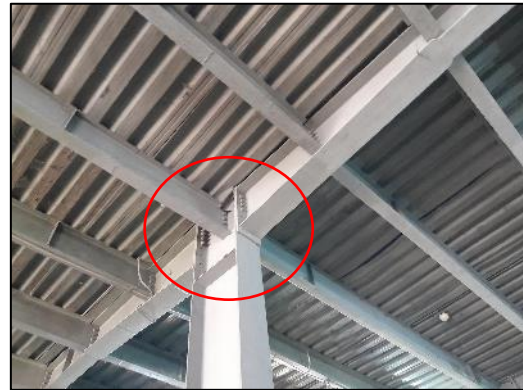
**Observation-4:** Missing bolt at several places. [Building 07 (Production Building)]

**Description:** During inspection, missing bolts were observed in connection at several places. The building engineer is required to identify all the missing bolts and install bolts in all missing areas.

| Observation | Action Plan | Timeline |
|---|---|---|
| Missing bolt at several places. [Building 07 (Production Building)] | The building engineer is required to identify all the missing bolts and install bolts in all missing areas. | within 6 weeks |

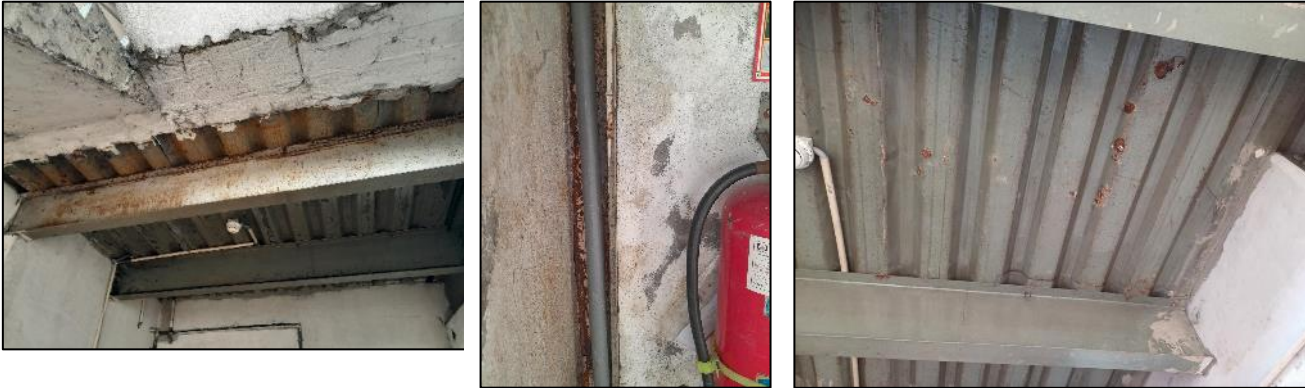
**Observation-5:** Corrosion in steel member. [Building 07 (Production Building)]

**Description:** During inspection, corrosion was observed in steel members at several places. The building engineer is required to identify all the corroded members, remove all corrosion, and apply anti-corrosive coating.

| Observation | Action Plan | Timeline |
|---|---|---|
| Corrosion in steel member. [Building 07 (Production Building)] | The building engineer is required to identify all the corroded member, remove all corrosion, and apply anti-corrosive coating. | within 6 months |

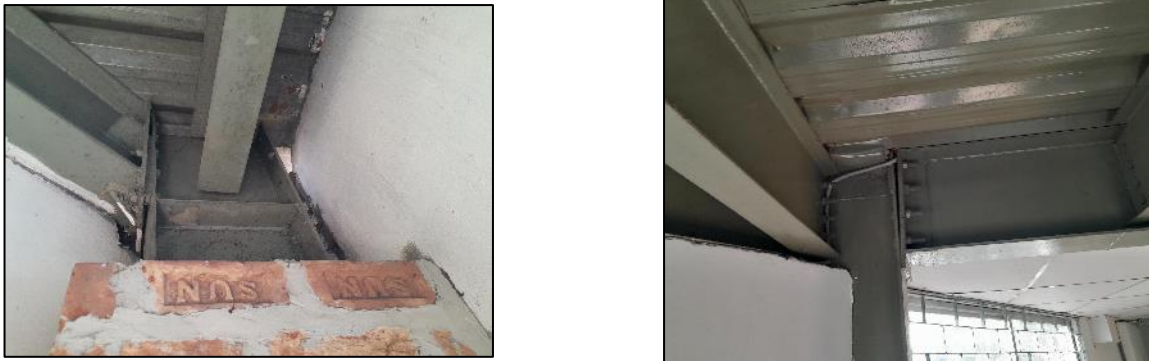
**Observation-6:** Significant connection gap. [Building 07 (Production Building)]

**Description:** During inspection, several connection gaps were observed in between steel beam & column connection at several places. The building engineer is required to identify all the connection gaps and provide suitable remedial measure as per engineer suggestion.

| Observation | Action Plan | Timeline |
|---|---|---|
| Significant connection gap. [Building 07 (Production Building)] | The building engineer is required to identify all the connection gaps and provide suitable remedial measure as per engineer suggestion. | within 6 months |

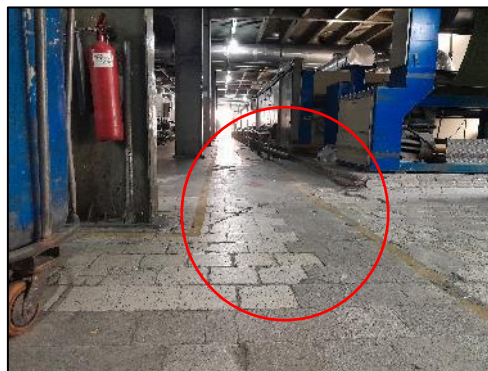
**Observation-7:** Settlement on the ground. [Building 07 (Production Building)]

**Description:** During inspection, signs of settlement were observed on the ground beside the heavily loaded stenter machine. The building engineer is required to investigate the actual reason of settlement and take necessary remedial measure as per engineer suggestion.

| Observation | Action Plan | Timeline |
|---|---|---|
| Settlement on the ground. [Building 07 (Production Building)] | The building engineer is required to investigate the actual reason for settlement and take necessary remedial measure as per engineer suggestion. | within 6 weeks |

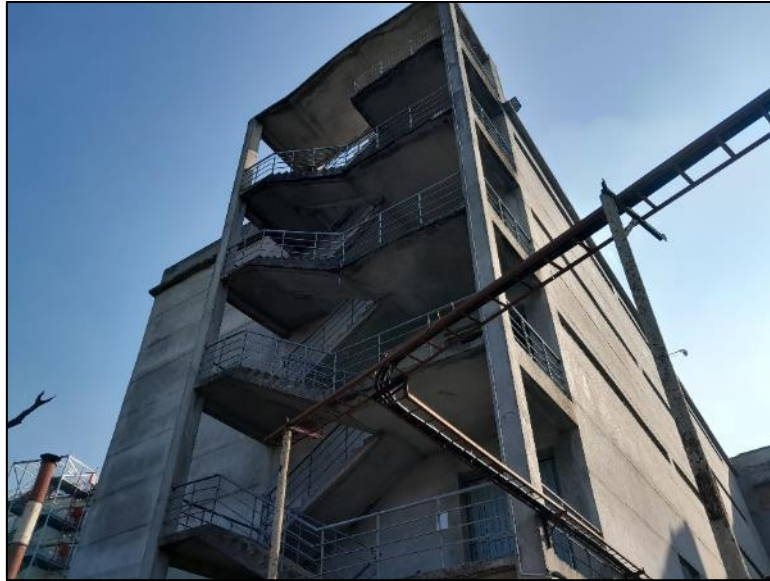
**Observation-8:** Lack of design documents. [Building-11 (Dyes Chemical Store)]

**Description:** During the inspection, design report & material test reports were not available on site for the structure. Also, foundation details and geotechnical investigation report were not found onsite. The building engineer is required to carry out Detailed Engineering Assessment (DEA) based on in-situ material strength & software-based analysis and submit it to RSC for review.

| Observation | Action Plan | Timeline |
|---|---|---|
| Lack of design documents. [Building 11 (Dyes Chemical Store)] | The building engineer is required to carry out Detailed Engineering Assessment (DEA) based on in-situ material strength & software-based analysis and submit it to RSC for review. | within 6 weeks |
| Lack of design documents. [Building 11 (Dyes Chemical Store)] | Carry out suggested remedial works if required. | within 6 months |

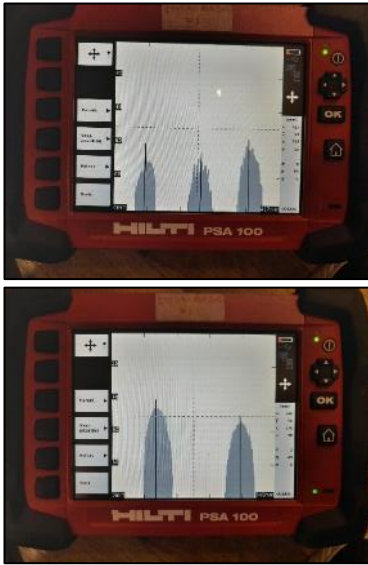
**C4 column:** 6 rebar found instead of 10

The building engineer is required to survey the full structure and prepare complete as built drawing.

| Observation | Action Plan | Timeline |
|---|---|---|
| Mismatch in as-built drawing. [Building 11 (Dyes Chemical Store)] | The building engineer is required to survey the full structure and prepare complete as built drawing. | within 6 weeks |

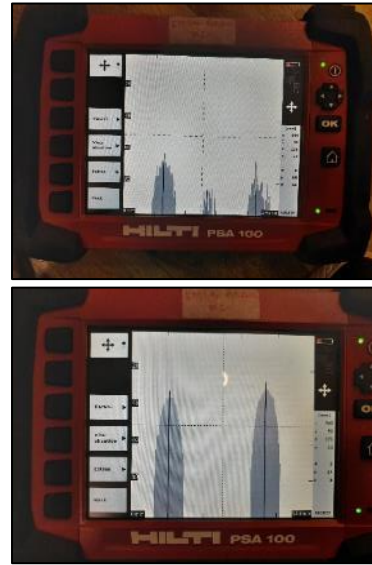
**C1 column:** 6 rebar found instead of 8 nos.

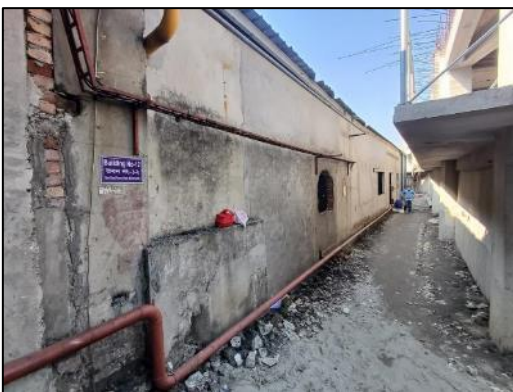
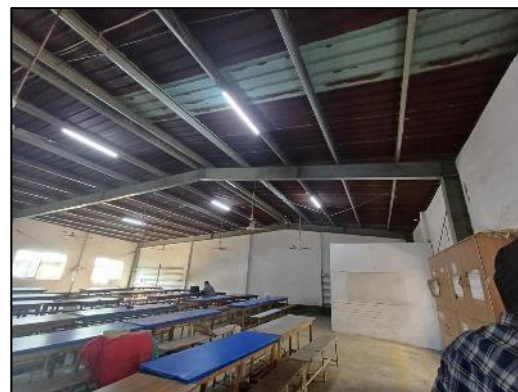
**Observation-10:** Lack of lateral load transfer media. [Building-12 (Dinning shed)]

**Description:** Lateral load transfer media (compression strut) was missing in the structure. Also, foundation details, geotechnical investigation report and design documents were not found onsite. The building engineer is required to carry out Detail Engineering Assessment (DEA) based on in-situ material strength in compliance with BNBC (part-6, section 1.9.1).

| Lack of lateral load transfer media. [Building-12 (Dinning shed)] | The building engineer is required to carry out Detail Engineering Assessment (DEA) based on in-situ material strength in compliance with BNBC (part-6, section 1.9.1). | within 6 weeks |
| Lack of lateral load transfer media. [Building-12 (Dinning shed)] | Carry out suggested remedial works if required. | within 6 months |

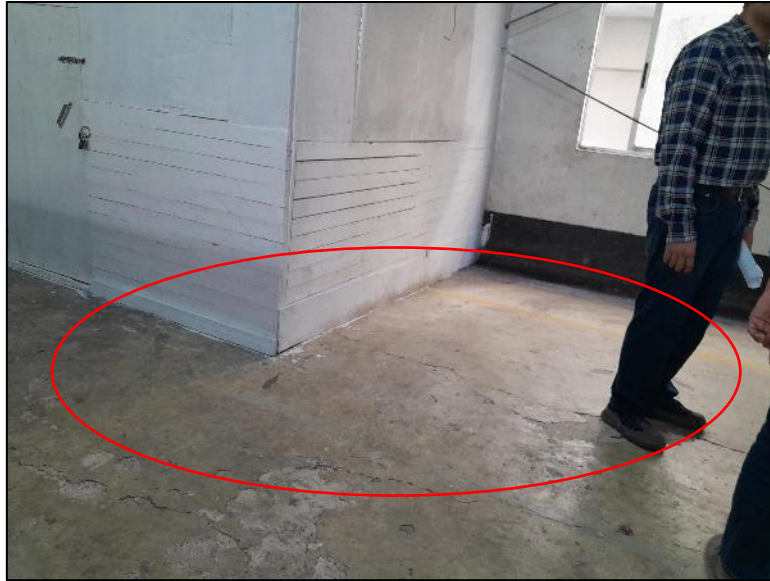
**Observation-11:** Signs of settlement on the ground slab. [Building 12 (Dinning shed)]

**Description:** During inspection, signs of settlement were observed on the ground slab. The building engineer is required to investigate the reason of settlement and take necessary remedial measure as per engineer suggestion.

| Settlement on the ground slab. [Building 12 (Dinning shed)] | The building engineer is required to investigate the reason of settlement and take necessary remedial measure as per engineer suggestion. | within 6 weeks |
