# S M Knitwears Limited (Extension)

Shirirchala, Bhabanipur, Gazipur

21 January 2024

## 2. Observations:

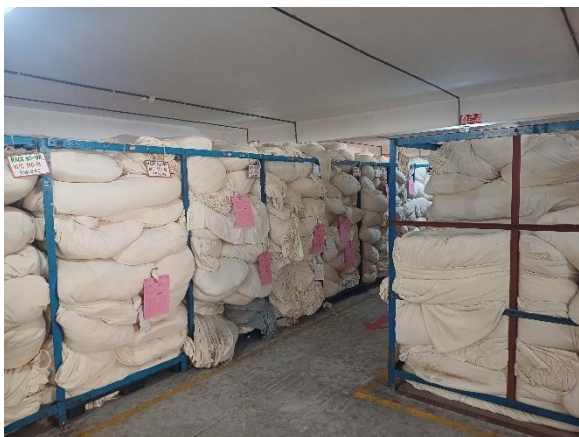
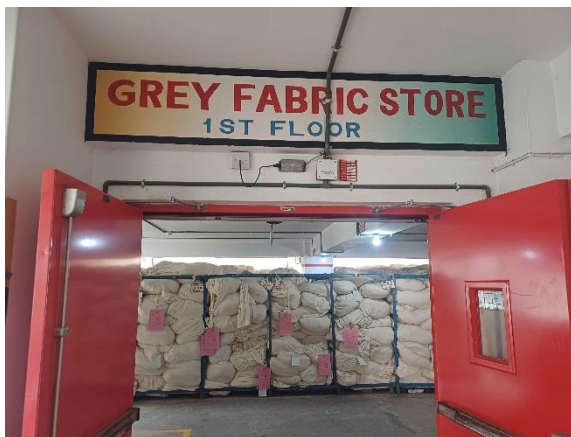
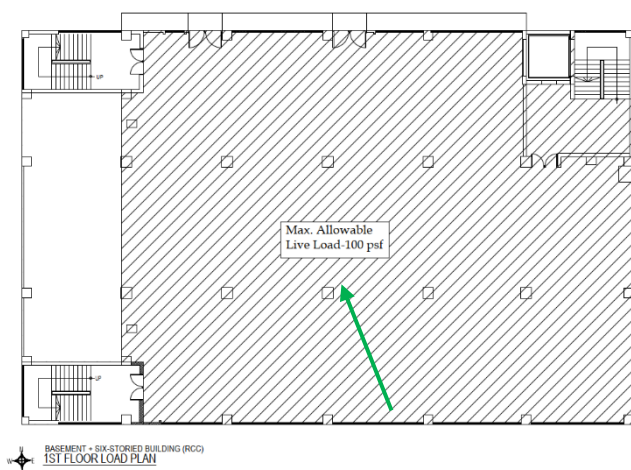
**Observation-1:** Storage live load limit doesn't satisfy the building code requirement (Building 4)

**Description:** As per BNBC, the minimum live load for storage in industrial building is 6 kPa, where 4.8 kPa has been considered in design report and load plan. The building engineer is required to revise the floor live load, design report and submit the design documents to RSC for review.

| Observation | Action Plan | Timeline |
|---|---|---|
| Storage live load limit doesn't comply BNBC requirement (Building 4) | The building engineer is required to revise the floor live load plan, design report and submit the design documents to the RSC for review. | within 6 weeks |
| | Carry out remedial work where required. | within 6 months |

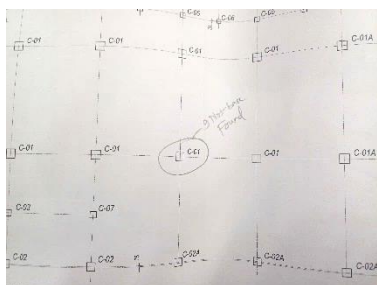
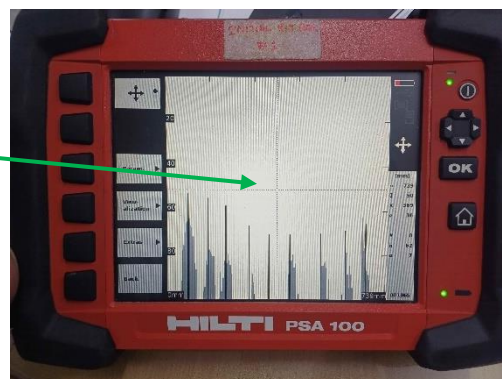
**Observation 2:** Mismatch in as-built drawings. (Building 4)

Rebar mismatch in as-built drawing

**Description:** Mismatch was found in as-built drawing of Column and toilet zone. During inspection, rebar of C-01 column was found 9-nos in one side instead of 10-nos and built-up (8") in toilet zone was not shown in drawing. The building engineer is required to revise the as-built drawing as per actual site condition.

| Observation | Action Plan | Timeline |
|---|---|---|
| Mismatch in as-built drawings. (Building 4) | The building engineer is required to revise the as-built drawing as per actual site condition. | within 6 weeks |

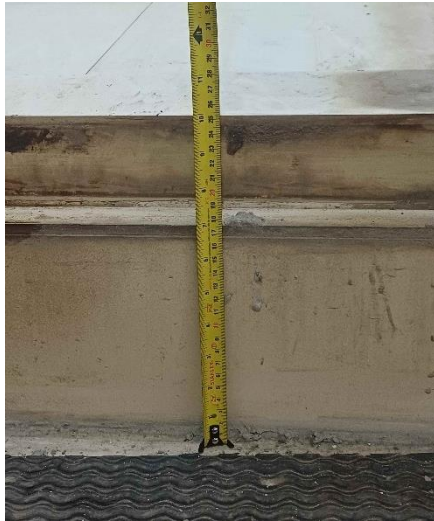
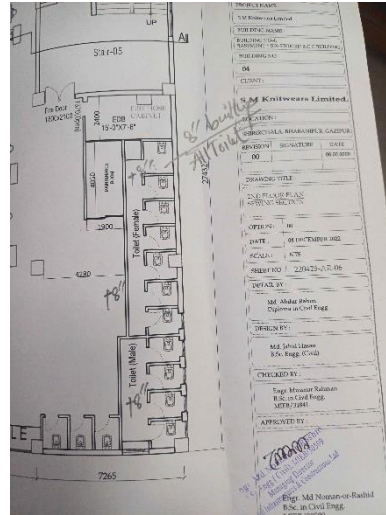
### Built-up in toilet zone was not shown in as-built drawing

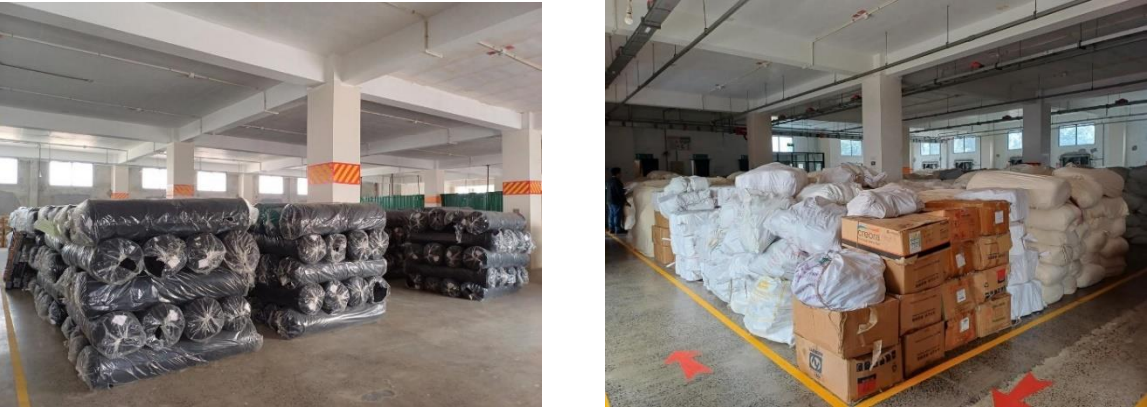
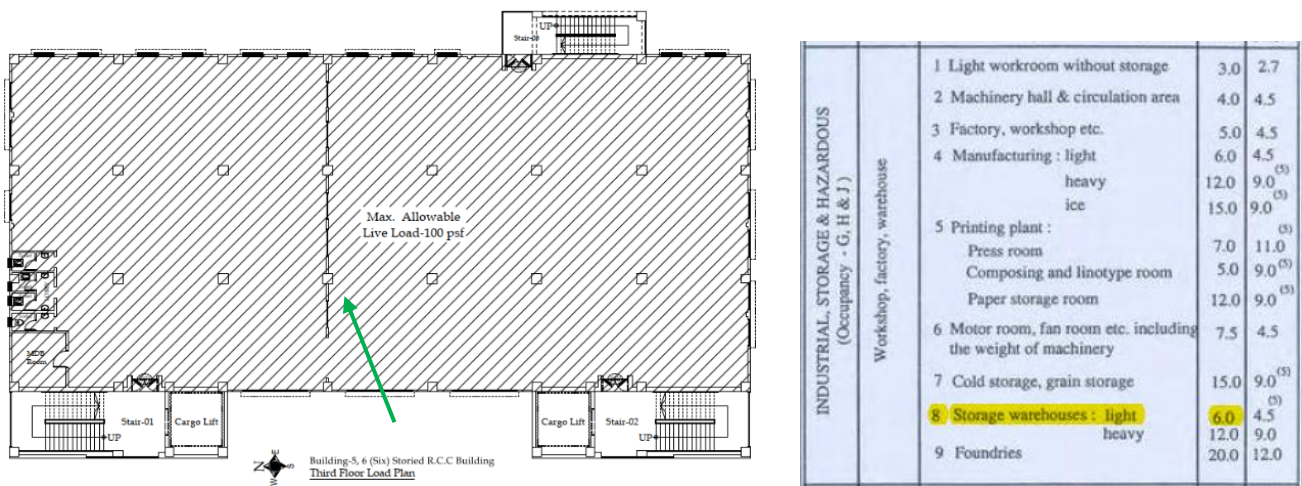
**Observation-4:** Storage live load limit doesn't satisfy the building code requirement (Building 5)

**Description:** As per BNBC, minimum live load for storage in industrial buildings is 6 kPa, where 4.8 kPa was considered in design report and load plan. The building engineer is required to revise the floor live load plan, design report and submit the design documents to the RSC for review.

| Observation | Action Plan | Timeline |
|---|---|---|
| Storage live load limit doesn't comply BNBC requirement (Building 5) | The building engineer is required to revise the floor live load plan, design report and submit the design documents to the RSC for review. | within 6 weeks |
| | Carry out remedial work where required. | within 6 months |

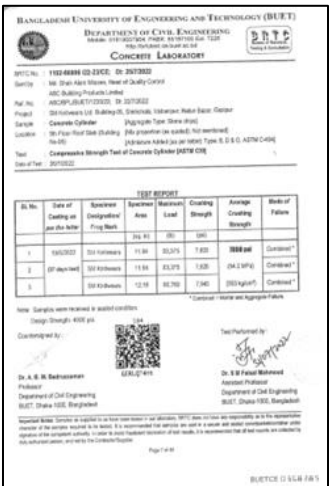
**Observation 5:** Inadequate number of material test report (Building 5)

**Description:** As per BNBC 5.12.2 (frequency of testing) requirement, an adequate number of concrete cylinder test reports were not available onsite to meet the design strength. The building engineer is required to verify in-situ material strength by taking a minimum four number of concrete cores from the lower tier of the existing building column.

| Observation | Action Plan | Timeline |
|---|---|---|
| Inadequate number of material test report (Building 5) | The building engineer is required to verify in-situ material strength by taking a minimum four number of concrete cores from the lower tier of the existing building column. | within 6 weeks |

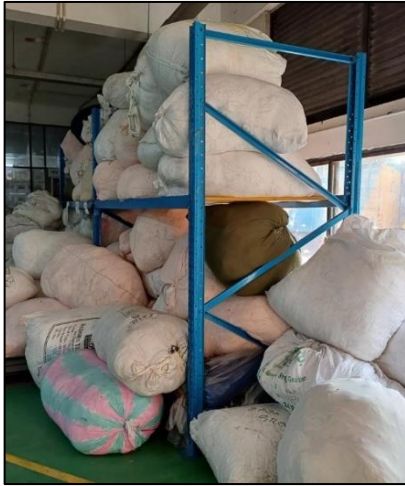
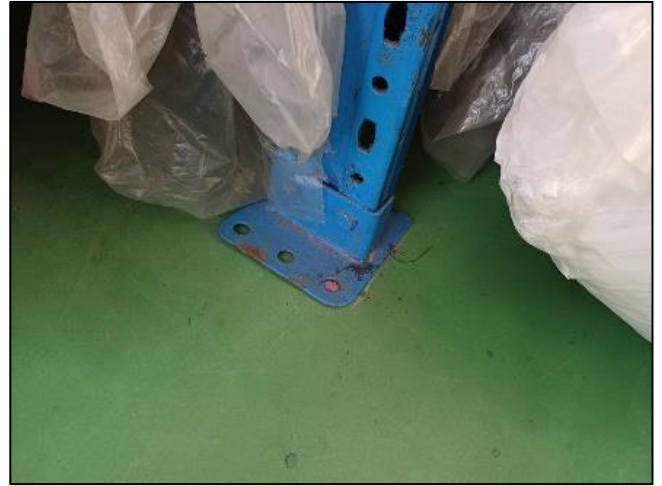
**Observation 6: Unbraced storage racks (Building 5)**

Unbraced storage racks

**Description:** Storage racks at several locations were found unbraced. The building engineer is required to brace/anchor all the non-structural elements including the storage racks.

| Observation | Action Plan | Timeline |
|---|---|---|
| Unbraced storage racks (Building 5) | The building engineer is required to brace/anchor all the non-structural elements. | within 6 months |

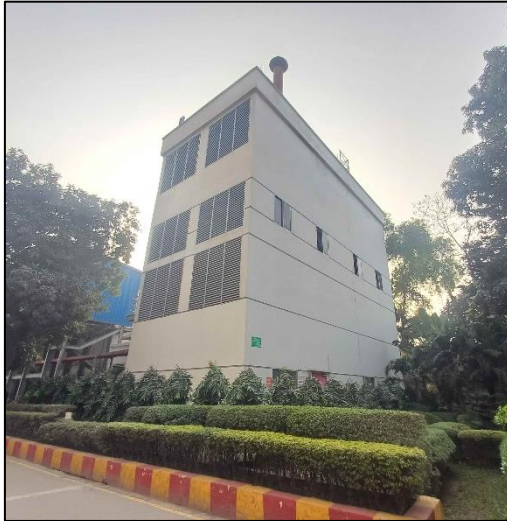
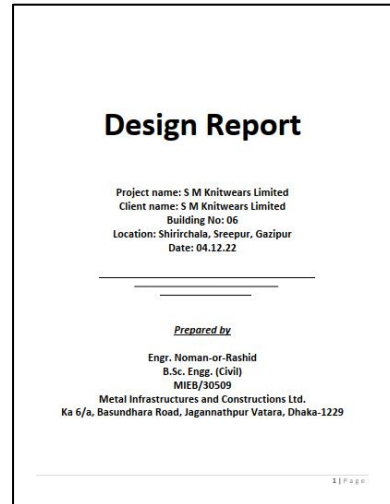
**Observation-7:** Design check against lateral loading needs to be reviewed in-depth (Building-6).

**Description:** Design check against lateral loading needs to be reviewed in-depth by RSC. The building engineer is required to submit Design documents to RSC for review.

| Observation | Action Plan | Timeline |
|---|---|---|
| Design check against lateral loading needs to be reviewed in-depth (Building-6). | The building engineer is required to submit Design documents to RSC for review. | within 6 weeks |
| | Carry out remedial work where required. | within 6 months |

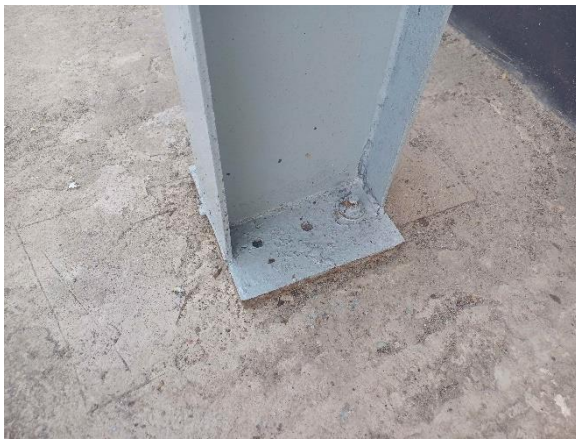
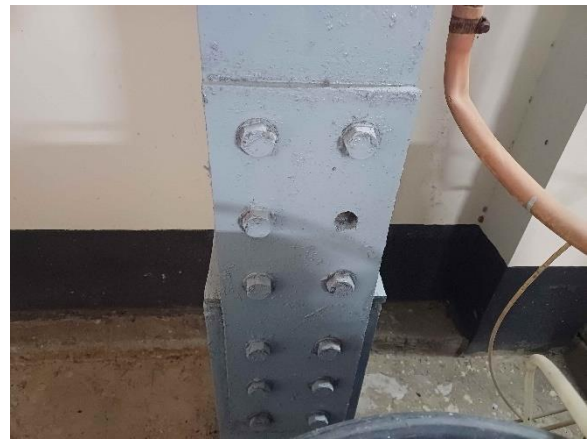
**Observation-8:** Bolt missing in several locations (Building-6).

Bolt missing found in several locations

**Description:** During inspection, bolts were found missing in some places. The building engineer is required to install the missing bolts without further delay.

| Observation | Action Plan | Timeline |
|---|---|---|
| Bolt missing in several locations (Building-6). | The building engineer is required to install the missing bolts without further delay. | within 6 weeks |

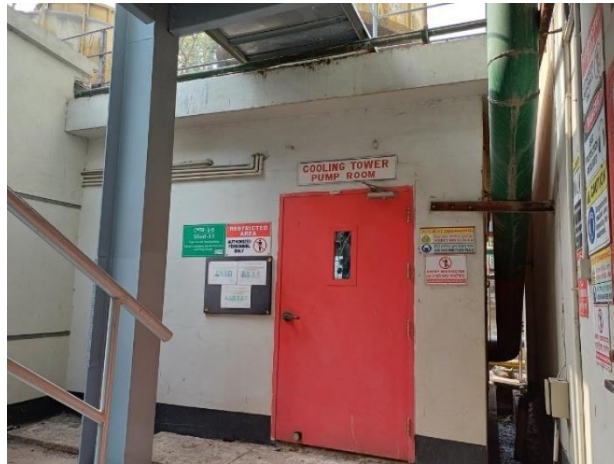
**Observation-9:** Absence of design report. (Building 8)

**Description:** As per BNBC, every building or structure designed shall have its design documents prepared in accordance with the provision of Section 1.9.1. The design document shall include a design report, a set of as-built drawings and load plans which shall be prepared in compliance with section 1.9.1.1 and section 1.9.1.2, part-6 of BNBC.

| Observation | Action Plan | Timeline |
|---|---|---|
| Absence of design report. (Building 8) | The building engineer is required to prepare design documents and submit to RSC for review. | within 6 weeks |
| | Carry out remedial work where required. | within 6 months |

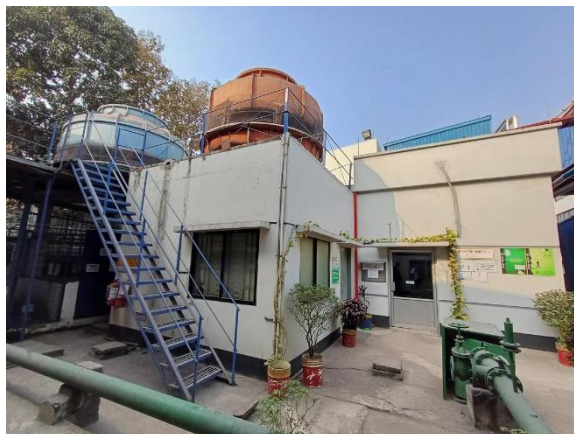
**Observation-10:** Absence of as-built documents. (Building 9)

**Description:** As-built documents were not available for the structure.

| Absence of as-built documents. (Building 9) | The building engineer is required to prepare as-built drawing and submit to RSC for review. | within 6 weeks |

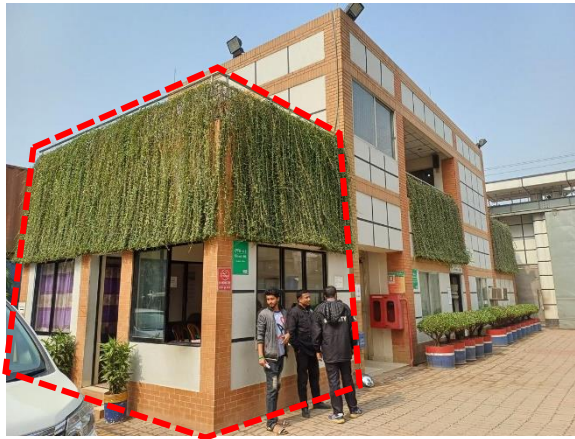
**Observation-11:** Absence of as-built drawing. (Shed 1)

**Description:** As per BNBC, every building or structure designed shall have its design documents prepared in accordance with the provision of Section 1.9.1. The design document shall include a set of as-built drawings which shall be prepared in compliance with section 1.9.1.1 and section 1.9.1.2, part-6 of BNBC.

The building engineer is required to prepare as-built drawings and submit the documents to RSC.

| Absence of as-built drawing. (Shed 1) | The building engineer is required to prepare as-built drawings and submit the documents to RSC. | within 6 weeks |

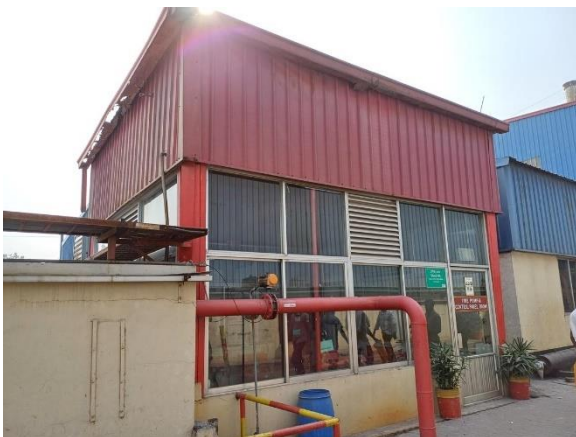
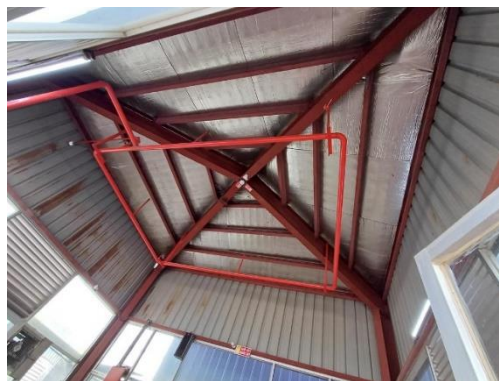
**Observation-12:** Lack of lateral stability. (Shed 6)

**Description:** Lack of lateral stability system and inadequate member sizes were observed in the structure. The building engineer is required to carry out Engineering Assessment (EA) to check the stability of the structure and suggest proper remedial actions accordingly. Submit the EA documents to RSC for review.

| Lack of lateral stability. (Shed 6) | The building engineer is required to carry out Engineering Assessment (EA) to check the stability of the structure and suggest proper remedial actions accordingly. Submit the EA documents to RSC for review. | within 6 weeks |
| | Carry out remedial work where required. | within 6 months |

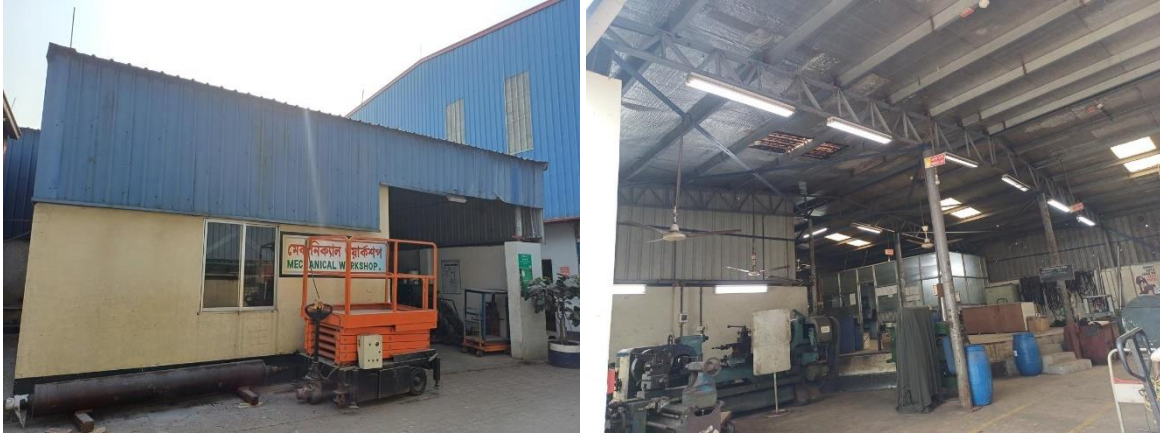
**Observation-13:** Lack of lateral stability. (Shed 7)

**Description:** Lack of lateral stability system and inadequate member sizes were observed in the structure. The building engineer is required to carry out Engineering Assessment (EA) to check the stability of the structure and suggest proper remedial actions accordingly. Submit the EA documents to RSC for review.

| Lack of lateral stability. (Shed 7) | The building engineer is required to carry out Engineering Assessment (EA) to check the stability of the structure and suggest proper remedial actions accordingly. Submit the EA documents to RSC for review. | within 6 weeks |
| | Carry out remedial work where required. | within 6 months |

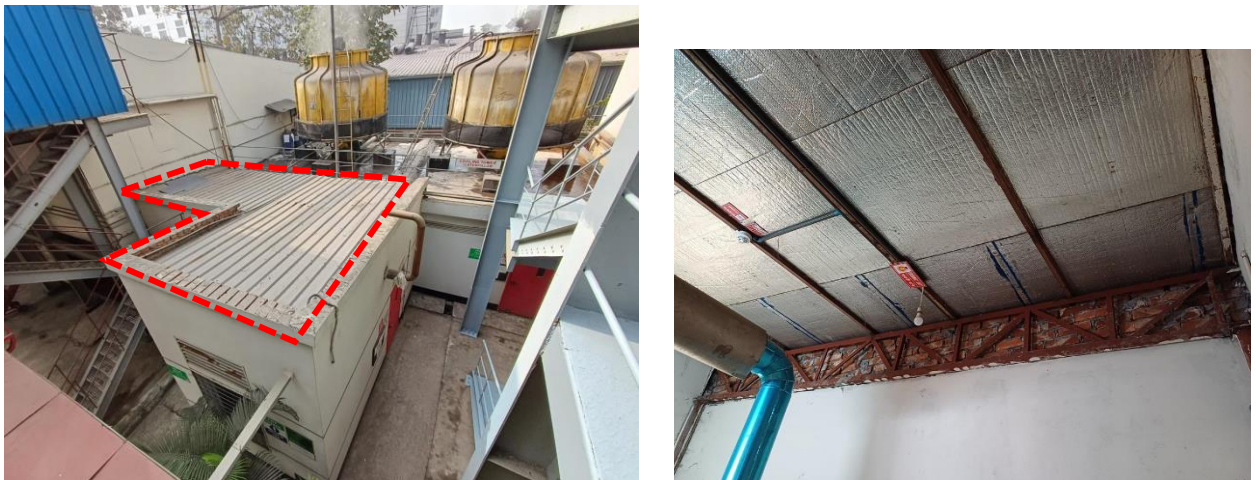
**Observation-14:** Lack of lateral stability. (Shed 13)

**Description:** Lack of lateral stability system and inadequate member sizes were observed in the structure. The building engineer is required to carry out Engineering Assessment (EA) to check the stability of the structure and suggest proper remedial actions accordingly. Submit the EA documents to RSC for review.

| Lack of lateral stability. (Shed 13) | The building engineer is required to carry out Engineering Assessment (EA) to check the stability of the structure and suggest proper remedial actions accordingly. Submit the EA documents to RSC for review. | within 6 weeks |
| | Carry out remedial work where required. | within 6 months |

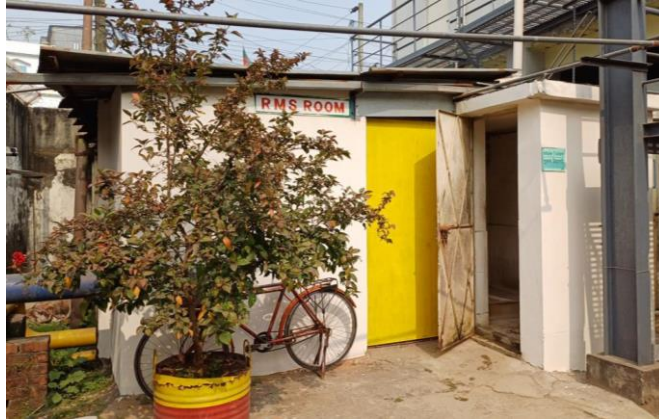
**Observation-15:** Absence of as-built drawing. (Shed 14)

**Description:** As per BNBC, every building or structure designed shall have its design documents prepared in accordance with the provision of Section 1.9.1. The design document shall include a set of as-built drawings which shall be prepared in compliance with section 1.9.1.1 and section 1.9.1.2, part-6 of BNBC.

The building engineer is required to prepare as-built drawings and submit the documents to RSC.

| Absence of as-built drawing. (Shed 14) | The building engineer is required to prepare as-built drawings and submit the documents to RSC. | within 6 weeks |

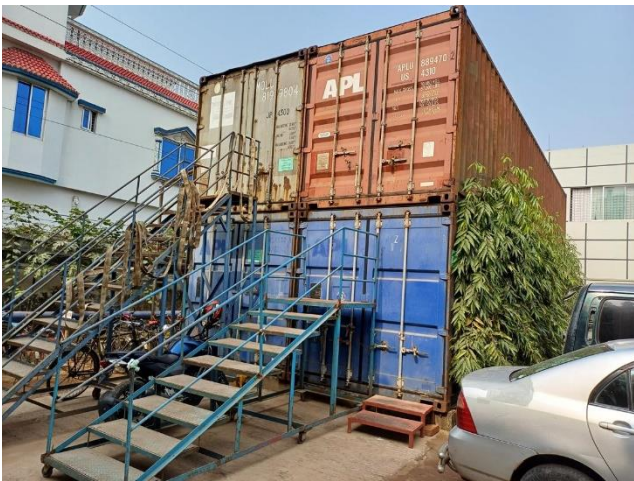
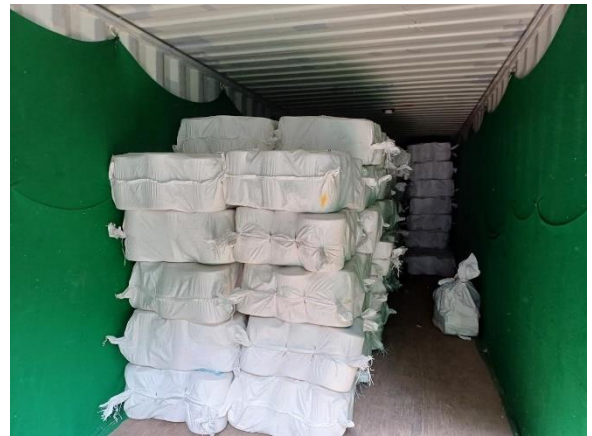
**Observation-16:** Lack of lateral stability. (Shed 15)

**Description:** Lack of lateral stability system and inadequate member sizes were observed in the structure. The building engineer is required to carry out Engineering Assessment (EA) to check the stability of the structure and suggest proper remedial actions accordingly. Submit the EA documents to RSC for review.

| Lack of lateral stability. (Shed 15) | The building engineer is required to carry out Engineering Assessment (EA) to check the stability of the structure and suggest proper remedial actions accordingly. Submit the EA documents to RSC for review. | within 6 weeks |
| | Carry out remedial work where required. | within 6 months |
