Apex Textile Printing Mills (Extension)

Ward No: 07, Holding No: D-84, Chandra, Kaliakoir Pouroshova, Kaliakoir, Gazipur, Bangladesh.
(24.043999, 90.260790)

17 December 2023

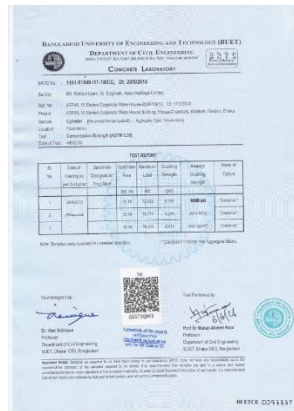
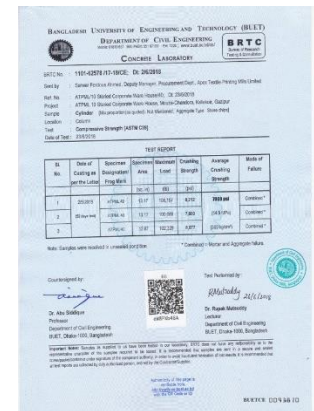
Observation-1: Design concrete strength needs to confirm by further testing (10 Story Corporate Office Building)

Description: In the provided design report concrete compression strength is considered 5000 psi for column & foundation. The factory has provided only a two-cylinder test report for the column in this regard, which does not meet the frequency of testing of BNBC. Also, column was found marginally overstressed considering 6 Kpa live load. The building engineer is required to revise the concrete strength in the design report by performing a core test.

Observation	Action Plan	Timeline
Design concrete strength needs to confirm by further testing (10 Story Corporate Office Building)	The building engineer is required to confirm the concrete strength by performing a core test.	within 6 weeks
	Building engineer is required to update the design documents based on verifying in-situ concrete strength in compliance with BNBC-2006.	within 6 weeks
	Building engineer is required to check the column stress accordingly.	within 6 weeks
	Implement remediation work if required.	within 6 months
Lack of drawings for roof steel stair. (10 Story Corporate Office Building)	Building engineer is required to prepare the as-built drawings with complete structural details.	within 6 weeks
Inadequate column guard. (10 Story Corporate Office Building)	Building engineer is required to take necessary action to prevent the trolley from impacting the columns properly.	within 6 weeks

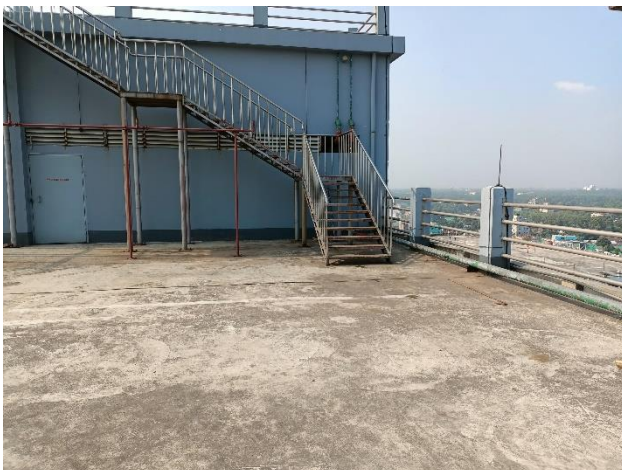
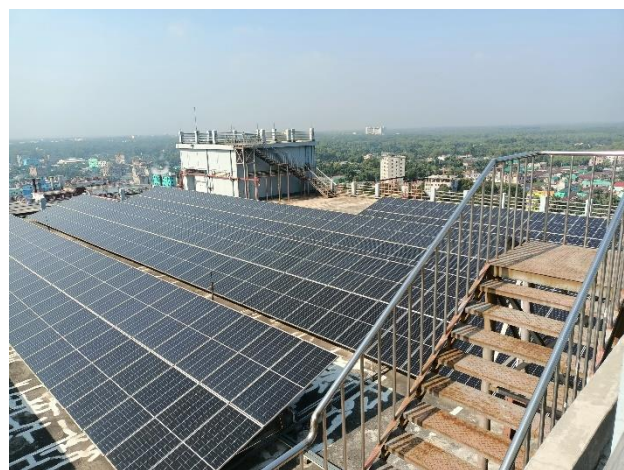
Observation 2: Lack of drawings for roof steel stairs. (10 Story Corporate Office Building)

Steel stair on the roof

Description: During the inspection, 3 nos of steel stairs were found on the roof adjacent to the stair room. However, no structural details were found for these stairs. The building engineer is required to prepare the as-built drawings with complete structural details.

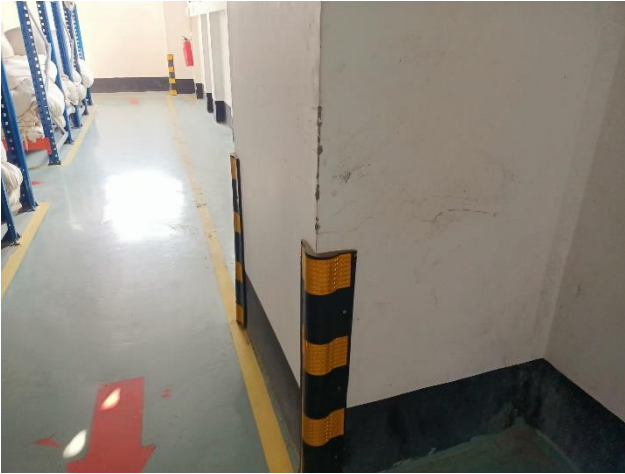
Observation-3: Inadequate column guard. (10 Story Corporate Office Building)

Inadequate column guard

Description: Inadequate column guards were observed to prevent trolley impact above the 5th floor. The building engineer is required to take necessary action to prevent the trolley impact in the columns.

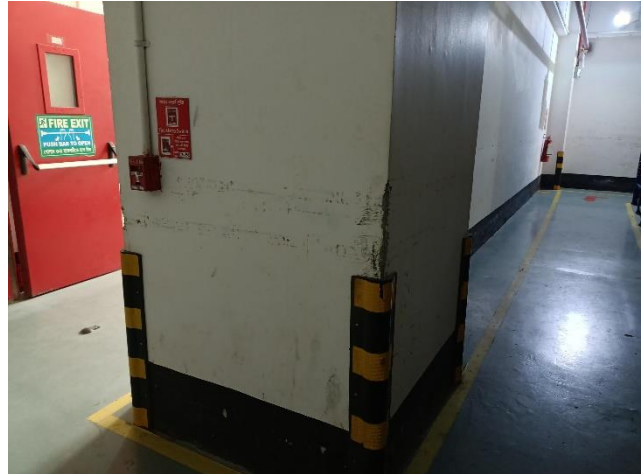
Trolley impact on column

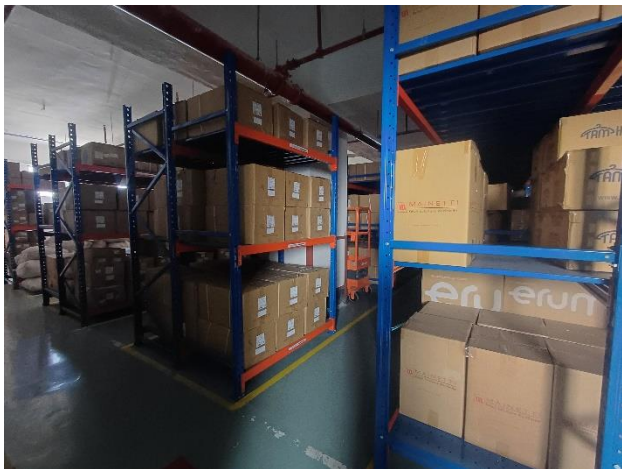
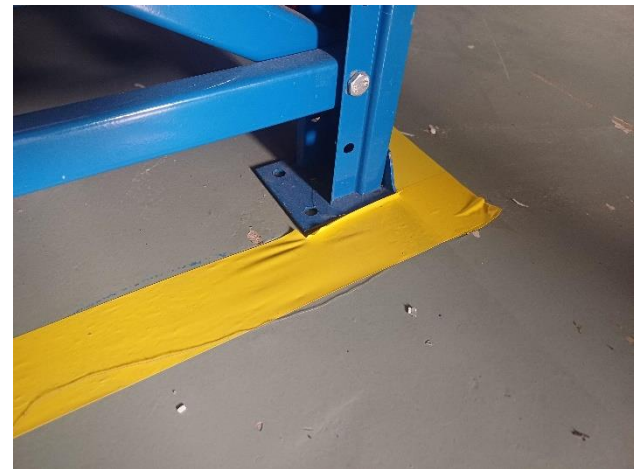
Observation-4: Non-structural elements not anchored or braced. (10 Story Corporate Office Building)

Unbraced racks on the floor

Description: Some racks on floors are not anchored or braced to resist lateral (earthquake) forces. The factory is required to anchor/brace all non-structural elements adequately to resist earthquake forces.

Non-structural elements are not anchored or braced. (10 Story Corporate Office Building)	Building engineer is required to anchor/brace all non-structural elements adequately to resist earthquake forces.	within 6 months
Design report required to be reviewed by RSC for lateral loading. (Thermic Fluid Heaters & Chiller Building)	Prepared design report to be checked against lateral loads following BNBC 2006 by RSC.	within 6 months
	Implement remediation work if required.	within 6 months

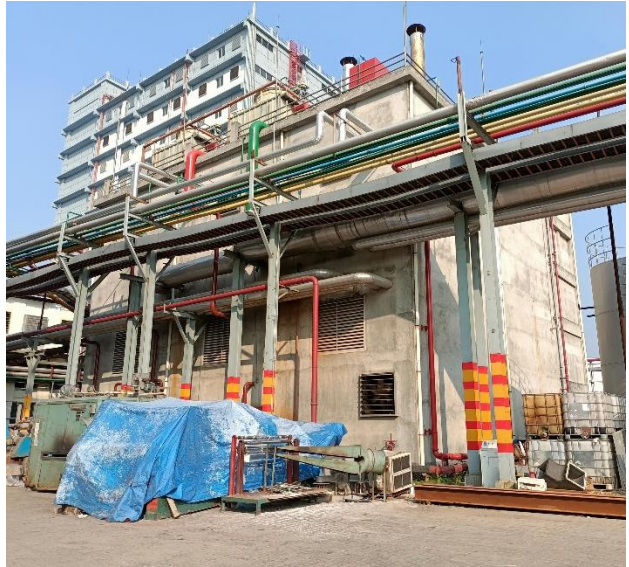
Thermic Fluid Heaters & Chiller Building

Observation-5: Design report required to be reviewed by RSC for lateral loading. (Thermic Fluid Heaters & Chiller Building)

Description: A set of design report was available for the Thermic Fluid Heaters & Chiller Building. Design report need to be reviewed against lateral loading.
