# TMSS Apparels Ltd.

66/3, Dhorpara, Sataish Chourasta, Tongi Gazipur.

26 December 2023

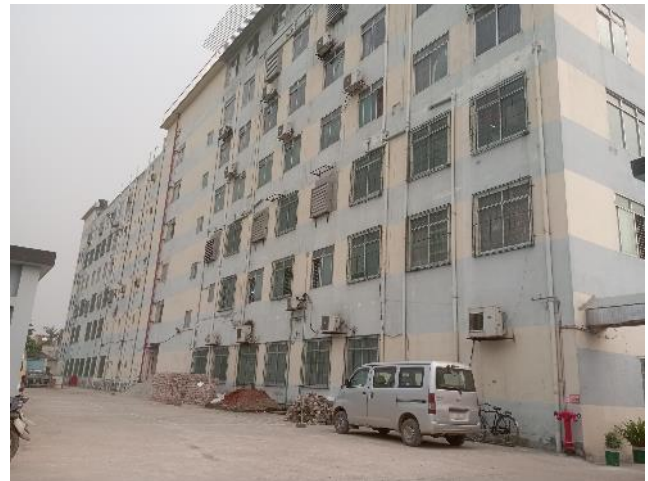
**Observation-1:** Design report doesn't comply with BNBC-2006 (Main Building).

**Description:** The structure was constructed between March 2014 and completed in June 2017, but the design report is prepared as per NTPA guidelines. The building engineer is required to update the design report as per BNBC 2006.

| Observation | Action Plan | Timeline |
|---|---|---|
| Design report doesn't comply with BNBC-2006 (Main Building). | The building engineer is required to update the design report as per BNBC 2006. | within 6 weeks |

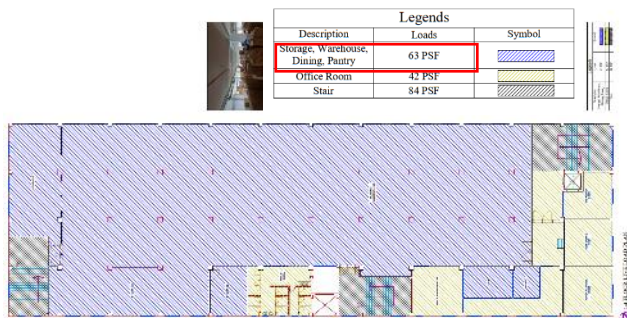
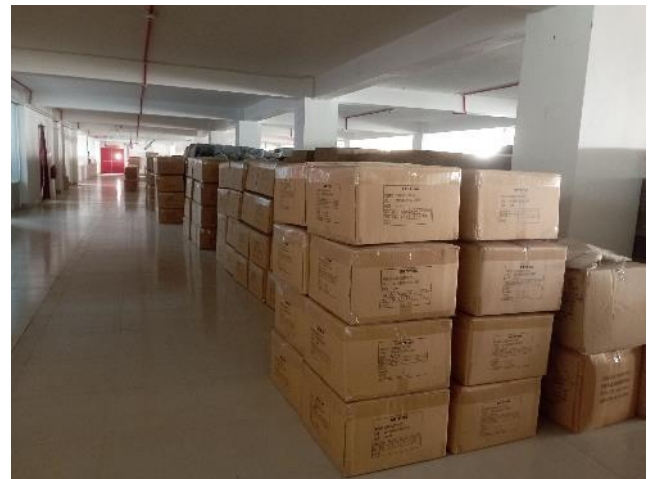
**Observation-2:** The load plan doesn't comply with BNBC requirements (Main Building).

**Description:** 3 kPa (63 Psf) live load is considered for storage on the 1<sup>st</sup> floor. The building engineer is required to update the load plan considering 6 kPa for storage areas and revise the design accordingly.

| Observation | Action Plan | Timeline |
|---|---|---|
| The load plan doesn't comply with BNBC requirements (Main Building). | The building engineer is required to update the load plan considering 6 kPa for storage areas and revise the design accordingly. | within 6 weeks |
| The load plan doesn't comply with BNBC requirements (Main Building). | Carry out suggested remedial works if required. | within 6 months |

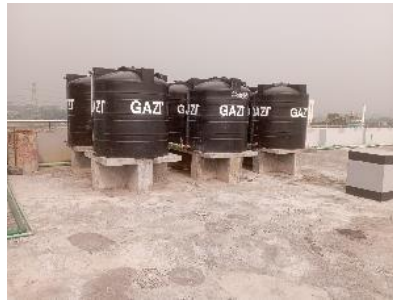
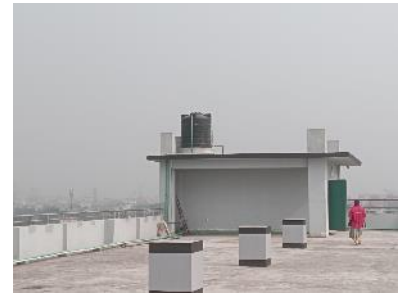
Floors build up not shown for toilet zone.

**Description:** 7 plastic water tanks (6–2000-litre, 1-1000 litre) were found on the roof slab which were not shown in as-built drawing. Also, 250mm floors were found at the toilet zone which was not shown in as-built drawing. The building engineer is required to update as-built drawing.

| Observation | Action Plan | Timeline |
|---|---|---|
| Discrepancy in as-built drawing (Main Building). | The building engineer is required to survey the full structure and update as-built drawings. | within 6 weeks |

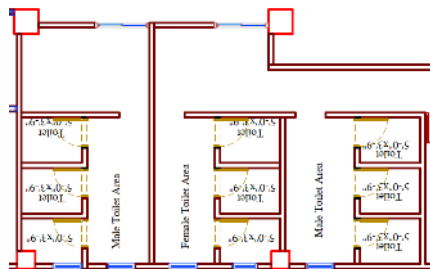
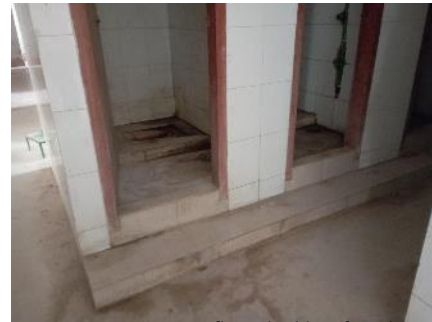
250mm floors build up found at toilet zone.

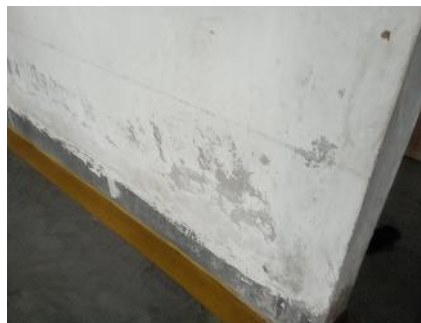
**Observation-4:** Dampness on brick wall at ground floor (Main Building).

**Description:** Dampness was found on brick wall on the ground floor. The building engineer is required to identify all damp areas and repair them with a suitable method.

| Observation | Action Plan | Timeline |
|---|---|---|
| Dampness on the brick wall on the ground floor (Main Building). | The building engineer is required to identify all damp areas and repair them with a suitable method. | within 6 weeks |

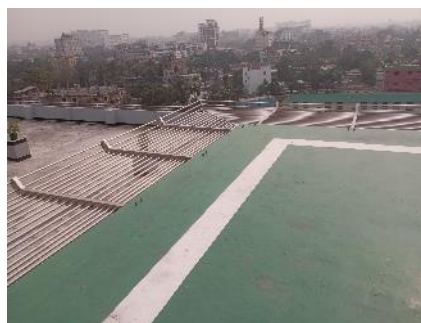
**Observation-5:** Falling hazard at roof level (Main Building).

**Description:** No barrier was found at the helipad area. The building engineer is required to provide edge protection to avoid falling hazard.

| Observation | Action Plan | Timeline |
|---|---|---|
| Falling hazard at roof level (Main Building). | The building engineer is required to provide edge protection to avoid falling hazards. | within 6 weeks |

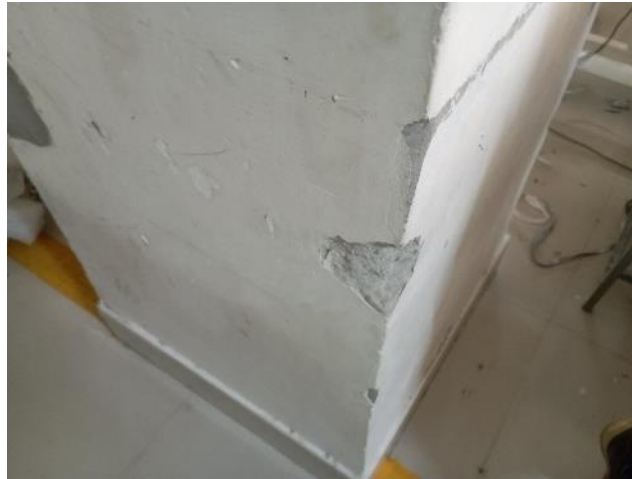
**Observation-6:** Column plaster damage due to trolley impact (Main Building).

**Description:** Column plaster was found damaged due to trolley impact at several locations. The building engineer is required to repair the damaged areas and provide protection to avoid trolley impact.

| Observation | Action Plan | Timeline |
|---|---|---|
| Column plaster damage due to trolley impact (Main Building). | The building engineer is required to repair the damaged areas and provide protection to avoid trolley impact. | within 6 weeks |

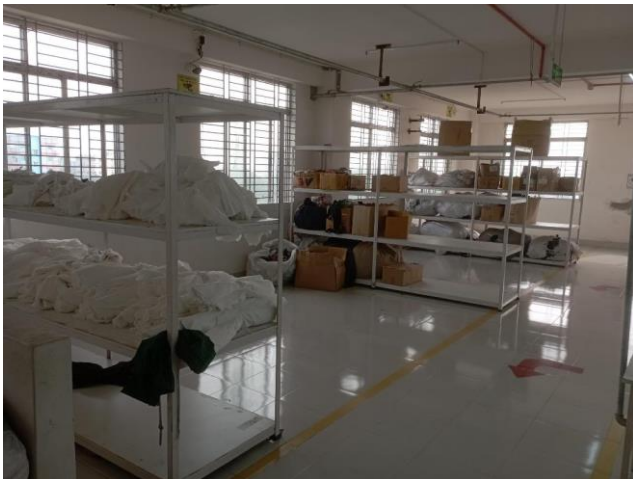
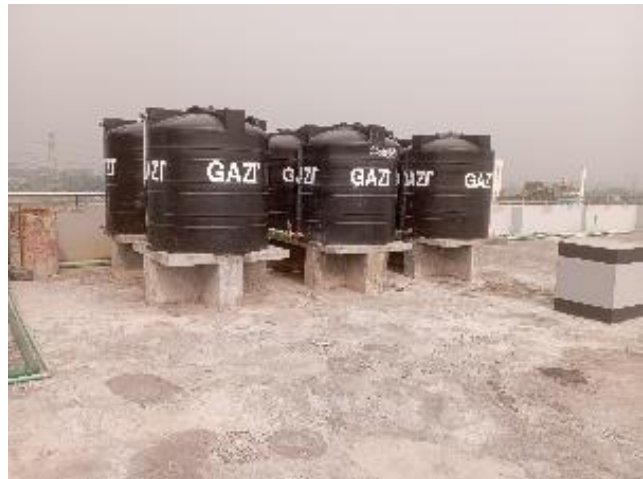
**Observation-7:** Non-structural elements found not anchored (Main Building).

**Description:** Non-structural elements found not anchored which may cause falling hazards during earthquakes. The building engineer is required to anchor/brace all non-structural elements within the factory.

| Observation | Action Plan | Timeline |
|---|---|---|
| Non-structural elements found not anchored (Main Building). | The building engineer is required to anchor/brace all non-structural elements within the factory. | within 6 weeks |

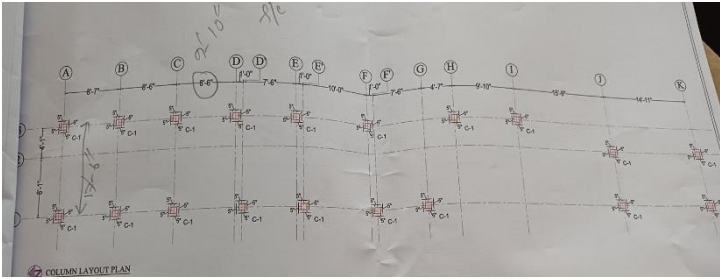
Mismatch in column grid spacing.

**Description:** Mismatch in column grid spacing between on site and as built drawing. Also, two beam sizes were observed instead of one. The building engineer is required to survey the full structure and prepare accurate as-built drawing.

| Observation | Action Plan | Timeline |
|---|---|---|
| Discrepancy in as-built drawing (Maintenance Building). | The building engineer is required to survey the full structure and prepare accurate as-built drawings. | within 6 weeks |

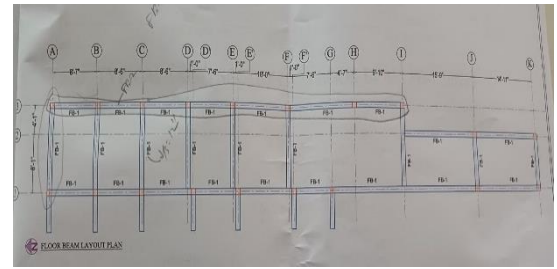
Mismatch in beam size.

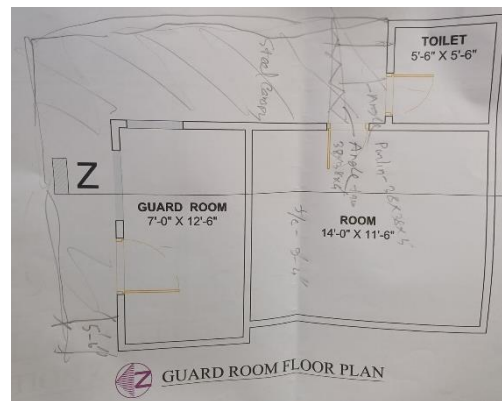
Steel Canopy is not shown in as built drawing.

**Description:** Lack of information was observed for Security and RMS room. Steel canopy is not shown in the layout. The building engineer is required to survey the full structure and prepare accurate as-built drawing.

| Observation | Action Plan | Timeline |
|---|---|---|
| Discrepancy in as-built drawing (Security and RMS room). | The building engineer is required to survey the full structure and prepare accurate as-built drawings. | within 6 weeks |

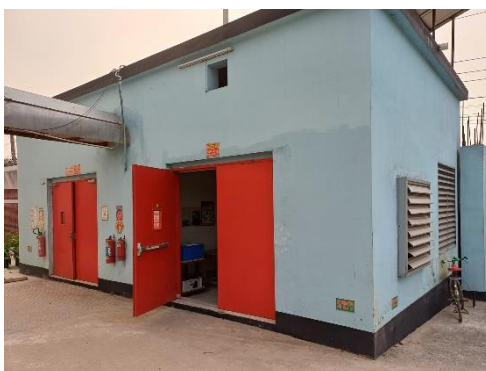
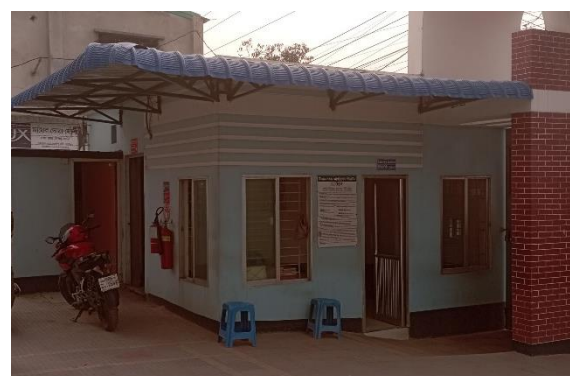
**Observation-10: Lack of structural drawing (Utility Building & Security and RMS room).**

**Description:** During inspection, no structural drawings of Utility Building, and Security and RMS room were not available. The building engineer is required prepare as-built structural drawings of these structures.

| Observation | Action Plan | Timeline |
|---|---|---|
| Lack of structural drawing (Utility Building & Security and RMS room). | The building engineer is required to prepare as-built structural drawings of these structures. | within 6 weeks |
