FIRE SAFETY INSPECTION REPORT

TOPAZ DRESSES LTD.

ACCORD ID: 12395

November 15, 2015

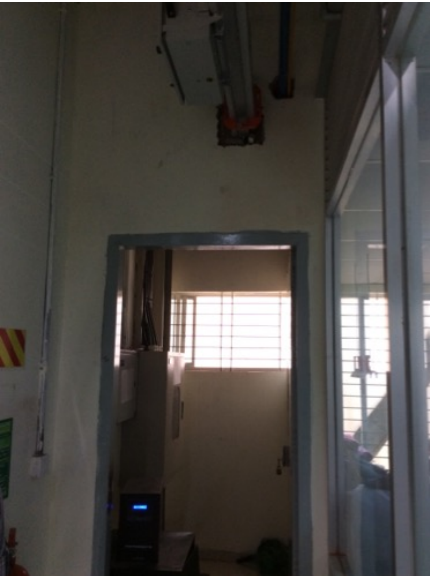
No.	Category	Finding	Recommendation	Remediation Timeframe
F-1	Fire Rated Construction	Unsealed electrical shafts are located in the fire-rated floor/ceiling assemblies.	Provide a minimum 2-hr fire-rated shaft to separate the utility risers from each floor level and seal all penetrations in floor/ceiling assemblies to maintain the fire separation.	Within 3 months

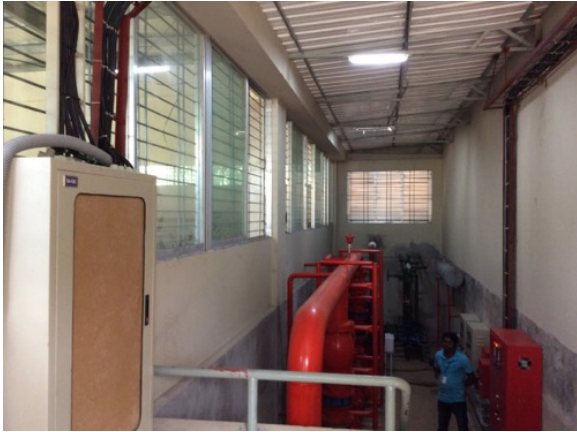
F-2	Fire Rated Construction	The fire pump room is not provided with adequate fire separation.	Provide fire pump room with 2 hr rated fire separation when not sprinklered and 1 hr rated fire separation when provided with automatic sprinklers, in accordance with NFPA 20.	Within 3 months

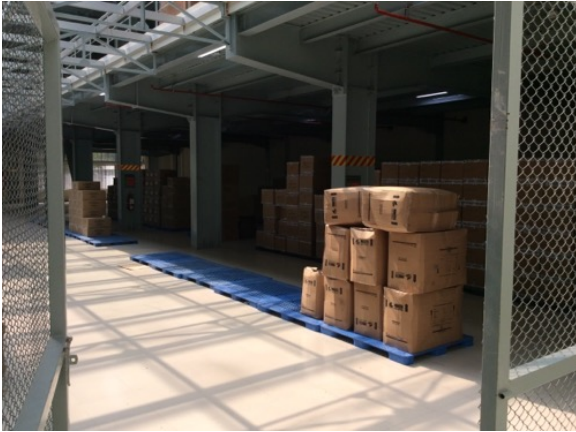
F-3	Fire Rated Construction	Areas used for combustible storage on ground floor open to the factory are not properly defined and/or not within limits.	<p>Provide defined storage areas and limit the storage arrangement as follows:</p> <ul style="list-style-type: none"> - Maximum height of 2.45m (8 ft) and maximum area of 23m² (250 ft²) - If sprinkler protected: maximum height of 3.66m (12 ft) and maximum area of 93m² (1000 ft²) <p>Separate areas of unenclosed combustible storage by a minimum clear distance of 3m (10 ft).</p>	Within 3 months
-----	-------------------------	---	--	-----------------

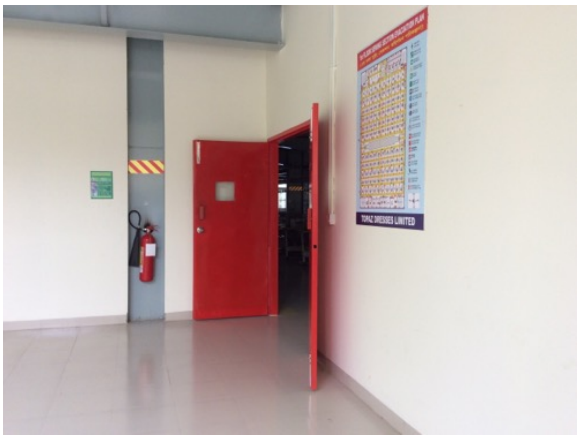
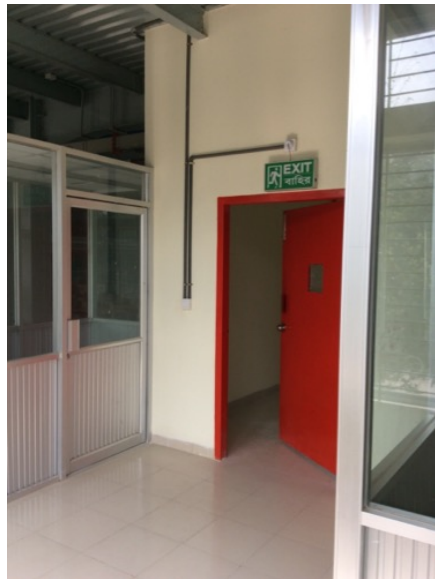
F-4	Fire Rated Construction	Exit stairs are not separated from work areas and other spaces on each floor by fire-rated construction due to unprotected openings and penetrations.	Separate the exit stairs from from work areas and other building spaces on all floor levels by minimum 1-hr fire-rated construction. Provide minimum 1-hr fire rated doors and seal all unprotected openings and penetrations to maintain the fire separation.	Within 3 months
-----	-------------------------	---	--	-----------------

Ensure that all fire doors are self-closing and positive latching, and are provided with fire exit (panic) hardware where serving production floors or assembly occupancies. If fire doors are required to be held open for functional reasons, provide automatic-closing devices tied to the fire alarm system.

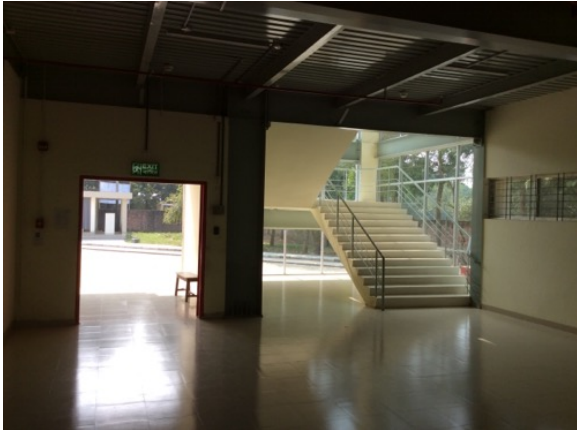
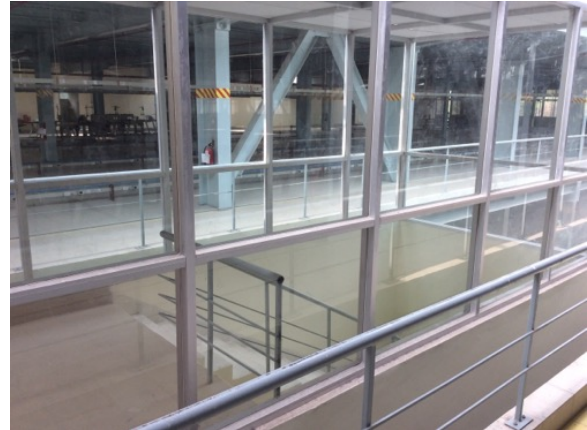
F-5	Fire Rated Construction	The exit stairs on the ground and second floors were open to factory areas due to unenclosed stairwells.	Separate the exit stairs from from work areas and other building spaces on all floor levels by minimum 2-hr fire-rated construction.	Within 3 months
-----	-------------------------	--	--	-----------------

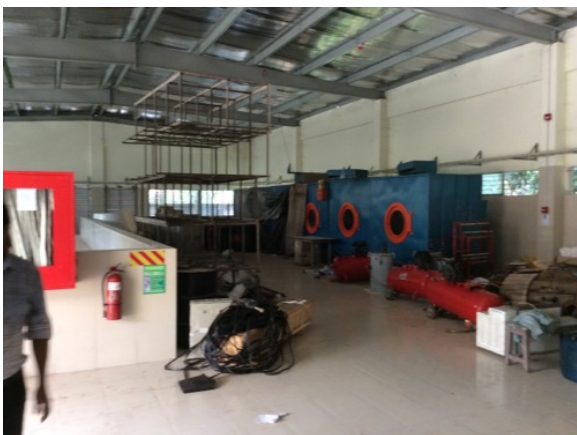
F-6	Fire Rated Construction	<p>The industrial dryers are not separated by fire-rated construction due to openings.</p> <p>This finding is for washing building. If this building is exclusively used for this then is no finding.</p>	<p>Separate the industrial dryer area by a minimum 2-hr fire-rated construction. Seal and/or protect all openings to maintain the required fire separations. Provide proper ventilation and consult with a qualified engineer.</p>	Within 3 months
-----	-------------------------	---	--	-----------------

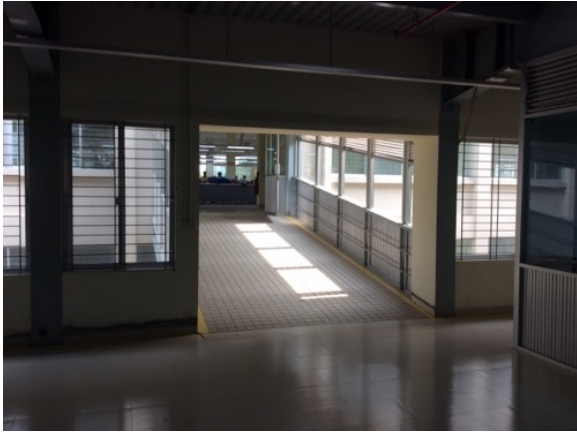
F-7	Fire Rated Construction	Bridge is not separated from work areas and other spaces on first floor by fire-rated construction due to unprotected openings.	Provide minimum 1-hr fire rated doors and seal all unprotected openings and penetrations to maintain the fire separation.	Within 3 months
-----	-------------------------	---	---	-----------------

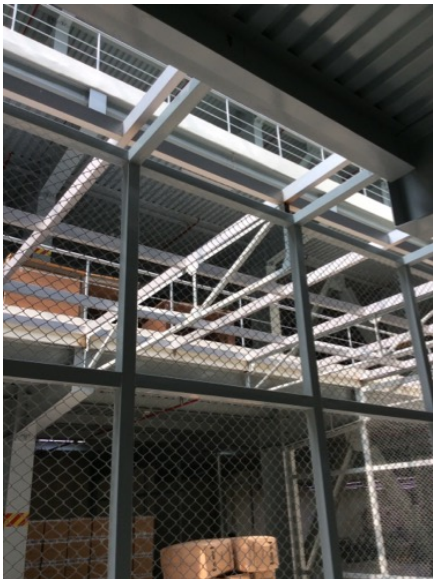
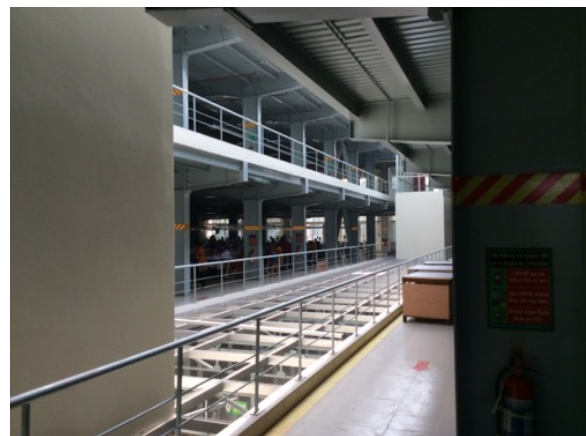
F-8	Fire Rated Construction	Atrium connecting all floors are not properly protected.	Provide proper fire protection in accordance with ACCORD standard 3.7.	Within 6 months
-----	-------------------------	--	--	-----------------

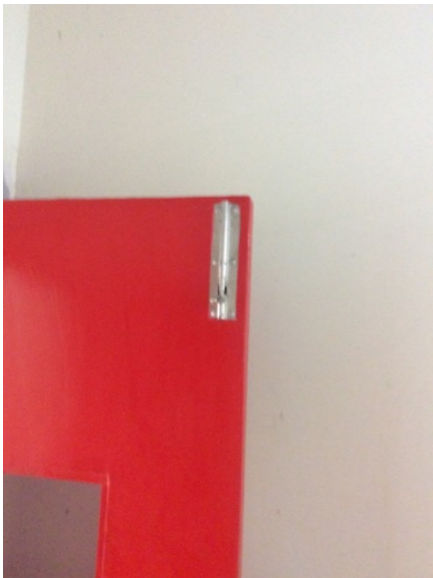
F-9	Egress	Egress doors with locking features are provided at building exits and exit stairs	Remove locking features from all egress doors and gates. If locks are required for security reasons, utilize special door locking features complying with ACCORD standard 6.8.2.	Immediately

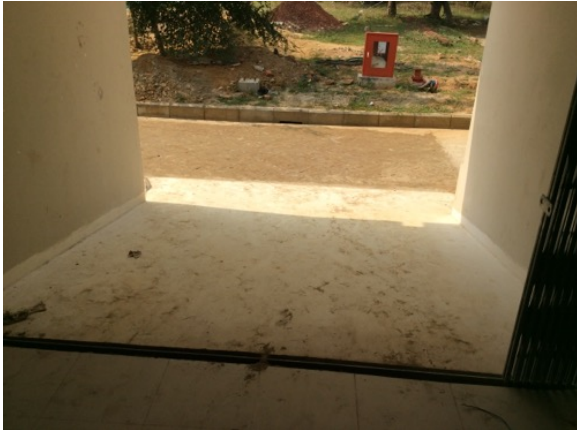
F-10	Egress	Collapsible gates are provided at building exit. This finding is for washing building.	Replace all gates and sliding doors along the means of egress with side-hinged, swinging egress doors in accordance with ACCORD standard 6.8.1.	Within 1 month
------	--------	---	---	----------------

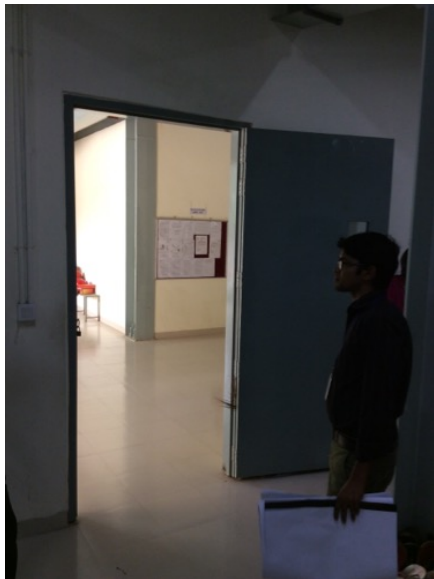
F-11	Egress	Egress door for locker room on ground floor serving 50 or more occupants does not swing in the direction of egress travel.	Modify the egress door to swing in the direction of egress travel.	Within 3 months
------	--------	--	--	-----------------

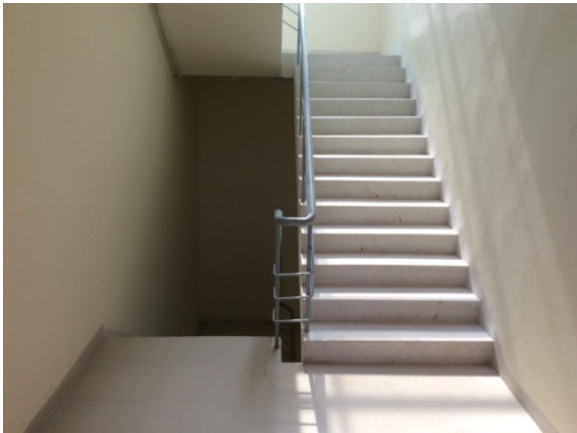
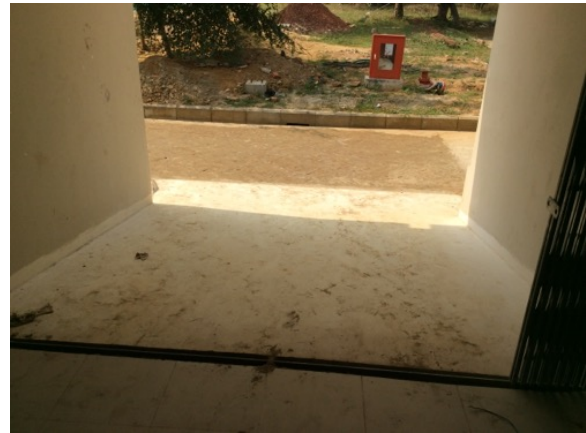
F-12	Egress	Handrails are not provided on both sides of the exit stair.	Provide handrails on both sides of the exit stair and ramp. New handrails shall have a minimum height of 865 mm (34 in.) and a maximum height of 965 mm (38 in.) as measured from the leading edge of the tread. Intermediate handrails shall be provided when the stair width exceeds 2.2 m (87 in.) .	Within 3 months
------	--------	---	---	-----------------

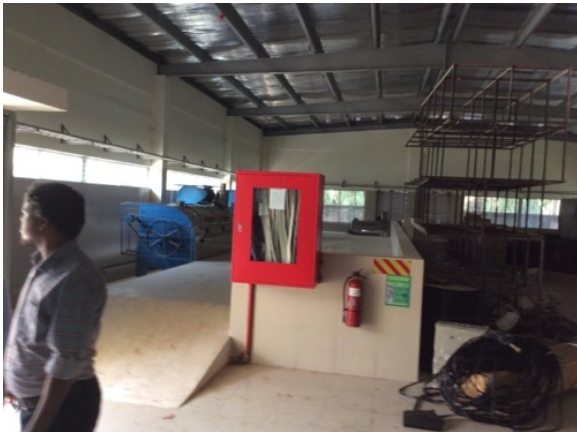
F-13	Egress	The number of provided exits is not adequate. This finding is for washing building.	Provide minimum of two, remotely located means of egress per ACCORD standard 6.6.1.	Within 6 months
------	--------	--	---	-----------------

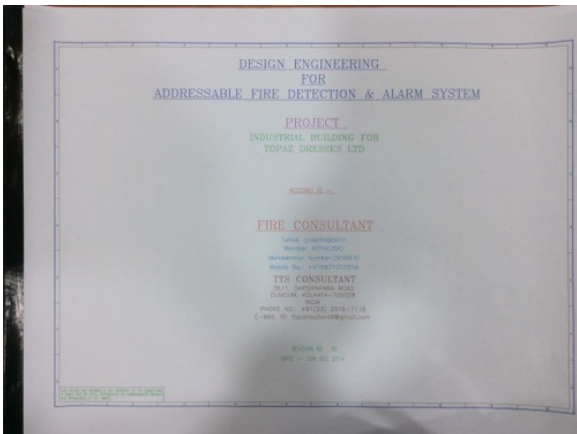
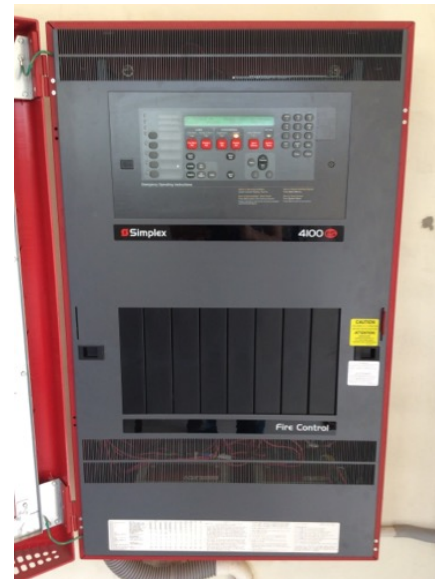
F-14	Fire Protection	Fire alarm system installation requires detailed review to confirm compliance with NFPA 72 and ACCORD standards.	Submit as-built drawings, testing records, equipment certification and other relevant documentation to the ACCORD for review and approval.	Within 1 month
------	-----------------	--	--	----------------

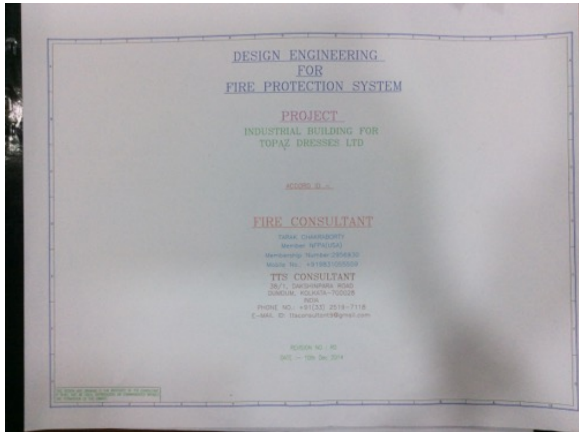
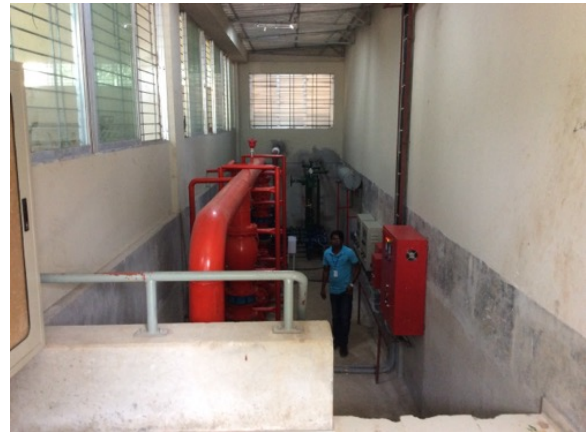
F-15	Fire Protection	Fire pump installation requires detailed review to confirm compliance with NFPA 20 and ACCORD standards.	Submit as-built drawings, testing records, equipment certification and other relevant documentation to the ACCORD for review and approval.	Within 1 month
------	-----------------	--	--	----------------

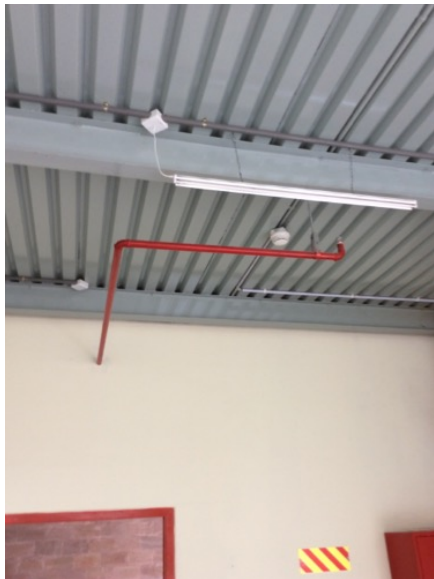
F-16	Fire Protection	Automatic sprinkler system installation requires detailed review to confirm compliance with NFPA 13 and ACCORD standards.	Submit as-built drawings, testing records, equipment certification and other relevant documentation to the ACCORD for review and approval.	Within 1 month
------	-----------------	---	--	----------------

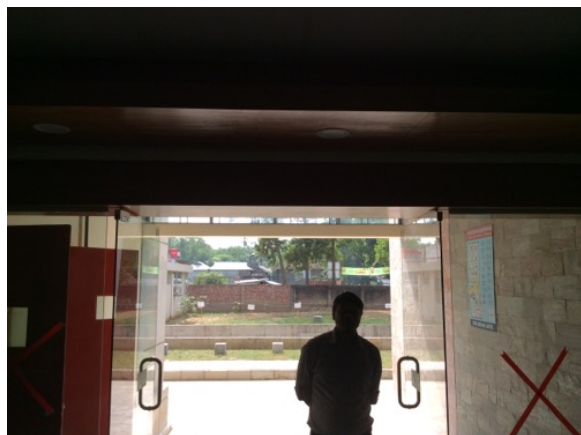
F-18	Fire Protection	Inspection, testing and maintenance of the standpipe system is not in accordance with NFPA 14.	Inspect, test and maintain the standpipe system and keep written records on-site, in accordance with NFPA 14 and ACCORD standards.	Within 3 months
F-19	Egress Lighting	Exit signage at office area was not provided at a building exit.	Provide exit signs above all building exits to the exterior, all doors to the exit stairs and along all paths of travel where a change of direction is not obvious.	Within 1 month

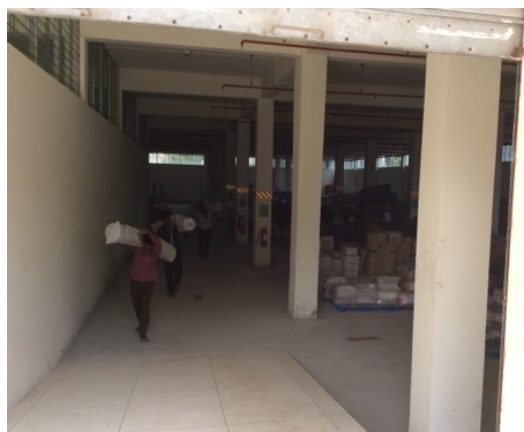
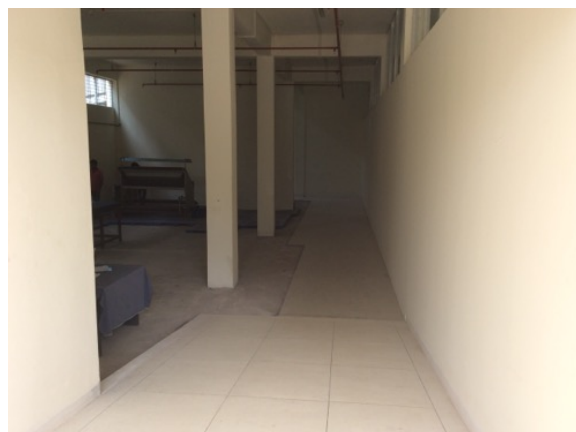
No.	Category	Finding	Recommendation	Remediation Timeframe
F-1	Fire Rated Construction	Rooms used for combustible storage on the ground floor are not separated by a minimum 1-hr fire-rated construction.	Provide dedicated storage rooms separated by minimum 1-hr fire-rated construction.	Within 3 months

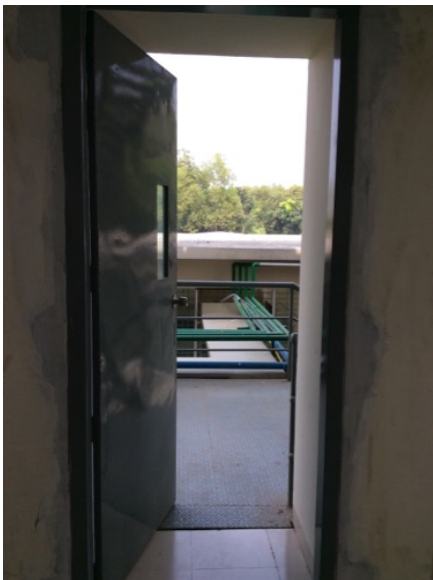
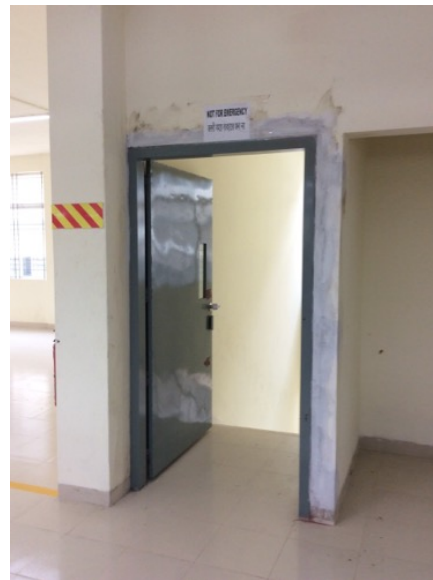
F-2	Fire Rated Construction	Exit stairs are not separated from work areas and other spaces on each floor by fire-rated construction due to unprotected openings and penetrations.	Separate the exit stairs from from work areas and other building spaces on all floor levels by minimum 1-hr fire-rated construction. Provide minimum 1-hr fire rated doors and seal all unprotected openings and penetrations to maintain the fire separation.	Within 3 months
			Ensure that all fire doors are self-closing and positive latching, and are provided with fire exit (panic) hardware where serving production floors or assembly occupancies. If fire doors are required to be held open for functional reasons, provide automatic-closing devices tied to the fire alarm system.

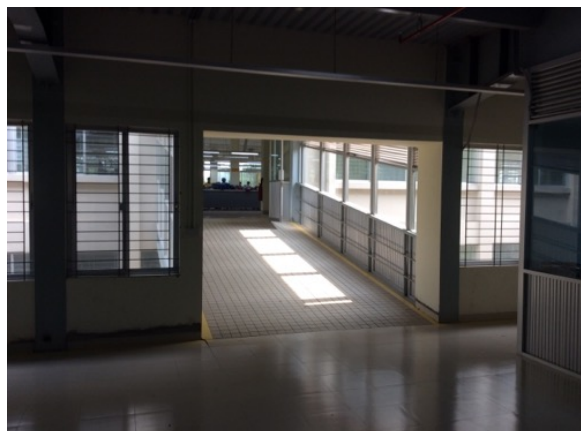
F-3	Fire Rated Construction	Bridge is not separated from work areas and other spaces on first floor by fire-rated construction due to unprotected openings.	Provide minimum 1-hr fire rated doors and seal all unprotected openings and penetrations to maintain the fire separation.	Within 3 months
-----	-------------------------	---	---	-----------------

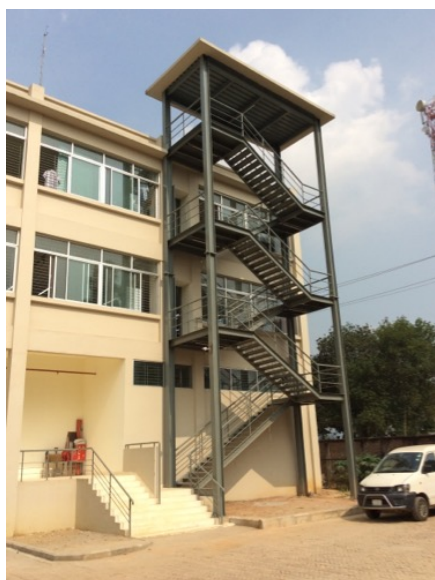
F-4	Fire Rated Construction	Exterior exit stairs are not properly separated from the building.	Exterior exit stairs shall be separated from the building with a rating requirement of 1 hr fire rating for 3 or fewer stories. The rating of the exterior wall shall extend 3.05 m (10 ft) beyond the ends of the stair structure.	Within 6 months
-----	-------------------------	--	---	-----------------

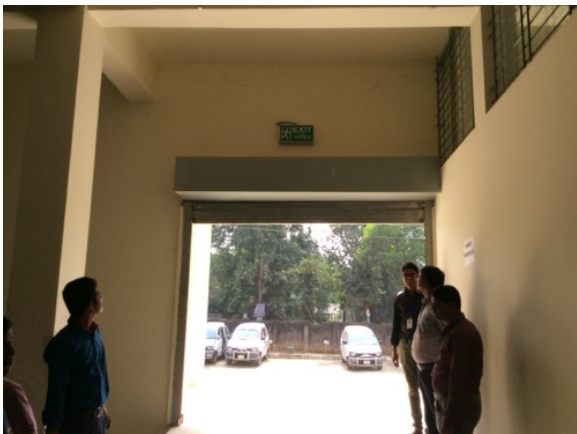
F-5	Egress	The exit capacity of the second floor (440) was insufficient for the maximum occupant load (600).	Reduce occupant load immediately to not more than available exit capacity (440). Provide additional exits in the future to increase exit capacity.	Immediately
F-6	Egress	Sliding doors are provided at building exit.	Replace all gates and sliding doors along the means of egress with side-hinged, swinging egress doors in accordance with ACCORD standard 6.8.1.	Within 1 month

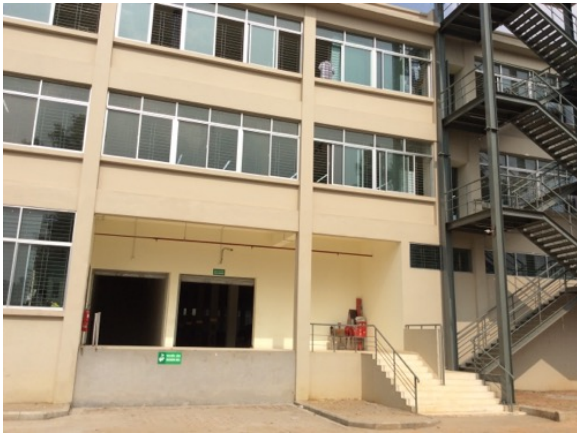
F-7	Egress	The number of provided exit on ground floor is not adequate.	Provide minimum of two, remotely located means of egress per ACCORD standard 6.6.1.	Within 6 months
-----	--------	--	---	-----------------
