# Babylon Garments & Dresses Ltd. (Extension)

2-B/1, DARUSSALAM ROAD, MIRPUR, DHAKA.

24 December 2023

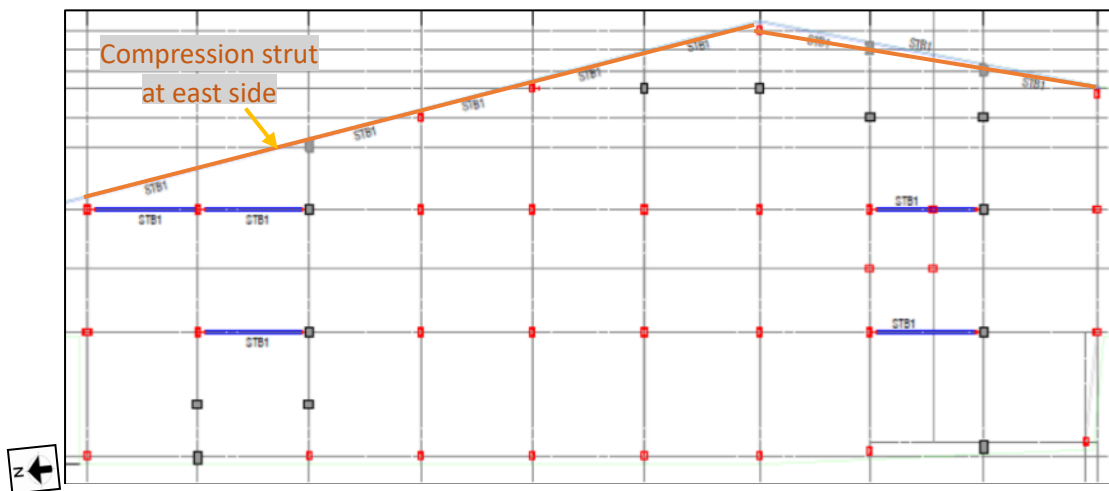
**Observation-1:** Lack of lateral stability for roof (Store Building).

**Description:** Compression strut is provided at east side only and lateral stability system appears to be incomplete. The building engineer is required to check the lateral stability of the structure and propose remedial measures if required.

| Observation | Action Plan | Timeline |
|---|---|---|
| Lack of lateral stability for roof (Store Building). | The building engineer is required to check the lateral stability of the structure and propose remedial measures if required. | within 6 weeks |
| Lack of lateral stability for roof (Store Building). | Carry out suggested remedial works if required. | within 6 months |

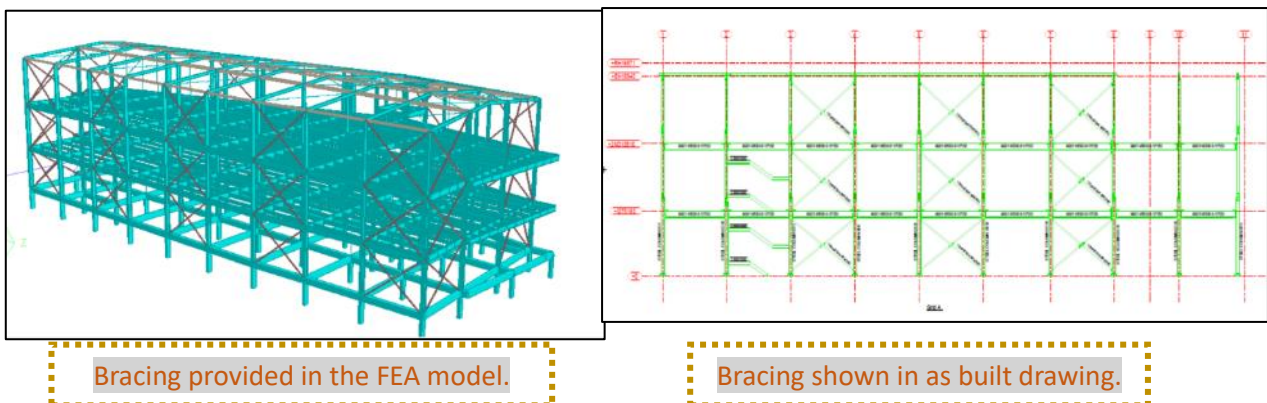
**Observation-2:** Inconsistency between as-built drawing and FEA model (Store Building).

**Description:** Position and number of bracings in FEA model are not exactly as per as-built drawing/as-built condition. The building engineer is required to update design report and FEA model as per as-built condition.

| Observation | Action Plan | Timeline |
|---|---|---|
| Inconsistency between as-built drawing and FEA model (Store Building). | The building engineer is required to update design report and FEA model as per as-built condition. | within 6 weeks |
| Inconsistency between as-built drawing and FEA model (Store Building). | Carry out suggested remedial works if required. | within 6 months |

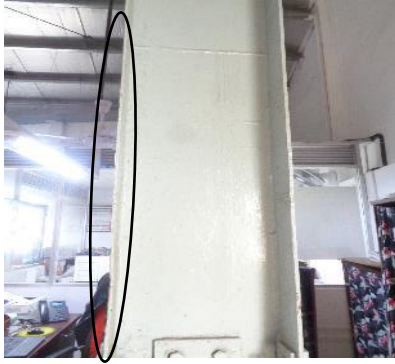
Mismatch was observed in  
member size

**Description:** During inspection, mismatches were found between onsite condition and as built drawing. Flange thickness was found 8mm instead of 10mm at gable frame column (south side). Also, canopy was not shown in the as-built drawing. The building engineer is required to survey the full structure and produce accurate as-built drawings.

| Observation | Action Plan | Timeline |
|---|---|---|
| Mismatch in as built drawing (Store Building). | The building engineer is required to survey the full structure and produce accurate as-built drawings. | within 6 weeks |

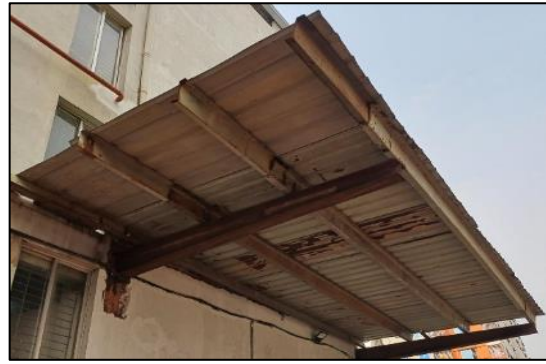
Canopy was not shown in  
the drawing.

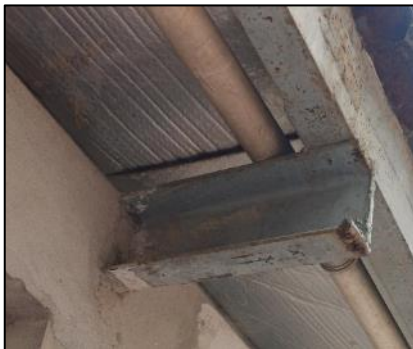
Rafter inserted to brick wall  
connection (Daycare Shed)

**Description:** Apparently inadequate connection was found at Daycare Shed and Kitchen Shed. The building engineer is required check the connection adequacy for uplift forces of all the structures.

| Observation | Action Plan | Timeline |
|---|---|---|
| Apparently Inadequate connection (Daycare Shed and kitchen Shed ). | The building engineer is required check the connection adequacy for uplift forces of all the structures. | within 6 weeks |
| Apparently Inadequate connection (Daycare Shed and kitchen Shed ). | Carry out suggested remedial works if required. | within 6 months |

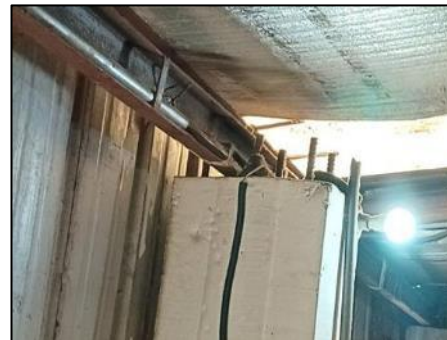
Poor connection between rafter  
and RC column (Kitchen Shed)

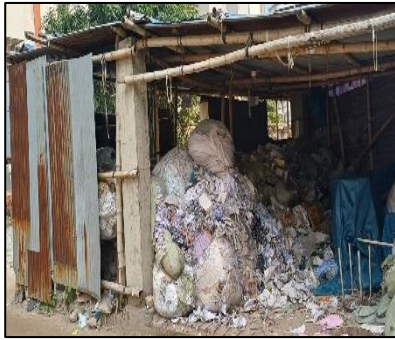
Roof made of tin and  
bamboo in wastage shed.

**Description:** The roof of Wastage Shed was found non-engineered (made of tin and bamboo). The building engineer is required to replace the non-engineered shed with engineered one.

| Observation | Action Plan | Timeline |
|---|---|---|
| Non-engineering shed need to be replaced (Wastage Shed). | Building engineer is required to produce as-built drawings for the Ancillary structures. | within 6 months |
