# Explore Garments Ltd.

Gorai, Mirzapur, Tangail-1941, Bangladesh

17 December 2023

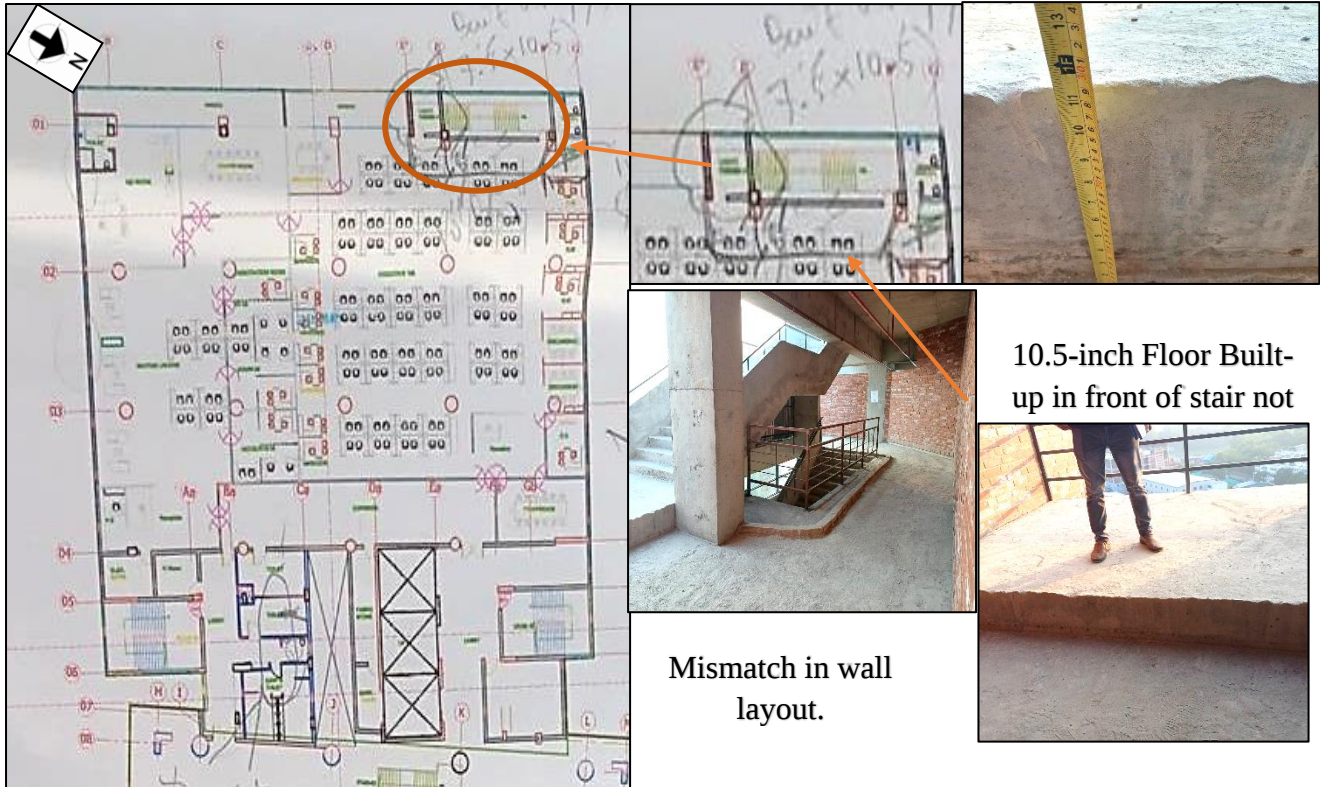
**Observation-2:** Mismatch in as-built drawings (Main Production Building).

**Description:** During inspection, mismatches were found between onsite condition and as-built drawing. Floor built-up was observed in front of stair on 10<sup>th</sup> floor on store part. Also, partition wall layout was not match with onsite condition near the stair area. The building engineer is required to survey the full structure and produce accurate as-built drawings.

| Observation | Action Plan | Timeline |
|---|---|---|
| Mismatch in as-built drawings (Main Production Building). | The building engineer is required to survey the full structure and produce accurate as-built drawings. | within 6 weeks |

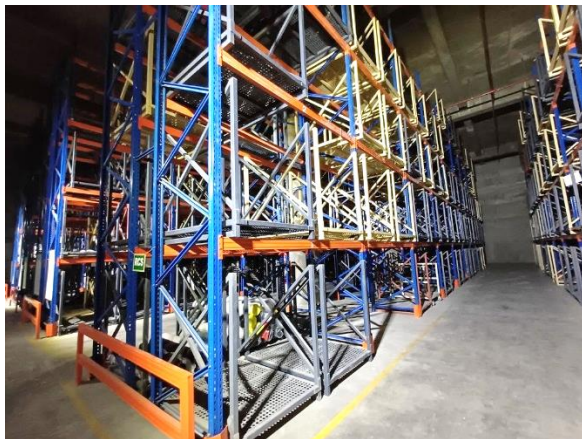
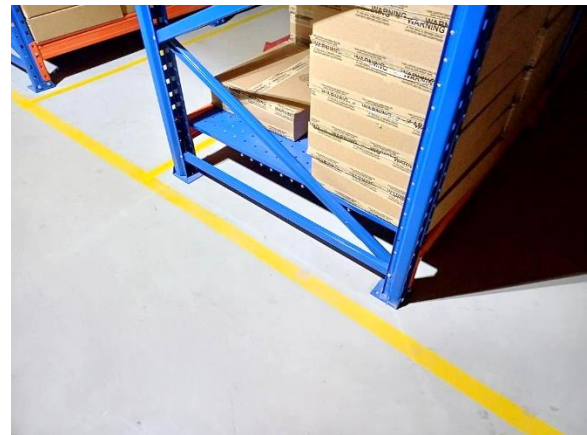
**Observation-3:** Non-structural elements found unbraced/not anchored (Main Production Building).

**Description:** Non-structural elements suspended from, attached to, or resting top the structure shall be adequately anchored and braced to resist earthquake forces. Factory is required to brace/anchor all non-structural elements.

| Observation | Action Plan | Timeline |
|---|---|---|
| Non-structural elements found unbraced/not anchored (Main Production Building). | Building engineer is required to brace/anchor all non-structural elements. | within 6 weeks |

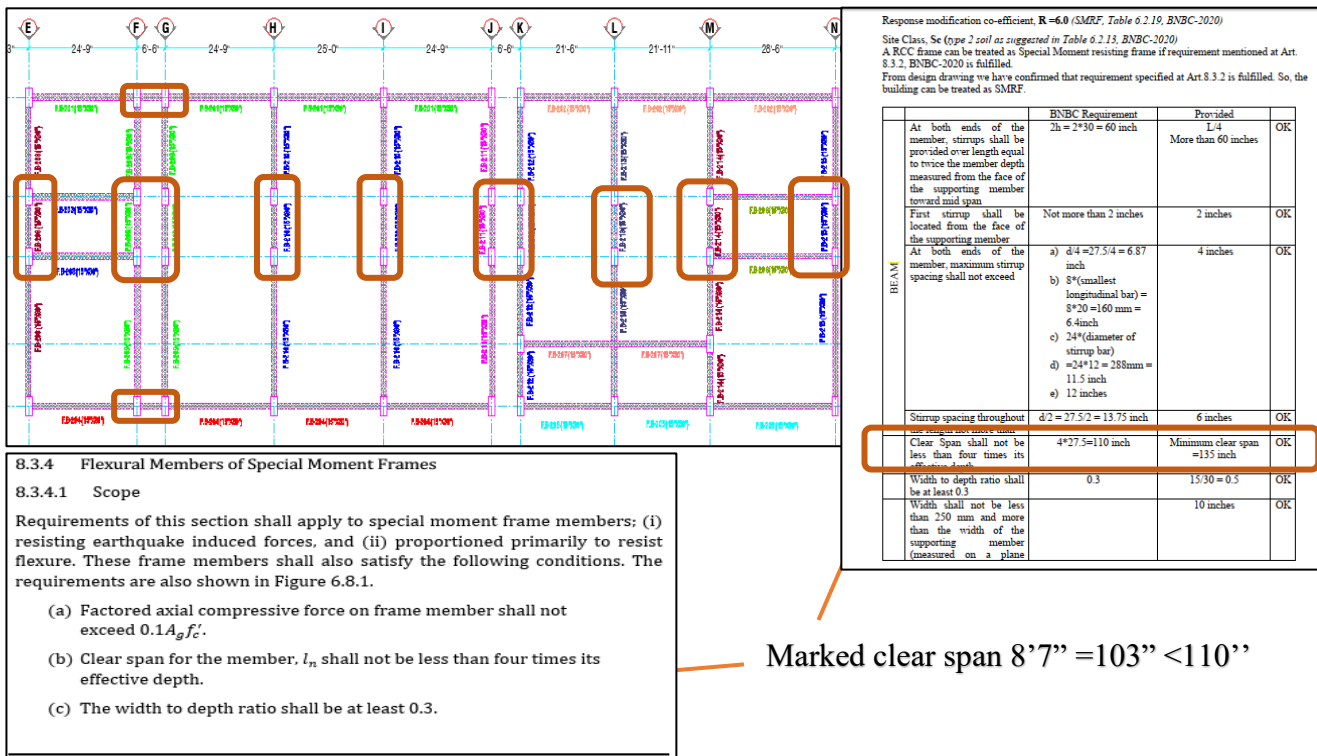
#### Observation-4: Design Report needs to be updated (Utility Building).

**Description:** Utility building has been designed in accordance with NBC 2020 considering Special Moment Resisting Frame (SMRF). Flexural members of the SMRF system have to comply with Sec. 8.3.4.1(b) of NBC 2020. However, several beams in the structural system observed not complying with this requirement. The building engineer is required to revise the design and design report with appropriate framing system complying with Table 6.2.19 and Sec 8.3 of NBC 2020.

| Observation | Action Plan | Timeline |
|---|---|---|
| Design Report needs to be updated (Utility Building). | The building engineer is required to revise the design report for the appropriate framing system complying with Table 6.2.19 and Sec 8.3 of BNBC 2020. | within 6 weeks |
| | Carry out remedial work if required. | within 6 months |

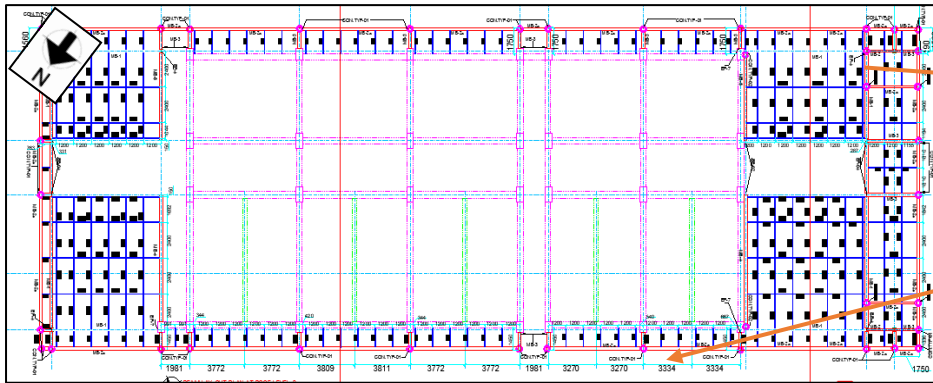
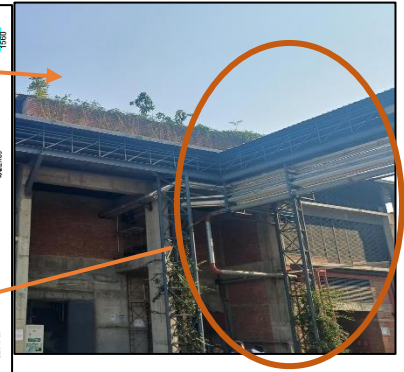
A steel pipe tray connected to the steel part which is absent in as-built drawings.

| Observation | Action Plan | Timeline |
|---|---|---|
| Mismatch in as-built drawings (Utility Building). | The building engineer is required to survey the full structure and produce accurate as-built drawings. | within 6 weeks |

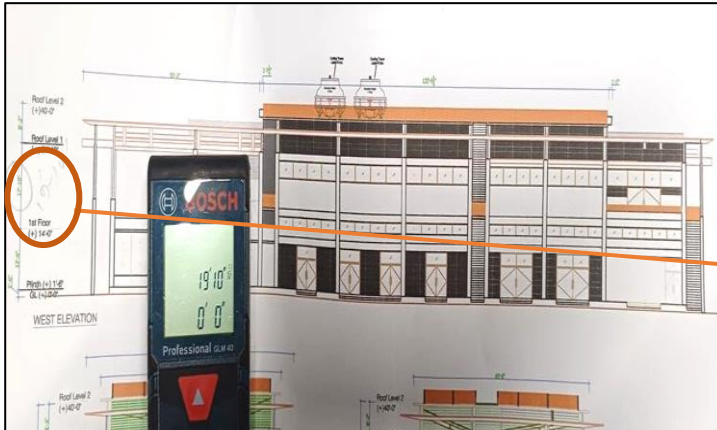
Floor to ceiling height was observed 6.04 m instead of 5.44 m.

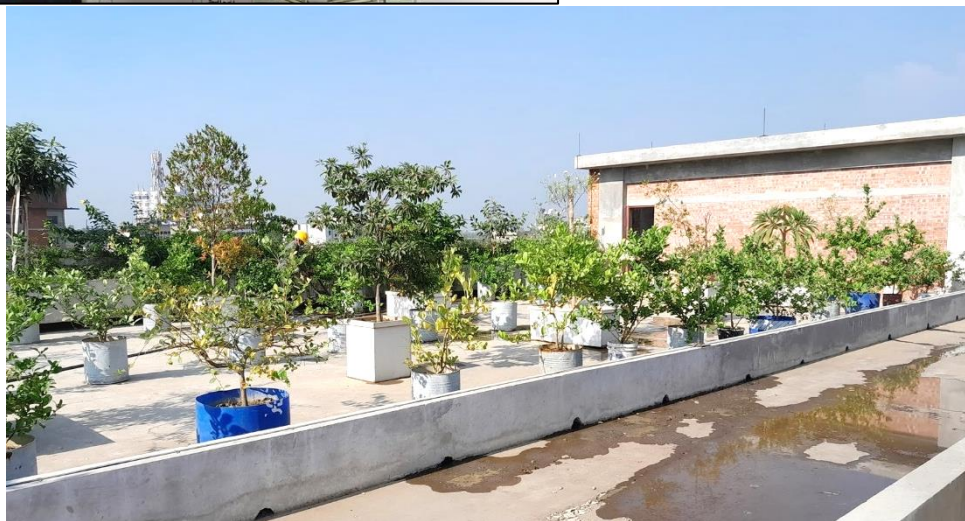
Gardening at the roof – not shown in the drawing

**Description:** During the inspection, mismatches were found between the onsite condition and the as-built drawing. Water tank and roof top gardening was not shown in the drawing. Also, steel pipe tray is connected to the steel portion which has not shown in drawings. The building engineer is required to survey the full structure and produce accurate as-built drawings.

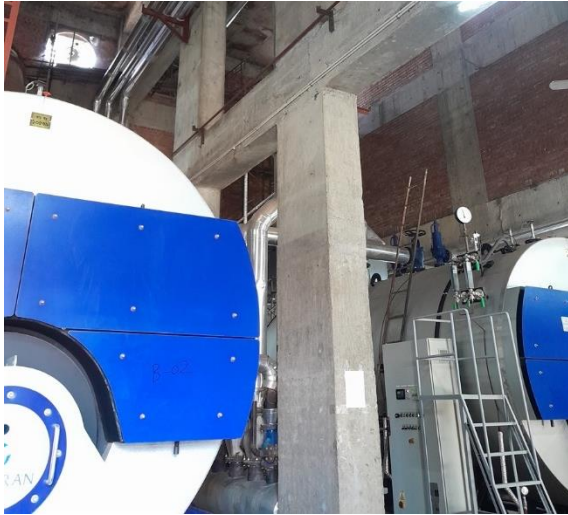
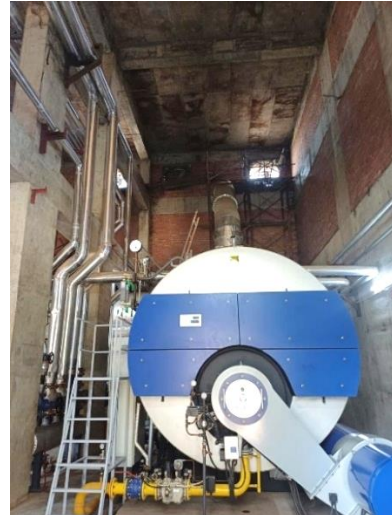
**Observation-6:** Load plan needs to be implemented at the ground floor (Utility Building)

**Description:** A boiler was found at the top slab of the underground water reservoir. Building engineer is required to produce and implement a load plan as per slab capacity.

| Observation | Action Plan | Timeline |
|---|---|---|
| Load plan needs to be implemented at ground floor (Utility Building) | Produce and actively manage a loading plan for all floor plates within the factory considering slab capacity. | within 6 weeks |

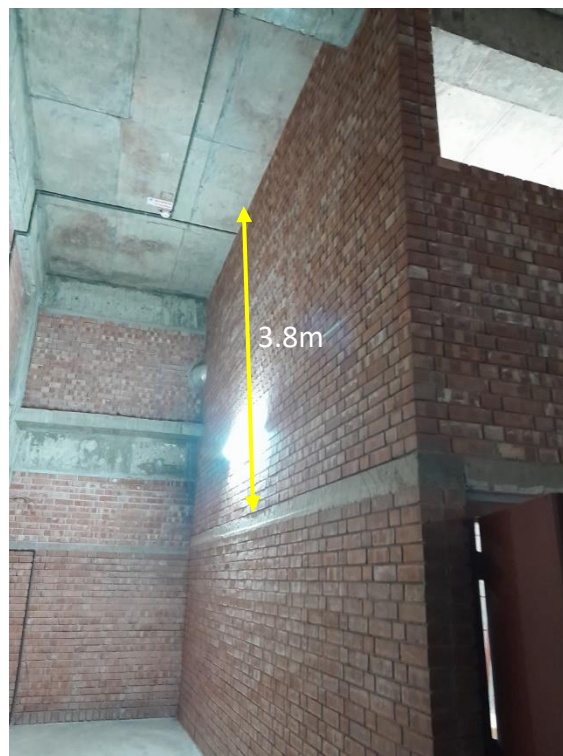
**Observation-7:** Apparently a high brick wall was observed (Utility Building)

**Description:** Apparently a high brick wall (3.8m height) was observed on the 1st floor. Building engineer is required to check the stability of the brick wall.

| Observation | Action Plan | Timeline |
|---|---|---|
| Apparently a high brick wall was observed (Utility Building) | Building engineer is required to check the stability of the brick wall. | within 6 weeks |
| | Carry out remedial work if required. | within 6 months |

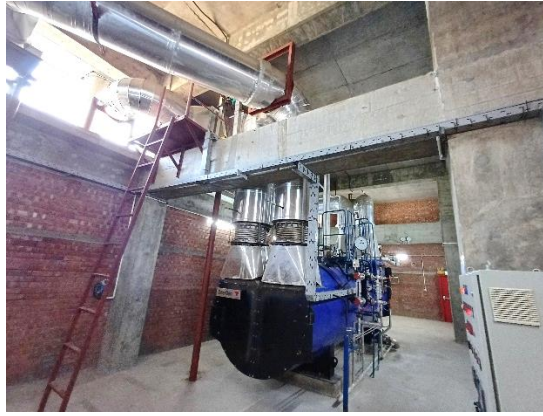
**Observation-8:** Vibration on 1<sup>st</sup> floor (Utility Building)

**Description:** Vibration was felt on the 1st floor. The building engineer is required to check the reason for the vibration, check the slab adequacy subject to imposed loading & vibration and suggest proper remedial/damping methodology.

| Observation | Action Plan | Timeline |
|---|---|---|
| Vibration on 1 <sup>st</sup> floor (Utility Building) | The building engineer is required to check the reason for the vibration, check the slab adequacy subject to imposed loading & vibration and suggest proper remedial/damping methodology. | within 6 weeks |
| | Carry out remedial work if required. | within 6 months |

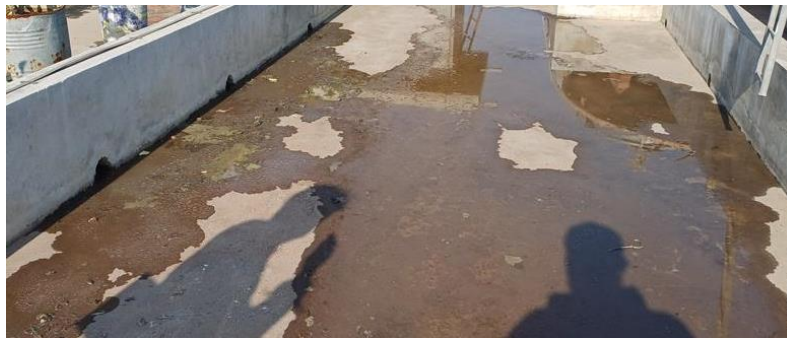
**Observation-9:** Water ponding on the roof (utility Building)

**Description:** Water ponding was observed on the roof of the building. The building engineer is required to develop a proper drainage system on the roof with an adequate slope.

| Water ponding on the roof (Utility Building) | Building engineer is required to develop a proper drainage system on the roof with adequate slope. | within 6 weeks |

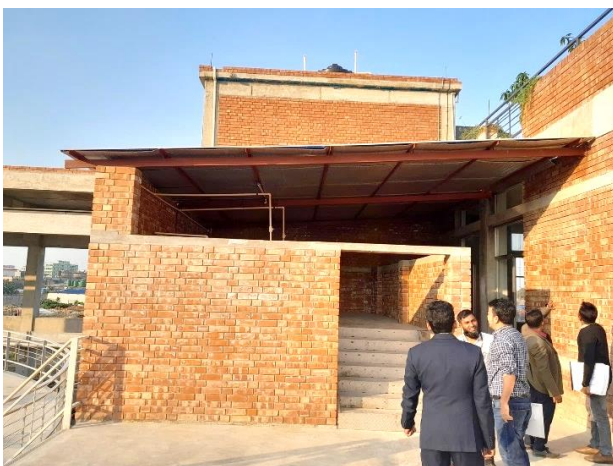
Non-Engineered Shed

**Description:** During the inspection, the apparently non-engineered shed was found. The building engineer is required to check the members, connection & stability system of the structure and suggest proper alternatives accordingly.

| Apparently non-engineered roof shed (ETP) | The building engineer is required to check the members, connection & stability system of the structure and suggest proper alternatives accordingly. | within 6 weeks |
| | Carry out remedial work if required. | within 6 months |

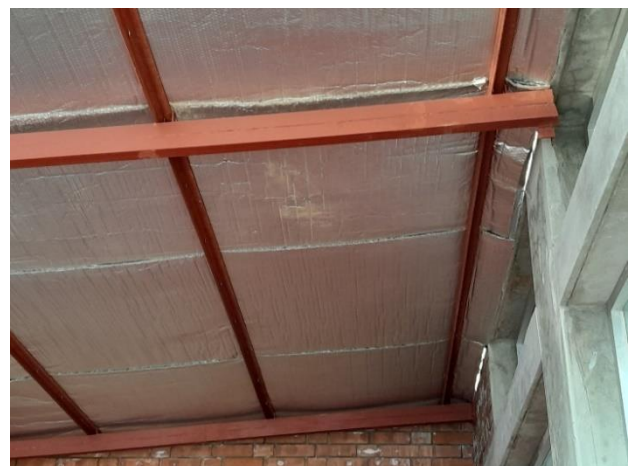
Poor Connection

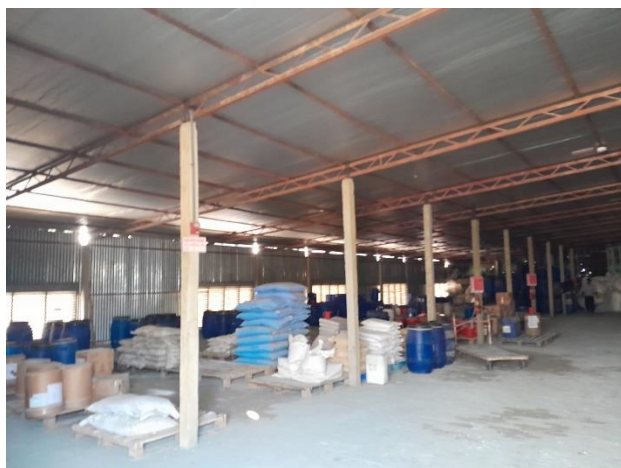
Non-Engineered Shed

**Description:** Lack of lateral stability system, apparent inadequate members and non-engineered connection were observed. The building engineer is required to check the member, connection & stability system of the structure and suggest proper remediation accordingly.

| Apparently non-engineered structure (Chemical Store) | The building engineer is required to check the member, connection & stability system of the structure and suggest proper remediation accordingly. | within 6 weeks |
| | Carry out remedial work if required. | within 6 months |

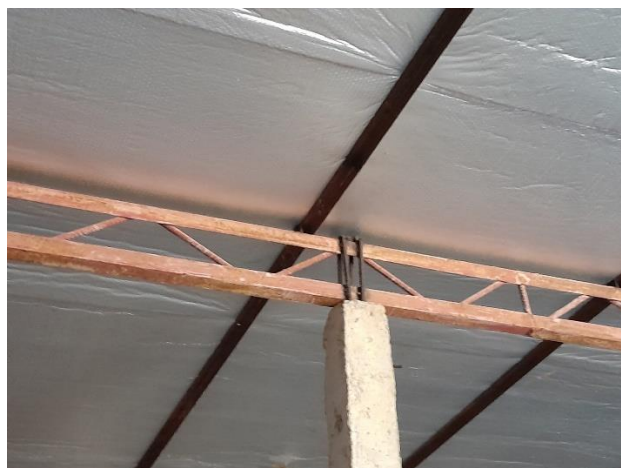
Poor Connection

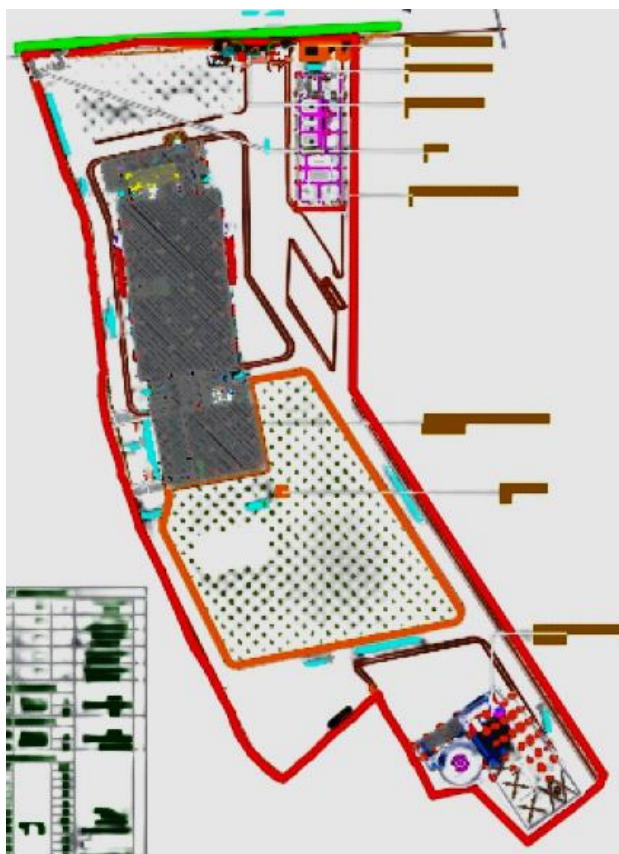
**Observation-12:** Building Permit from local authority not available (All Structures)

**Description:** During the inspection, the building permit from the local authority was not available for all buildings. The factory authority is required to collect building permits from the local government authority for all buildings.

| Building Permit from local authority not available (All Structures) | The factory authority is required to collect building permits from the local government authority for all buildings. | within 6 months |
