Alim Knit (BD) Ltd (Extension)

24 December 2023

Structural Inspection Report

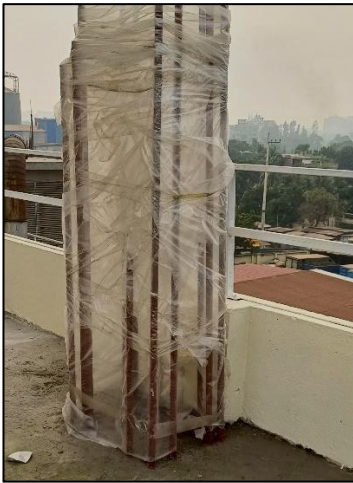
Observation-1: Discrepancies in as-built structural drawings (Building-3).

12@25mm dia rebar (4X4) for NC1 Column found at site

Description: During the inspection, total 12 numbers of 25mm dia of re-bar was found for the NC1 at site. But in the provided drawing total 16 numbers of 20mm dia re-bar has been shown. The building engineer is required to survey the full structure and produce accurate as-built drawings.

1.	Discrepancies in as-built structural drawings (Building-3).	The building engineer is required to survey the full structure and produce accurate as-built drawings.	within 6 weeks

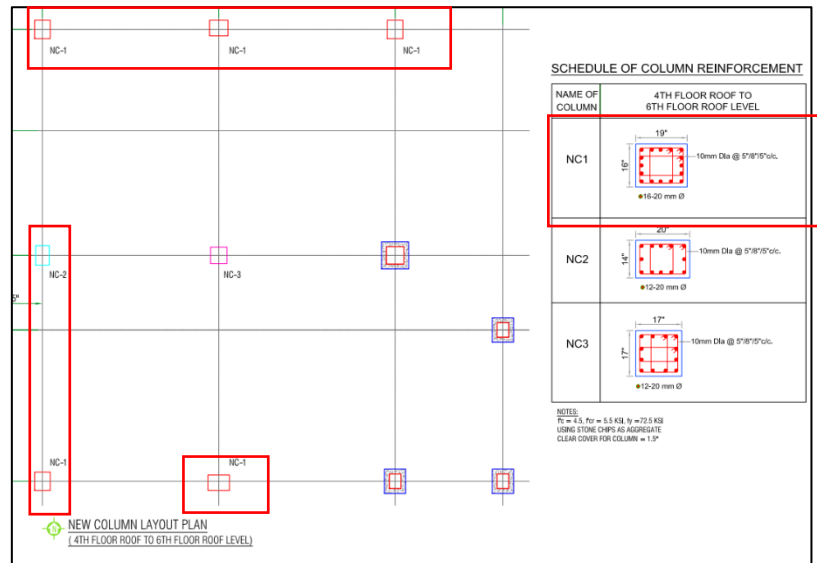
4 numbers of re-bar were found each of the NC1 column instead of 5 numbers.

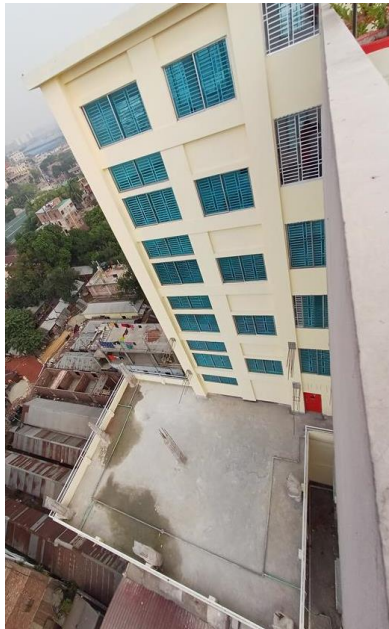
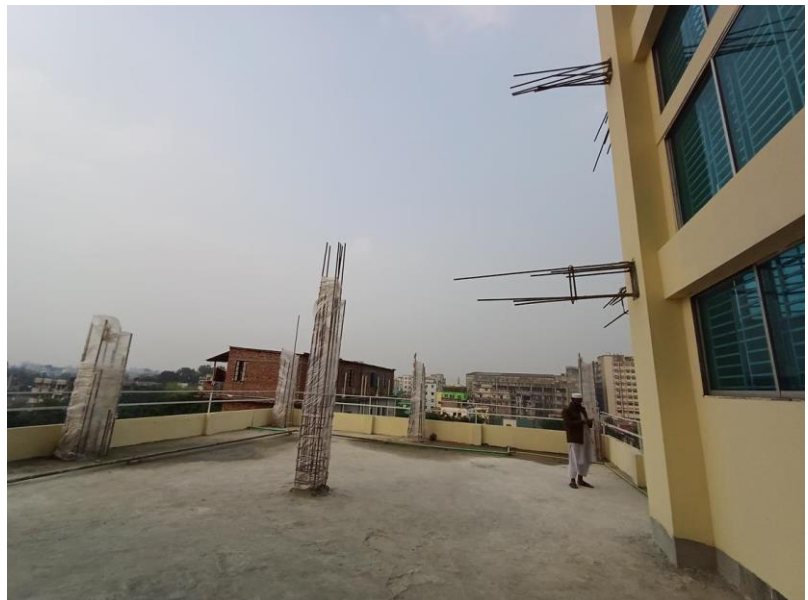
Building-3

Observation-2: Design check is required for lateral loading. (Building-3).

Description: Design report was available for Building-3. The factory is required to submit design documents to the RSC for detailed review against lateral loading for the existing building.

2.	Design check required against lateral loading. (Building-3).	The factory is required to submit design documents to the RSC for detailed review against lateral loading for the existing building.	within 6 weeks

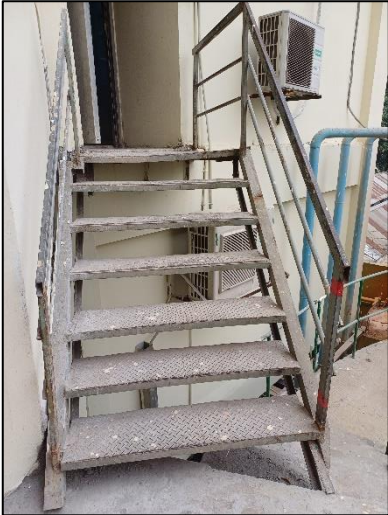
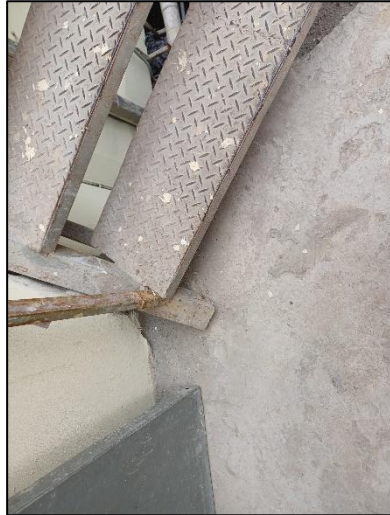
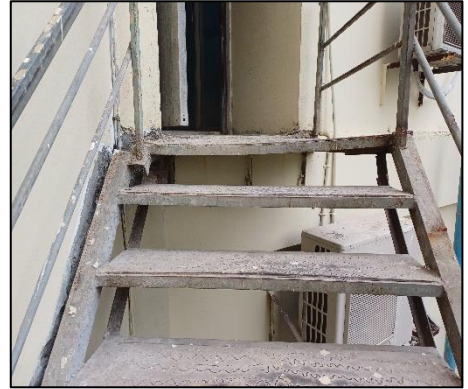
Observation-3: Apparently non-engineered steel stair. (Building-3)

Description: The connections of the steel stair is inadequate at 2nd floor. A building engineer is required to check the adequacy of the steel stair.

3.		Carry out suggested remedial works if required.	within 6 months
4.	Apparently non-engineered steel stair. (Building-3)	Building engineer is required to check the structural adequacy of the steel stair.	within 6 weeks

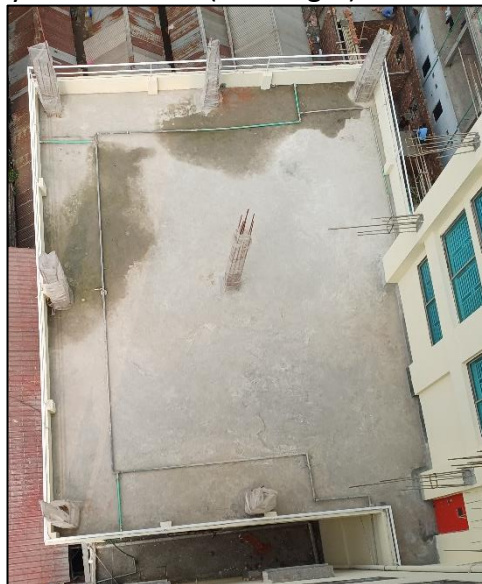
Observation-4: Poor drainage system on roof. (Building-3)

Description: During the inspection, a poor roof drainage system and signs of stagnant water were found on the roof. The building engineer is required to improve the water drainage system on the roof with proper slope & adequate number of water outlets.

5.		Carry out suggested remedial works if required.	within 6 months
6.	Poor drainage system on roof. (Building-3)	The building engineer is required to improve the water drainage system on the roof with proper slope & adequate number of water outlets.	within 6 weeks

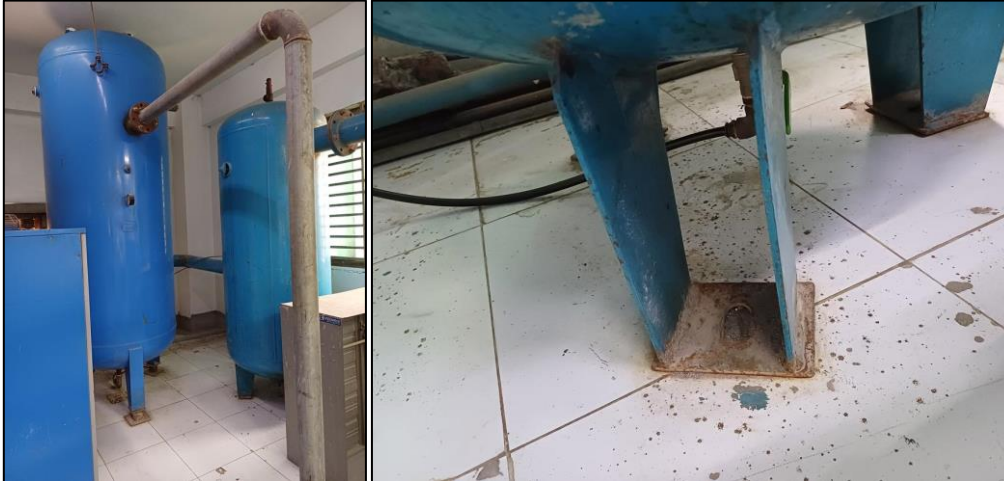
Observation-5: Lack of anchorage of machine on 2nd floor. (Building-3)

Description: On the 2nd floor, anchorages were not found. Building engineer is required to anchor all the vessel/tanks/machinery.

7.	Lack of anchorage of machine on 2 nd floor. (Building-3)	Building engineer is required to anchor all the vessel/tanks/machinery.	within 6 weeks
8.	Design report needs to be reviewed for lateral loading. (Thermo Oil Heater & EGB Boiler Building)	The building engineer is required to submit the design report to RSC for further checking considering lateral loading.	within 6 weeks

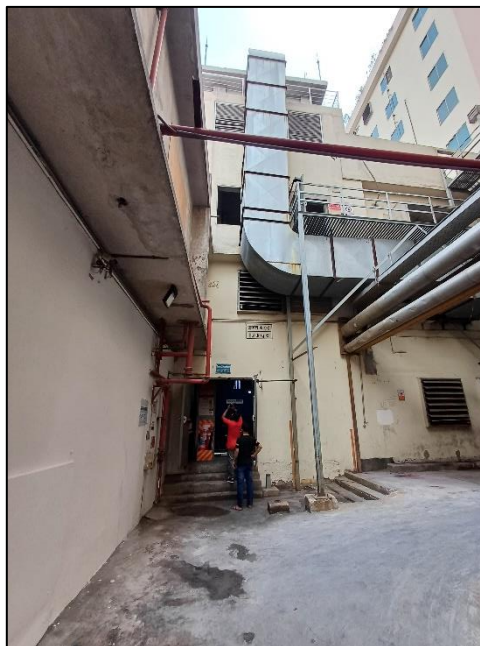
Observation-6: Design report needs to be reviewed for lateral loading. (Thermo Oil Heater & EGB Boiler Building)

Description: A set of design reports was available for the building. The building engineer is required to submit the design documents to the RSC for detail review against lateral forces.

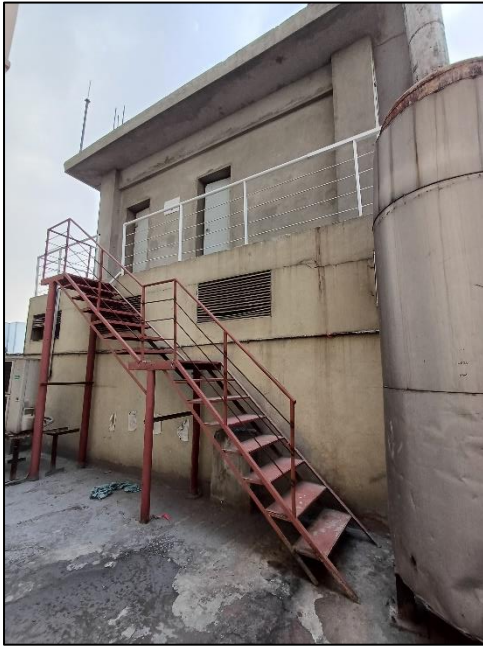
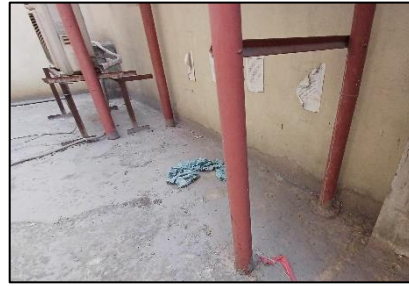
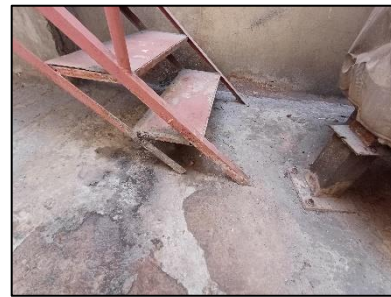
Observation-7: Inadequate connection/anchorage of steel stair. (Thermo Oil Heater & EGB Boiler Building)

Description: Inadequate structural connections were found on steel stair to enter 2nd floor of Thermo Oil Heater & EGB Boiler Building. Building engineer is required to check the connection adequacy of the steel stair.

9.		Carry out suggested remedial works if required.	within 6 months
10.	Adequacy of steel stairs needs to be checked. (Thermo Oil Heater & EGB Boiler Building)	Building engineer is required to check the structural adequacy of the steel stair.	within 6 weeks

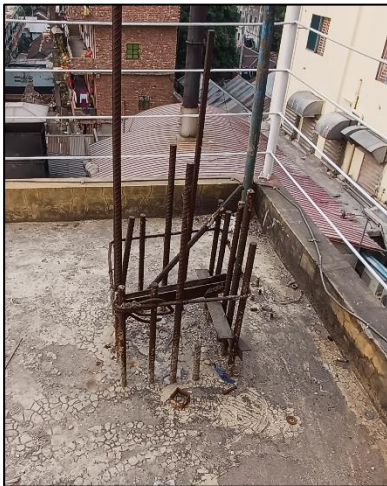
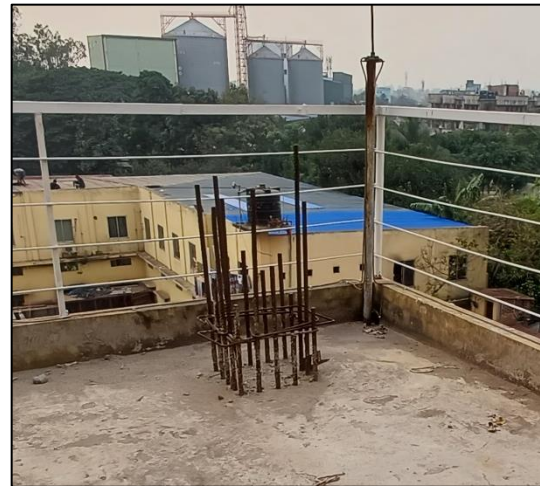
Observation-8: Exposed rebar on roof. (Thermo Oil Heater & EGB Boiler Building)

Description: Exposed reinforcement is left at roof and 2nd floor open area, which is prone to corrosion. Building engineer is required to remove the rust and provide rust proof coating on exposed reinforcement to protect from corrosion.

11.		Carry out suggested remedial works if required.	within 6 months
12.	Exposed rebar on roof. (Thermo Oil Heater & EGB Boiler Building)	Building engineer is required to provide rust proof coating on exposed reinforcement to protect from corrosion.	within 6 weeks

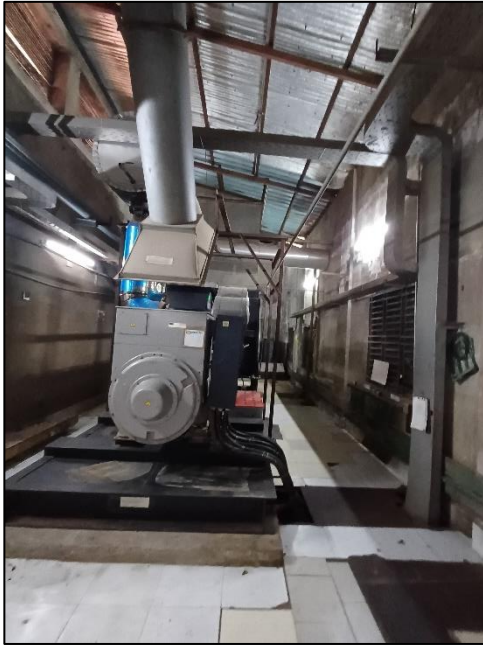
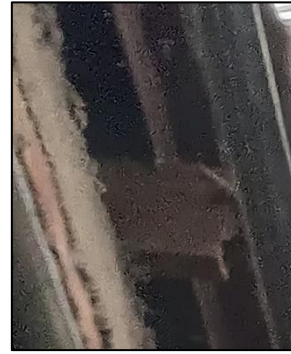
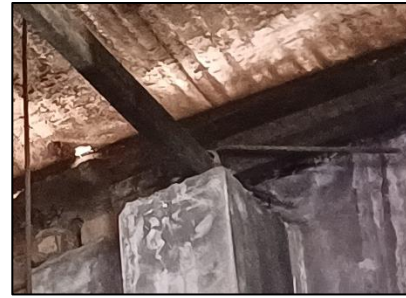
Observation-9: Adequacy of connection needs to be verified. (Diesel Generator Shed)

Description: The roof of the structure is made of light weight steel shed supported by brick wall. The connection of the steel shed with brick wall seems to be inadequate. Building engineer is required to check the adequacy of the steel connection for uplift forces.

13.	Apparently inadequate connection. (Diesel Generator Shed)	Building engineer is required to check the adequacy of the steel connection for uplift forces.	within 6 weeks

14.		Carry out suggested remedial works if required.	within 6 months

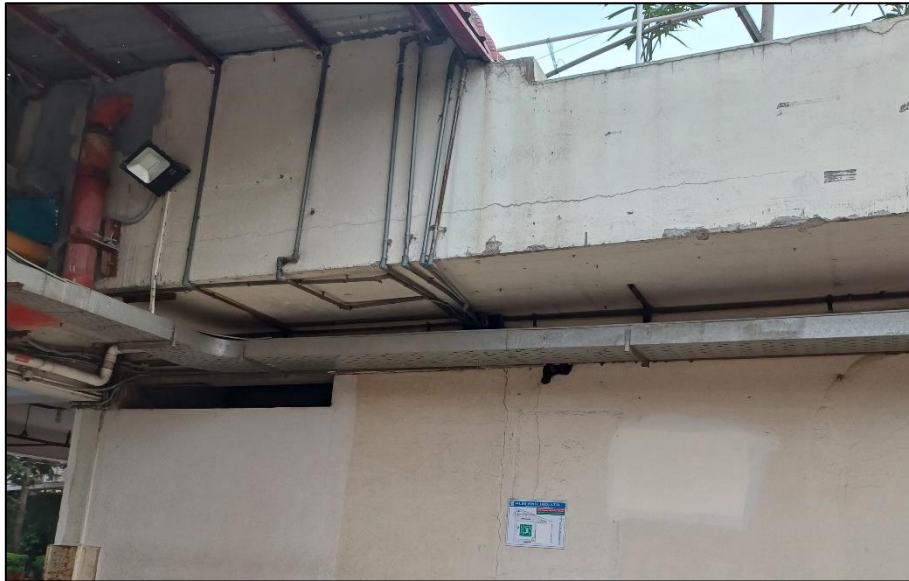
Observation-10: Crack on Brick wall. (Fire Control & Guard room)

Description: Crack found on brick wall of Fire Control & Guard room. Building engineer is required to investigate the cause of wall cracks and repair with a suitable method.

15.	Crack on Brick wall. (Fire Control & Guard room)	Building engineer is required to investigate the cause of wall cracks and repair with a suitable method.	within 6 weeks

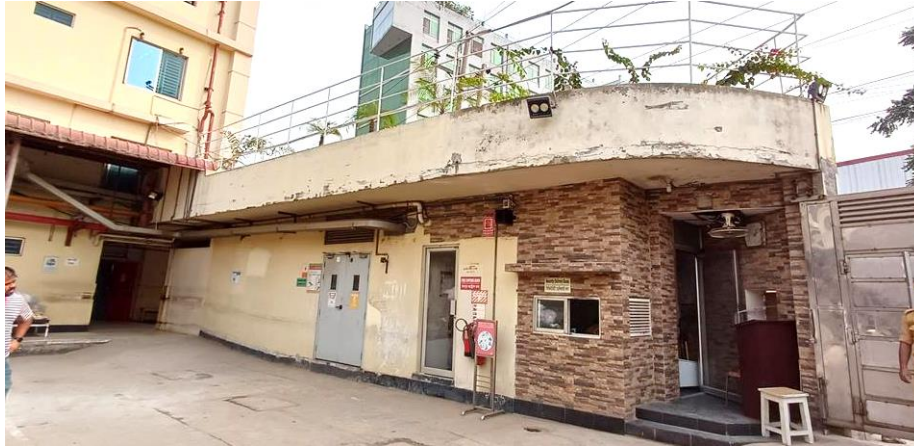
Observation-11: Vehicle impact on slab & parapet wall. (Fire Control & Guard Room)

Description: Parapet walls are susceptible to vehicle impact. The building engineer is required to take necessary action to avoid the vehicle impact in the wall.

16.	Vehicle impact on wall. (Fire Control & Guard room)	The building engineer is required to take necessary action to prevent the vehicle impact in the wall.	within 6 weeks

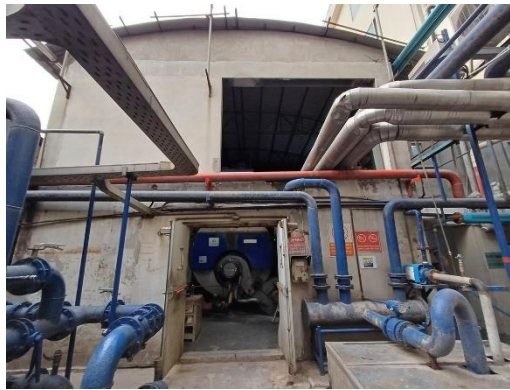
Observation-12: Structural connection between Boiler Shed and adjacent Building-3. (Boiler Shed)

Description: The truss of the shed is supported by the slab of adjacent Building-3. The building engineer is required to suggest necessary alternatives to make the shed separate, develop proper remedial scheme and submit the design documents to the RSC for detail review.

17.	Structural connection between Boiler Shed and adjacent structure. (Boiler Shed)	The building engineer is required to suggest necessary alternatives to make the shed separate, develop proper remedial scheme and submit the design documents to the RSC for detail review.	within 6 weeks

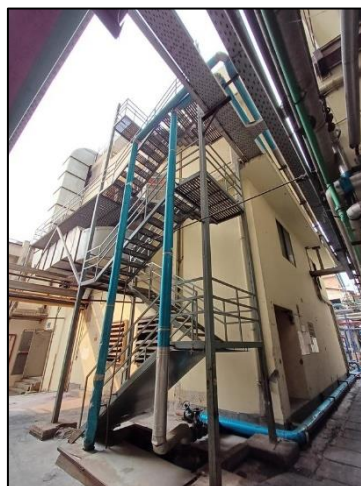
Observation-13: Design report needs to be reviewed for lateral loading. (Generator Building)

Description: A set of design reports was available for the building. The building engineer is required to submit the design documents of the building and adjacent steel stair to the RSC for detail review against lateral forces.

18.		Carry out suggested remedial works.	within 6 months
19.	Design report needs to be reviewed for lateral loading. (Generator Building)	The building engineer is required to submit the design documents of the building and adjacent steel stair to the RSC for detail review against lateral forces.	within 6 weeks

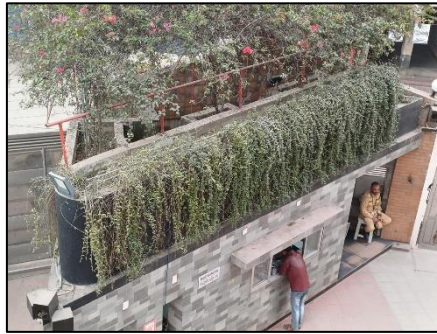
Observation-14: Heavy loading on suspended floor (Security Control Post)

Description: Heavy loading on 1st floor of Security Control Post. The building engineer is required to check the slab adequacy for the imposed loading and submit the design documents to the RSC for review.

20.		Carry out suggested remedial works if required.	within 6 months
21.	Heavy loading on suspended floor (WTP & Security Control Post)	The building engineer is required to check the slab adequacy for the imposed loading and submit the design documents to the RSC for review.	within 6 weeks

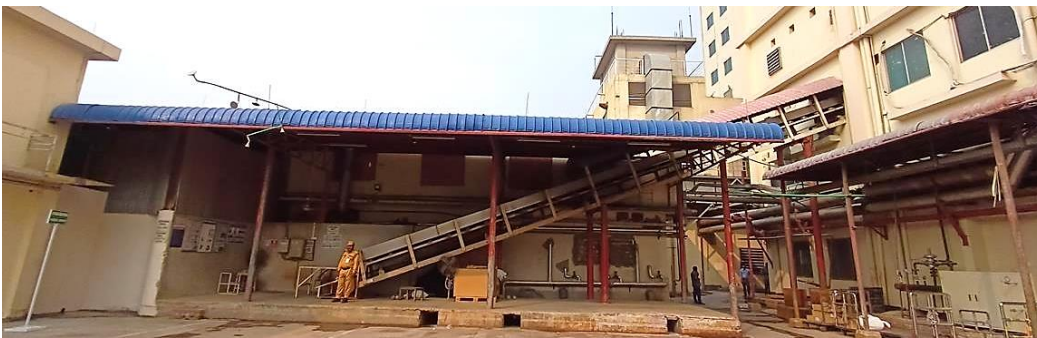
Observation-15: Lack of design document for Conveyor Belt Shed.

Description: An undocumented conveyor belt shed was observed having no design documents. The building engineer is required to prepare a set of design reports for the shed and conveyor belt and submit the design documents to the RSC for review against lateral & gravity forces.

22.		Carry out suggested remedial works if required.	within 6 months
23.	Lack of design document for Conveyor Belt Shed.	The building engineer is required to prepare a set of design reports for the shed and conveyor belt and submit the design documents to the RSC for review against lateral & gravity forces.	within 6 weeks

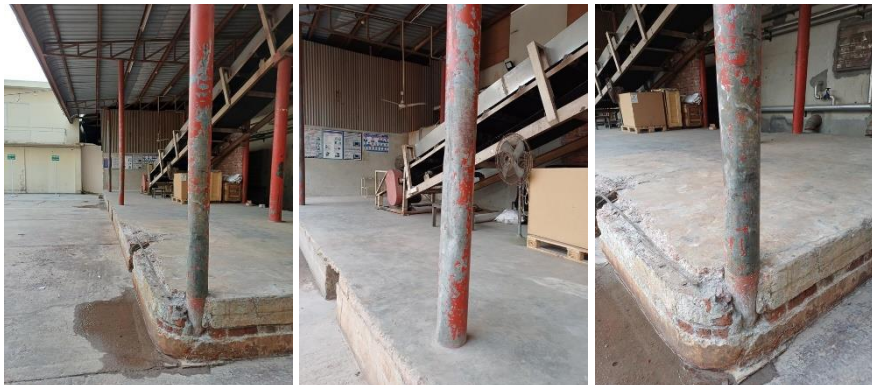
Observation-16: Vehicle impact on the steel column of Conveyor Belt Shed.

Description: Distress due to vehicle observed on the steel column. The factory is required to provide necessary precautionary signage and barrier surrounding the susceptible steel columns to avoid further impact.

24.		Carry out suggested remedial works.	within 6 months
25.	Vehicle impact on the steel column of Conveyor Belt Shed.	The factory is required to provide necessary precautionary signage and barrier surrounding the susceptible steel columns to avoid further impact.	within 6 weeks
