# Amtranet Limited (New Buildings 2)

14 December 2023

## Structural Inspection Report

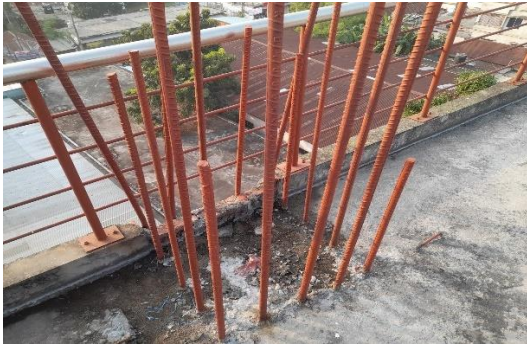
Column C2 exposed rebar at roof

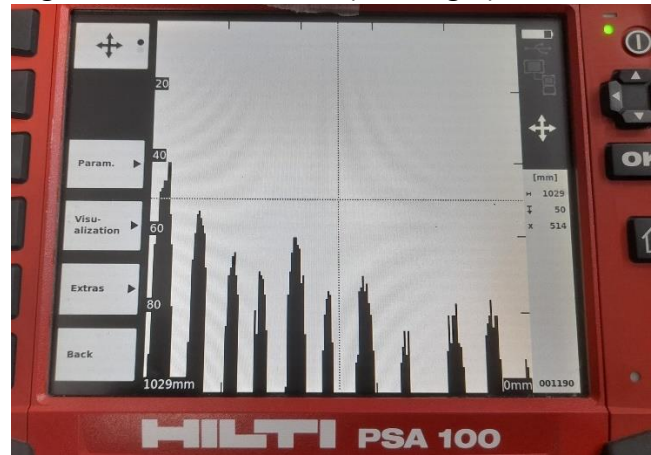
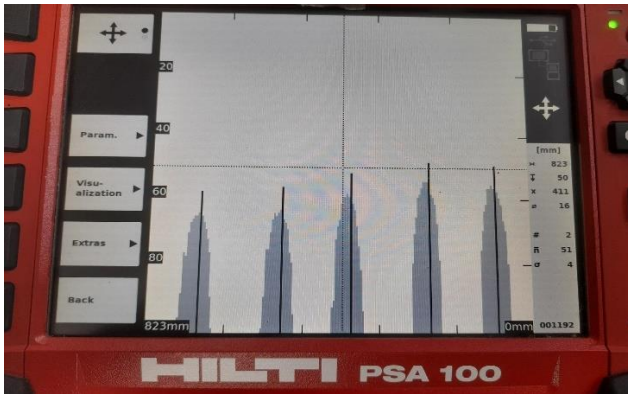
Column C2 re-bar profile scan at 1<sup>st</sup> floor

Column C2; less numbers of re-bar observed

**Description:** During the inspection, column type C2 & C12 re-bar information mismatches observed with the provided drawing and on-site condition. The building engineer is required to survey the full structure and prepare accurate as-built drawings accordingly.

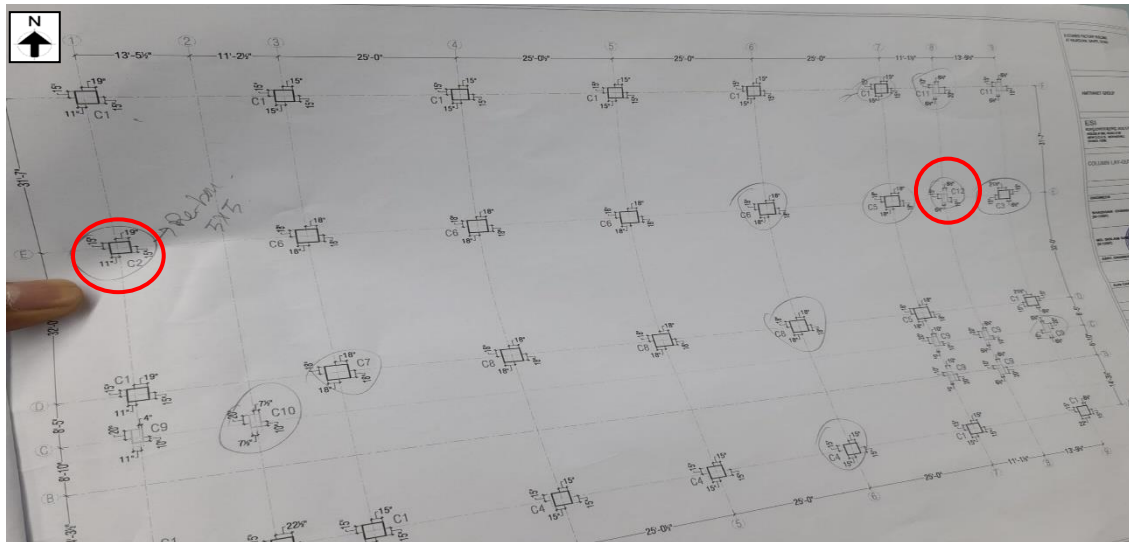
### Column Layout; Rebar profile mismatch at C2 (Grid-1-E) and C12 (Grid-8-E)

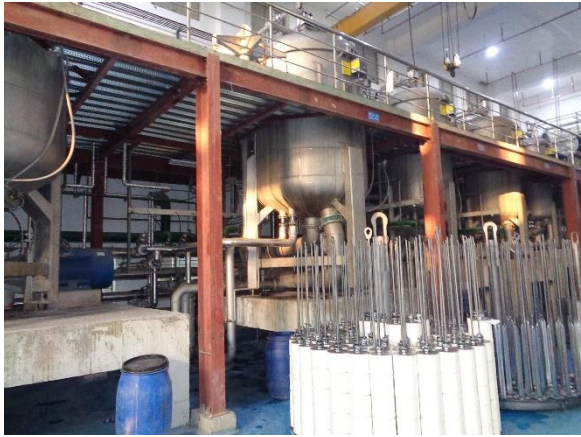
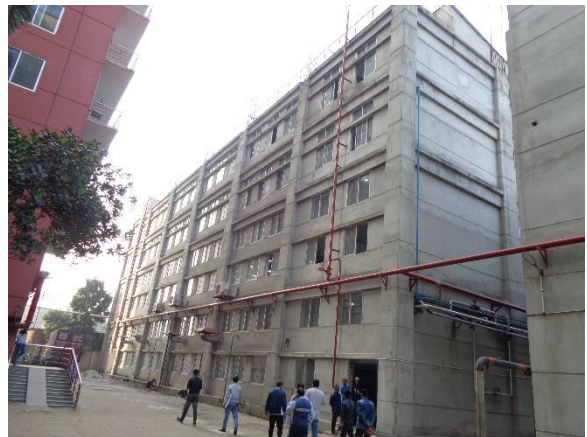
**Observation-2:** Lack of full sets of design documents. (Building-3)

**Description:** During inspection, a full set of design documents was not available for building 3. A set of as-built drawings, load plan and only two sets of cylinder test report was available. The number of cylinder test reports does not comply with the requirement for the frequency of test as per BNBC. Also, the design report was not available for the for the structure. There is a self-supported steel mezzanine on the ground floor. No information has been provided for the steel mezzanine. As per BNBC, every building or structure designed shall have its design documents prepared in accordance with the provision of Section 1.9.1. The design document shall include a design report, and a set of structural drawings, which shall be prepared in compliance with section 1.9.1.1 and section 1.9.1.2 as per BNBC. Factory engineers is required prepare full set of the design documents including design report based on in-situ concrete strength in compliance with section 1.9.1 (part-6, BNBC).

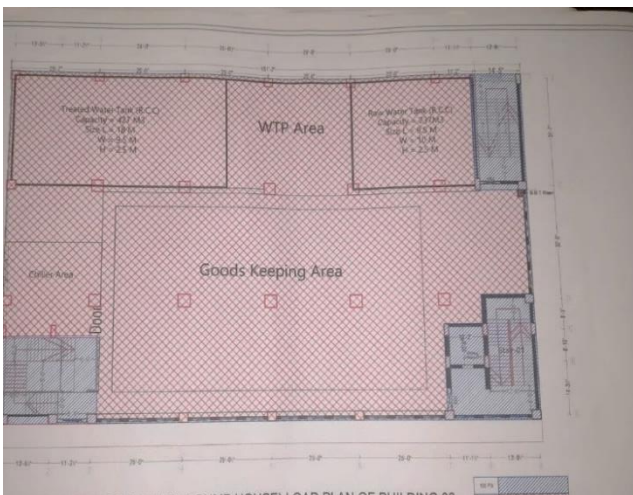
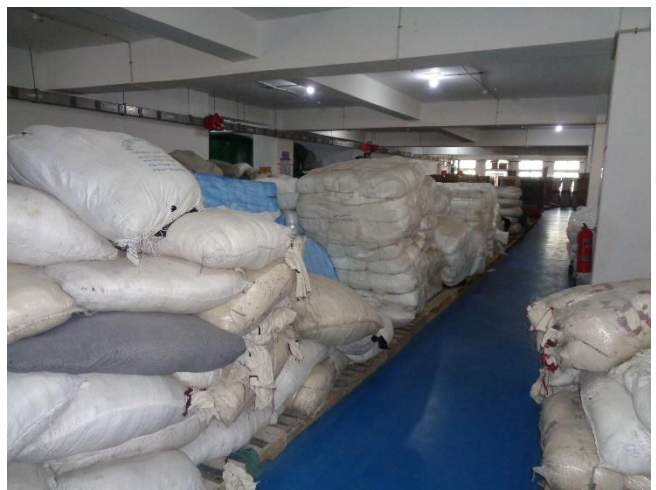
**Observation-3:** Load plan does not comply with BNBC requirement. (Building-3)

**Description:** Factory has prepared a load plan. The live load has been considered 3 kPa for the storage area at 2<sup>nd</sup> floor instead of 6 kPa as per BNBC. Also, storage loading was found in some locations at 1<sup>st</sup> floor. Factory is required to revise the load plan for as per requirement of BNBC

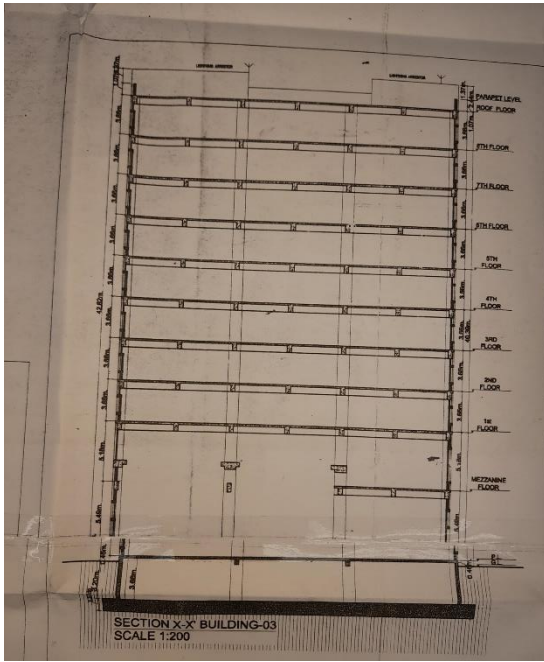
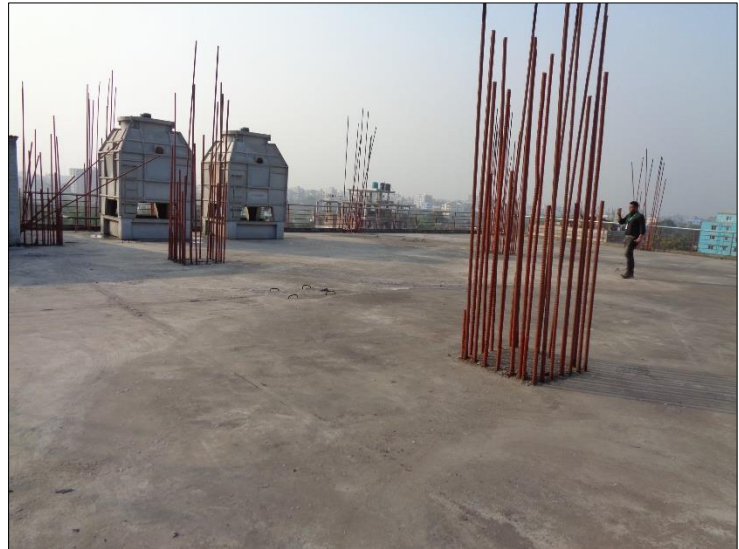
#### Observation-4: Possibility of Vertical Extension. (Building-3)

**Description:** The building permission layout is for nine storied with mezzanine at ground floor approved from Savar Pouroshova (Local Authority) dated 19-April-2017. For the structural changes and adding new structures the factory had taken revised approval on 16th July 2023 for the Building-3. There are extended column rebar at roof. The building engineer is required to check the structure for lateral loading considering full proposed nine storied and submit to RSC for review and submit to RSC for further review.

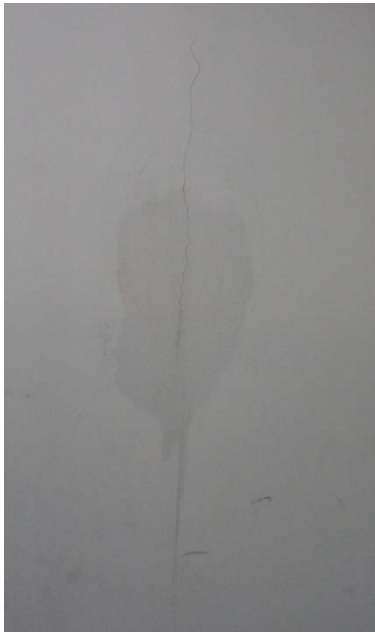
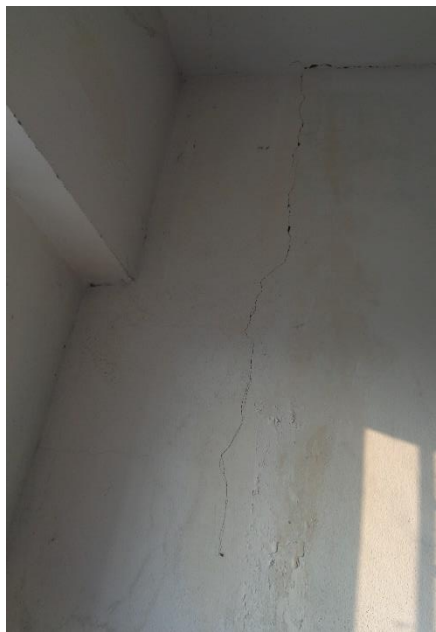
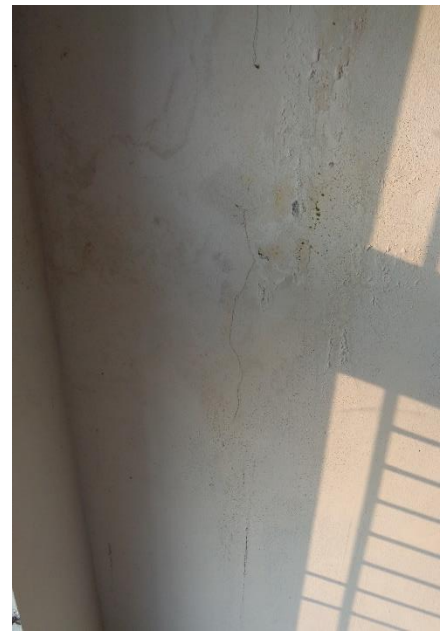
#### Observation-5: Water seepage from RC water tank. (Building-3)

**Description:** During the inspection, water seepage was found from the RC water tank at 2<sup>nd</sup> floor. The water seepage may happen due to poor construction of the RC water tank. The building engineer is required to investigate the reason of the water seepage, extend of damage due to moisture and suggest proper remedial action to solve the issue.

Water seepage from RC water tank. (Building-3)	Building engineer is required to investigate the reason of the water seepage, extend of damage due to moisture and suggest proper remedial action to solve the issue.	within 6 weeks
Exposed re-bar at roof (Building-3)	All exposed reinforcement is to be protected from corrosion which may cause degradation of the concrete.	within 6 weeks
Non-structural elements not anchored or braced. (Building-3)	Building engineer is required to adequately anchor and brace all non-structural elements to resist earthquake forces.	within 6 months
Trolley impact on Column. (Building-3)	The building engineer is required to repair the damaged portion of columns and provide protection to prevent the trolley impact.	within 6 weeks
Lack of full sets of design documents. (Building-4)	Building engineer is required to prepare a set of design documents in compliance with BNBC.	within 6 weeks

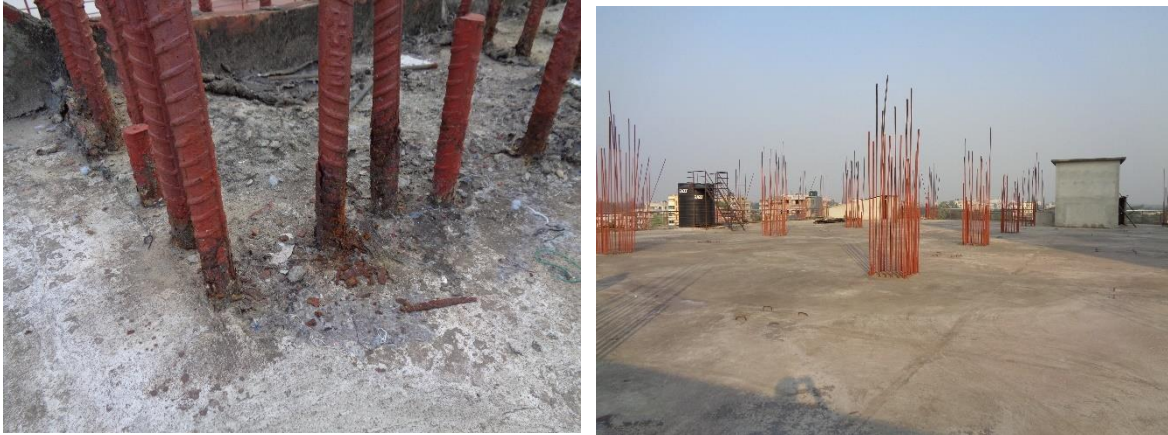
**Observation-6:** Exposed re-bar at roof (Building-3)

**Description:** During inspection, the presence of corrosion was found in exposed reinforcement was found on roof columns. Building engineers is required to take necessary measures to prevent corrosion in exposed rebar.

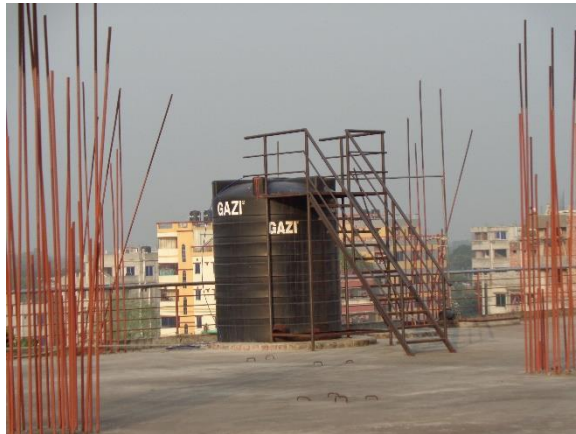
**Observation-7:** Non-structural elements not anchored or braced. (Building-3)

**Description:** Water tanks resting on the rooftop is not adequately anchored or braced to resist lateral (earthquake) forces. Adequately anchor and brace all non-structural elements to resist earthquake forces.

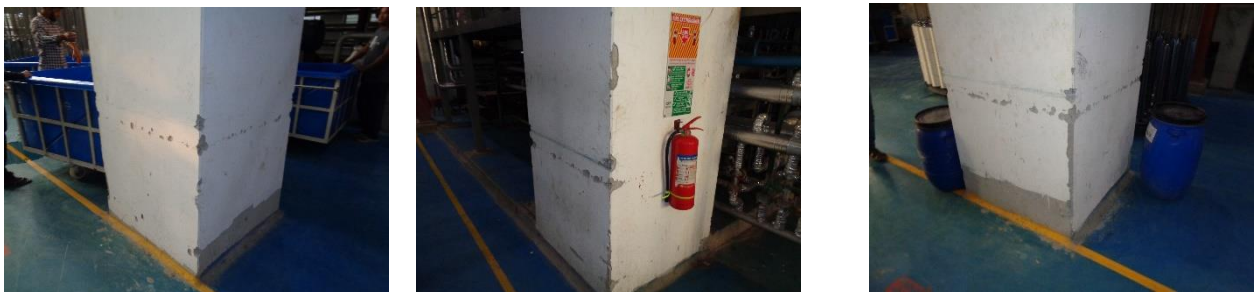
**Observation-8:** Trolley impact on Column. (Building-3)

**Description:** RC Column was found damaged due to the impact with trolley. The engineer is required to investigate the damage and suggest a remedial action as well as provide suggestion to prevent such damages in future. Factory is required to follow the suggestion of the engineer for remedial actions.

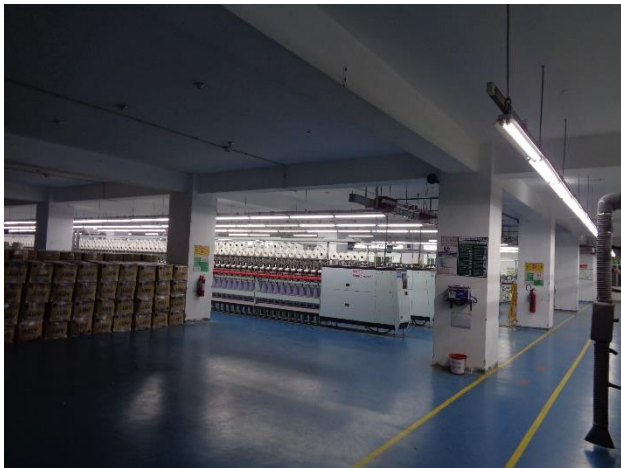
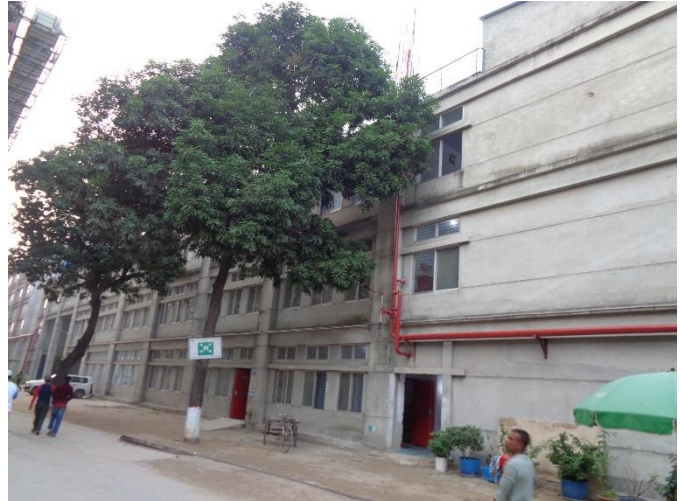
**Observation-9:** Lack of full sets of design documents. (Building-4)

**Description:** During inspection, a full set of design documents was not available for Building-4. A set of as-built drawings was available. Design report was not available for the for the structure. Also, lack of material test was observed.

As per BNBC, every building or structure designed shall have its design documents prepared in accordance with the provision of Section 1.9.1. The design document shall include a design report, and a set of structural drawings, which shall be prepared in compliance with section 1.9.1.1 and section 1.9.1.2 as per BNBC. Factory engineers is required prepare full set of the design documents including design report based on in-situ concrete strength in compliance with section 1.9.1 (part-6, BNBC).

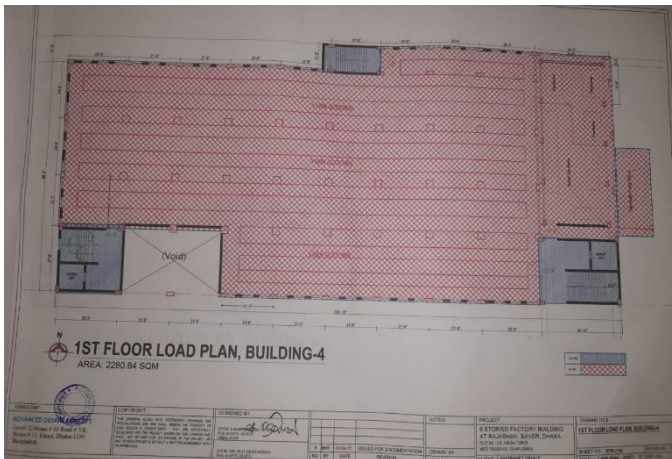
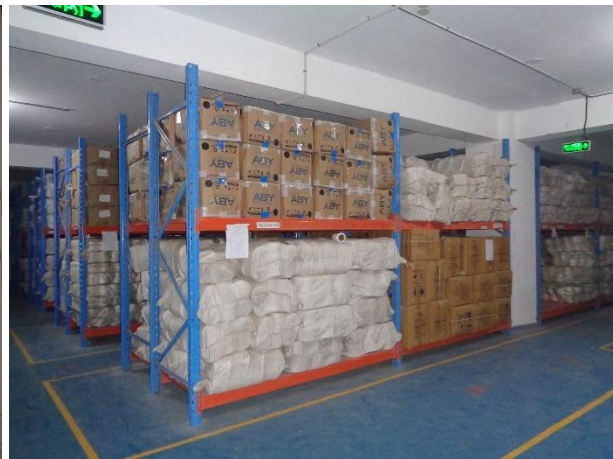
**Observation-10:** Load plan does not comply with BNBC requirement. (Building-4)

**Description:** Factory has prepared a load plan. The live load has been considered 3 kPa for the storage area on 1<sup>st</sup> floor instead of 6 kPa as per BNBC. Also, storage loading was found in some locations the 2<sup>nd</sup> floor. Factory is required to revise the load plan as per the requirement of BNBC.

Load plan does not comply with BNBC requirement. (Building-4)	Revise the floor loading plan as per BNBC.	within 6 weeks
	Implement the floor load management plan.	within 6 months
Possibility of Vertical Extension. (Building-4)	The building engineer is required to check the structure for lateral loading considering full proposed nine storied and submit to RSC for review and submit to RSC for further review.	within 6 months
Exposed re-bar at roof (Building-4)	All exposed reinforcement is to be protected from corrosion which may cause degradation of the concrete.	within 6 weeks
Non-structural elements not anchored or braced. (Building-4)	Building engineer is required to adequately anchor and brace all non-structural elements to resist earthquake forces.	within 6 weeks
Column susceptible to vehicle impact. (Building-4)	The factory engineer is required to take necessary measures to prevent the vehicle impact by providing barrier around the columns.	within 6 weeks

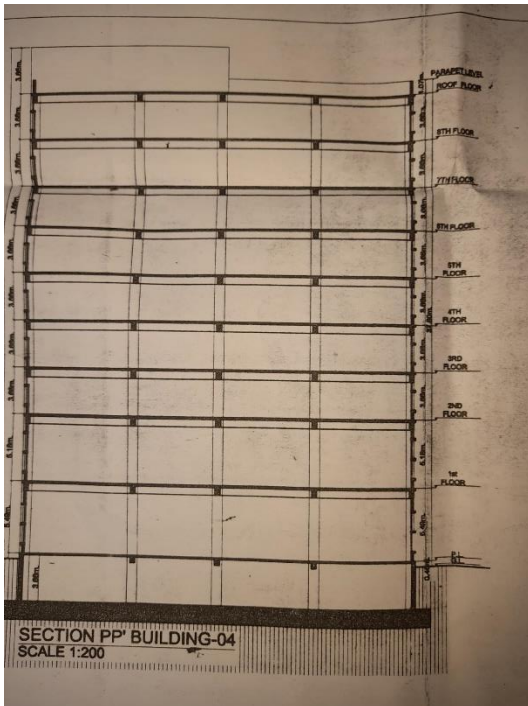
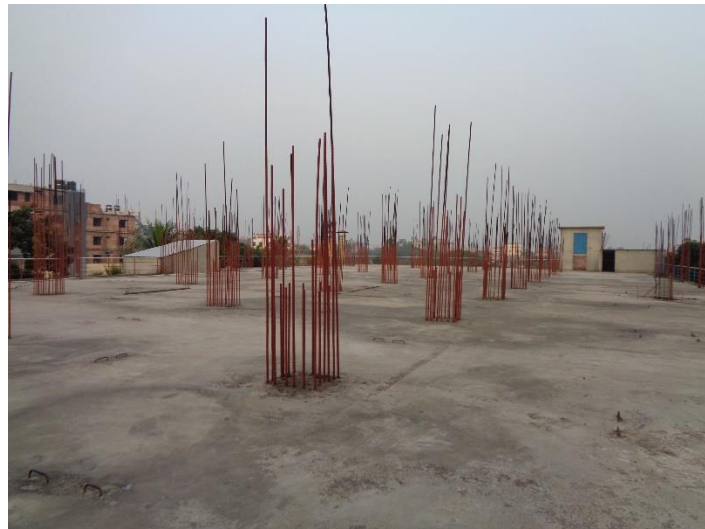
**Observation-11:** Possibility of Vertical Extension. (Building-4)

**Description:** The building permission layout is for nine storied with basement (B+G+8) approved from Savar Pouroshova (Local Authority) dated 19-April-2017. For the structural changes and adding new structures the factory had taken revised approval on 16th July 2023 for the Building-4. There is extended column re-bar at roof.

So, there is a possibility of future vertical extension. The building engineer is required to check the structure for lateral loading considering full proposed nine storied and submit to RSC for review and submit to RSC for further review.

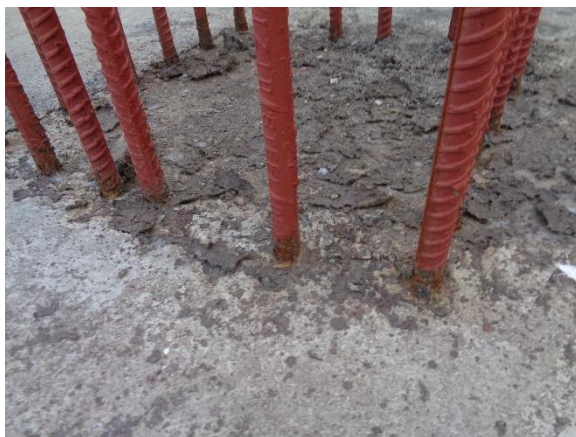
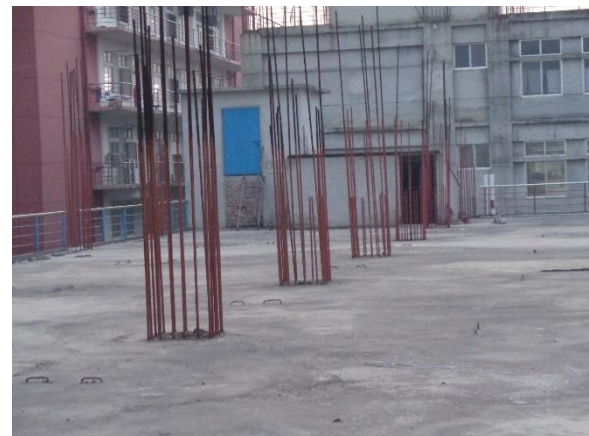
**Observation-12:** Exposed re-bar at roof (Building-4)

**Description:** During inspection, the presence of corrosion was found in exposed reinforcement was found on roof columns. Building engineers is required to take necessary measures to prevent corrosion in exposed rebar.

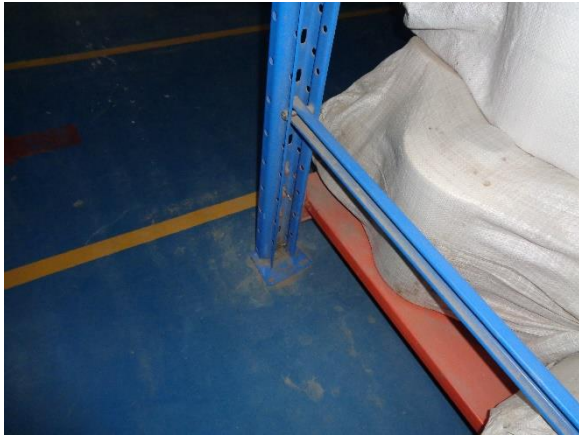
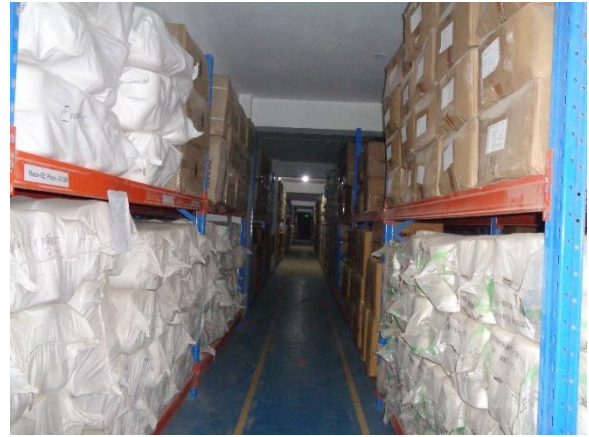
**Observation-13:** Non-structural elements not anchored or braced. (Building-4)

**Description:** Racks are not adequately anchored or braced to resist lateral (earthquake) forces. Adequately anchor and brace all non-structural elements to resist earthquake forces.

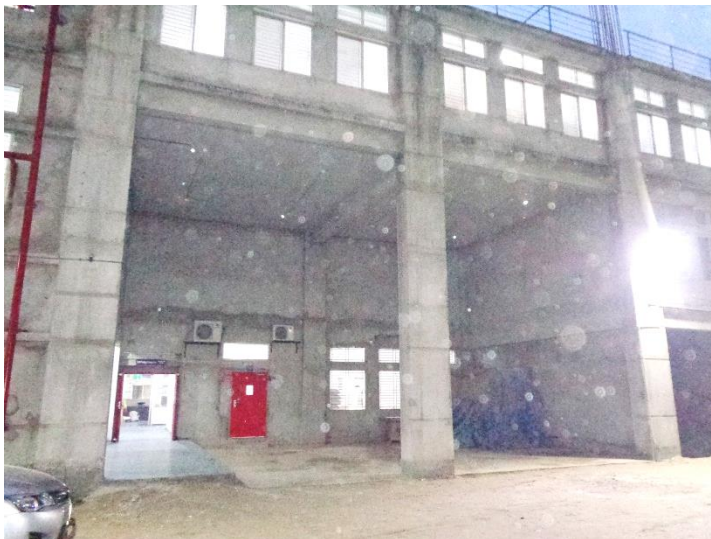
**Observation-14:** Column susceptible to vehicle impact. (Building-4)

**Description:** Columns are susceptible to vehicle impact. The factory engineer is required to take necessary measures to prevent the vehicle impact by providing the barrier around the columns.

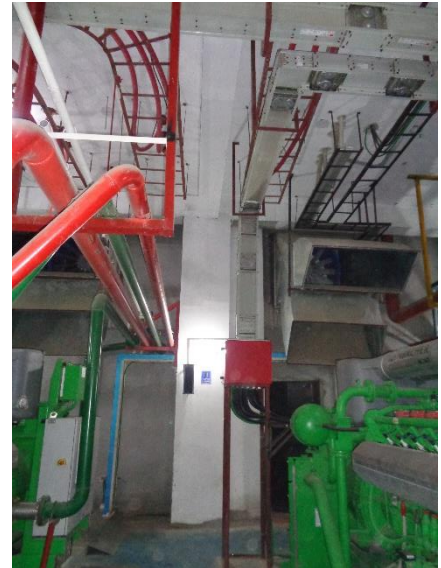
**Description:** During inspection, a full set of design documents was not available for the Utility Building and Cooling Tower Building-4. Only a set of structural drawings for the Cooling tower Building-4 and Utility building where all the required information has not been provided for the Utility Building. No documents were found for the Cooling tower Building-2. The building engineer is required to survey the structures and prepare accurate as-built drawing.

As per BNBC, every building or structure designed shall have its design documents prepared in accordance with the provision of Section 1.9.1. The design document shall include a design report, and a set of structural drawings, which shall be prepared in compliance with section 1.9.1.1 and section 1.9.1.2 as per BNBC. Building engineer is required prepare full set of the design documents including design report based on in-situ concrete strength in compliance with section 1.9.1 (part-6, BNBC).

Lack of design documents. (Utility Building)	Building engineer is required to prepare a set of design documents including full set of as-built drawings in compliance with 1.9.1 BNBC.	within 6 weeks
	Verify in-situ material strength by further testing if required.	within 6 weeks
	Complete implementation of remedial works if required.	within 6 months
Lack of design documents. (Cooling Tower Building-4)	Building engineer is required to prepare a set of design documents including full set of as-built drawings in compliance with 1.9.1 BNBC.	within 6 weeks
	Verify in-situ material strength by further testing if required.	within 6 weeks
	Complete implementation of remedial works if required.	within 6 months
