# ECHOKNITS LTD (Extension)

A-99/1; Bokterpur; Kaliakoir; Gazipur

27 December 2023

## 2. Observation

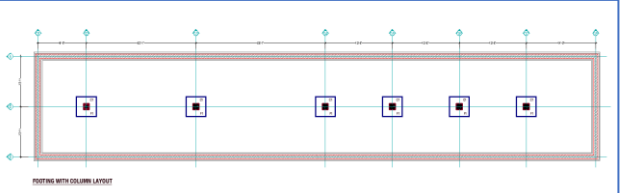
Column Schedule & layout

### Observation-01: Mismatches in as-built drawings. (Building-04 (General Store))

**Description:** Number of rebar in C-1 column was found 4 nos instead of 6 nos. Building engineer is required to survey the whole structure and prepare accurate as-built drawings.

| Item No. | Observation | Action Plan | Timeline |
|---|---|---|---|
| 1 | Mismatches in as-built drawings. (Building-04 (General Store)) | Building engineer is required to prepare the as-built drawings with complete structural details. | within 6 weeks |

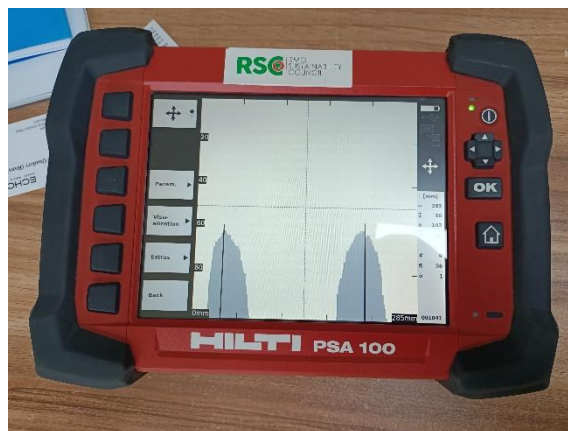
Number of rebar by ferro scan

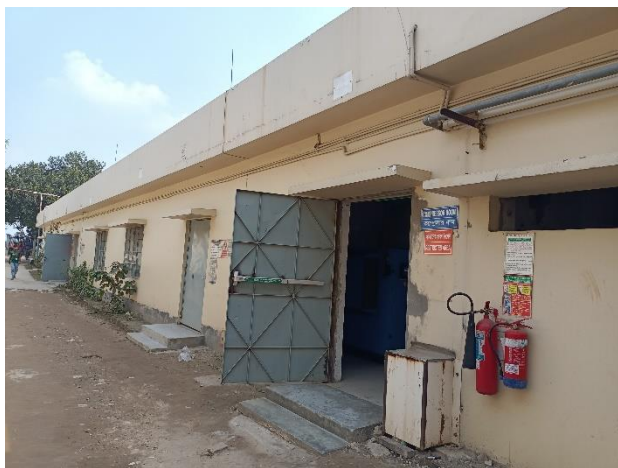
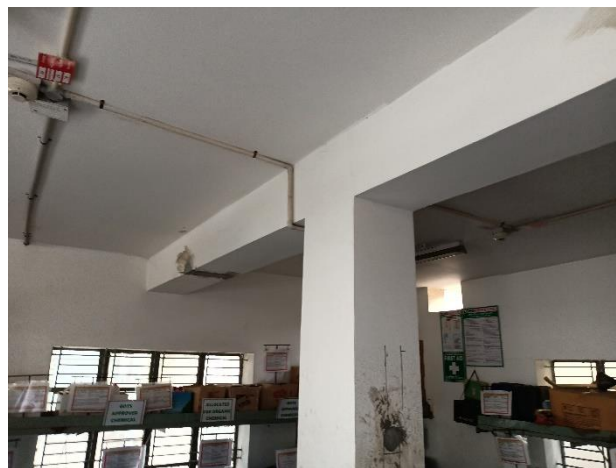
### Observation-02: Lack of design report. (Building-04 (General Store))

**Description:** As per BNBC, every building or structure designed shall have its design documents prepared following the provision of Section 1.9.1. The design document shall include a design report, and a set of structural drawings, which shall be prepared in compliance with section 1.9.1.1 and section 1.9.1.2, part 6 of BNBC. On the other hand, core cutting location was found onsite but core cutting layout was not available. The building engineer is required to prepare the design report considering concrete strength based on core test report.

| Item No. | Observation | Action Plan | Timeline |
|---|---|---|---|
| 2 | Lack of design report. (Building-04 (General Store)) | Building engineer is required to prepare the design documents including a design report, and a set of structural drawings in compliance with section 1.9.1.1 and section 1.9.1.2, part-6 of BNBC and submit it to RSC for review. | within 6 weeks |
| 3 | Lack of design report. (Building-04 (General Store)) | Implement remediation work if required. | within 6 months |

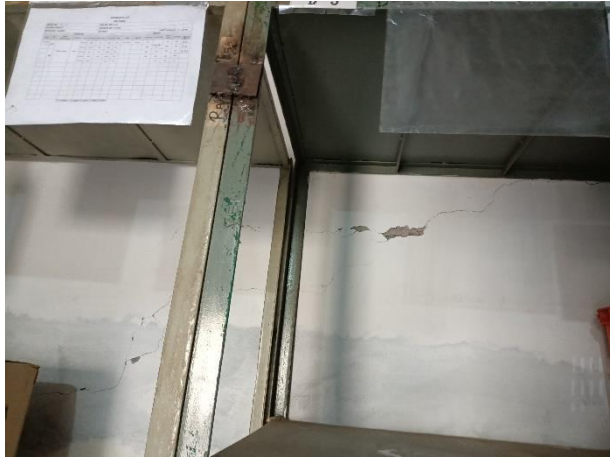
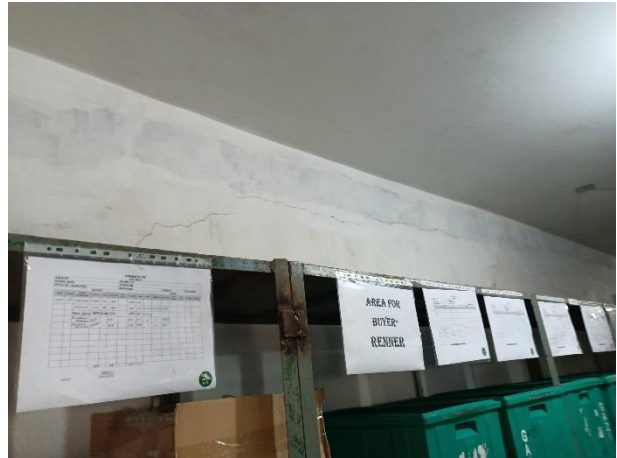
Cracks on load bearing wall

**Description:** Crack found on the load bearing walls of General Store. Building engineer is required to investigate the cause of cracking and repair with a suitable method.

| Item No. | Observation | Action Plan | Timeline |
|---|---|---|---|
| 4 | Cracks found on the load bearing walls. (Building-04 (General Store)) | Building engineer is required to investigate the cause of cracking and repair with a suitable method. | within 6 weeks |

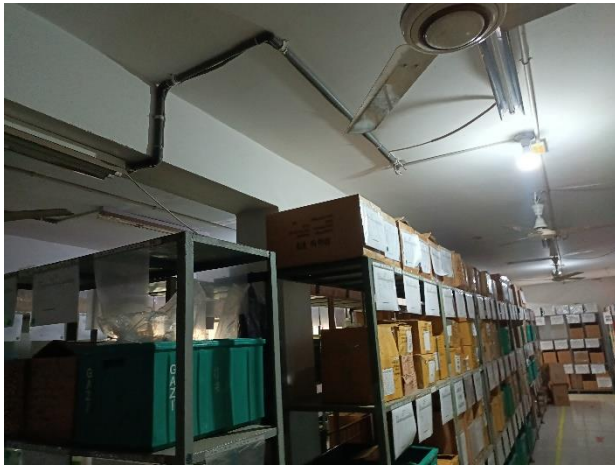
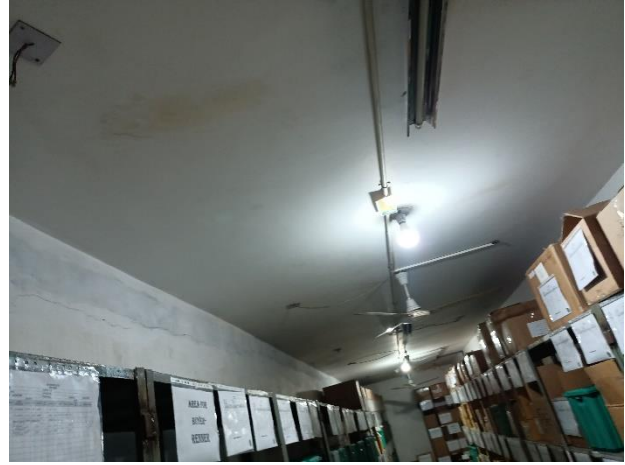
Unbraced racks on floor

**Description:** Some racks on floors are not anchored or braced to resist lateral (earthquake) forces. The factory is required to anchor/brace all non-structural elements adequately to resist earthquake forces.

| Item No. | Observation | Action Plan | Timeline |
|---|---|---|---|
| 5 | Non-structural elements are not anchored or braced. (Building-04 (General Store)) | The factory is required to anchor/brace all non-structural elements adequately to resist earthquake forces. | within 6 weeks |

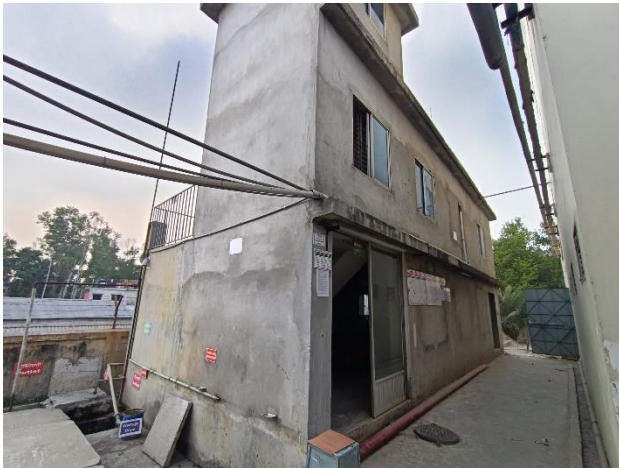
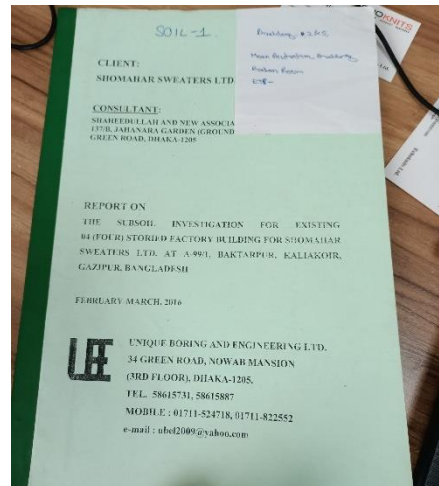
**Observation-05: Lack of foundation details & soil test report. (Building-05 (ETP))**

**Description:** Foundation details and soil test report were not found for the two storied ETP Building. Factory has provided a soil test report for a 4-storied Factory Building in which bore hole location is almost 27 m far from the ETP building. Detail engineering assessment (DEA) required to be carried out for the structure.

| Item No. | Observation | Action Plan | Timeline |
|---|---|---|---|
| 6 | Lack of foundation details & soil test report. (Building-05 (ETP)) | Detail engineering assessment (DEA) required to be carried out for the structure. | within 6 weeks |
| 7 | Lack of foundation details & soil test report. (Building-05 (ETP)) | Building engineer is required to survey the whole structure and prepare full set of as-built drawings. | within 6 weeks |

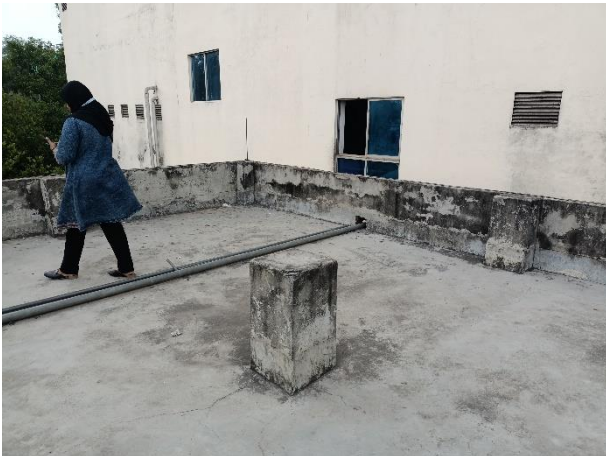
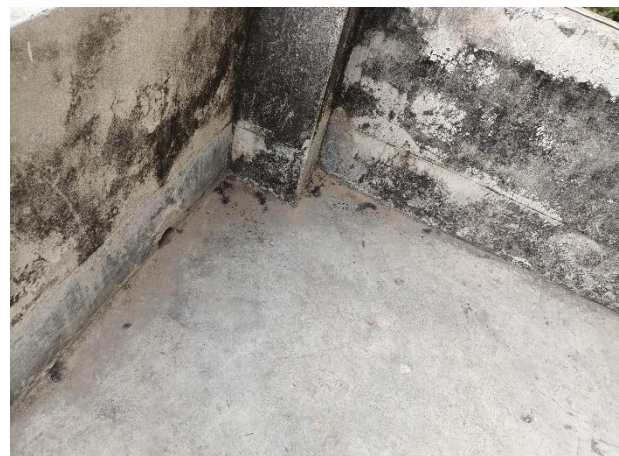
Parapet on roof

**Description:** Falling hazard risk was observed on the roof of ETP building. The existing parapet wall's height was found only 24 inches. Building engineer is required to increase the wall height at least 42 inches to mitigate the falling hazard risk.

| Item No. | Observation | Action Plan | Timeline |
|---|---|---|---|
| 11 | Falling hazard risk on roof. (Building-05 (ETP)) | Building engineer is required to increase the wall height at least 42 inches to mitigate the falling hazard risk. | within 6 months |

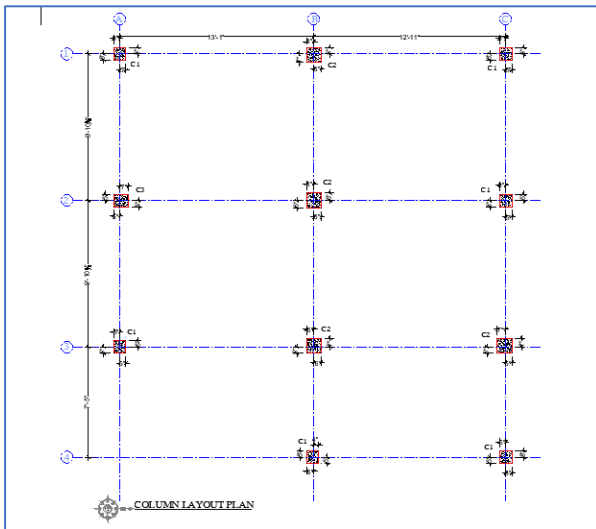
Column Layout

**Observation-07: Discrepancies in as-built drawings. (Building-06 (Maintenance Building))**

**Description:** Number of rebar in C-2 column was found 4 nos instead of 6 nos. Building engineer is required to survey the whole structure and prepare accurate as-built drawings.

| Item No. | Observation | Action Plan | Timeline |
|---|---|---|---|
| 12 | Discrepancies in as-built drawings. (Building-06 (Maintenance Building)) | Building engineer is required to survey the whole structure and prepare accurate as-built drawings. | within 6 weeks |

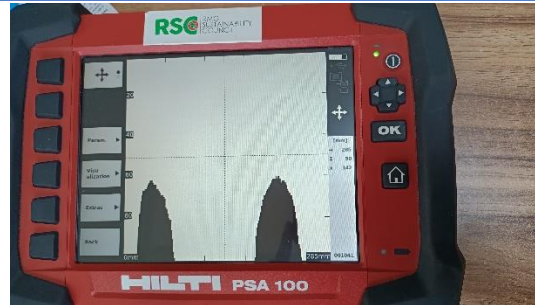
Number of rebar by ferro scan

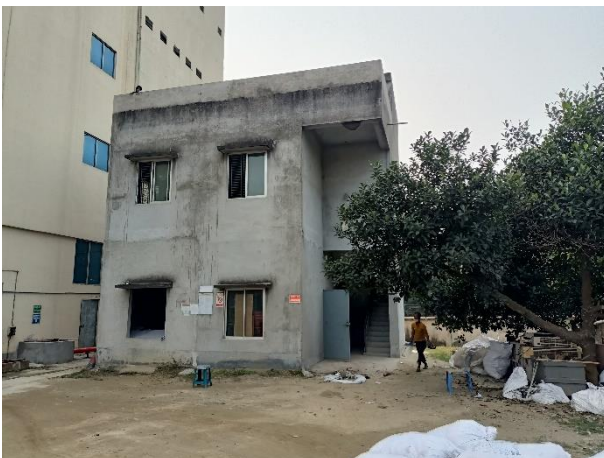
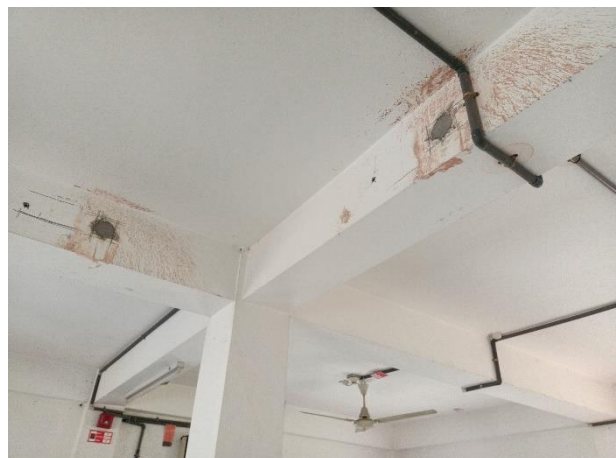
**Observation-8: Lack of design report. (Building-06 (Maintenance Building))**

**Description:** As per BNBC, every building or structure designed shall have its design documents prepared following the provision of Section 1.9.1. The design document shall include a design report, and a set of structural drawings, which shall be prepared in compliance with section 1.9.1.1 and section 1.9.1.2, part 6 of BNBC. On the other hand, core cutting location was found onsite but core cutting layout was not available. The building engineer is required to prepare the design report considering concrete strength based on core test report.

| <b>13</b> | Lack of design report. (Building-06 (Maintenance Building)) | Building engineer is required to prepare the design documents including a design report, and a set of structural drawings in compliance with section 1.9.1.1 and section 1.9.1.2, part-6 of BNBC and submit it to RSC for review. | within 6 weeks |
| <b>14</b> | Lack of design report. (Building-06 (Maintenance Building)) | Carry out remedial works (if any) after review by RSC. | within 6 months |

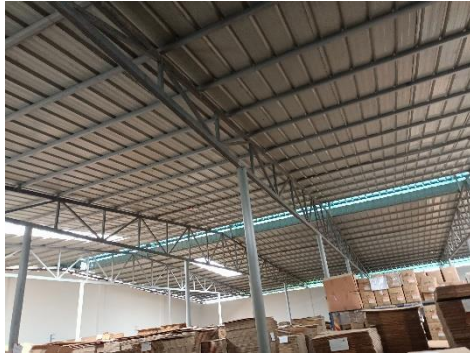
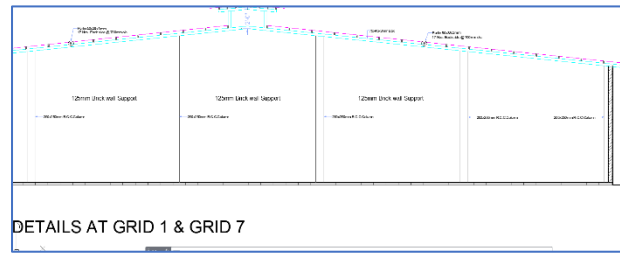
**Observation-09:** Lack of information in the as-built drawings. (Shed-12 (Empty Carton Store))

**Description:** Connection details are not shown in the grid sections. Also, lintel or tie beams are not shown in the sectional details of end grid. Building engineer is required to survey the whole structure and prepare complete structural drawings.

| <b>16</b> | lack of information in the as-built drawings. (Shed-12 (Empty Carton Store)) | Building engineer is required to survey the whole structure and prepare accurate as-built drawings. | within 6 weeks |

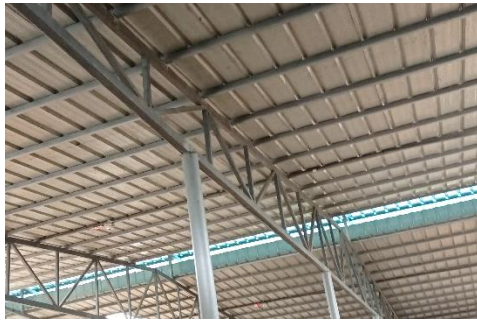
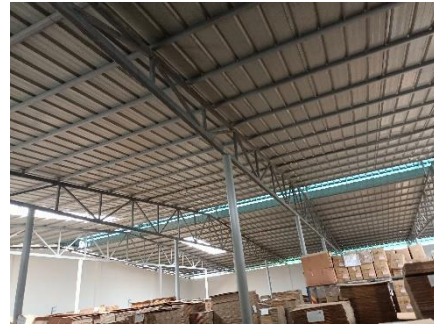
**Observation-10:** Apparently inadequate connection. (Shed-12 (Empty Carton Store))

**Description:** Lack of lateral stability system (strut and bracing), apparent inadequate members and non-engineered connection was observed. The building engineer is required to check the member, connection & stability system of the structure and suggest proper alternatives accordingly.

| <b>17</b> | Apparently inadequate connection. (Shed-12 (Empty Carton Store)) | The building engineer is required to check the member, connection & stability system of the structure and suggest proper alternatives accordingly. | within 6 weeks |
| <b>18</b> | Apparently inadequate connection. (Shed-12 (Empty Carton Store)) | Implement remediation work if required. | within 6 months |

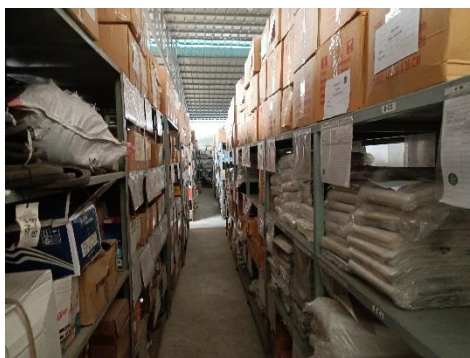
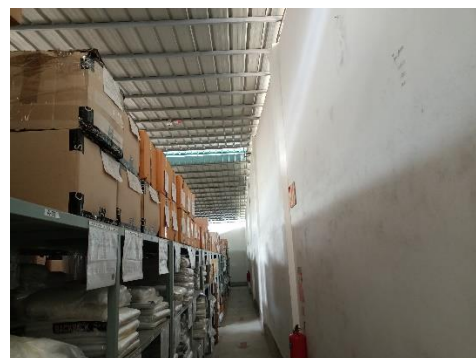
**Observation-11:** Non-structural elements not anchored or braced. (Shed-12 (Empty Carton Store))

**Description:** Some racks on floors are not anchored or braced to resist lateral (earthquake) forces. The factory is required to anchor/brace all non-structural elements adequately to resist earthquake forces.

| <b>19</b> | Non-structural elements not anchored or braced. (Shed-12 (Empty Carton Store)) | The factory is required to anchor/brace all non-structural elements adequately to resist earthquake forces. | within 6 weeks |

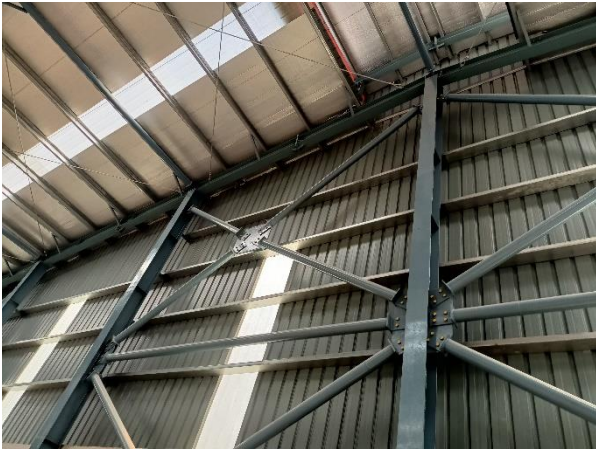
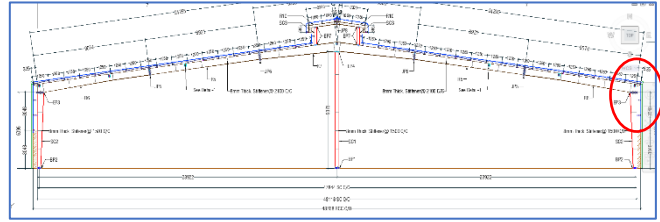
**Observation-12: Discrepancies in as-built drawings. (Shed – 13 (Warehouse))**

**Description:** Compression strut layout and connection details of vertical bracing were not found in the drawings. Also, the number of bolts were not matched in joint type EP-3. On site 10 nos of bolts were found instead of 12 nos. Building engineer is required to survey the whole structure and prepare complete structural drawings.

| <b>20</b> | Discrepancies in as-built drawings. (Shed – 13 (Warehouse)) | Building engineer is required to survey the whole structure and prepare complete as-built drawings. | within 6 weeks |

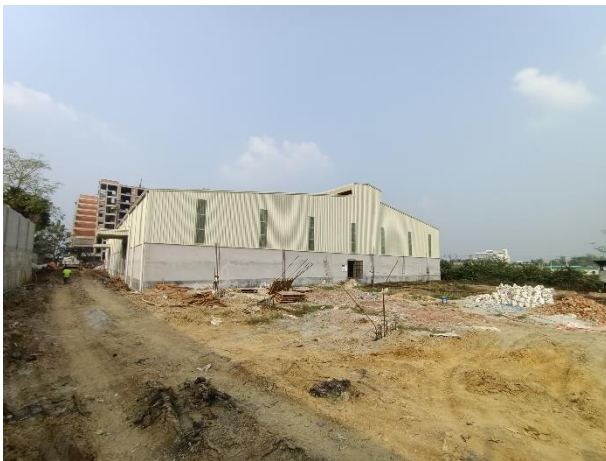
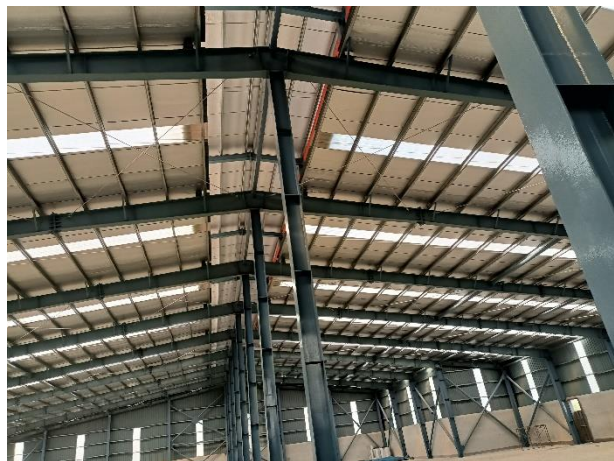
**Observation-13: Lack of design report. (Shed – 13 (Warehouse))**

**Description:** As per BNBC, every building or structure designed shall have its design documents prepared following the provision of Section 1.9.1. The design document shall include a design report, and a set of structural drawings, which shall be prepared in compliance with section 1.9.1.1 and section 1.9.1.2, part 6 of BNBC.

| <b>21</b> | Lack of design report. (Shed – 13 (Warehouse)) | Building engineer is required to prepare the design documents including a design report, and a set of structural drawings in compliance with section 1.9.1.1 and section 1.9.1.2, part-6 of BNBC and submit it to RSC for review. | within 6 weeks |
| <b>22</b> | Lack of design report. (Shed – 13 (Warehouse)) | Implement remediation work if required. | within 6 months |
