# East Coast Knitwear Pvt. Ltd. (Extension)

Takkarmath, Sehachar, Fatullah, Narayanganj-1420

4 February 2024

**Extension Building:** Six (G+5) storied RC building with an underground water reservoir and fire pump room.

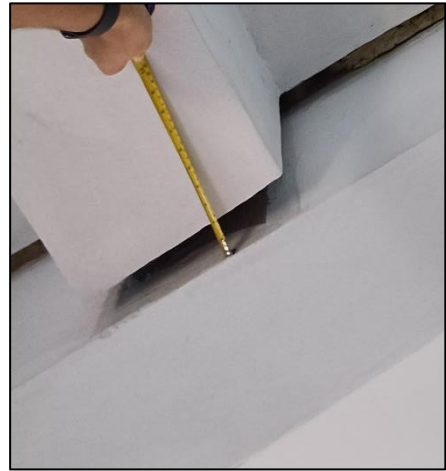
R=8 considered in the design report

50mm Expansion Gap

**Description:** Response modification factor  $R=8$  has been considered in the design report. But no detailed calculation has been provided to support the consideration for the connection details. During inspection, the 50 mm expansion gap was observed in expansion joint. Calculations regarding building separation need to be included in design report in compliance with BNBC. The building engineer is required to provide necessary calculations to support  $R=8$  and justify the provided expansion gap & submit the design report to RSC for further review.

| Item No. | Observation | Action Plan | Timeline |
|---|---|---|---|
| 1 | Design documents need to be reviewed by RSC. | The building engineer is required to provide necessary calculations to support R=8 and justify the provided expansion gap & submit the design report to RSC for further review. | within 6 weeks |

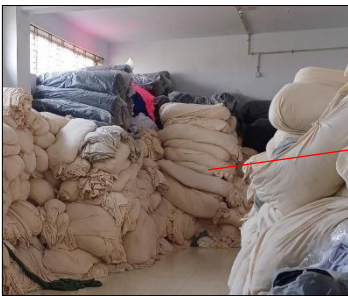
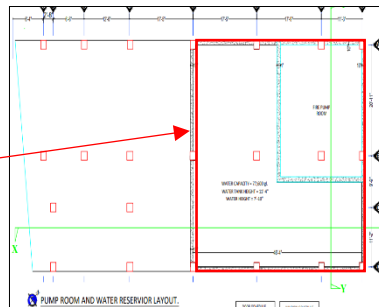
Storage on suspended ground floor

**Description:** Storage found on the ground floor suspended slab over the water reservoir and fire pump room. However, the load plan has not been prepared for this suspended floor. Additionally, 4 kPa live load is considered for stairs instead of 5 kPa.

The building engineer is required to update the load plan considering 6 kPa for storage areas and 5 kPa for stairs and revise the design documents accordingly.

| Item No. | Observation | Action Plan | Timeline |
|---|---|---|---|
| 3 | The load plan does not comply with BNBC requirements. | The building engineer is required to update the load plan considering 6 kPa for storage areas and 5 kPa for stairs and revise the design documents accordingly. | within 6 weeks |

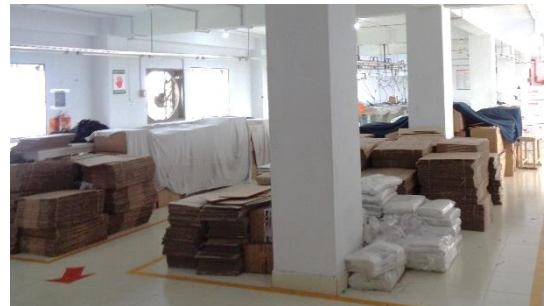
Storage on 3<sup>rd</sup> floor

Moreover, in the provided load plan 3 kPa has been considered on the 3<sup>rd</sup> floor but the floor is being used as storage which does not comply with BNBC. As per BNBC, 6kPa needs to be considered for storage live load.

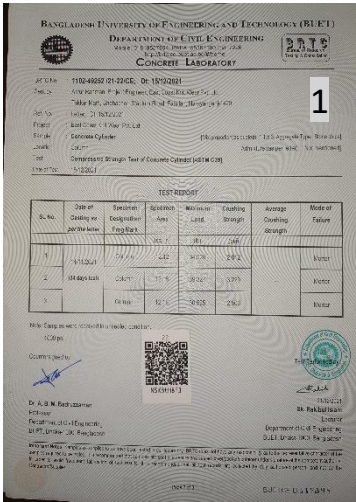
**1**

**Description:** Concrete compressive strength  $f'_c$  considered 4000 psi (27.5 MPa) in the design documents. The adequate number of concrete cylinder test reports were not available onsite as per BNBC. Additionally, two sets of cylinder test reports were available from the column, where the average result was not obtained. However, the individual strength of the cylinder does not meet the design strength at the age of more than 28 days for columns. The building engineer is required to verify in-situ material strength by taking four numbers of 100mm dia concrete core samples from lower tier of columns to justify the design strength.

| Item No. | Observation | Action Plan | Timeline |
|---|---|---|---|
| 4 | Inadequate number of concrete cylinder test reports. | The building engineer is required to verify in-situ material strength by taking four numbers of 100mm dia concrete core samples from lower tier of columns to justify the design strength. | within 6 weeks |

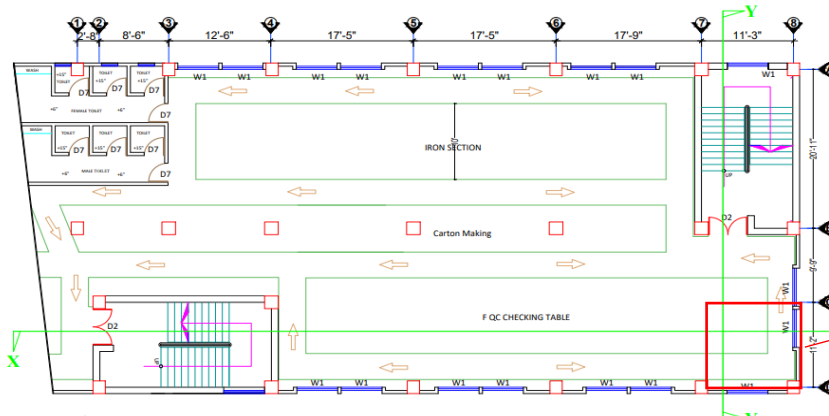
3rd-floor layout plan

**Description:** During the inspection, mismatches were found between the onsite condition and the as-built drawing. On the 3<sup>rd</sup> floor toilet with 250mm build-up was found which is not mentioned in the drawing. Also, the C1 column on the 4<sup>th</sup> floor was found 18" 20" instead of 15" 20". The building engineer is required to survey the full structure and produce accurate as-built drawings.

| Item No. | Observation | Action Plan | Timeline |
|---|---|---|---|
| 5 | Mismatch in the as-built drawing. | The building engineer is required to survey the full structure and produce accurate as-built drawings. | within 6 weeks |

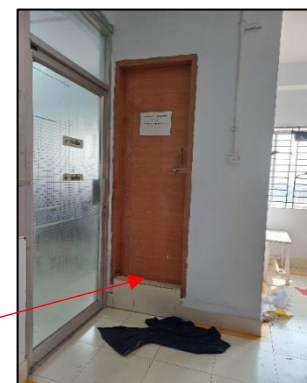
Toilet with 250mm build-up

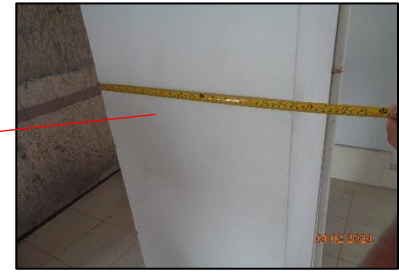
C1 column at 4<sup>th</sup> floor found 18"x20" instead of 15"x20"

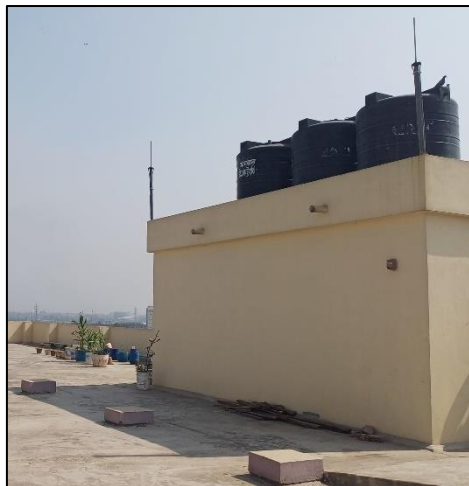
Unbraced PVC tank on the roof

**Description:** During inspection, three unbraced PVC tanks on the roof were observed. The building engineer is required to brace/anchor all nonstructural elements to avoid falling hazards during lateral loading.

| Item No. | Observation | Action Plan | Timeline |
|---|---|---|---|
| 6 | Unbraced nonstructural elements. | The building engineer is required to brace/anchor all nonstructural elements to avoid falling hazards during lateral loading. | within 6 weeks |
