INITIAL FIRE SAFETY INSPECTION REPORT

FCI (BD) Ltd -Extended new warehouse building

RSC ID: 24982

Date: 24/01/2024

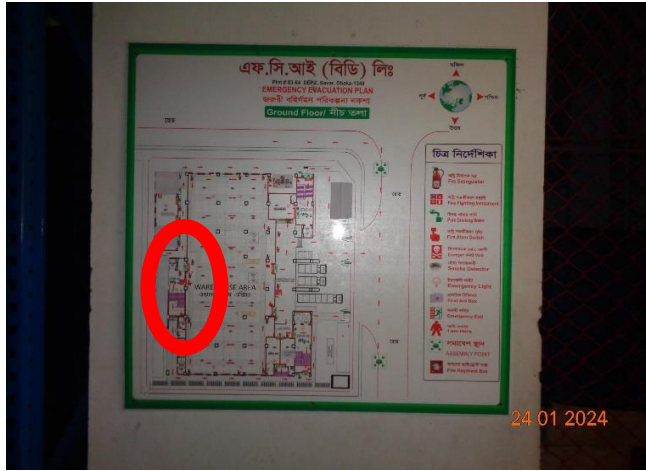
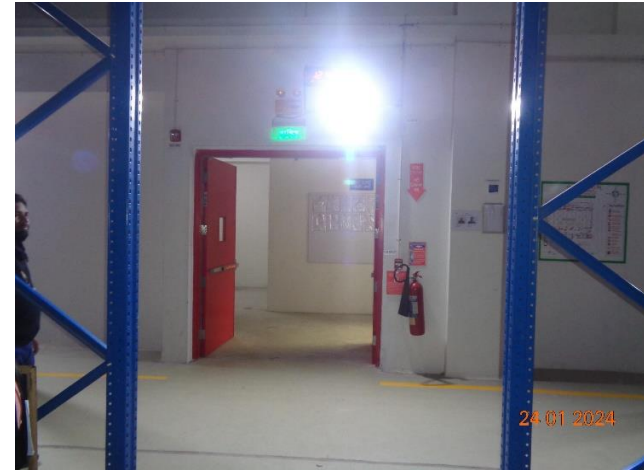
Sl No.	Category	Findings	Required Action	Remediation Time Frame
1	Fire Rated Construction	Openings from exit enclosures to storage areas are not provided with vestibules. Location: Building 1: Ground floor.	Provide vestibules for openings from exit enclosures to storage areas, basements, transformer rooms, generator rooms, boiler rooms, and similar normally unoccupied spaces according to RSC Technical Guideline (Standard)- 6.14.3.	Within 3 months

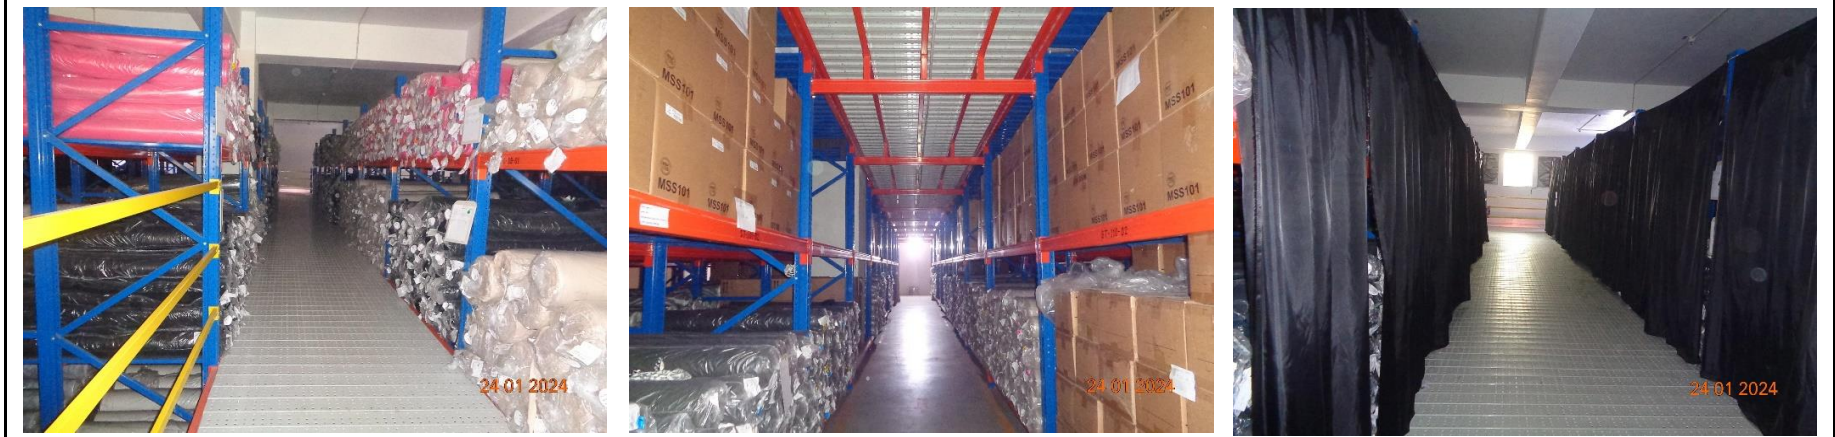
2	Fire Rated Construction	<p>Catwalk has been constructed on high rack storage and the area of the the intermediate deck creates a full floor where the size of the deck is more than 33% of the total floor area and requires fire rated separation.</p> <p>Location: Store Building, 1st floor.</p>	<p>Remove all catwalk and stair from the multi-storied storage (combustible materials) rack facilities area.</p> <p>or</p> <p>Separate each floors by fire rated construction as per BNBC, Part-3, chapter-3 and Table 3.3.1.</p>	Within 6 months
---	-------------------------	---	---	-----------------

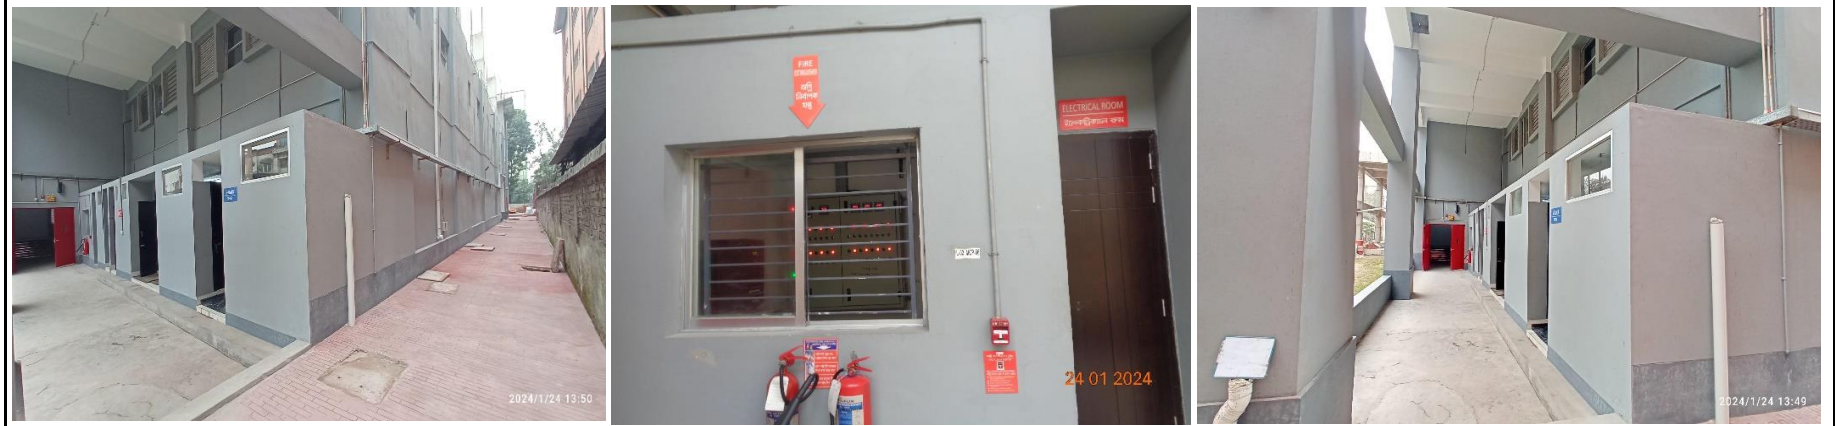
3	Fire Rated Construction	The exit discharge path (Passageway) is not separated by fire-rated construction. Location: Northeast and north side of the building.	Provide minimum 2 hr. fire rated exit discharge path which will lead directly outside.	Within 3 months
---	-------------------------	---	--	-----------------

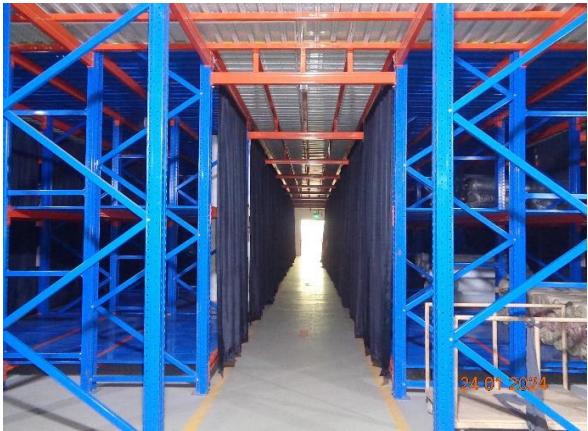
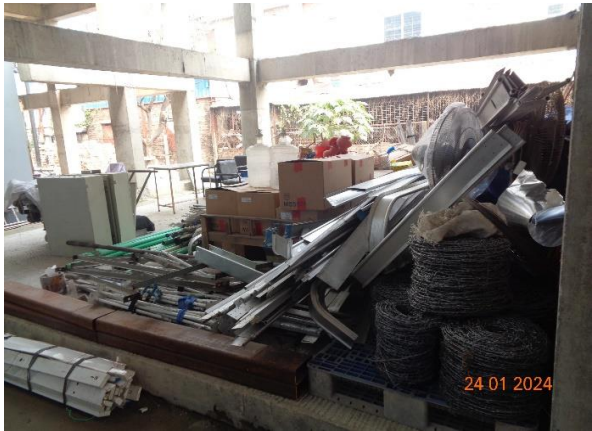
4	Fire Rated Construction	Rooms used for storage of combustible materials are not separated from the surrounding occupancy/areas & floors. Location: Building 1: Ground floor.	Rooms used for storage of combustible materials shall be separated from the surrounding occupancy with a minimum 1 hour construction according to RSC Technical Guidelines (Standard) Section 3.4.2.1.5.	Within 3 months

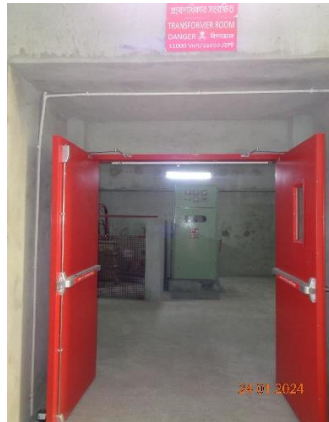
5	Fire Rated Construction	The substation room is not separated with fire rated construction from main building. Ground floor of building 2.	Separate the generator and substation room by a minimum 2-hr fire rated construction with 1.5-hr fire rated opening protective assemblies like fire rated door. Provide proper ventilation and consult a qualified engineer for overall solution. When located to the exterior of a building by at least 3m (10 ft.) distance from surroundings then fire rated construction barrier is not mandatory.	Within 3 months

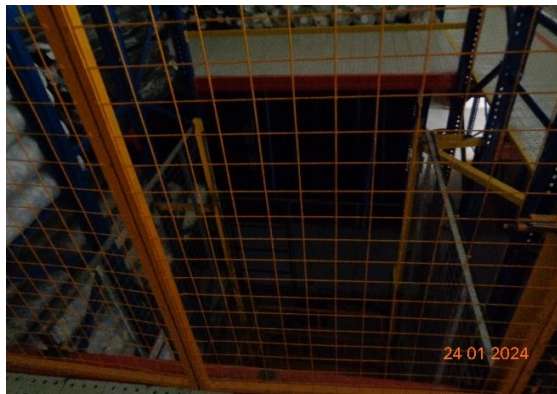
6	Fire Rated Construction	Elevator shafts are directly open inside the floor. Location: Building-1 ground floor.	Ensure minimum 1.5-hr fire rating for the doors of elevator shafts otherwise close the shafts area with 2-hr fire rated construction barrier and 1.5-hr fire rated doors.	Within 3 months
---	-------------------------	---	---	-----------------

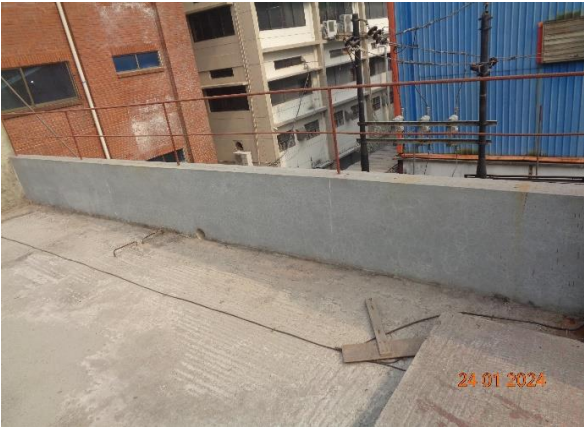
7	Means of egress	Building did not have stair designation signs and occupant load signs at required locations on all floor. Location: Building 1.	Provide stair designation signs and occupant load signs at required locations.	Within 1 month
8	Means of egress	Occupiable roof is not provided with an adequate parapet / guard rail.	All occupiable roofs shall be provided with parapets or guards with a minimum height of 1067 mm (42 in.)	Within 3 months

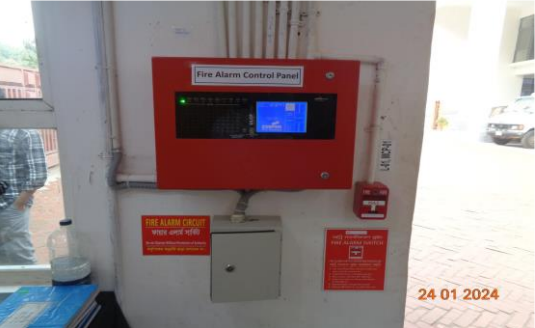
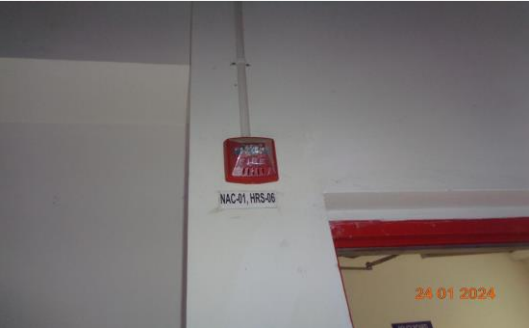
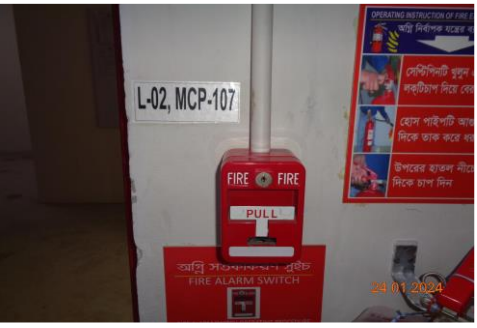
9	Fire Alarm & Detection System (FADS)	Fire detection system installation requires detailed review to confirm compliance with NFPA72 and in accordance with The RSC Technical Guidelines (Standard).	Submit design, drawings and other relevant documentation to the RSC for review. Replace the fire detection system with a new, listed addressable fire detection system in accordance with NFPA 72.	Design within 1 month and installation within 3 months
