# Midland Knitwear Ltd. (Extension)

Stadium Link Road, Narayanganj 1421

20 December 2023

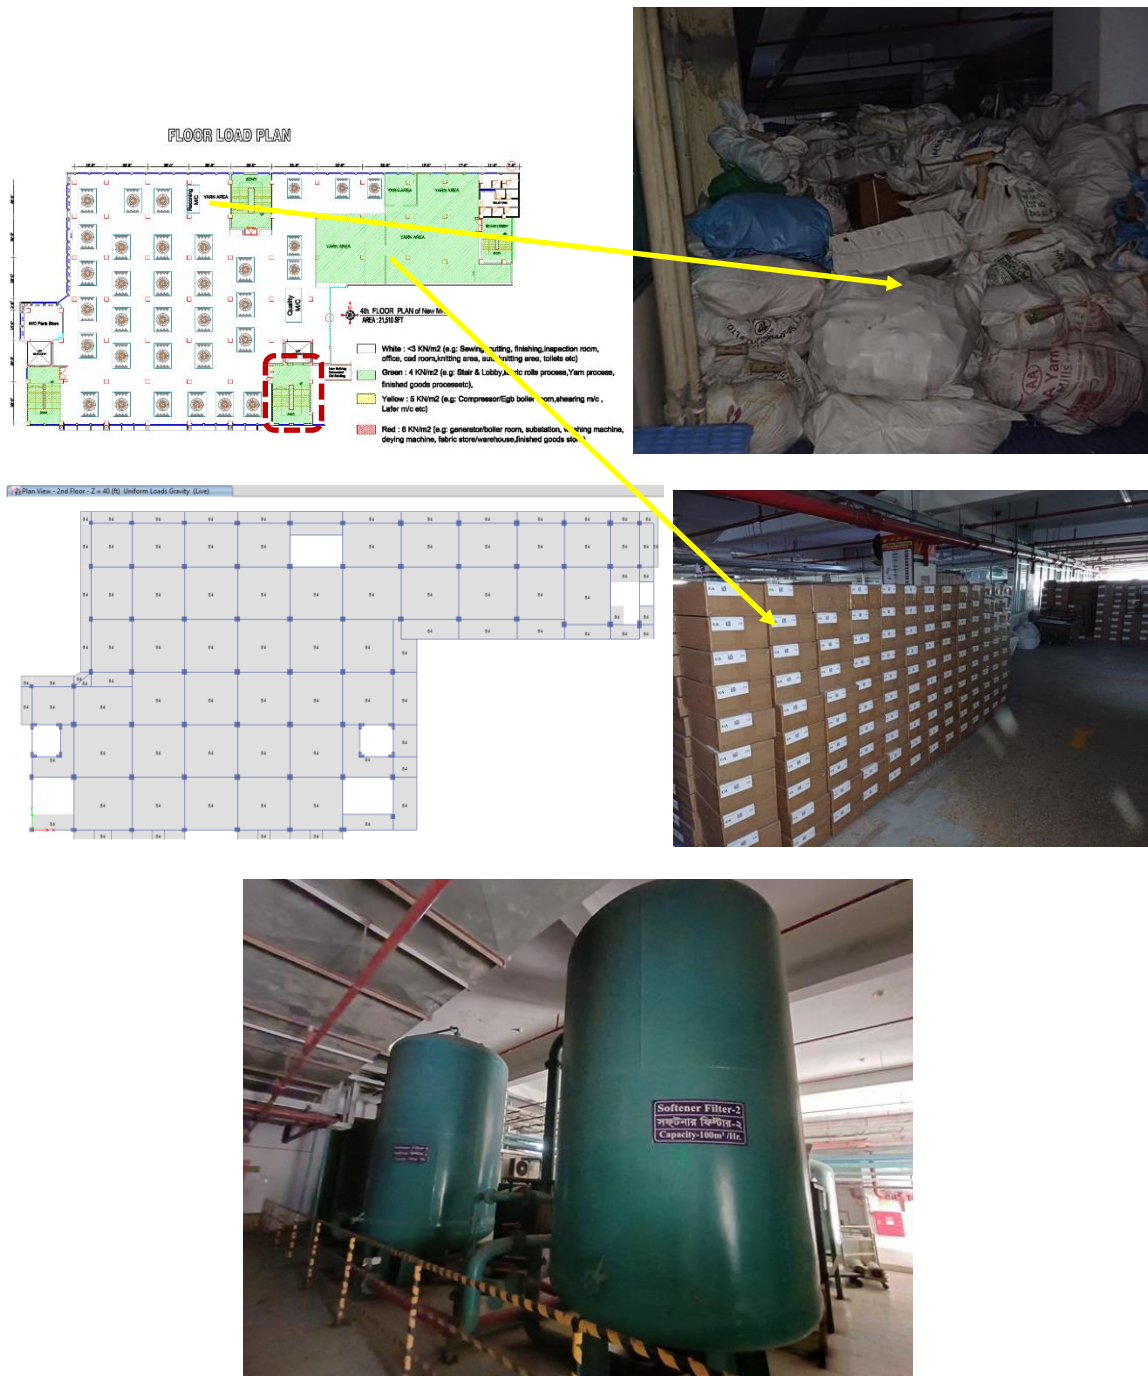
**Observation-1:** Considered loading doesn't comply with BNBC 2006. (Extension building-02)

**Description:** During the inspection, live load for storage area in several locations was found considered 4 kPa which doesn't comply with BNBC 2006. Also, in stairs, the live load was considered 4 kPa instead of 5 kPa. Furthermore, the load of large vessels over the ground floor suspended slab was not incorporated in the analysis model.

The building engineer is required to survey the whole structure revise the design documents as per BNBC loading and submit it to RSC for review.

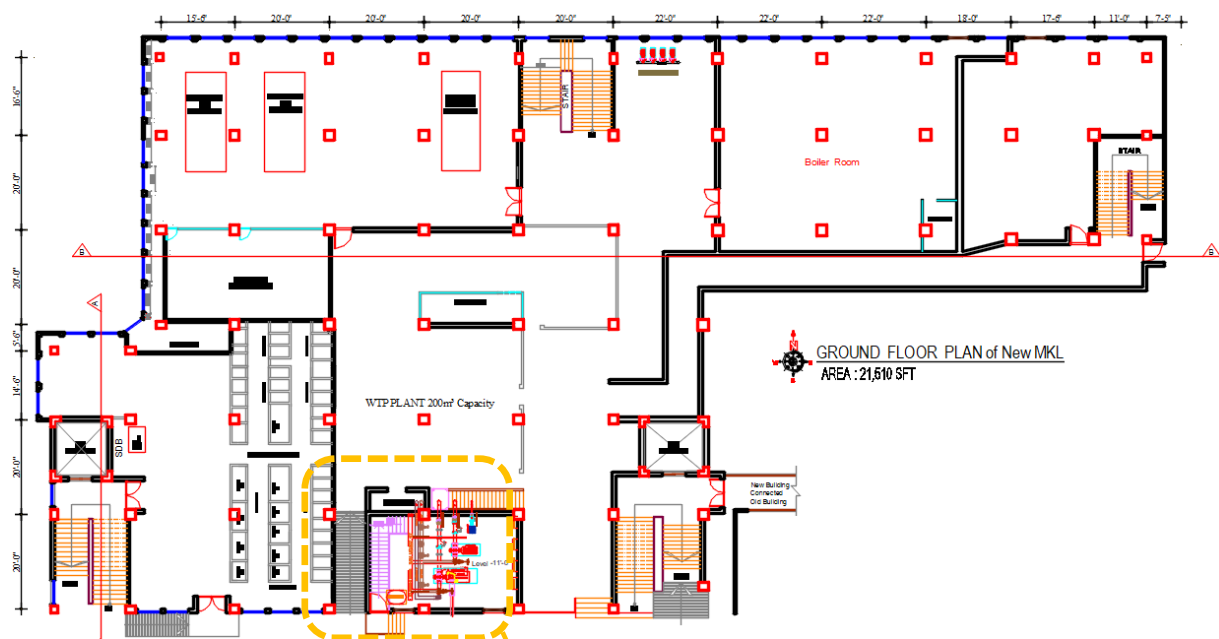
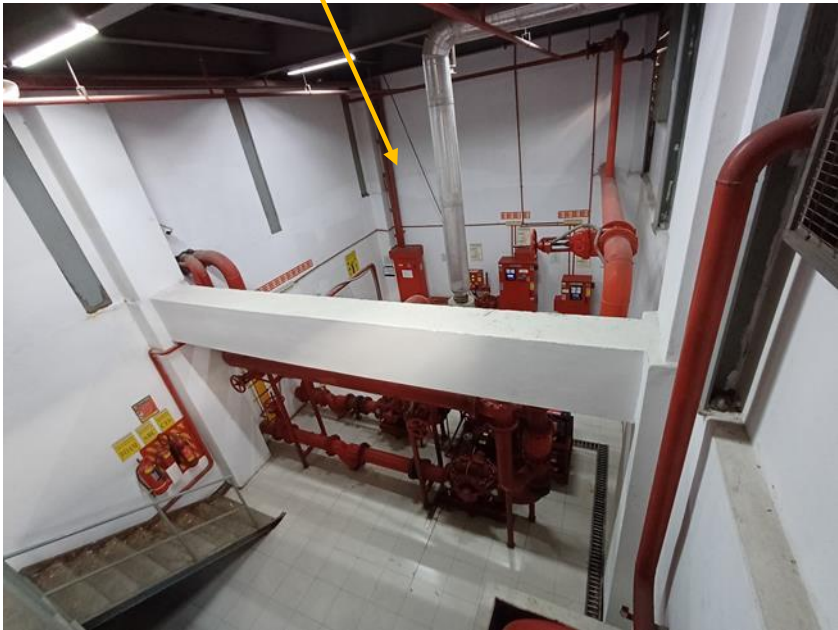
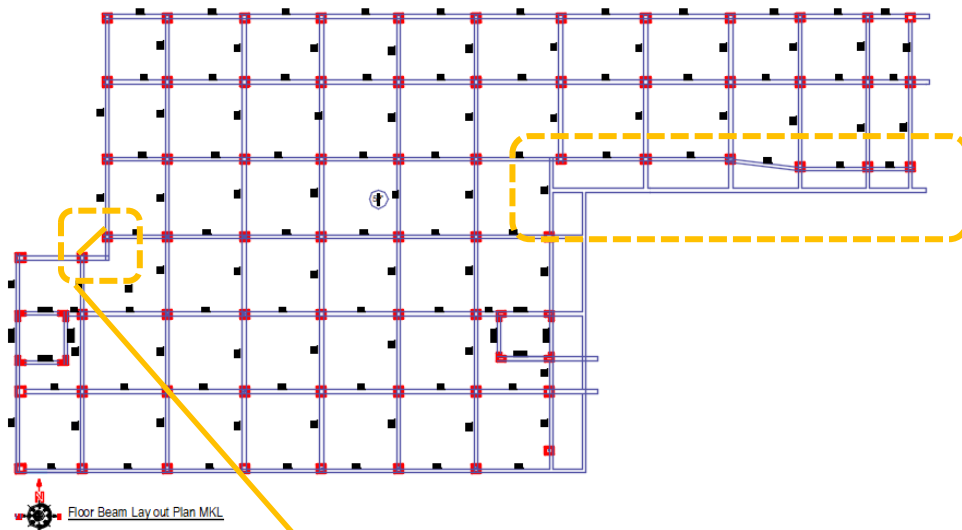
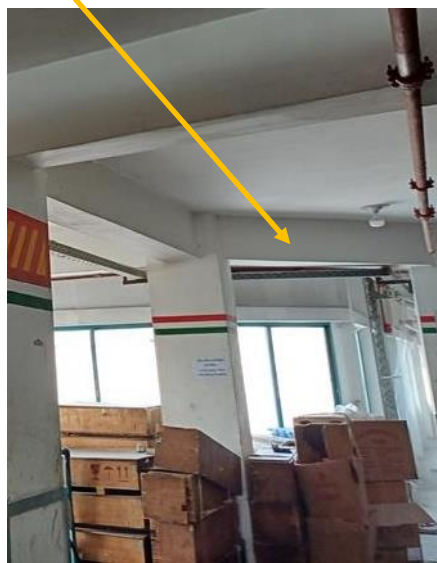
**Observation-2:** Discrepancies in as-built drawings (Extension building-02)

**Description:** In the as-built drawings, no information was found regarding the mezzanine portion. Also, the beam layout did not match the actual site condition.

The building engineer is required to survey the full structure and produce accurate as-built drawings.

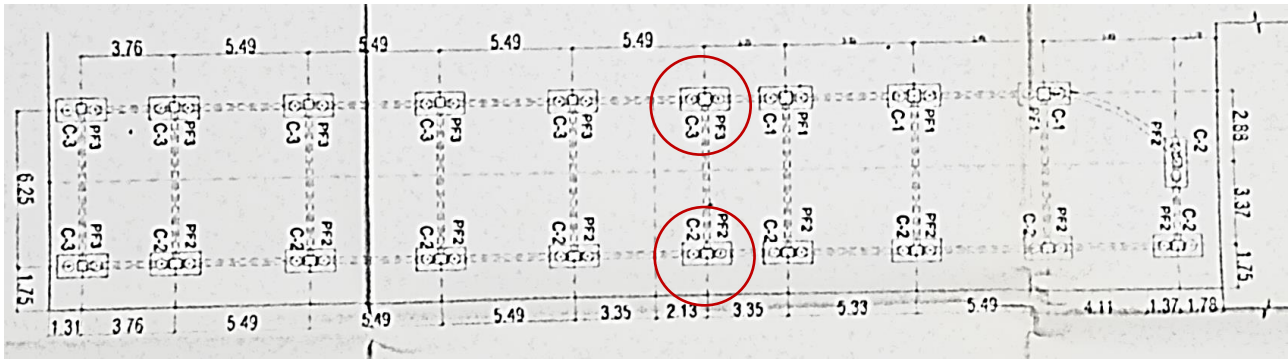
**Observation-3:** Stress in column exceeds normal design limit (Admin Building).

**Description:** The cursory calculation indicates that column stress exceeds the normal design limit considering a typical floor live load of 2kPa, roof live load of 1.5 kPa, and concrete strength of 16.31 MPa.

The building engineer is required to review the design, loads, and column stresses for the marked columns based on in-situ material strength.

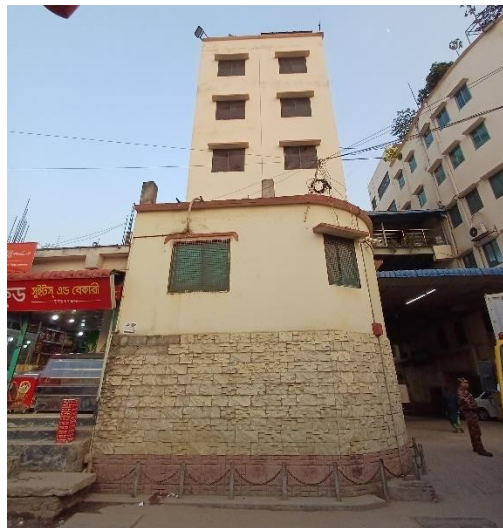
**Observation-4:** Lack of design report (Admin Building).

**Description:** As per BNBC, every building or structure designed shall have its design documents prepared following the provision of Section 1.9.1. The design documents shall include as-built drawings and a design report which shall be prepared in compliance with section 1.9.1, part-6 of BNBC.

During inspection, the design report was not available on site. The building engineer is required to prepare a design report based on in-situ material strength & software-based analysis and submit it to RSC for review.

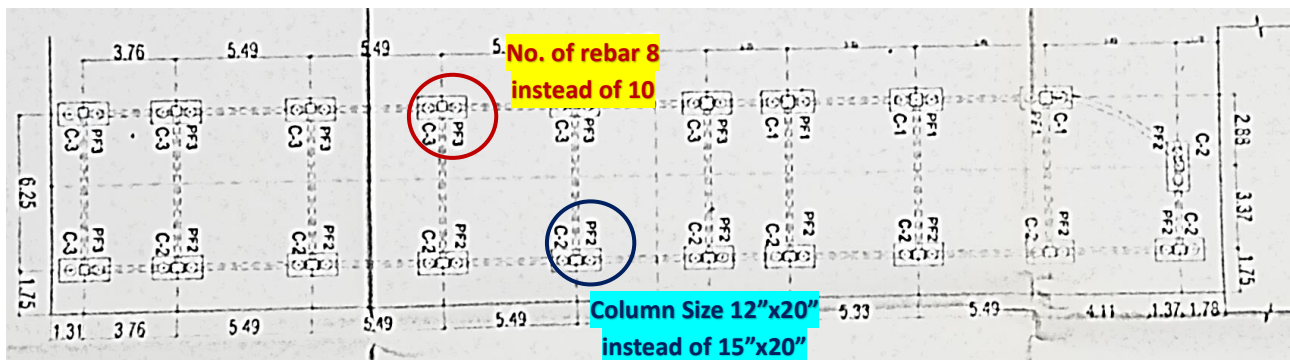
**Observation-5:** Discrepancies in as-built drawings (Admin Building).

**Description:** During the inspection, mismatches were found between the onsite condition and the as-built drawing. Discrepancies were found in column size (C-2), and column rebar (C-3). Also, the beam layout was missing in the as-built drawings.

The building engineer is required to survey the full structure and produce accurate as-built drawings.

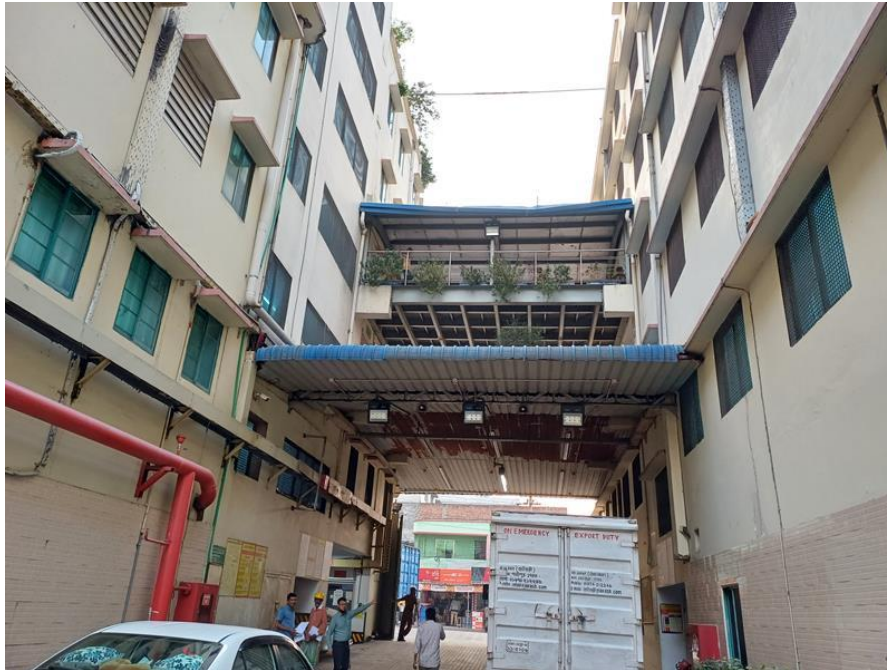
**Observation-6:** Load transfer from the connection bridge (Admin Building).

**Description:** During the inspection, a connecting bridge was observed between the admin building and Liberty Knitwear Ltd (ID-9501) at the 2nd-floor and 3rd-floor levels.

The building engineer is required to survey the full structure and produce accurate as-built drawings. Also building engineer is required to check the load transfer mechanism from the connecting bridge and include in design report. Factory is required to submit the required design documents to RSC for review.

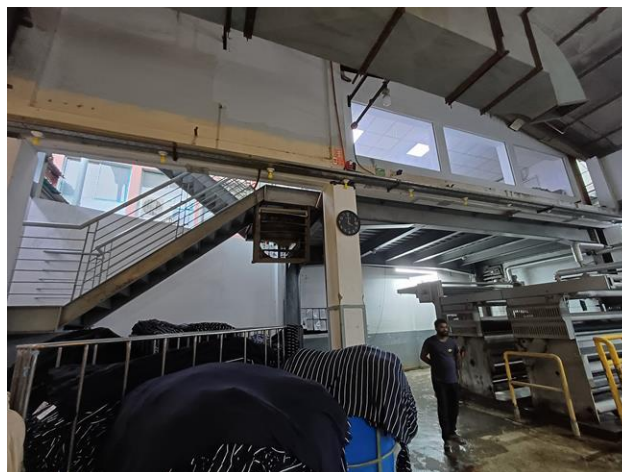
**Observation-7:** Lack of design report (Dyeing and Finishing (Office Building)).

**Description:** As per BNBC, every building or structure designed shall have its design documents prepared following the provision of Section 1.9.1. The design documents shall include drawings as built and a design report which shall be prepared in compliance with section 1.9.1, part-6 of BNBC.

During the inspection, the design report was not available on site. The building engineer is required to prepare a design report based on in-situ material strength & software-based analysis and submit it to RSC for review.

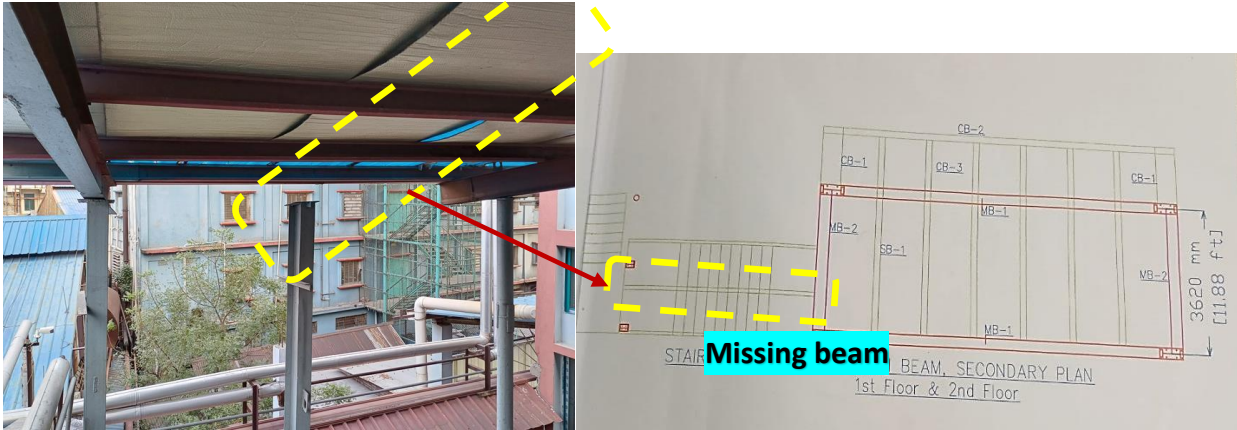
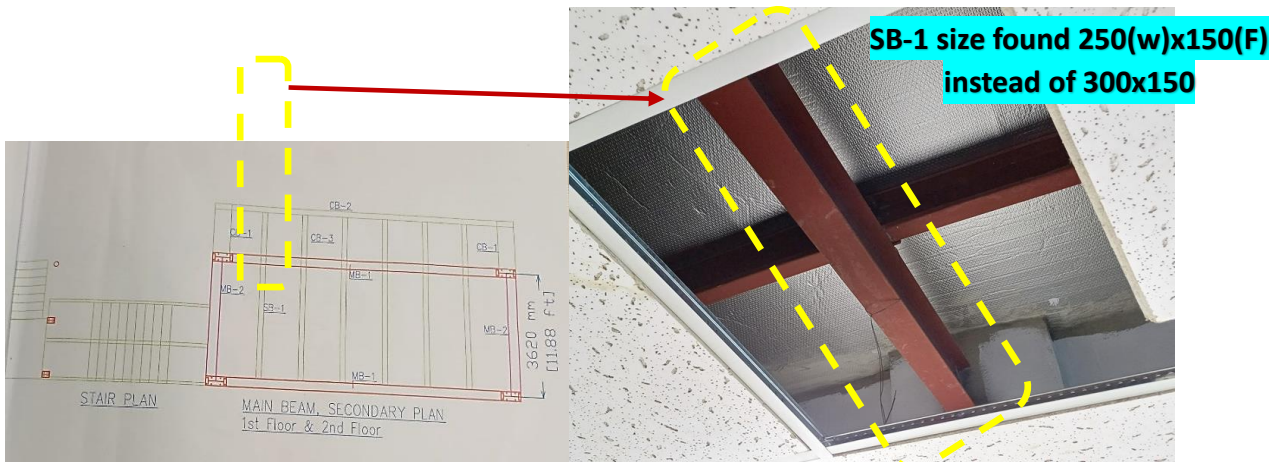
**Observation-8:** Incomplete as-built drawings (Dyeing and Finishing (Office Building))

**Description:** During the inspection, the Roof beam was found missing. Also, the SB-1 beam size was found changed. Furthermore, no connection details and dimensions were provided. The building engineer is required to survey the full structure and produce accurate as built drawings

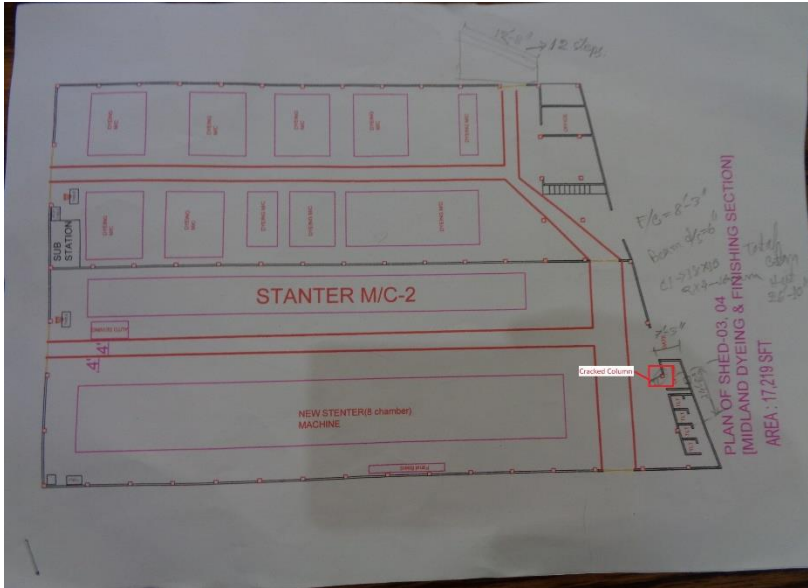
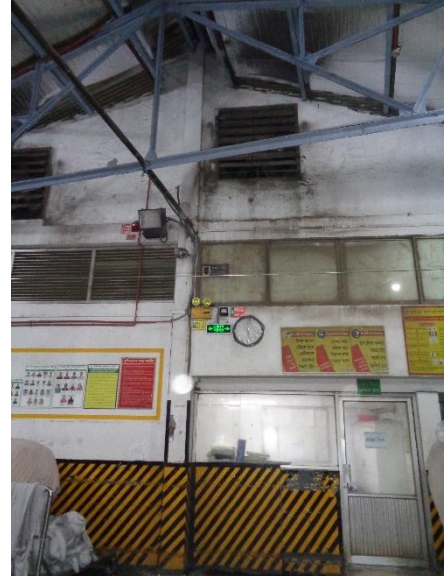
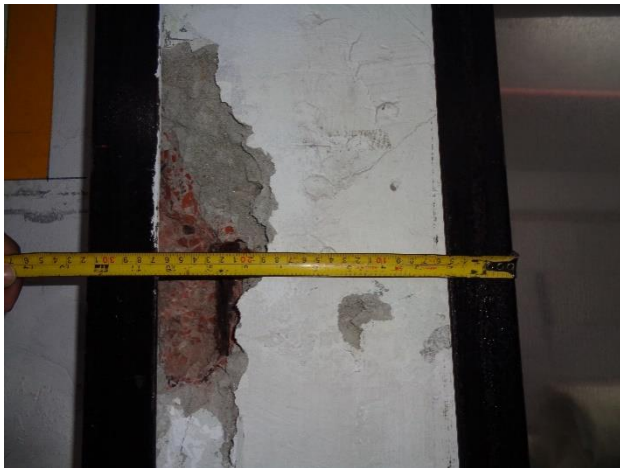
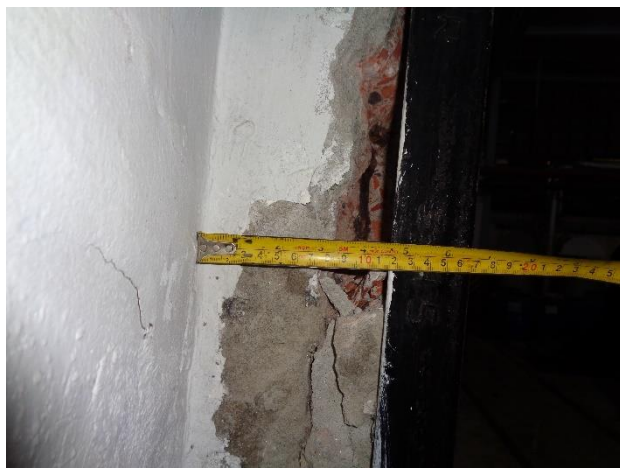
**Observation-9:** Crack found in column (Dyeing & Finishing Shed-1).

**Description:** Crack was found in the ground floor column of the two-storied RC mezzanine of the Dyeing & Finishing Shed-1 marked in the provided layout. The factory must immediately engage a consultant to investigate the cracks and prepare a detailed investigation report with proper remediation methodology. Any safety measures, if required as suggested by the consultant, must be taken immediately to ensure safety.

| Crack found in column (Dyeing & Finishing Shed-1). | The building engineer is required to investigate the cracks and prepare a detailed investigation report with proper remediation methodology. | Immediate |
| | Any safety measures, if required as suggested by the consultant, must be taken immediately to ensure safety. | Immediate |
| | Complete the remediation as suggested in the investigation report | within 6 weeks |

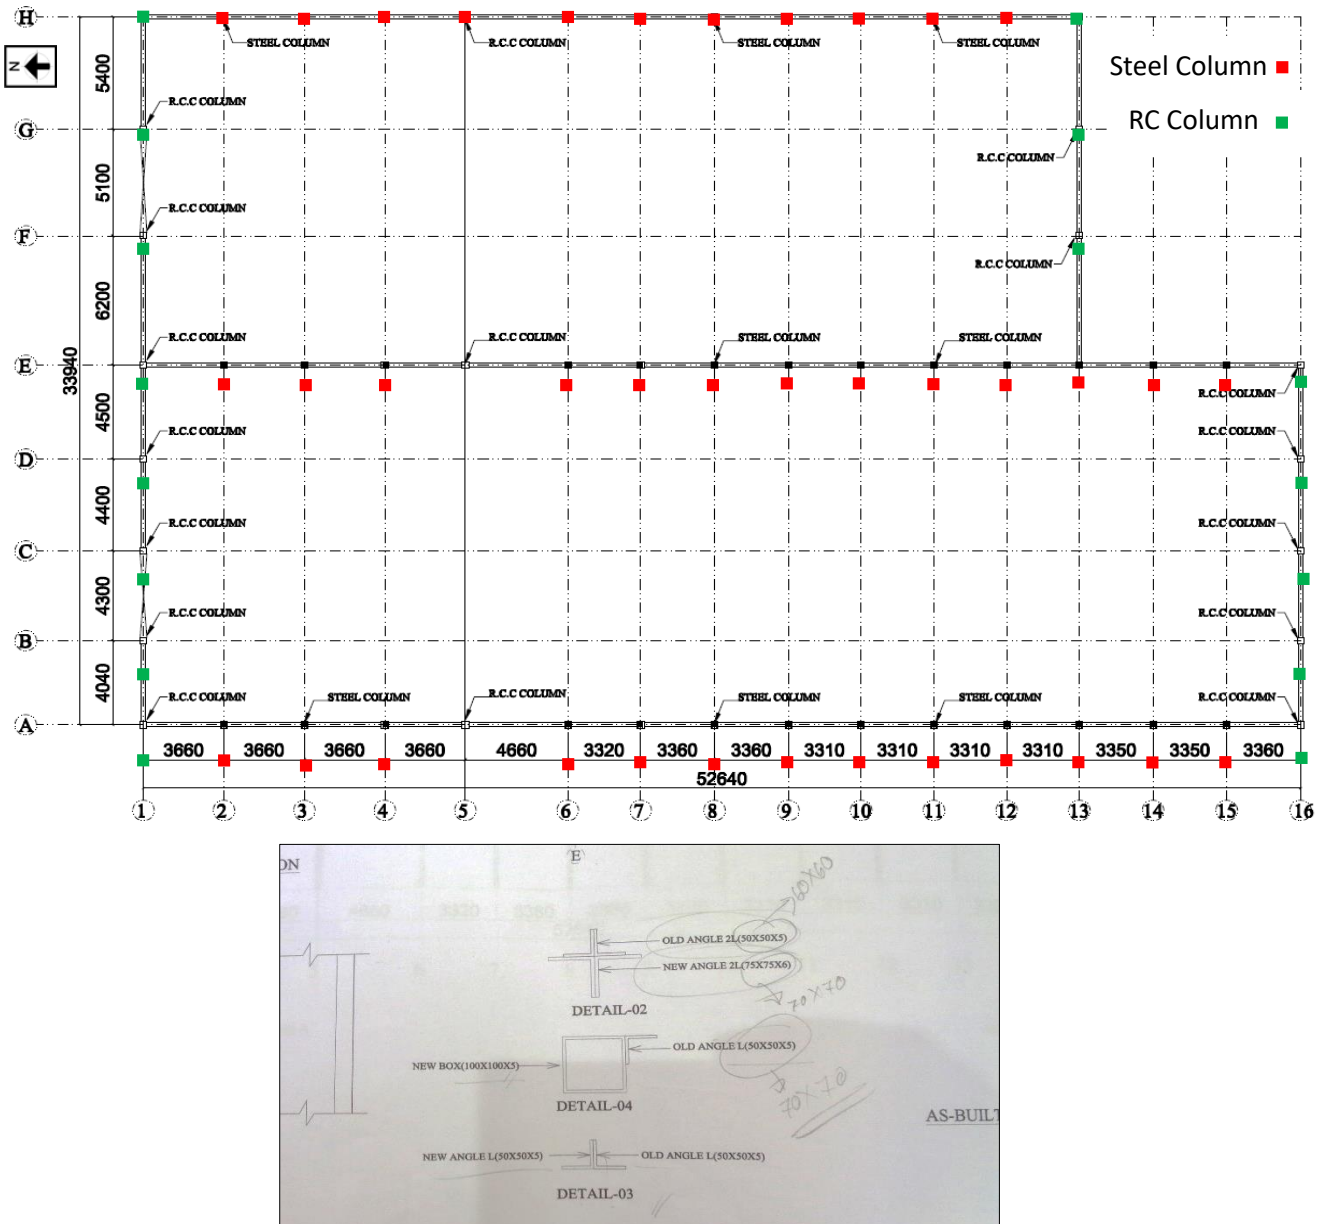
**Observation-10:** Inconsistencies in as-built drawings and lack of design documents.  
(Dyeing & Finishing Shed-1).

**Description:** During the inspection, mismatch was found between the provided as-built drawing and the actual site condition. Steel columns were found in the red-marked location which has not been shown in the drawing. The bottom cord angle leg length was found to be 60mm and 70mm instead of 50mm and 75mm respectively. The angle leg length of the top cord was found 70mm instead of 50mm. The Truss layout has not been shown properly in the drawing. No information has been provided for the RC Mezzanine.

As per BNBC, every building or structure designed shall have its design documents prepared following the provision of Section 1.9.1. During the inspection, the design report and as-built structural drawing were not available on site. The building engineer is required to survey the whole structure and prepare accurate as building as-built drawings. Also Building engineer is required to prepare a set of design documents including as-built drawings, live load plan at the roof and a design report based on actual site condition in compliance with section 1.9.1, part-6 of BNBC.

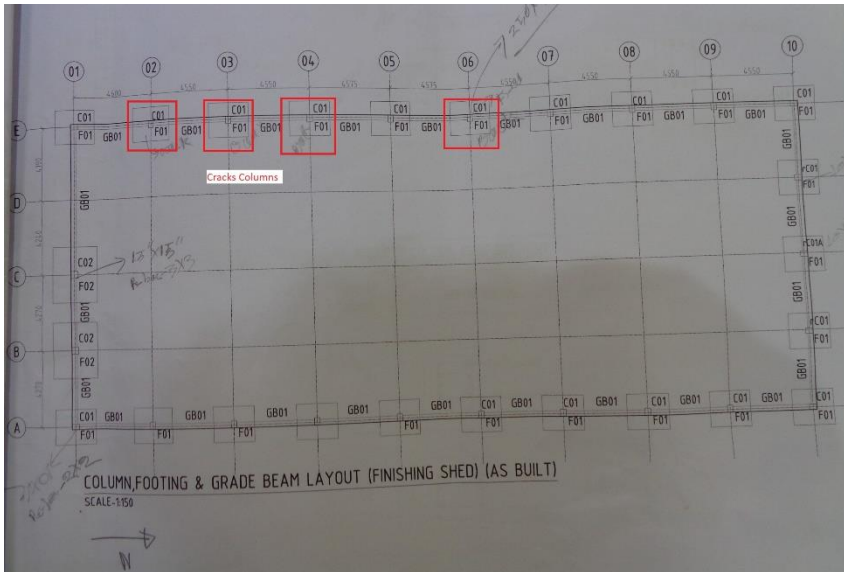
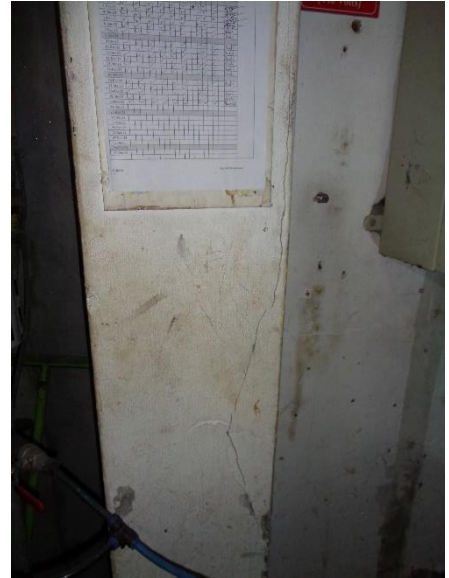
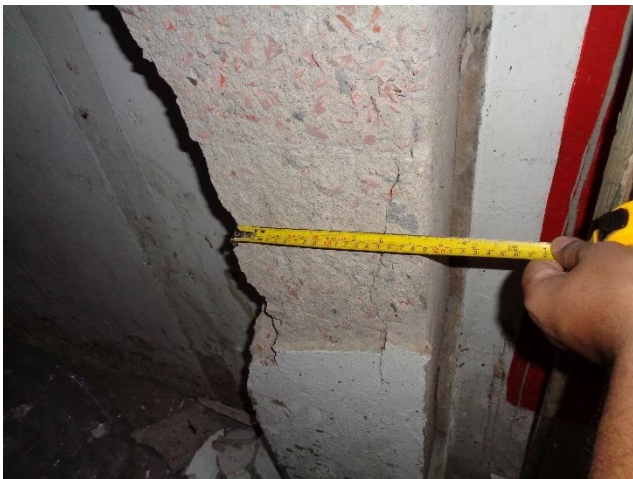
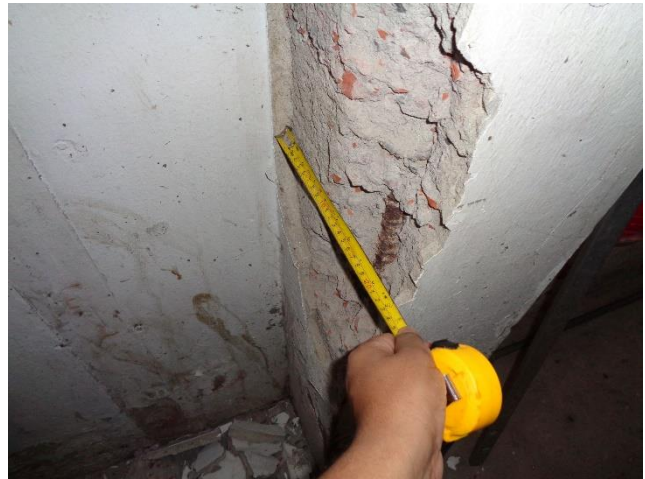
**Observation-11: Crack found in column (Dyeing & Finishing Shed-2: Part A-Finishing Shed).**

**Description:** Crack was found in the ground floor column of Dyeing & Finishing Shed 2 marked in provided layout. The factory must immediately engage a consultant to investigate the cracks and prepare a detailed investigation report with proper remediation methodology. Any safety measures, if required as suggested by the consultant, must be taken immediately to ensure safety.

| Crack found in column (Dyeing & Finishing Shed-2: Part A-Finishing Shed). | The building engineer is required to investigate the cracks and prepare a detailed investigation report with proper remediation methodology. | Immediate |
| | Any safety measures, if required as suggested by the consultant, must be taken immediately to ensure safety. | Immediate |
| | Complete the remediation as suggested in the investigation report | within 6 weeks |

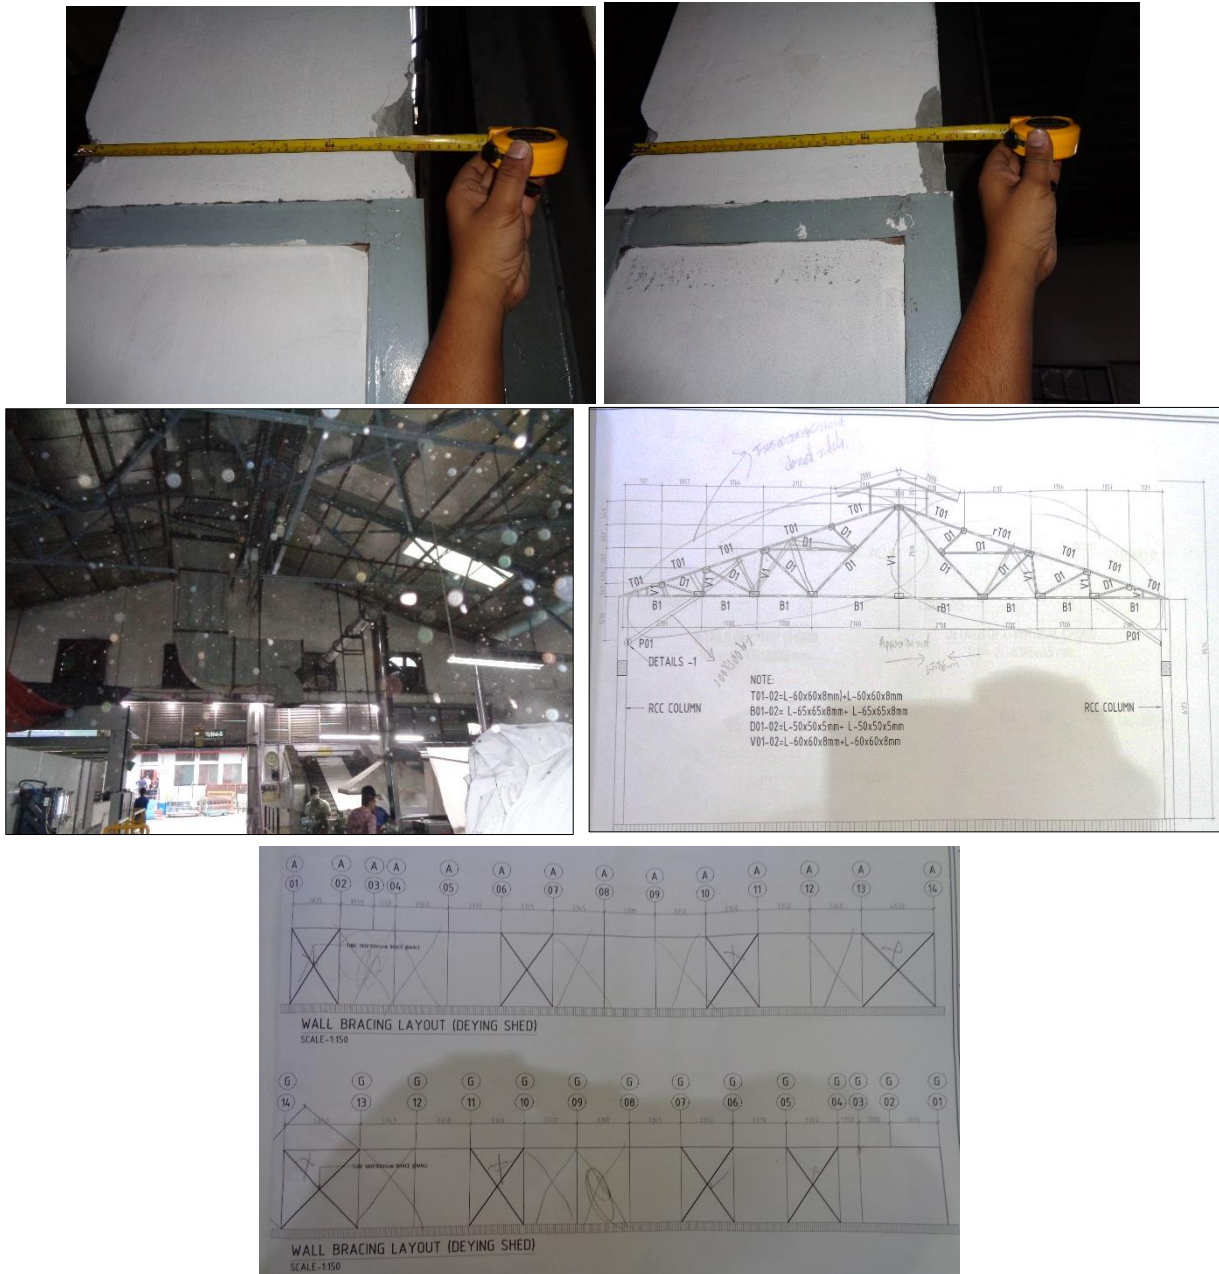
**Observation-12:** Inconsistencies in as-built drawings and lack of design documents.  
(Dyeing & Finishing Shed-2).

**Description:** During the inspection, mismatch was found between the provided as-built drawing and the actual site condition. The size of the RC columns do not match the as-built drawing. The arrangement of the vertical and diagonal members of the truss do not match the site condition. The truss was found at the gable but shown in the as-built drawing. The layout of the vertical bracing does not match with site conditions.

As per BNBC, every building or structure designed shall have its design documents prepared following the provision of Section 1.9.1. During the inspection, the design report and as-built structural drawing were not available on site.

The building engineer is required to survey the whole structure and prepare accurate as building as-built drawings. Also Building engineer is required to prepare a set of design documents including as-built drawings, live load plan at the roof and a design report based on actual site condition in compliance with section 1.9.1, part-6 of BNBC.

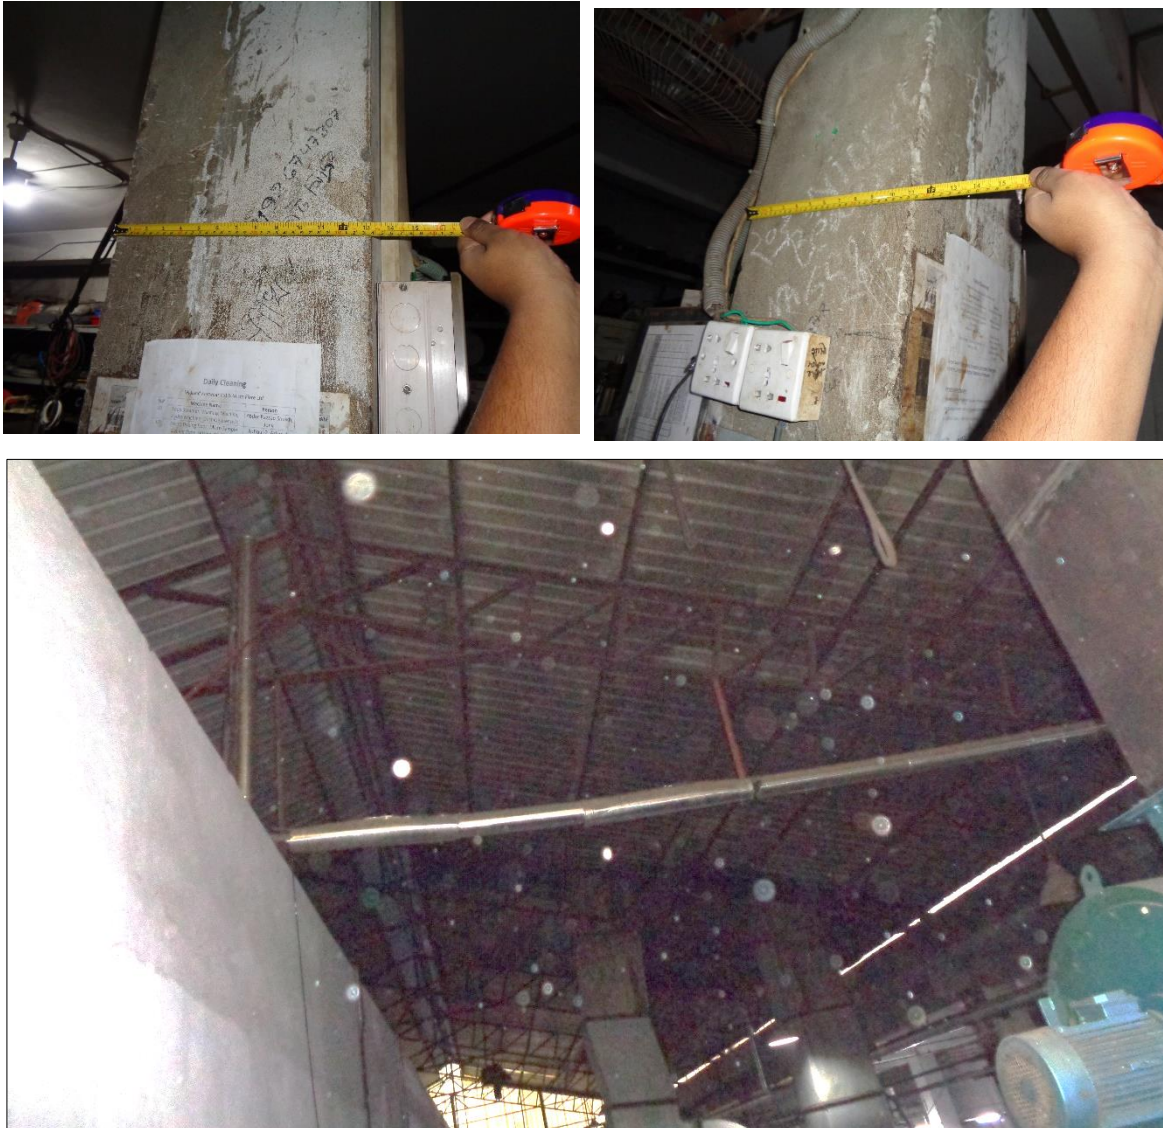
**Observation 13:** Inconsistencies in as-built drawings and lack of design documents.  
(Sample Dyeing and Maintenance Shed-3)

**Description:** The size of the truss members has not been mentioned in the as-built drawing. Also, the mismatch was found in column size and re-bar.

As per BNBC, every building or structure designed shall have its design documents prepared following the provision of Section 1.9.1. During the inspection, the design report and as-built structural drawing were not available on site.

The building engineer is required to survey the whole structure and prepare accurate as building as-built drawings. Also Building engineer is required to prepare a set of design documents including as-built drawings, live load plan at the roof and a design report based on actual site condition in compliance with section 1.9.1, part-6 of BNBC.
