# DYNAMIC SWEATER INDUSTRIES LIMITED (DHAKA SWEATER) (Extension)

10, Ganda, Savar, Dhaka-1340

5 February 2024

**Finished Goods Warehouse:** is a single storied steel shed.

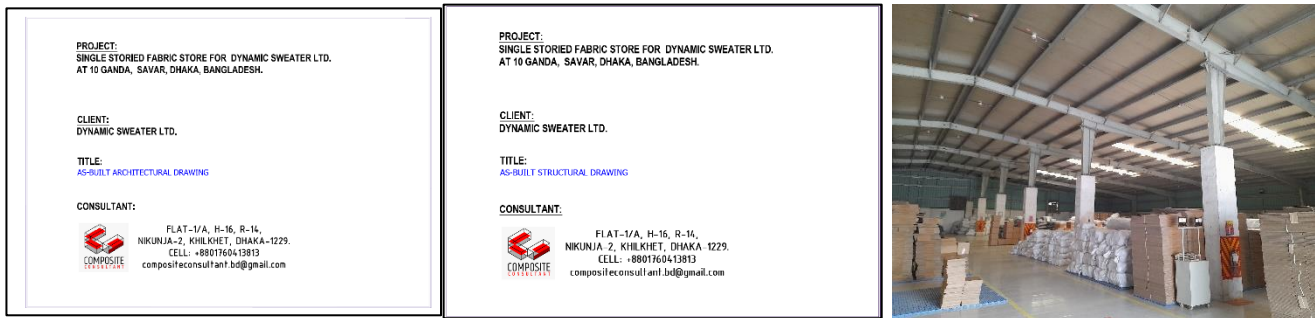
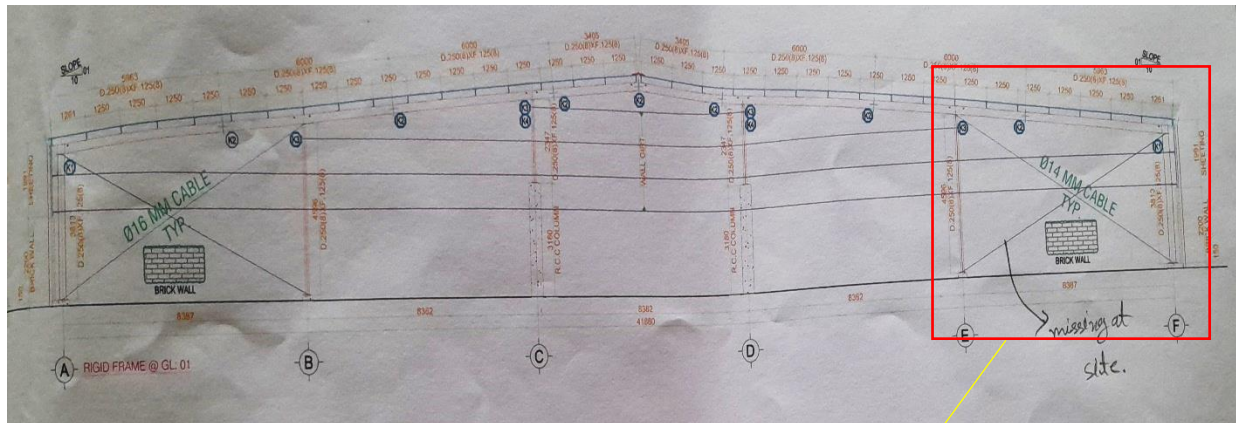
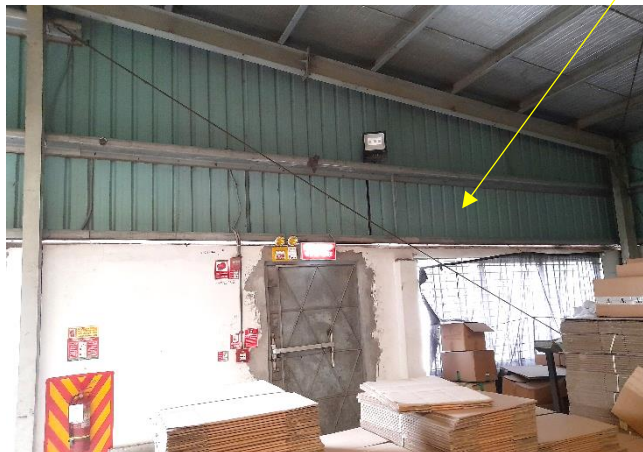
### Observation-1: Lack of information in as-built drawing.

**Description:** During inspection, only as-built architectural and structural drawings for steel parts were available. The details of the RC columns and sub structures such as pedestal, grade-beam and foundations has not been provided in the drawing.

The vertical cable bracing was not found at site as per provided as-built drawing. The cable bracing was found missing as marked in figure.

Building Engineer is required to survey the whole structure and prepared accurate as-built drawing including the foundation information.

| Serial No | Observation | Action Plan | Timeline |
|---|---|---|---|
| 1 | Lack of information in as-built drawing. | The building engineer is required to survey the full structure and produce accurate as-built drawings including the foundation details. | within 6 weeks |

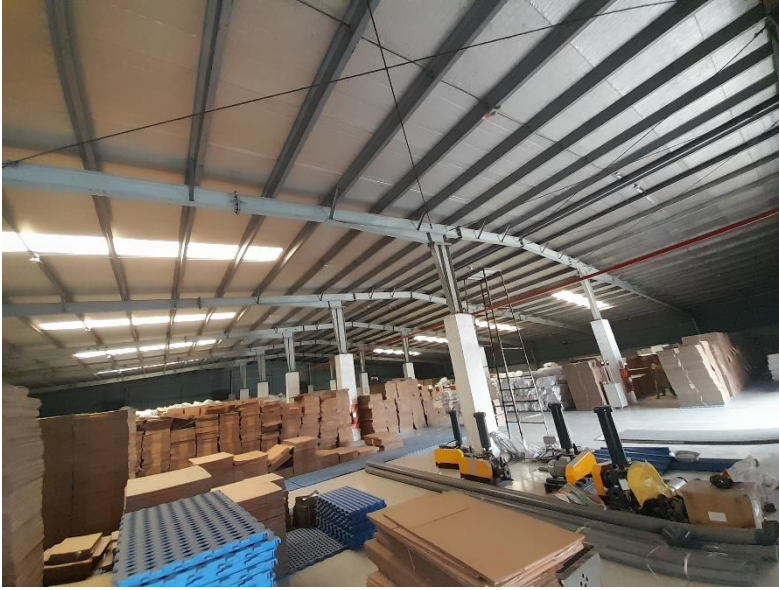
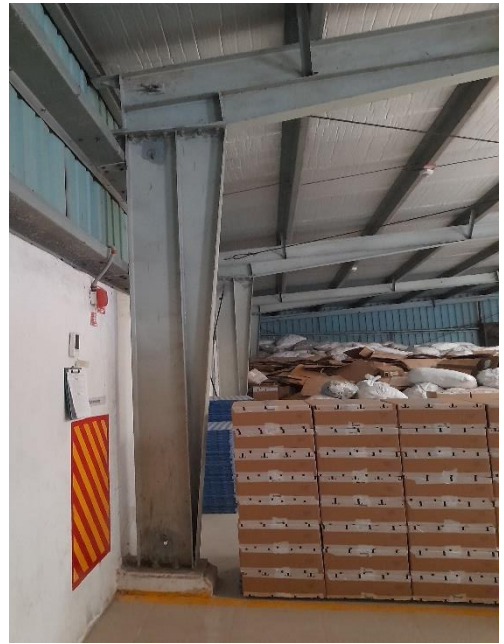
**Observation-2:** Missing continuous lateral load transfer media.

**Description:** During inspection, Lateral load transfer media (compression strut) along the ridge and eaves were missing. Also, cable bracing at roof and wall seems to be inadequate. The building engineer is required to check the lateral load path and review the stability of the structure accordingly.

Also, the sub-structure information was not available in as-built drawing as well as sub-soil investigation report was not available.

The building engineer is required to prepare a full set of design documents including the adequacy of the RC columns, grade beam and foundation.

| Serial No | Observation | Action Plan | Timeline |
|---|---|---|---|
| 2 | Missing continuous lateral load transfer media. | The building Engineer is required to confirm the lateral load path & verify the lateral stability of the steel shed. | within 6 weeks |
| 3 | Missing continuous lateral load transfer media. | Check the adequacy of RC members and adequacy of foundation. | within 6 weeks |
| 4 | Missing continuous lateral load transfer media. | Implement the remediation if required. | within 6 months |

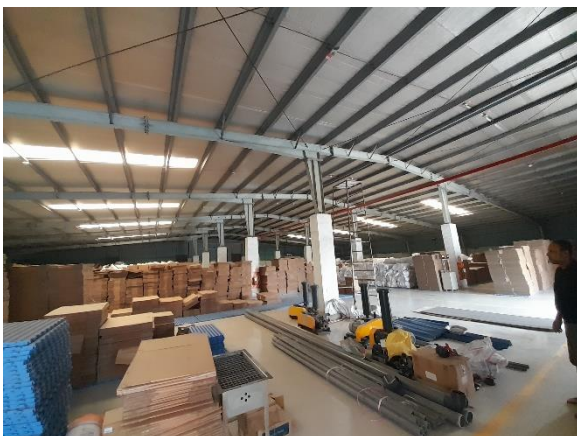
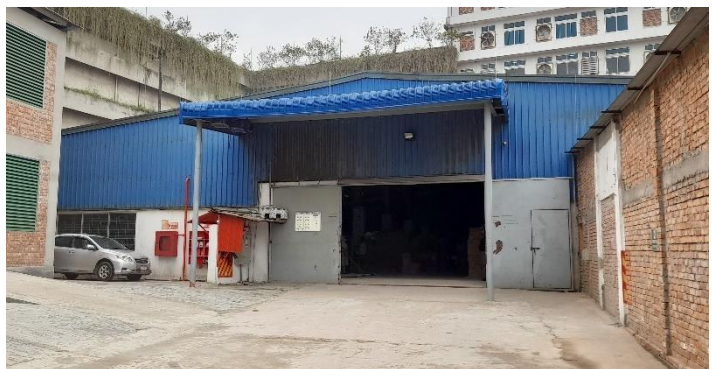
**Observation-3:** Lack of permit drawing.

**Description:** The structure is a single storied steel shed. The shed is being used for storage purposes. The construction of the shed was started in June-2012 and completed in May-2013. The shed has been occupied since March 2021. During inspection, the building permit drawing from the local authority was not available for the single storied steel shed. The factory is required to collect permission for the shed from local government authority.

| Serial No | Observation | Action Plan | Timeline |
|---|---|---|---|
| 5 | Lack of permit drawing. | The factory is required to collect the building permit from the local government authority. | within 6 months |

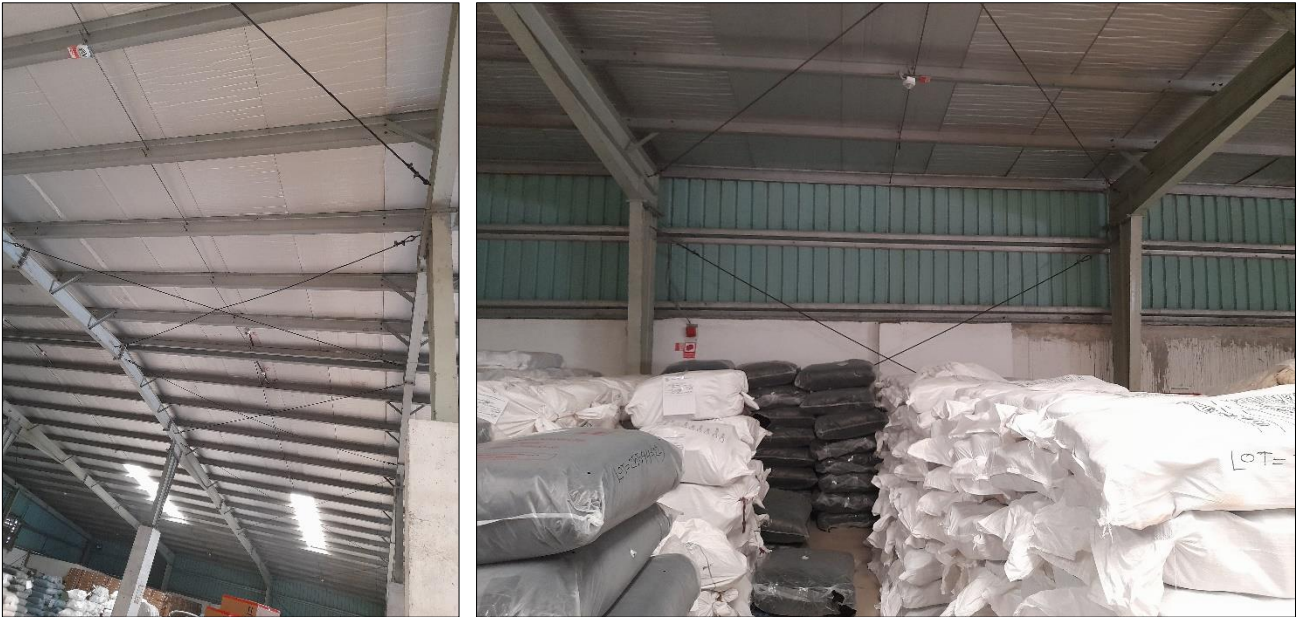
**Observation-4:** Cable bracing found loose.

**Description:** During inspection, the horizontal and vertical cable bracing was found loose. Factory is required to take necessary measures to tighten the loose bracings.

| Serial No | Observation | Action Plan | Timeline |
|---|---|---|---|
| 6 | Cable bracing found loose | The factory is required to tighten the cable bracings. | within 6 weeks |

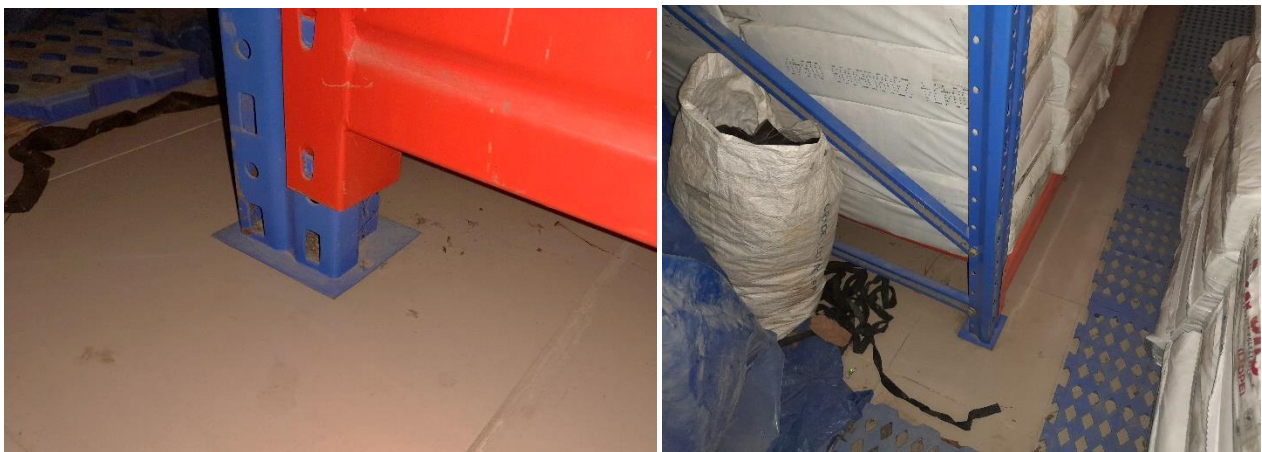
**Observation-5:** Non-structural elements not anchored or braced.

**Description:** Racks are not adequately anchored or braced to resist lateral (earthquake) forces. Building is required to adequately anchor and brace all non-structural elements to resist earthquake forces to comply with the BNBC.

| Serial No | Observation | Action Plan | Timeline |
|---|---|---|---|
| 7 | Non-structural elements not anchored or braced. | The factory is required to adequately anchor and brace all non-structural elements to resist earthquake forces to comply with the BNBC. | within 6 months |
