# Abir Fashions (Extension)

Plot #44, Road #02, Kutubail, Fatullah, Narayanganj.

11 February 2024

## 2. Observations:

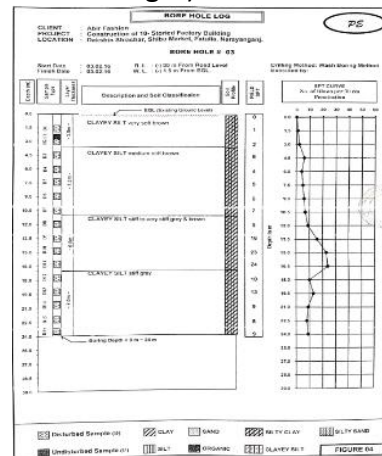
### Observation-2: Lack of information in soil test report (Production Building-5).

**Description:** Recommendation for foundation is given based on 12 borehole data but no borehole layout is given in soil test report. Also, bore log data is provided only for 3 boreholes. The building engineer is required to submit the complete soil test report with all bore log data along with design report to the RSC.

| Observation | Action Plan | Timeline |
|---|---|---|
| Lack of information in soil test report (Production Building-5). | The building engineer is required to submit the complete soil test report with all bore log data along with the design report to RSC for review. | within 6 weeks |

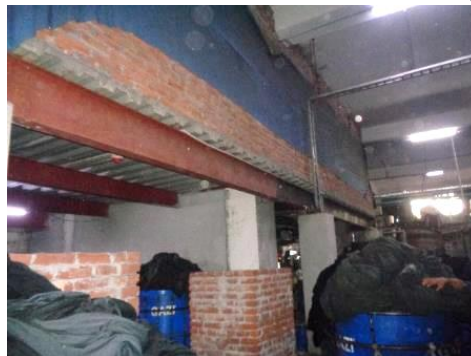
### Observation-3: Lack of foundation information of mezzanine floor (Production Building-5).

**Description:** Foundation information is not provided for the mezzanine floor on the ground floor. The building engineer is required to verify the onsite foundation system, produce the complete as-built drawing, and submit the documents to the RSC along with the design report.

| Observation | Action Plan | Timeline |
|---|---|---|
| Lack of foundation information of mezzanine floor (Production Building-5). | The building engineer is required to verify the onsite foundation system, produce the complete as-built drawing, and submit the documents to the RSC along with the design report. | within 6 weeks |

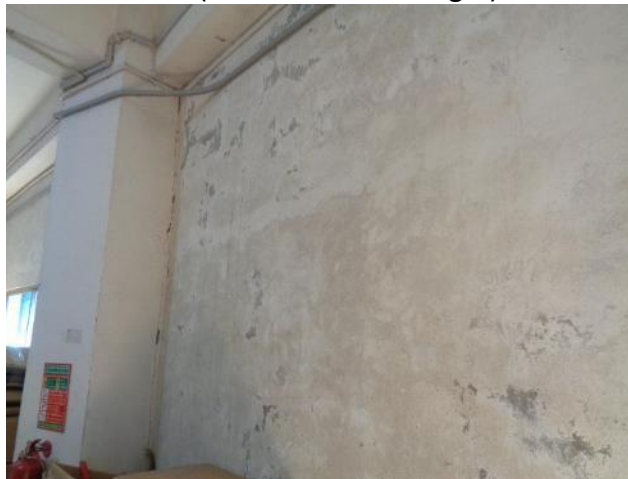
**Observation-8:** Dampness on brick wall (Production Building-5).

**Description:** Dampness was found on brick wall. The building engineer is required to repair dampness with a suitable method.

| Observation | Action Plan | Timeline |
|---|---|---|
| Dampness on brick wall (Production Building-5). | The building engineer is required to repair dampness with a suitable method. | within 6 weeks |

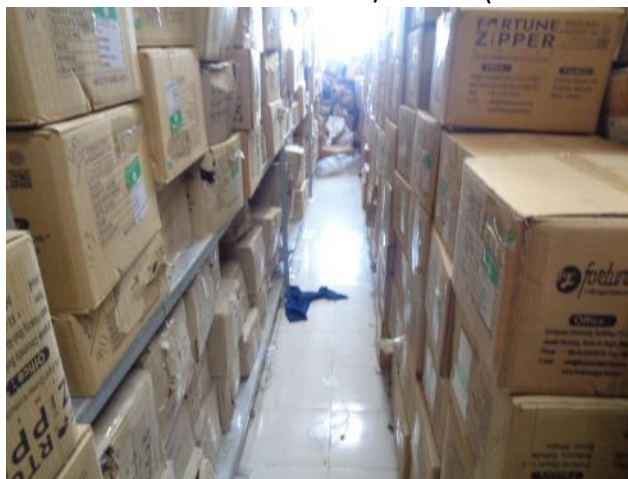
**Observation-9:** Nonstructural elements not anchored/braced (Production Building-5).

**Description:** Nonstructural elements were found not anchored/braced. The building engineer is required to anchored/braced all nonstructural elements within the factory.

| Observation | Action Plan | Timeline |
|---|---|---|
| Nonstructural elements not anchored/braced (Production Building-5). | The building engineer is required to anchored/braced all nonstructural elements within the factory. | within 6 months |

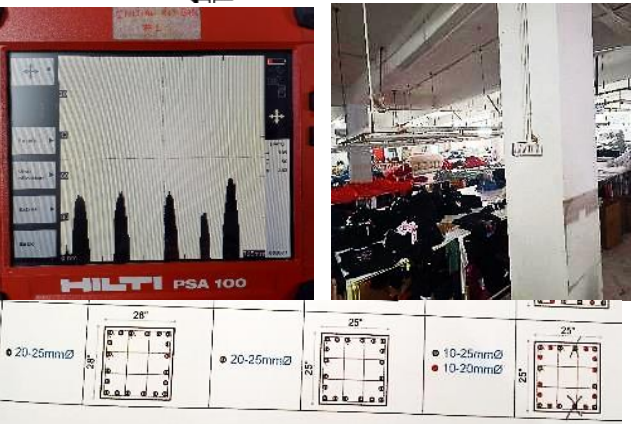
Column C8 (625X625) re-bar profile found by scanning 6/5 (18 no's) instead of 6/6 (20 no's)

| Observation | Action Plan | Timeline |
|---|---|---|
| Lack of information and discrepancies in the provided drawing (Production Building-6). | The building engineer is required to survey the whole structure and revise as-built drawing reflecting the on-site condition. | within 6 weeks |

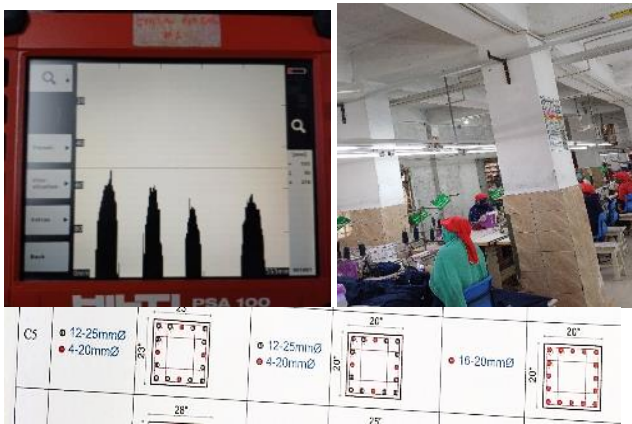
Column C5 (500X500) re-bar profile found by scanning 4/5 (14 no's) instead of 5/5 (16 no's)

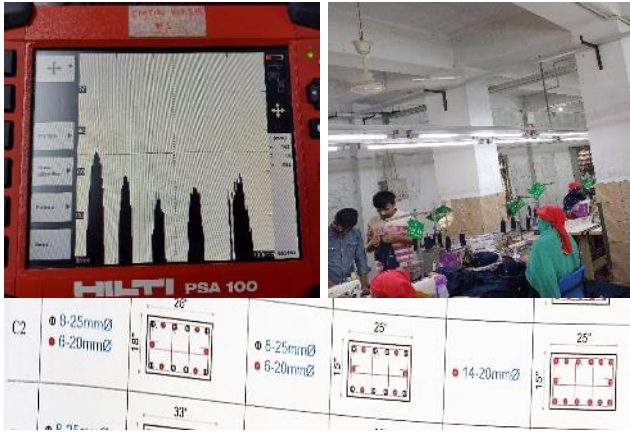
Column C2 (625X375) re-bar profile found by scanning 5/3 (12 no's) instead of 6/3 (14 no's)

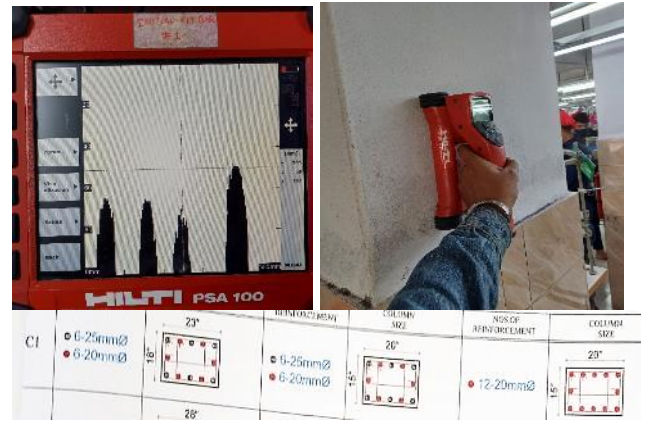
Column C1 (375X500) re-bar profile found by scanning 4/3 (10 no's) instead of 5/3 (12 no's)

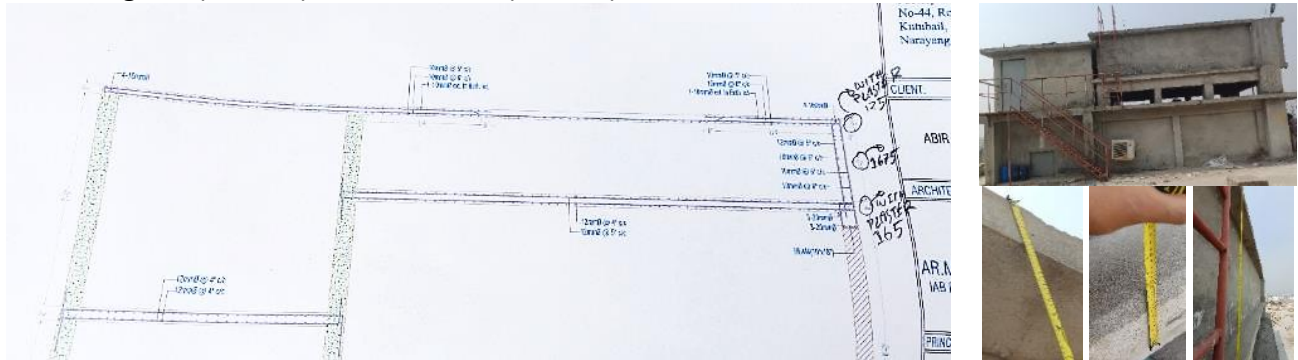
RC OHWT: Bottom slab thickness found 165mm (with both side plaster) instead of 200mm (without plaster) as well as top slab thickness found 125mm (with both side plaster) instead of 125mm (without plaster). Also, water tank height observed 1800mm instead of 1325mm.

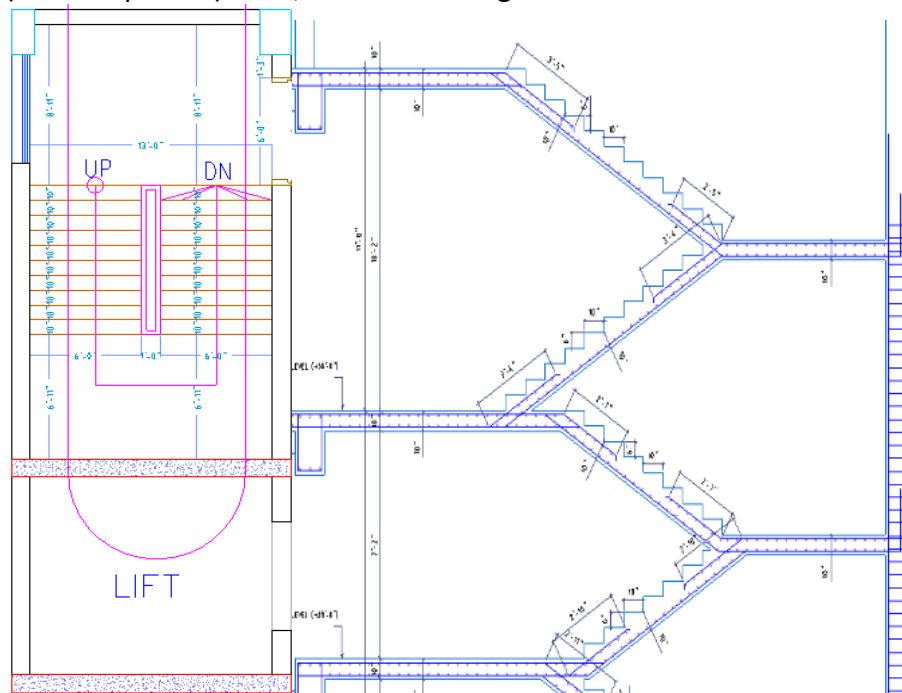
South Stair: numbers of tread, height of riser, and landing width are mismatching with provided drawing

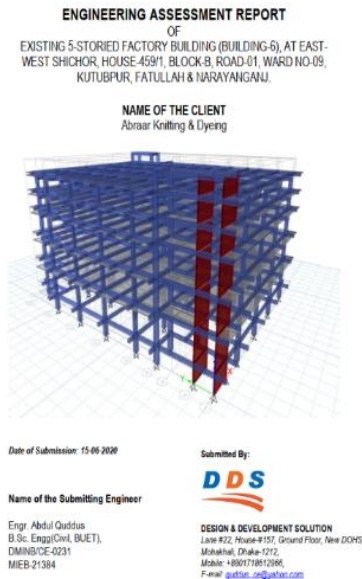
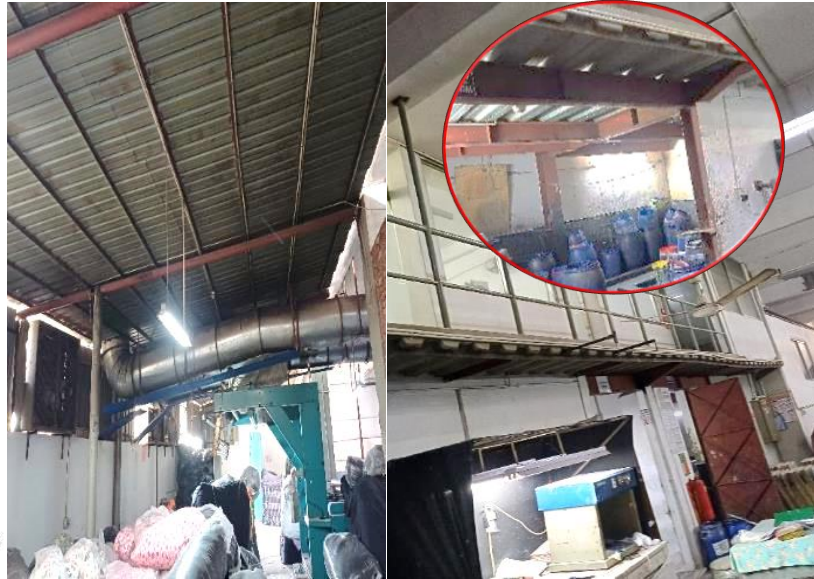
**Observation-12:** Lack of information in the design report (Production Building-6).

**Description:** In the provided design report, adequacy check of ground floor extended shed and steel supported mezzanine floor is not included. Also, RC beam demand-capacity ratio, foundation punching, deflection & displacement and other vertical & horizontal irregularity checks were not incorporated in the report. Based on the in-situ material strength, update the structural analysis & design of the structures, and submit design documents to the RSC for review.

| Observation | Action Plan | Timeline |
|---|---|---|
| Lack of information in the design report (Production Building-6). | Based on the in-situ material strength, the building engineer is required to update the structural analysis & design of the structures and submit design documents to the RSC for review. | within 6 weeks |

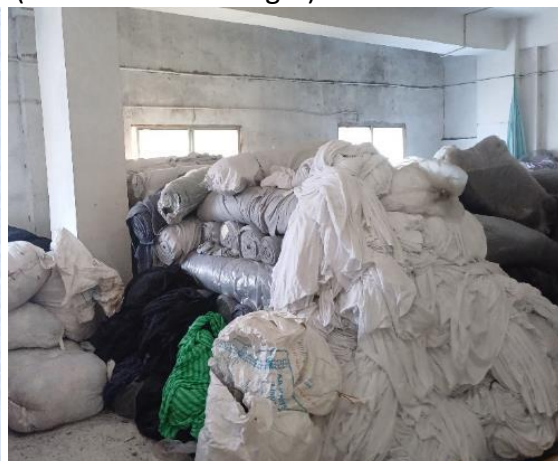
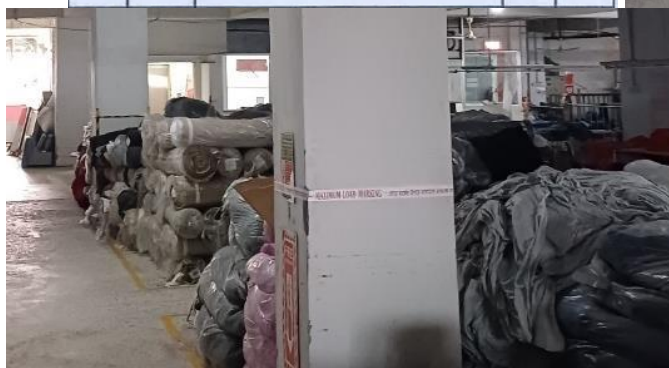
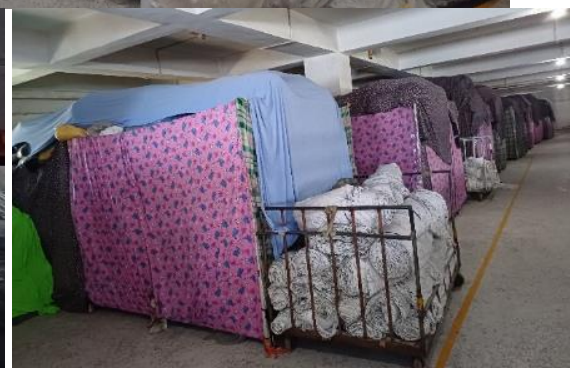
**Observation-13:** Prepared load plan to be revised (Production Building-6).

**Description:** This Building was constructed between May 2017 and August 2019 confirmed by factory management. However, typical live load considered as 5 Kpa in all floors. As per BNBC- Part 6, live load for light storage area is required to be considered minimum 6 kPa. The building engineer is required to revise the load plan as per BNBC requirement and submit the revised design documents to RSC for review.

| Observation | Action Plan | Timeline |
|---|---|---|
| Prepared load plan to be revised (Production Building-6) | The building engineer is required to revise the load plan as per BNBC requirement and submit the revised design documents to RSC. | within 6 weeks |

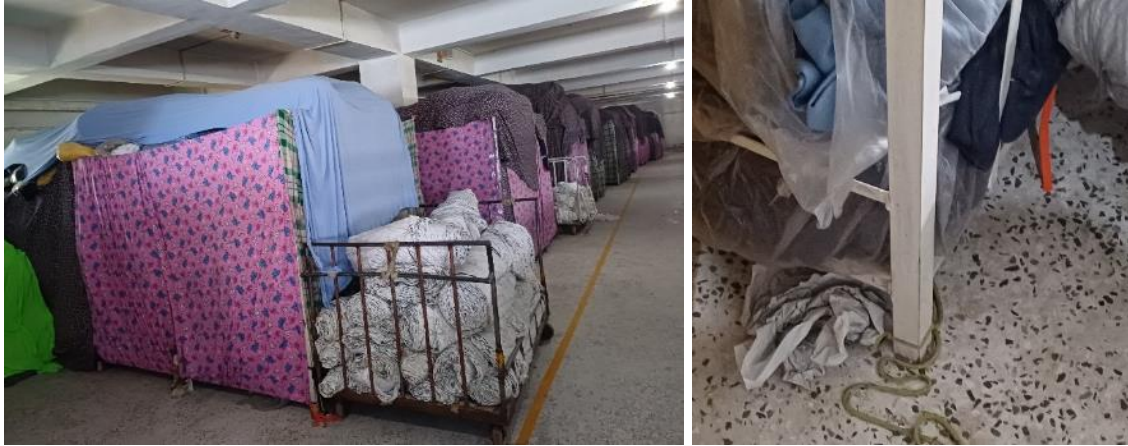
**Observation-14:** Anchorage missing for the non-structural elements (Production Building-6).

**Description:** During the inspection, storage racks were observed on the several floors and locations without anchorage. The non-structural elements suspended from, attached to, or resting atop the structure shall be adequately anchored and braced to resist earthquake forces. The factory is required to brace/anchor all non-structural elements.

| Observation | Action Plan | Timeline |
|---|---|---|
| Anchorage missing for the non-structural elements (Production Building-6) | The factory is required to brace/anchor all non-structural elements. | within 6 months |

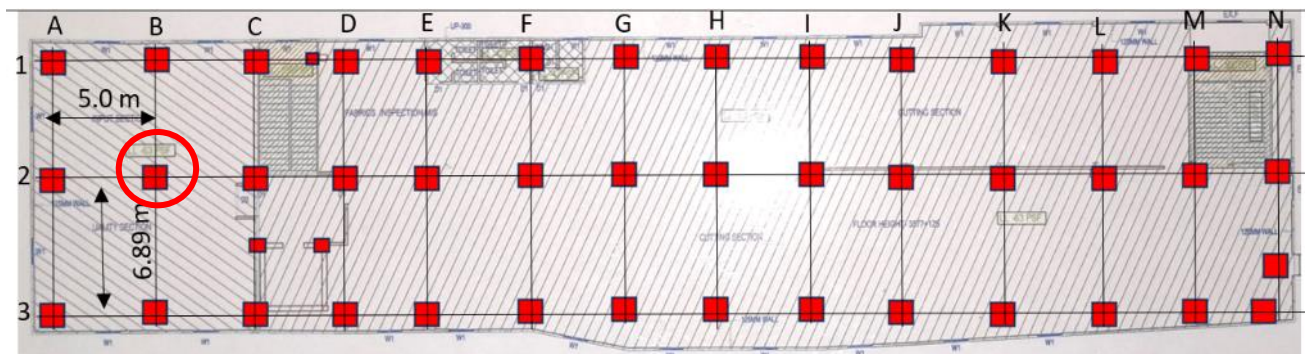
Column Layout Plan

**Observation-15:** High stress in RC column. (Production Building-7)

**Description:** Cursory calculation indicates that the marked columns appear to be stressed above normal design limits based on 6 kPa floor live load with minimum concrete strength (16.3 MPa) based on aggregate type. Also, due to lack of drawing, foundation adequacy check was not verified. The building engineer is required to carry out Detail Engineering Assessment (DEA) to review the design, loads and column & foundation stress based on in-situ material strength and soil bearing capacity.

| Observation | Action Plan | Timeline |
|---|---|---|
| High stress in RC column.<br>(Production Building-7) | Verify in-situ concrete material strength by taking concrete cores from lower tier building columns. And verify in-situ MS plate strength by taking samples from existing building beam & columns. | Immediate |
| | The building engineer is required to carry out Detail Engineering Assessment (DEA) to review the design, loads and column stress based on in-situ material strength. | within 6 weeks |

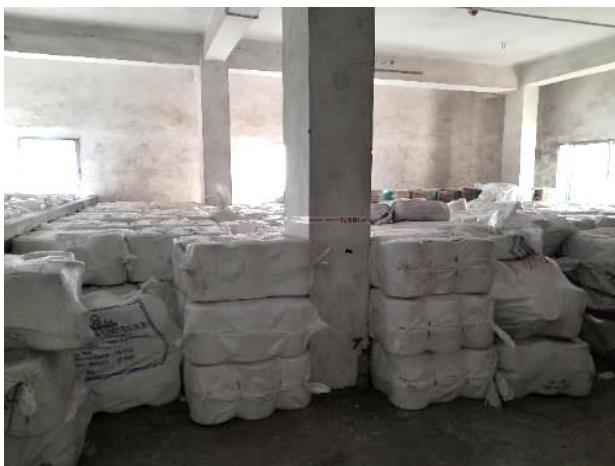
Storage area

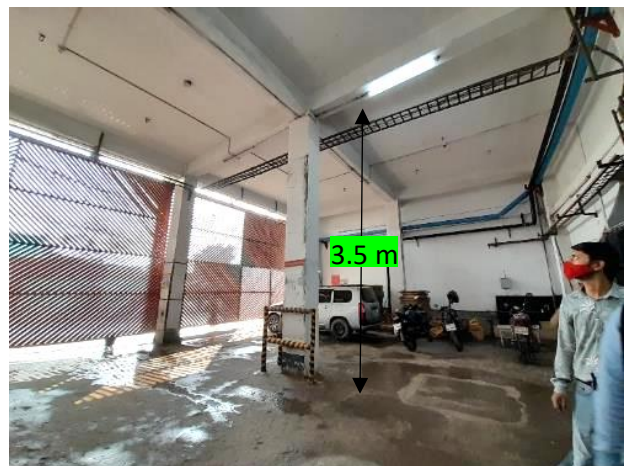
Stressed RC column

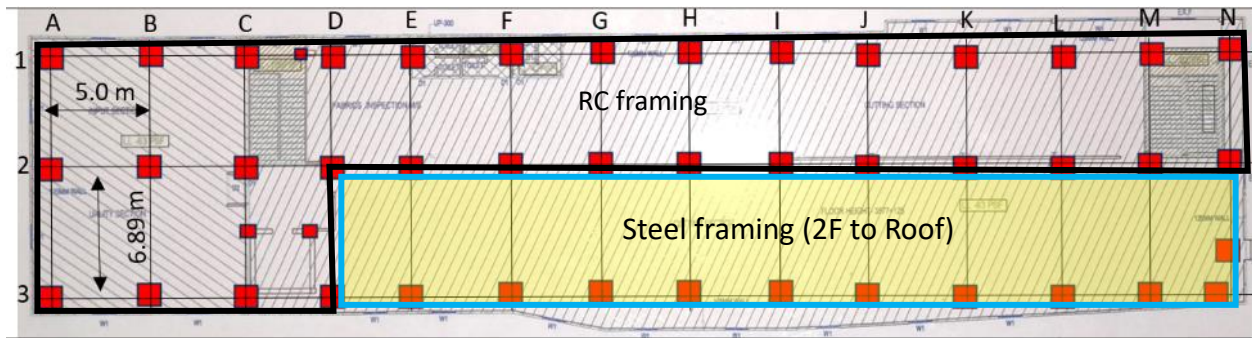
Building Plan

**Observation-16:** Different and irregular structural framing system. (Production Building-7)

**Description:** The building consists of both RC & steel framing system where the shape of the RC framing is horizontally irregular. The irregular shape induces torsion into the structure. Also, the structural integrity of the structure is questionable. The building engineer is required to check the framing system, all types of irregularities & structural integrity of the structure. Incorporate the above issues in the software-based analysis model & revise the design report accordingly.

| Observation | Action Plan | Timeline |
|---|---|---|
| Different and irregular structural framing system | The building engineer is required to check the framing system, all types of irregularities & structural integrity of the structure. Incorporate the above issues in the software-based analysis model & revise the design report accordingly. | within 6 weeks |

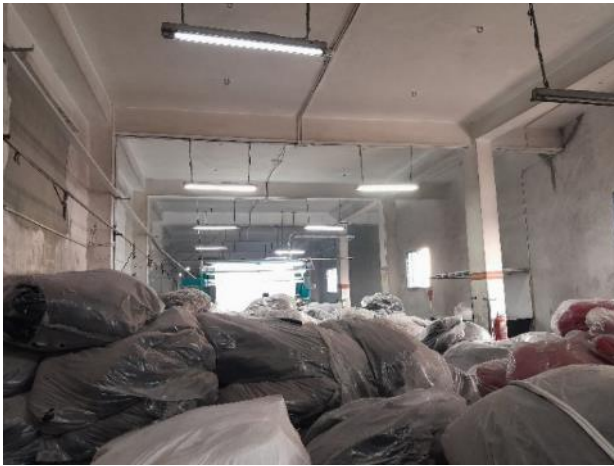
RC framing systme

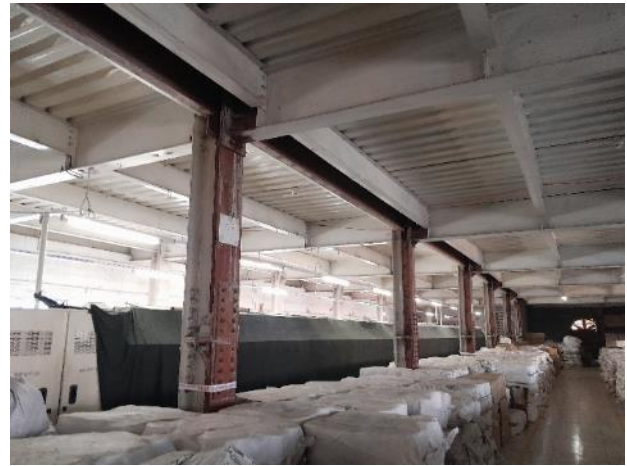
Steel framing systme

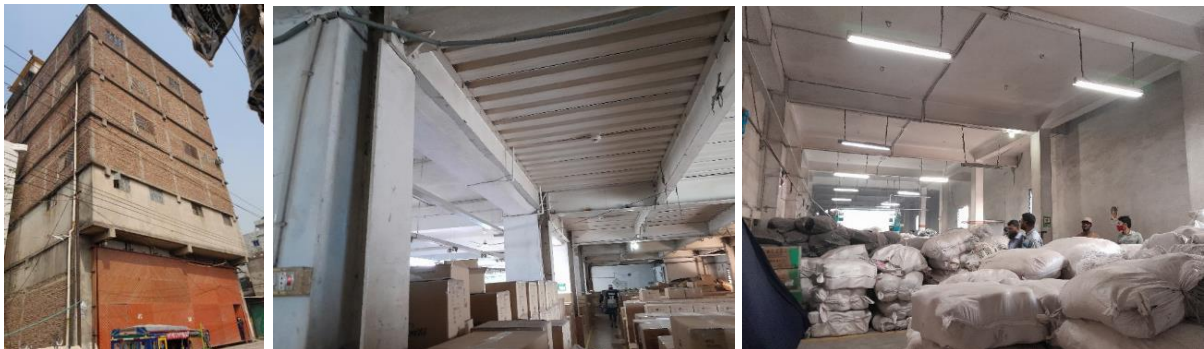
**Observation-17:** Lack of as-built drawing. (Production Building-7)

**Description:** During inspection, no architectural and structural drawing was found on site for Production Building -7. The building engineer is required to survey the full structure and produce accurate as-built drawing.

| Observation | Action Plan | Timeline |
|---|---|---|
| Lack of as-built drawing.<br>(Production Building-7) | The building engineer is required to survey the full structure and produce accurate as-built drawing. | within 6 weeks |

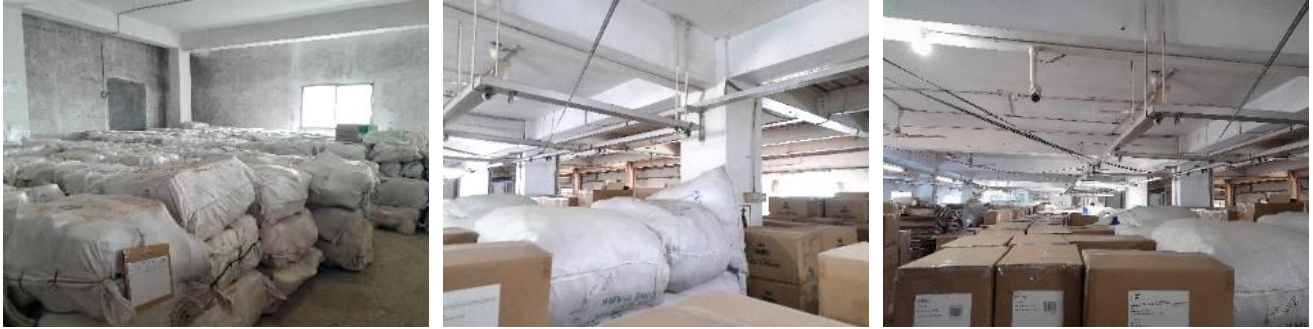
Storage on different floors

**Description:** During inspection, proper load management program was not observed. The building is being used for storage on the 2nd floor to 5<sup>th</sup> floor. The building engineer is required to produce and actively manage a loading plan for all floor plates within the factory considering floor, column, and foundation capacity.

| Observation | Action Plan | Timeline |
|---|---|---|
| Lack of load management.<br>(Production Building-7) | The building engineer is required to produce and actively manage a loading plan for all floor plates within the factory considering floor capacity and column capacity. | within 6 weeks |

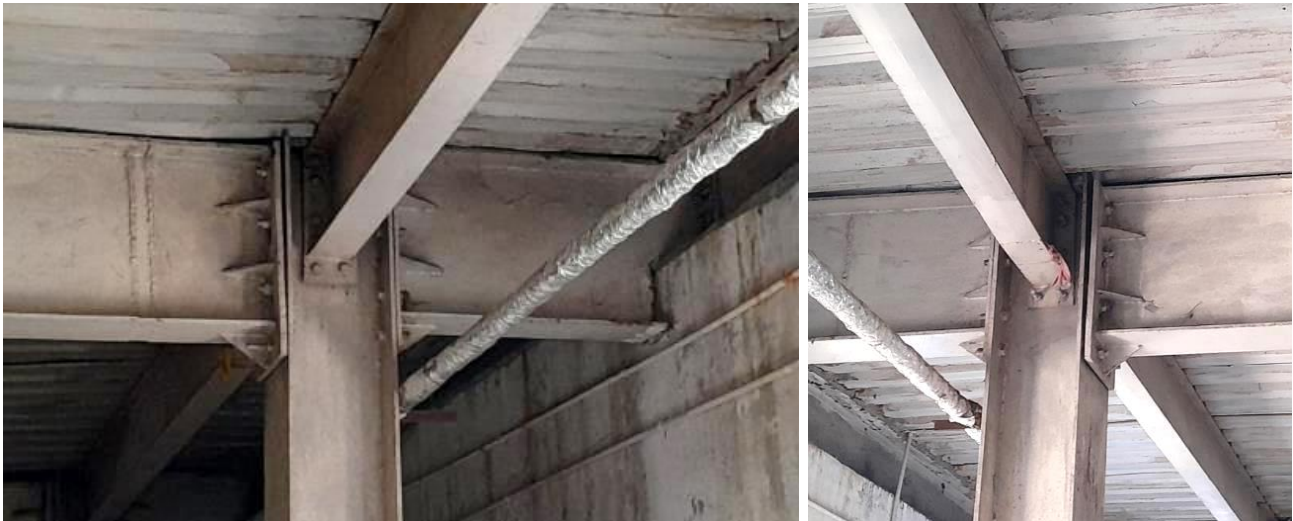
**Observation-19:** Gap between steel connection plates. (Production Building-7)

**Description:** Connection gap between steel connection plates of steel beam and column was found in several locations. The building engineer is required to fill all the steel connection gap with suitable method.

| Observation | Action Plan | Timeline |
|---|---|---|
| Gap between connection plates. (Production Building-7) | The building engineer is required to fill all the steel connection gap with suitable method. | within 6 months |

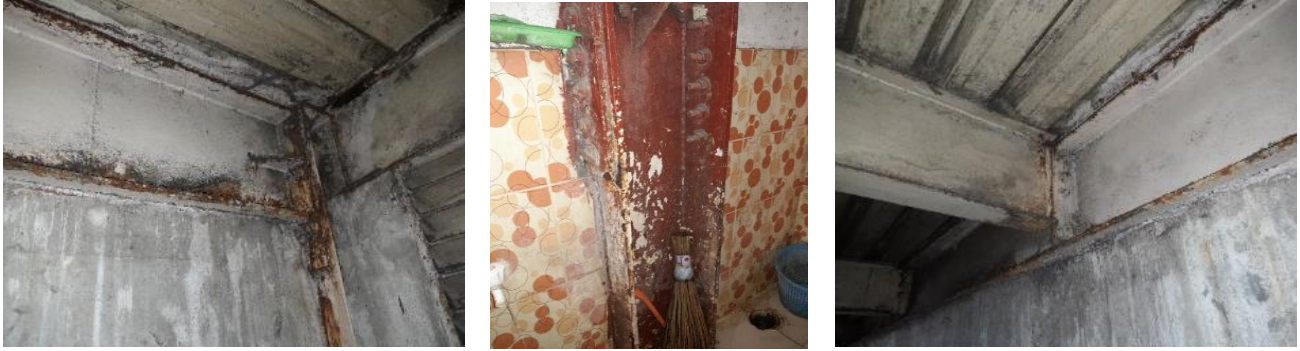
**Observation-20:** Corrosion on steel member. (Production Building-7)

**Description:** Corrosion was found on steel members. The building is required to identify all corroded member, remove the corrosion, and apply suitable anti-corrosive coating to the affected steel members.

| Observation | Action Plan | Timeline |
|---|---|---|
| Corrosion on steel member.<br>(Production Building-7) | The building is required to identify all corroded member, remove the corrosion, and apply suitable anti-corrosive coating to the affected steel members. | within 6 months |

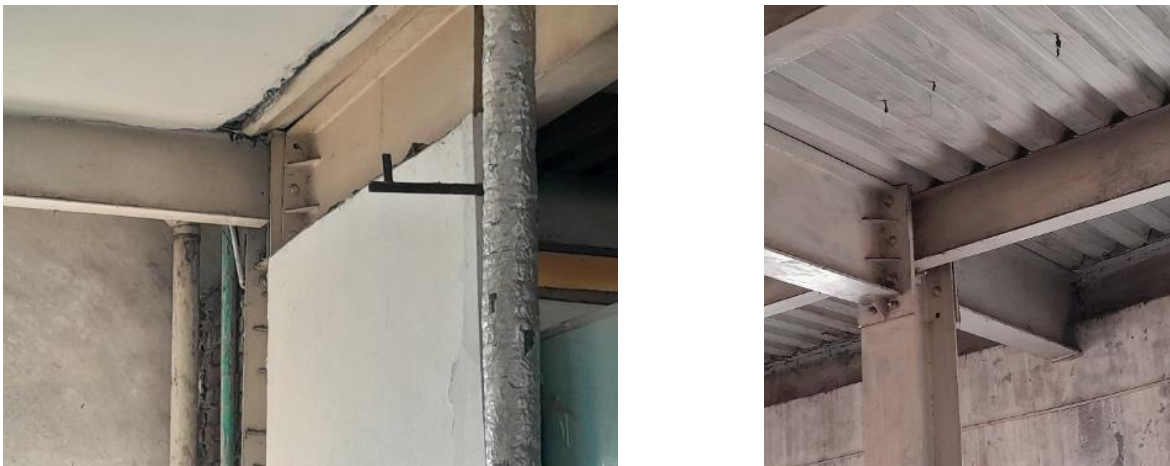
**Observation-21:** Missing bolt at steel connection. (Production Building-7)

**Description:** The building is required to identify all missing bolts and install adequate bolts.

| Observation | Action Plan | Timeline |
|---|---|---|
| Missing bolt at connection plate. (Production Building-7). | The building is required to identify all missing bolts and install adequate number of bolts | within 6 months |

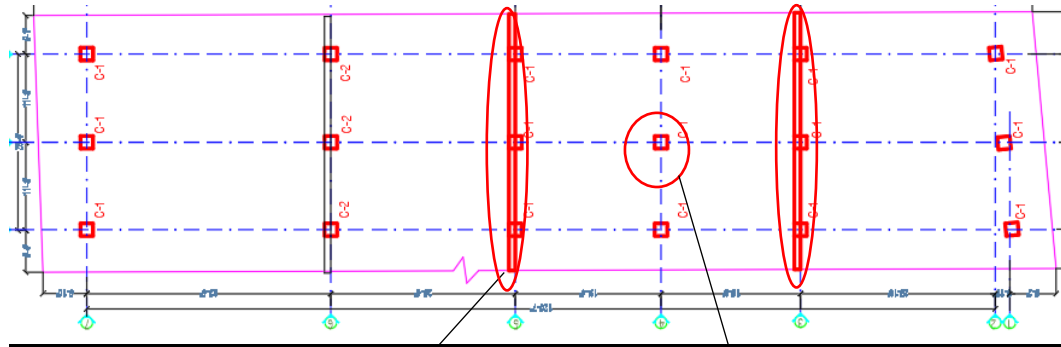
**Observation-22: Mismatch in structural drawing. (Utility Building)**

- A RC column and two nos share wall (Marked above) were found missing onsite, which was shown in drawing.
- An undocumented apparently non engineered roof shed was found at roof.
- Floor level was different at 2<sup>nd</sup> floor, which was not shown in drawing.

The Building engineer is required to survey the whole structure and update the as-built drawings and perform Engineering Assessment (EA).

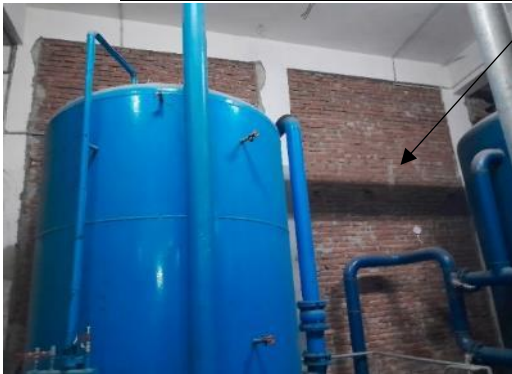
Missing share wall

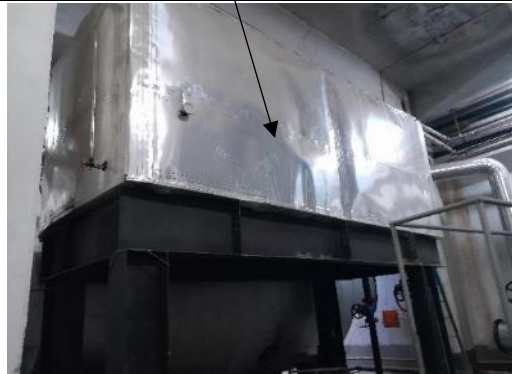
Missing RC column.

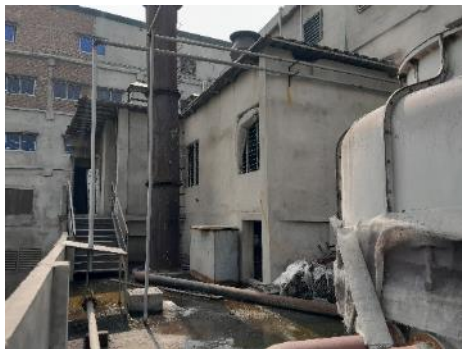
Undocumented roof top shed

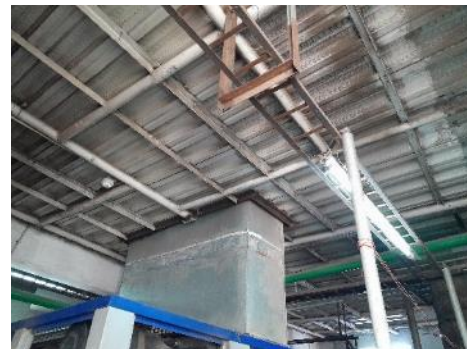
Apparently non engineered roof shed

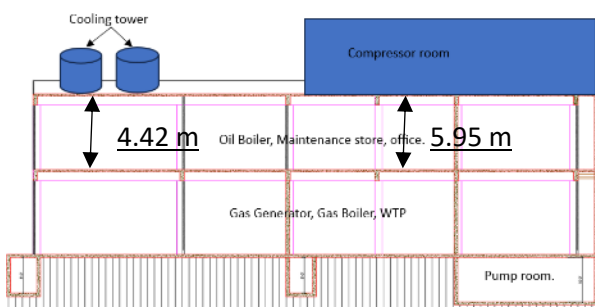
Different floor heights

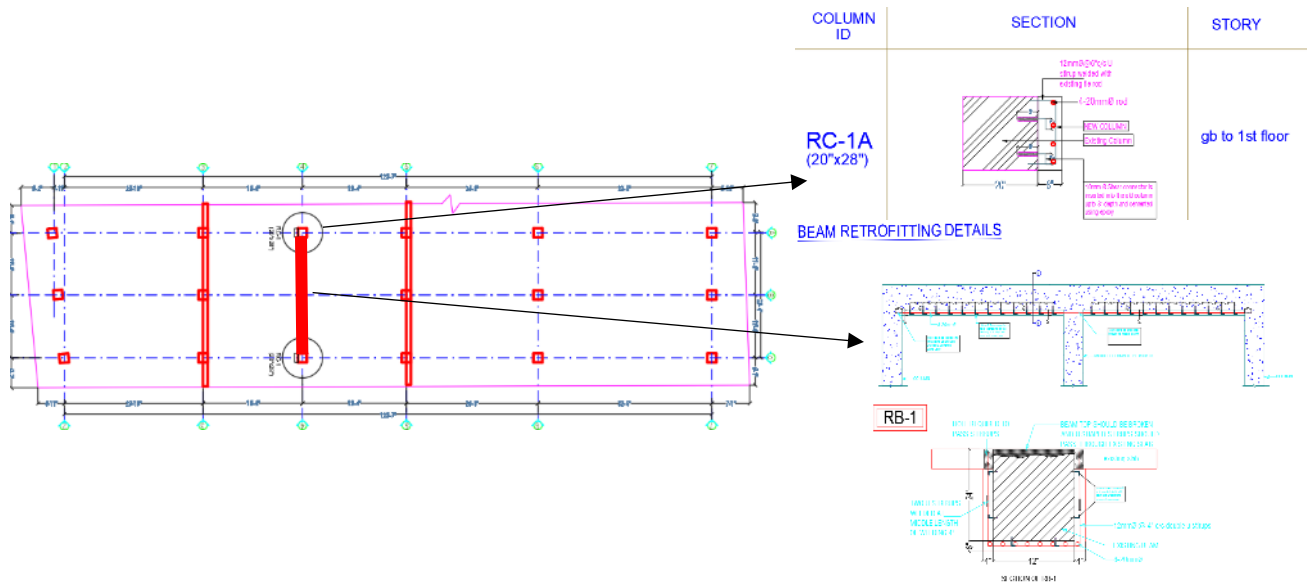
**Observation-23:** Retrofitting documents needs to be reviewed. (Utility Building)

**Description:** Two columns and a beam have been retrofitted for the Utility building. The building engineer is required to submit the DEA documents to the RSC for further review to justify the capacity of foundation, column, and beam & slab against the lateral & vertical loading.

| Observation | Action Plan | Timeline |
|---|---|---|
| Retrofitting documents needs to be reviewed. (Utility Building) | The building engineer is required to submit the Detail Engineering Assessment (DEA) documents to the RSC for further review to justify the capacity of foundation, column, and beam & slab against the lateral & vertical loading. | within 6 weeks |

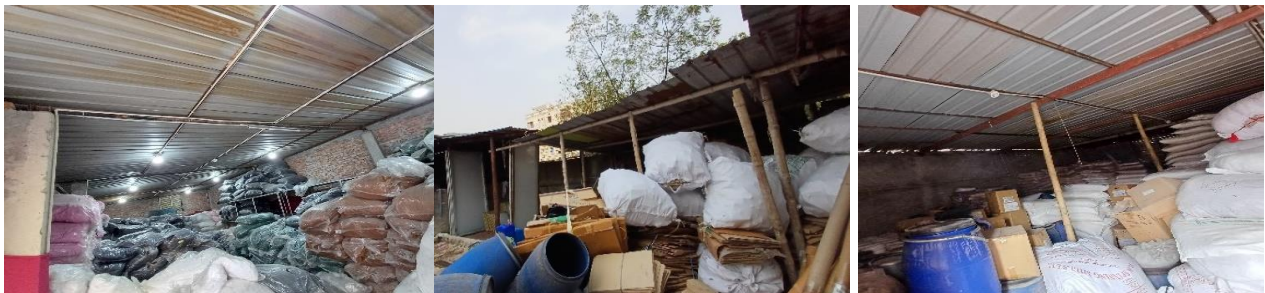
Apparently non-engineered shed: steel roof supported by RC, steel and bamboo columns

**Description:** During the inspection, an apparently non-engineered steel shed was observed where the stability system, member size and connections were inadequate. The building engineer is required to check the structural system, member size and connection of the structure and provide necessary alternatives.

| Observation | Action Plan | Timeline |
|---|---|---|
| Apparently non-engineered shed (Shed-2) | The building engineer is required to check the structural system, member size and connection of the structure and provide necessary alternatives. | within 6 weeks |
| | Carryout suggested remedial works; otherwise demolish the structure. | within 6 months |

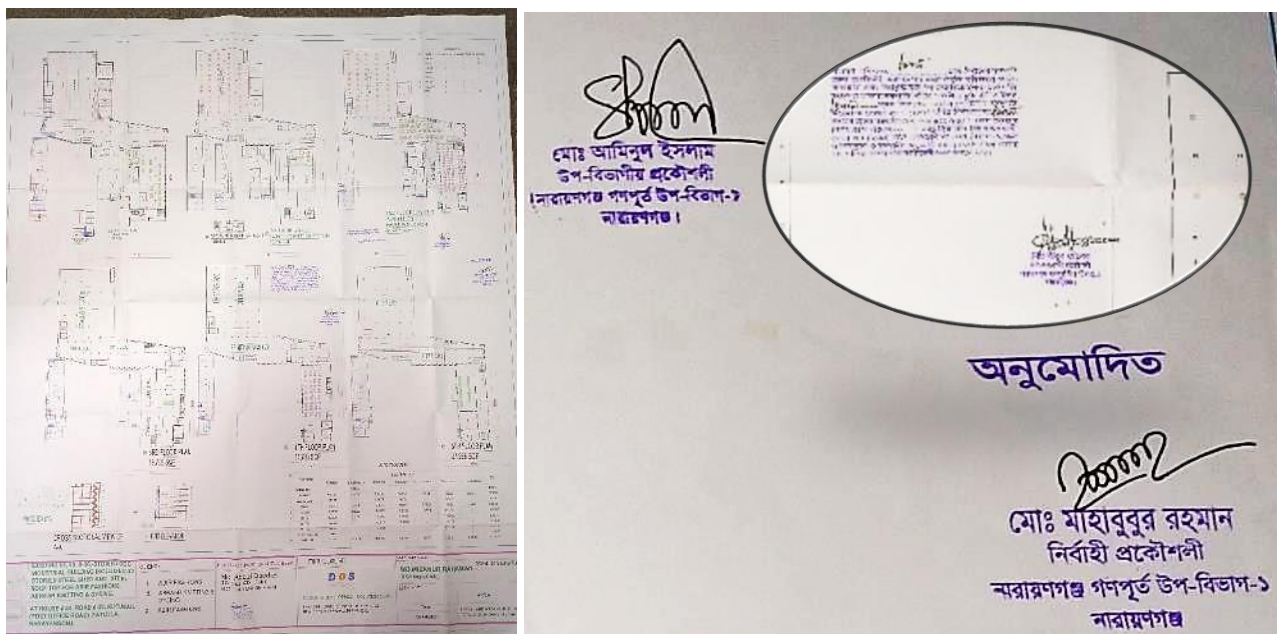
**Observation-26:** Lack of authentication in the permit drawing (All structure).

**Description:** The provided permit drawing was approved and signed by Executive Engineer, PWD Sub-Division-1, Narayanganj. But no date was mentioned in the approval sign. The building engineer is required to authenticate the permit drawing with valid date and sign.

| Observation | Action Plan | Timeline |
|---|---|---|
| Lack of authentication in the permit drawing (All structure) | The building engineer is required to authenticate the permit drawing with valid date and sign. | within 6 months |
