# Anowara Fashions Ltd – Extension (Anowara Group)

35/A, Hajigonj Road, Narayanganj  
(23.635043, 90.512368)

11 February 2024

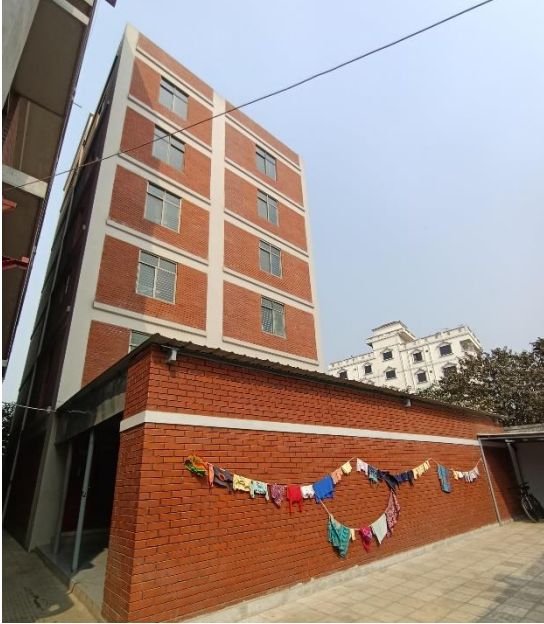
Godown Building

**Observation-1:** Absence of design documents and load plan (Godown Building).

**Description:** As per BNBC, every building or structure designed shall have its design documents prepared following the provision of Section 1.9.1. The design document shall include a design report, and a set of structural drawings, which shall be prepared in compliance with section 1.9.1.1 and section 1.9.1.2 as per BNBC. At the time of inspection, no architectural drawings or design reports were available which are required to be prepared in compliance with section 1.9.1.1 and section 1.9.1.2 (part 6, BNBC).

| Observation | Action Plan | Timeline |
|---|---|---|
| Absence of design documents and load plan (Godown Building). | The building engineer is required to prepare a set of design reports (based on verified concrete strength) with a set of structural drawings in compliance with section 1.9.1.1 and section 1.9.1.2 (part 6, BNBC). | within 6 weeks |
| Absence of design documents and load plan (Godown Building). | Verify in-situ concrete strength by taking cores from lower tier columns. | within 6 weeks |
| Absence of design documents and load plan (Godown Building). | Produce and actively manage floor loading plans considering floor slab, column, and foundation capacities. | within 6 weeks |
| Absence of design documents and load plan (Godown Building). | Implement remediation work if required. | within 6 months |
| Absence of design documents and load plan (Godown Building). | Implement floor loading plan. | within 6 months |

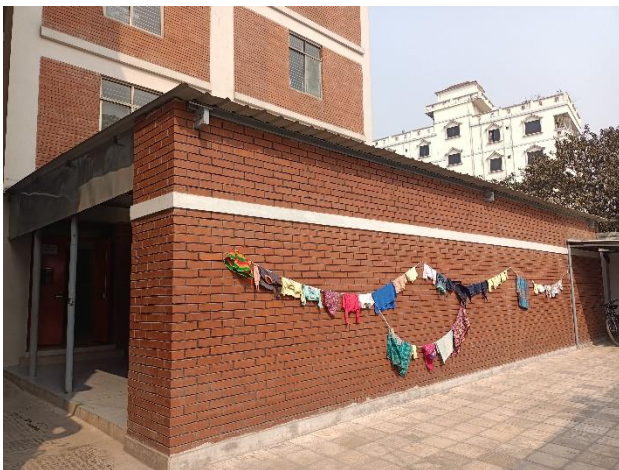
Godown Shed

**Observation 2:** Lack of permit drawings (Godown Shed, Utility Building).

**Description:** At the time of inspection, no approval drawing from the local authority was available for the above-mentioned structures. Building engineer is required to seek approval from the local authority.

| Observation | Action Plan | Timeline |
|---|---|---|
| Lack of permit drawings (Godown Shed, Utility Building). | Building engineer is required to seek and collect approval from the local authority. | within 6 months |

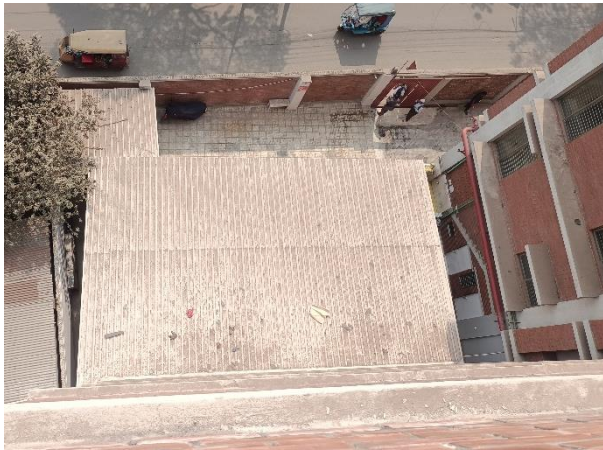
Godown Shed

**Observation-3:** Lack of as-built drawings (Godown Shed).

**Description:** As-built structural and architectural drawings were not available for the Godown Shed. Building engineer is required to survey the whole structure and prepare a full set of as-built drawings.

| Observation | Action Plan | Timeline |
|---|---|---|
| Lack of as-built drawings (Godown Shed). | Building engineer is required to survey the whole structure and prepare complete structural and architectural drawings for the building. | within 6 weeks |

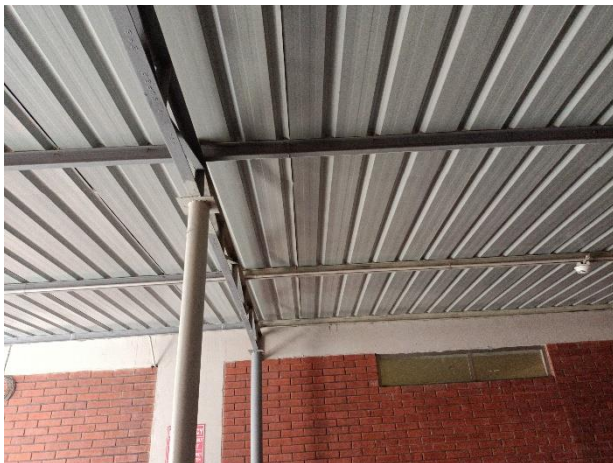
Connection

**Observation-4:** Lack of lateral stability and connection adequacy (Godown Shed).

**Description:** Lack of lateral stability system (strut and bracing), and apparently non-engineered connection was observed. The building engineer is required to check the connection & stability system of the structure and suggest proper alternatives accordingly.

| Observation | Action Plan | Timeline |
|---|---|---|
| Lack of lateral stability and connection adequacy (Godown Shed). | The building engineer is required to check the connection & stability system of the structure and suggest proper alternatives accordingly. | within 6 weeks |
| Lack of lateral stability and connection adequacy (Godown Shed). | Implement remediation work if required. | within 6 months |

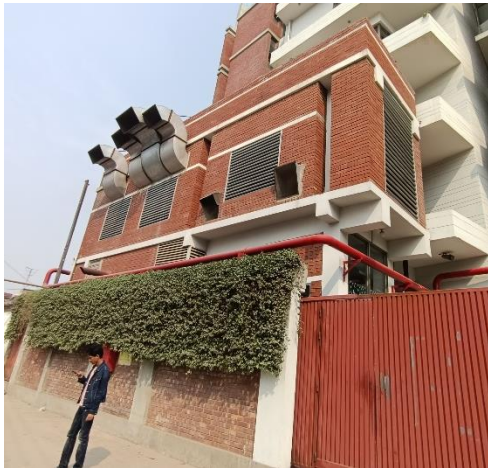
Utility Building

**Observation-5: Lack of Structural drawings (Utility Building).**

**Description:** As-built structural drawings were not available for the Godown Shed. Building engineer is required to survey the whole structure and prepares full set of as-built structural drawings.

| Observation | Action Plan | Timeline |
|---|---|---|
| Lack of Structural drawings (Utility Building). | The building engineer is required to prepare accurate as-built drawings with complete structural details. | within 6 weeks |

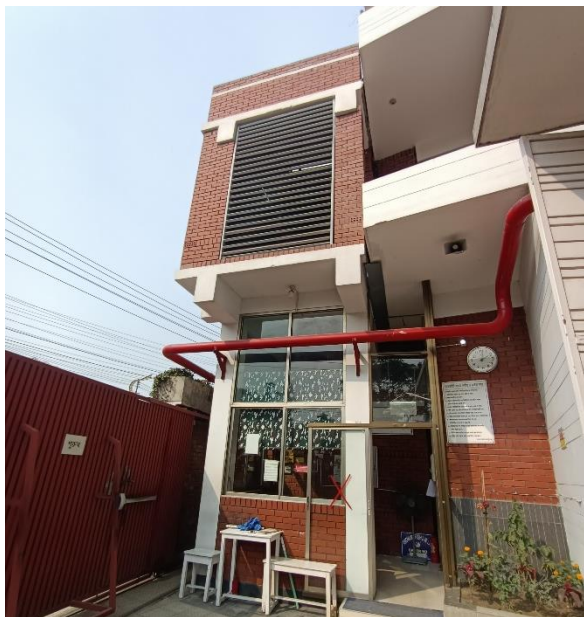
Utility Building

**Observation 6: Absence of design documents (Utility Building).**

**Description:** As per BNBC, every building or structure designed shall have its design documents prepared following the provision of Section 1.9.1. The design document shall include a design report, and a set of structural drawings, which shall be prepared in compliance with section 1.9.1.1 and section 1.9.1.2 as per BNBC. At the time of inspection, no architectural drawing or design reports were available which are required to be prepared in compliance with section 1.9.1.1 and section 1.9.1.2 (part 6, BNBC).

| Observation | Action Plan | Timeline |
|---|---|---|
| Absence of design documents. (Utility Building). | The building engineer is required to prepare a set of design reports with a set of structural drawings in compliance with section 1.9.1.1 and section 1.9.1.2 (part 6, BNBC). | within 6 weeks |
| Absence of design documents. (Utility Building). | Implement remediation work if required. | within 6 months |
