# Bottoms Gallery (pvt) Ltd. (New Location)

D-127/2 Teknogopara, Chandon, Bason, Gazipur-1702

12 February 2024

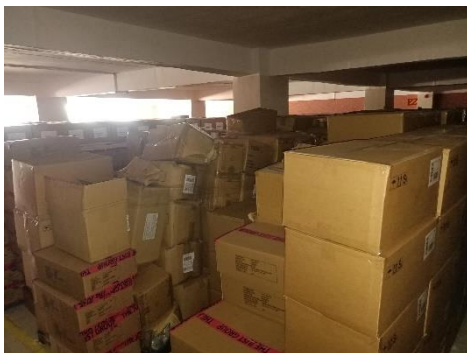
Storage & Live load table (BNBC part 6)

**Observation-01:** The design report and load plan need to be revised. (Building-1)

**Description:** Live load on storage area of Ground and 1<sup>st</sup> floor is considered as 3 kPa in prepared load plan. As per BNBC-2006, live load for light storage areas is required to be considered minimum 6 kPa. Therefore, the factory engineer is required to revise the load plan as per BNBC requirement and check the design report accordingly.

| Observation | Action Plan | Timeline |
|---|---|---|
| The design report and load plan need to be revised. (Building-1) | Building engineer is required to revise the load plan as per BNBC requirement and check the design report accordingly. | within 6 weeks |

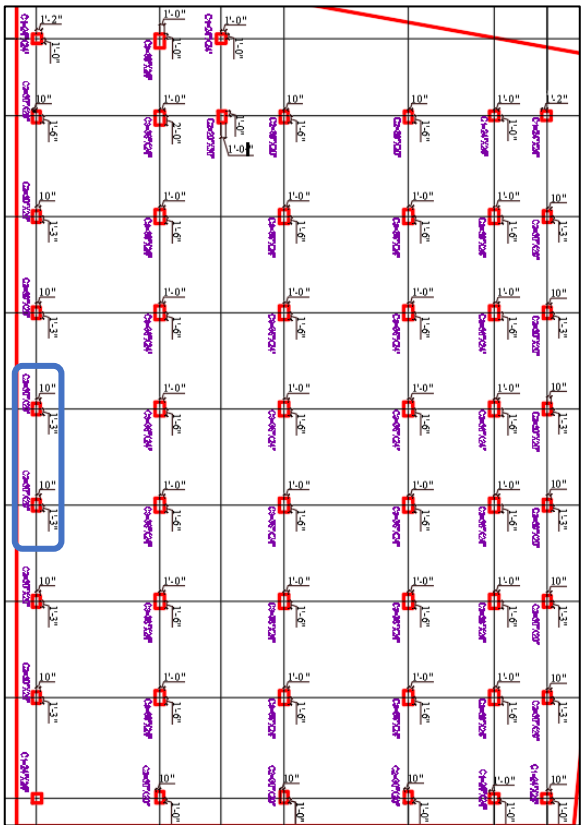
Column layout plan

**Observation-02:** Discrepancies in as-built drawings. (Building-1).

| Observation | Action Plan | Timeline |
|---|---|---|
| Inconsistencies in as built drawings. (Building-1). | The building engineer is required to survey the structure and prepare full set of as-built drawings. | within 6 weeks |

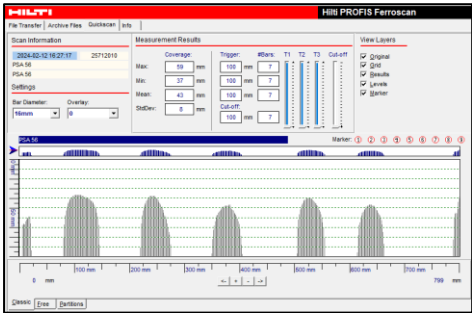
6 nos rebar was found by ferro scan instead of 7 in Column C2 shown in column schedule.

**Description:** During inspection, 6 nos rebar was found by ferro scan instead of 7 in long face of Column C2 shown in column schedule. The building engineer is required to survey the structure and prepare full set of as-built drawings.

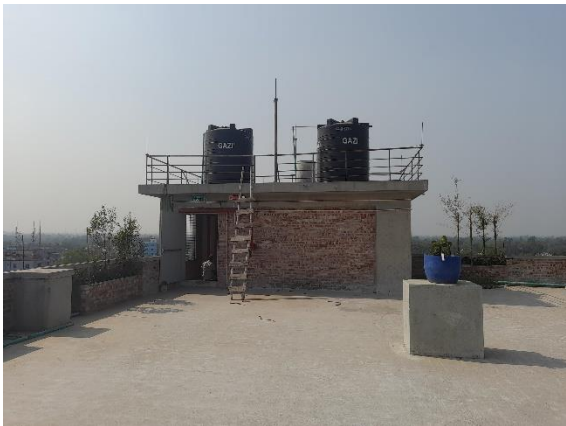
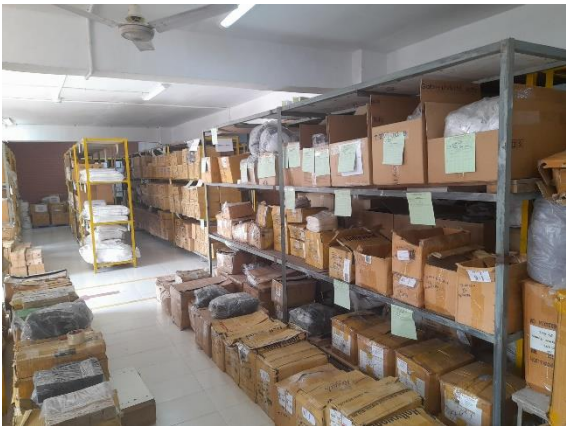
**Observation-03:** Non-structural elements not anchored or braced. (Building-1)

**Description:** Some PVC water tanks on roof and storage racks on different floors are not anchored or braced to resist lateral forces. The factory is required to anchor/brace all non-structural elements adequately to resist lateral loading.

| Observation | Action Plan | Timeline |
|---|---|---|
| Non-structural elements not anchored or braced. (Building-1) | The factory is required to anchor/brace all non-structural elements adequately to resist lateral loading. | within 6 weeks |

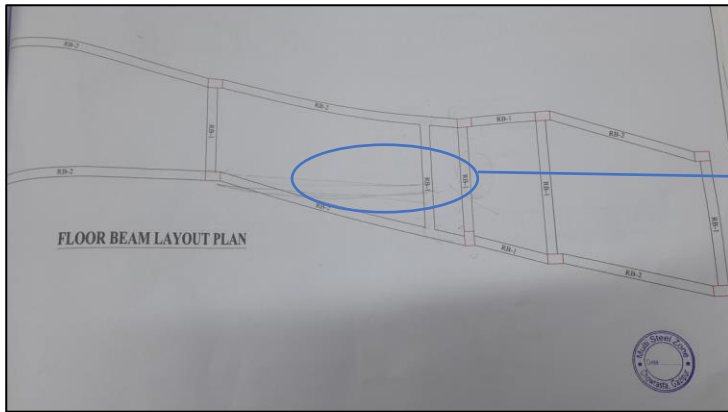
Beam layout plan (Building-2)

**Observation-04:** Mismatches in as-built drawings. (Building 02 & 03).

**Description:** During inspection mismatches between beam layout plan and onsite condition were observed for Building 2 & 3. The building engineer is required to survey the structure and prepare full set of as-built drawings.

| Observation | Action Plan | Timeline |
|---|---|---|
| Mismatches in as-built drawings. (Building-2). | The building engineer is required to survey the full structure and produce accurate as-built drawings. | within 6 weeks |
