# The Civil Engineers Woven Limited (Extension)

14 February 2024

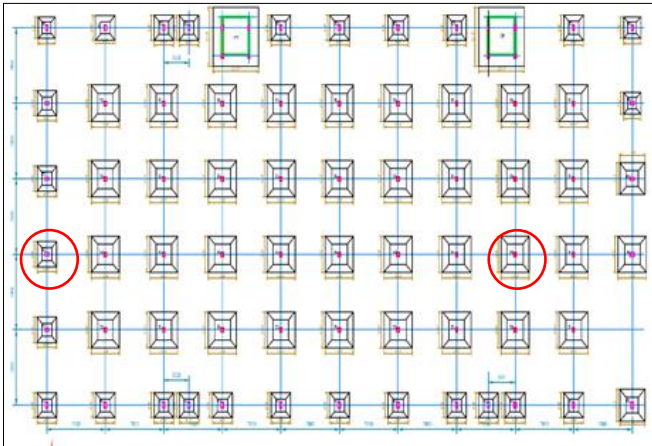
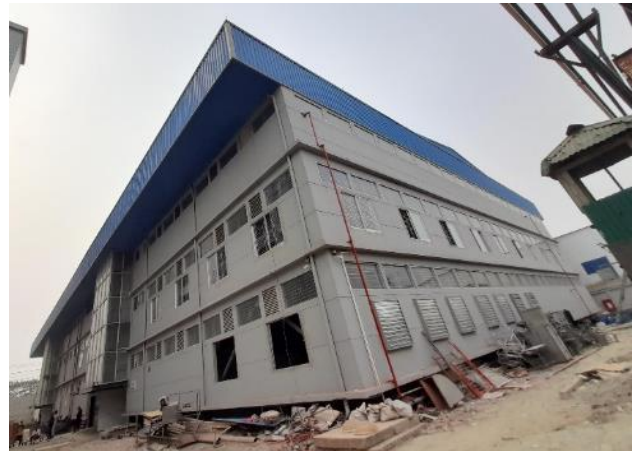
**Observation 1:** Cursory calculation indicates the column and foundation is marginally overstressed. (Warehouse Steel Building)

**Description:** The cursory calculation indicates that columns and footings are stressed above the normal design limit at the marked locations considering floor live load of 6 kPa for the typical floors. We have considered minimum concrete strength based on aggregate type (16.3 MPa), steel plate strength 345 MPa and rebar strength 415 MPa from the available test report. We have also considered ultimate soil bearing capacity 1.44 Ksf from available soil test report. The building engineer is required to review design loads, and column-foundation stresses based on in-situ material strength at the marked location. Also, produce and actively manage a set of floor live load plan.

| Observation | Action Plan | Timeline |
|---|---|---|
| Cursory calculation indicates the column and foundation is marginally overstressed (Warehouse Steel Building) | Building engineer is required to review the design load and foundation stresses. | within 6 weeks |
| | Building engineer is required to prepare a full set of design documents in compliance with BNBC- Article 1.9.1 | within 6 weeks |
| | Produce and actively manage a set of floor live load plan. | within 6 weeks |
| | Carry out remedial work where required. | within 6 months |

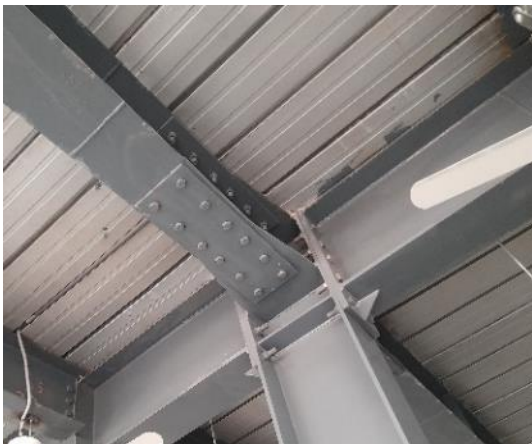
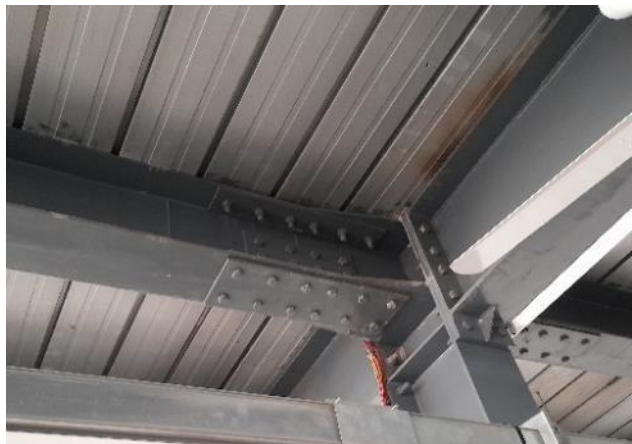
**Observation-2:** Discrepancy and lack of information in the provided drawing. (Warehouse Steel Building)

Lack of connection details in the drawing

**Description:** During the inspection, discrepancies and lack of information were observed between the provided drawing and on-site conditions. The building engineer is required to survey the whole structure and update the drawing reflecting on-site condition.

| Observation | Action Plan | Timeline |
|---|---|---|
| Discrepancy and lack of information in the provided drawing (Warehouse Steel Building) | The building engineer is required to survey the whole structure and revise as-built drawing reflecting the on-site condition. | within 6 weeks |

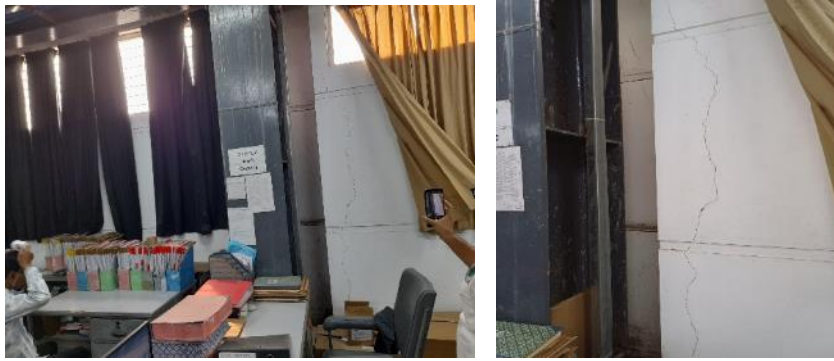
**Observation-5: Cracks in brick wall. (Warehouse Steel Building)**

**Description:** Cracks was found in brick wall at 1st floor office area. These cracks may have been generated due to the torsional irregularity of the structure or/and deflection of slab. The building engineer is required to investigate the cause of crack and repair the crack as per the building engineer recommendation.

| Observation | Action Plan | Timeline |
|---|---|---|
| Cracks in brick wall (Warehouse Steel Building) | The building engineer is required to investigate the cause of crack and repair the crack as per the building engineer recommendation. | within 6 months |

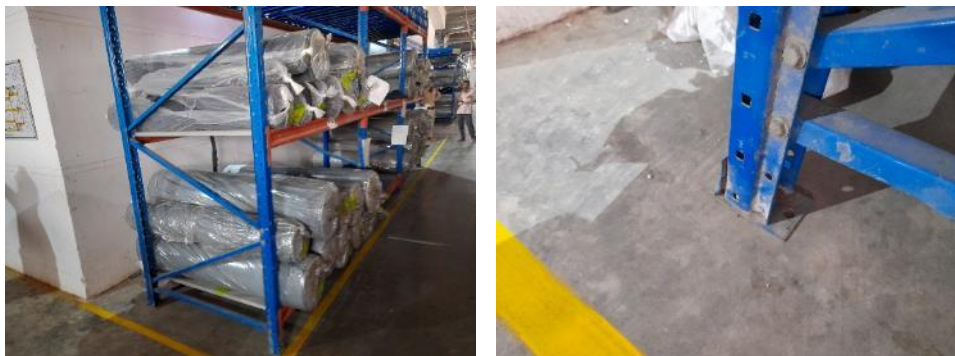
**Observation-6: Anchorage missing for the non-structural elements. (Warehouse Steel Building)**

**Description:** During the inspection, storage racks were observed on the several floors and locations without anchorage. The non-structural elements suspended from, attached to, or resting atop the structure shall be adequately anchored and braced to resist earthquake forces. The factory is required to brace/anchor all non-structural elements.

| Observation | Action Plan | Timeline |
|---|---|---|
| Anchorage missing for the non-structural elements (Warehouse Steel Building) | The factory is required to brace/anchor all non-structural elements. | within 6 months |

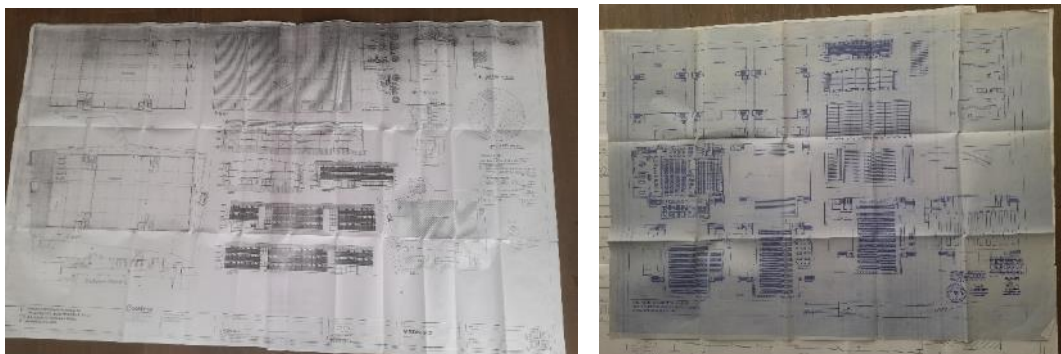
**Observation-7: Lack of building permit from local authority. (Cycle Stand and Connecting Bridge)**

**Description:** During the inspection, it was observed that the local authority approval was not available for the following structures i.e. Cycle Stand and Connecting Bridge.

| Observation | Action Plan | Timeline |
|---|---|---|
| Lack of building permit from local authority. (Cycle Stand and Connecting Bridge) | The factory is required to collect building permit from the government approved local authority and revise design documents based on the BNBC for all structure. | within 6 months |
