# MNR Sweaters Ltd Extension Building

Holdings No-467, Block-G, Ward-7, Sreepur, Baraiderchala, Gazipur

12 February 2024

## 2. Observations:

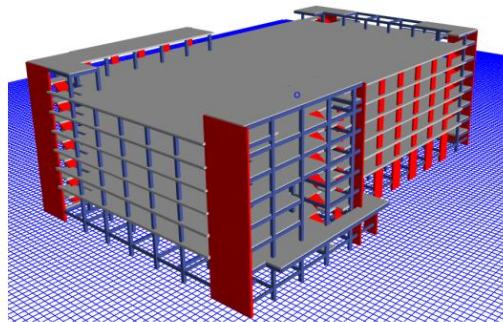
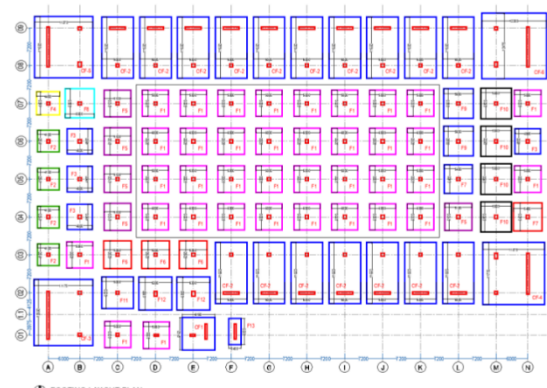
### Observation 1: Inconsistencies in the design report. (Factory Building)

- The lateral load-resisting system is considered a Building Frame System, where 93% of the seismic force is resisted by shear walls in the X direction and 94% of the seismic force is resisted by shear walls in the Y direction. Building engineer is required to check and confirm whether the remaining lateral forces taken by the shear walls or other framing systems can be considered in the design or not.
- Combined footing adequacy check not provided in the design report, also the foundation is not checked against lateral loading.
- Shear Wall adequacy check and seismic detailing confirmation of SW not included in the design report.

| Observation | Action Plan | Timeline |
|---|---|---|
| Inconsistency in design report.<br>(Factory Building) | Building engineer is required to check and confirm whether the remaining lateral forces taken by the shear walls or other framing systems can be considered in the design or not. | within 6 weeks |
| | Building engineer is required to prepare the design report according to the BNBC 1.9 | within 6 weeks |
| | Carry out remedial work if required. | within 6 months |

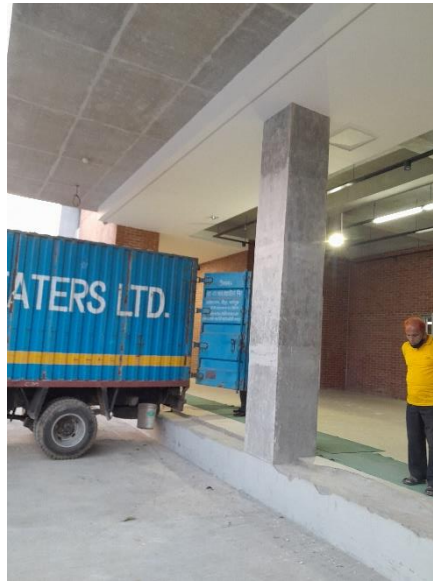
**Observation 2:** Possible vehicle impact on the column. (Factory Building)

**Description:** Possible vehicle impact on the column was observed on the ground floor. The building engineer is required to provide vehicle impact protection on the ground floor column.

| Observation | Action Plan | Timeline |
|---|---|---|
| Possible vehicle impact on the column. (Factory Building) | The building engineer is required to provide vehicle impact protection on the ground floor column. | within 6 weeks |

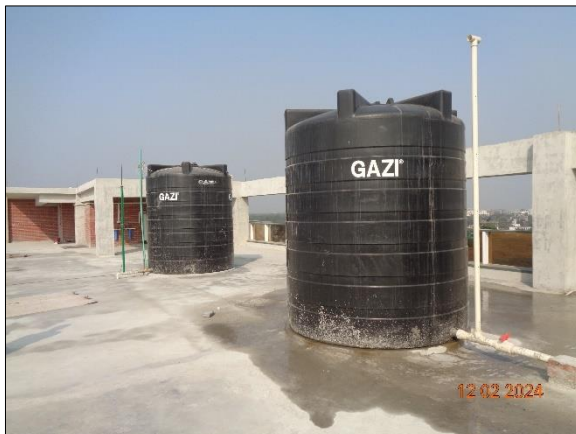
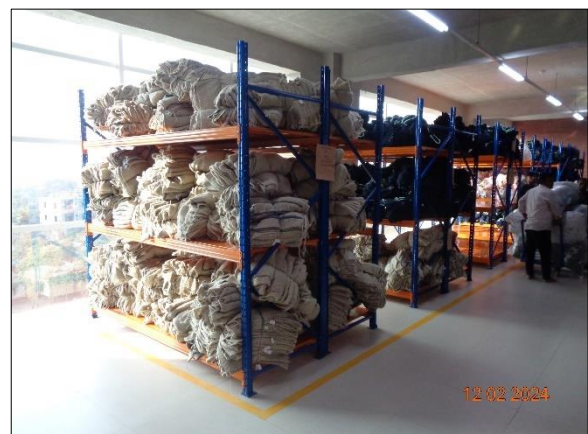
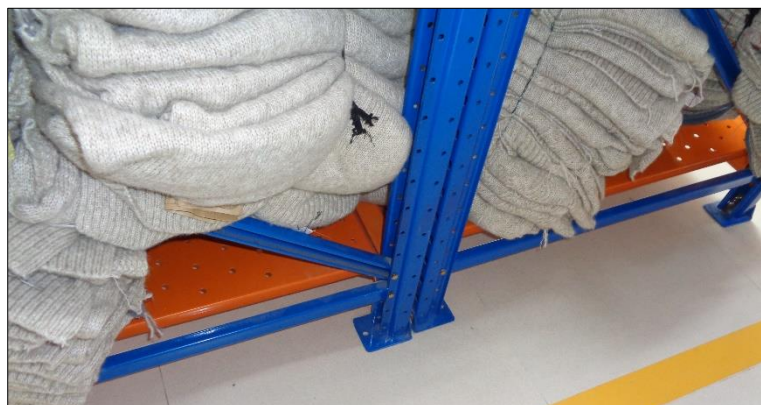
**Observation-3:** Anchorage of nonstructural elements (Factory Building)

**Description:** PVC water tanks at roof and Racks on different floors are not adequately anchored or braced to resist lateral (earthquake) forces. Building is required to adequately anchor and brace all non-structural elements to resist earthquake forces to comply with the BNBC.

| Observation | Action Plan | Timeline |
|---|---|---|
| Anchorage of nonstructural elements (Factory Building) | Building engineer is required to adequately anchor and brace all non-structural elements to resist earthquake forces. | within 6 months |

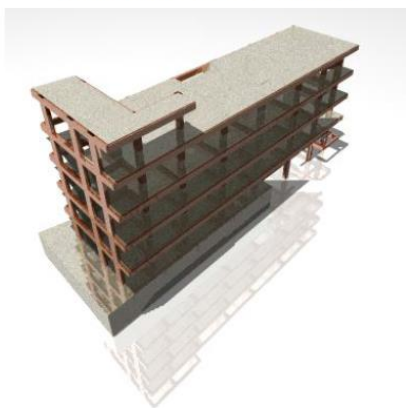
### Observation-4: . Inconsistencies in the design report (Facility Building)

**Description:** Combined footing adequacy check not provided in the design report, also the foundation is not checked against lateral loading. Shear Wall adequacy check and seismic detailing confirmation of SW are not included in the design report.

| Observation | Action Plan | Timeline |
|---|---|---|
| Inconsistency in design report.<br>(Facility Building) | Building engineer is required to prepare the design report according to the BNBC 1.9 | within 6 weeks |
| | Carry out remedial work if required. | within 6 months |

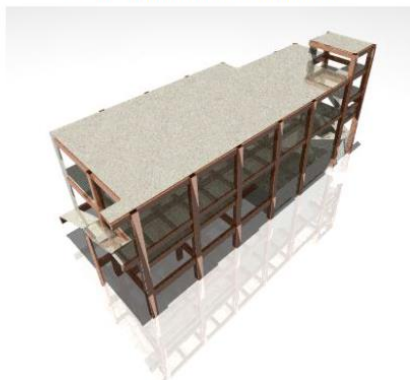
### Observation-5: Inconsistencies in the design report (Utility Building)

**Description:** Shear Wall adequacy check and seismic detailing confirmation of SW are not included in the design report.

| Observation | Action Plan | Timeline |
|---|---|---|
| Inconsistency in design report.<br>(Utility Building) | Building engineer is required to prepare the design report according to the BNBC 1.9 | within 6 weeks |
| | Carry out remedial work if required. | within 6 months |

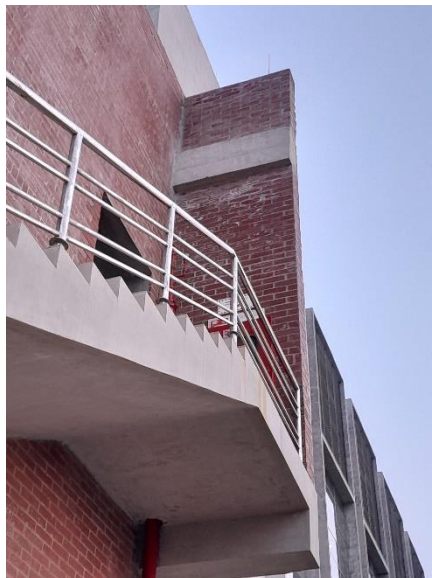
**Observation-6: Unrestraint brick wall (Utility Building)**

**Description:** Brick wall observed without head restraint. Building engineer is required to stabilize the unrestraint brick wall.

| Observation | Action Plan | Timeline |
|---|---|---|
| Unrestraint brick wall (Utility Building) | Building engineer is required to stabilise the unrestrained brick wall. | within 6 weeks |

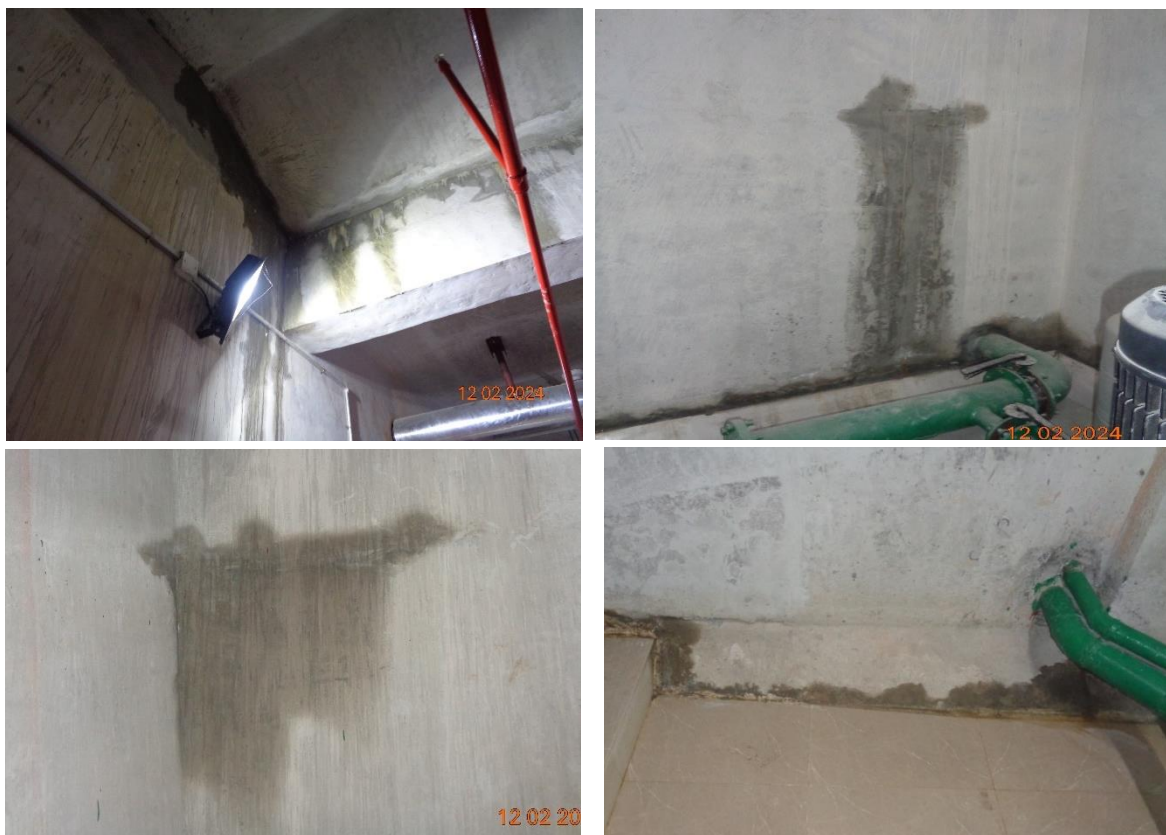
**Observation-7: Water seepage through the basement wall (Utility Building)**

**Description:** Seepage of water through the basement wall was observed. Building engineer is required to investigate the reason for the water seepage through the wall and repair it with a suitable method.

| Observation | Action Plan | Timeline |
|---|---|---|
| Water seepage through the basement wall (Utility Building) | Building engineer is required to investigate the reason for the water seepage through the wall and repair it with a suitable method. | within 6 weeks |

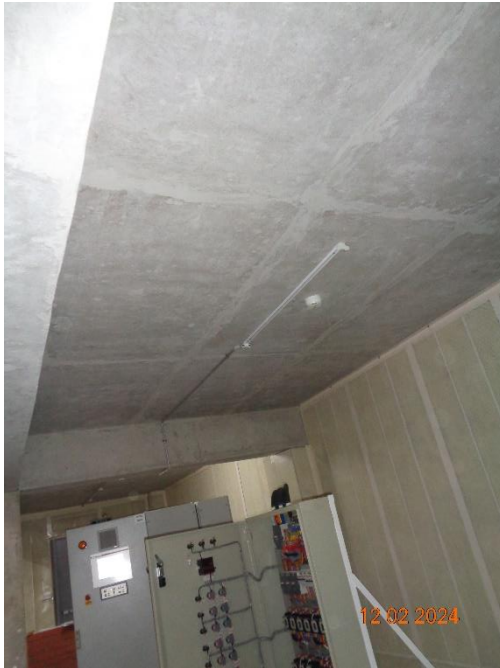
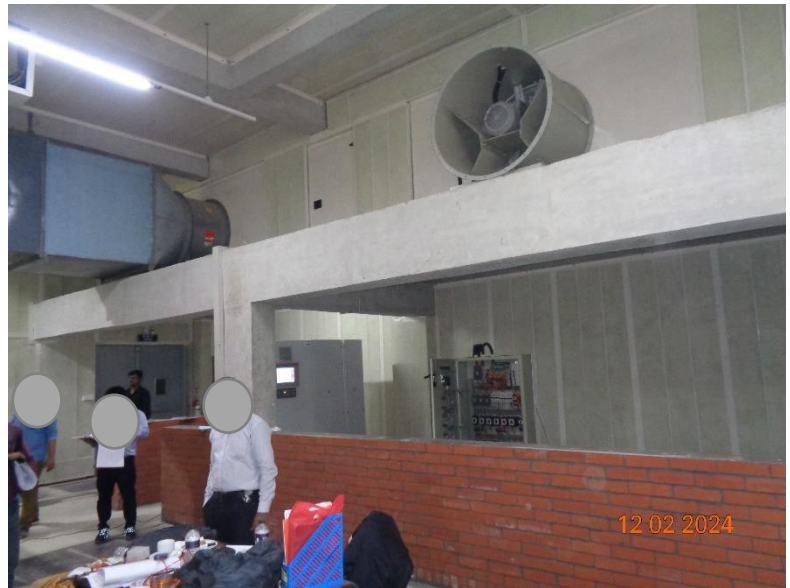
**Observation-8:** Mismatch in as-built drawing (Utility Building)

**Description:** During inspection, an RC beam-column frame mezzanine was found on the found floor of the utility building. In the as-built drawing, the mezzanine has not shown. The building engineer is required to survey the whole structure and prepare accurate as-built drawing.

| Observation | Action Plan | Timeline |
|---|---|---|
| Mismatch in as-built drawing<br>(Utility Building) | The building engineer is required to survey the whole structure and prepare accurate as-built drawing. | within 6 weeks |
