# FRIENDS KNITTINGS LTD (EXTENSION)

1406/1, South Salna, Word -19, Deshipara road, Gazipur, Bangladesh

19 February 2024

**Warehouse Building:** This is a seven-storied (G+6) RC building.

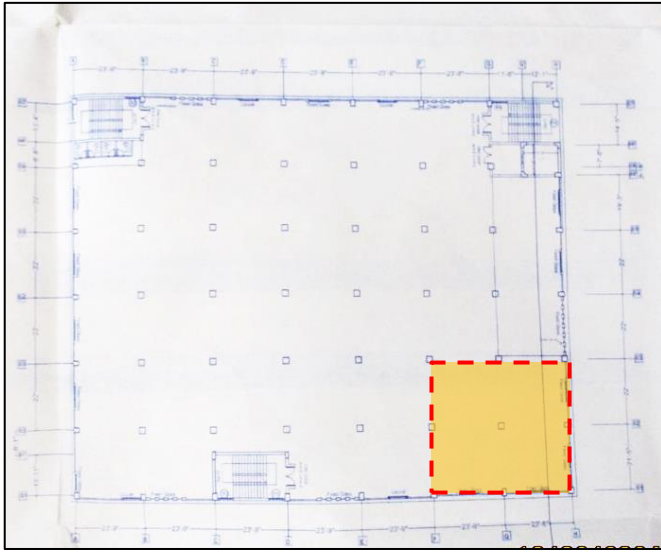
Approved Layout by Local Authority

**Observation-1:** Inconsistency in the design documents.

**Description:** The marked portion at the local authority approved layout and a snapshot of the EA report has not been constructed yet. The yield strength of reinforcement has been considered as 72,500 psi, but from the rebar test report, it has been confirmed that lower-strength rebar was used in the construction of the building.

The building engineer is required to revise the EA report based on in-situ material strength and submit the EA documents to RSC for review. Also, prepare a set of as-built drawings for the as-built condition.

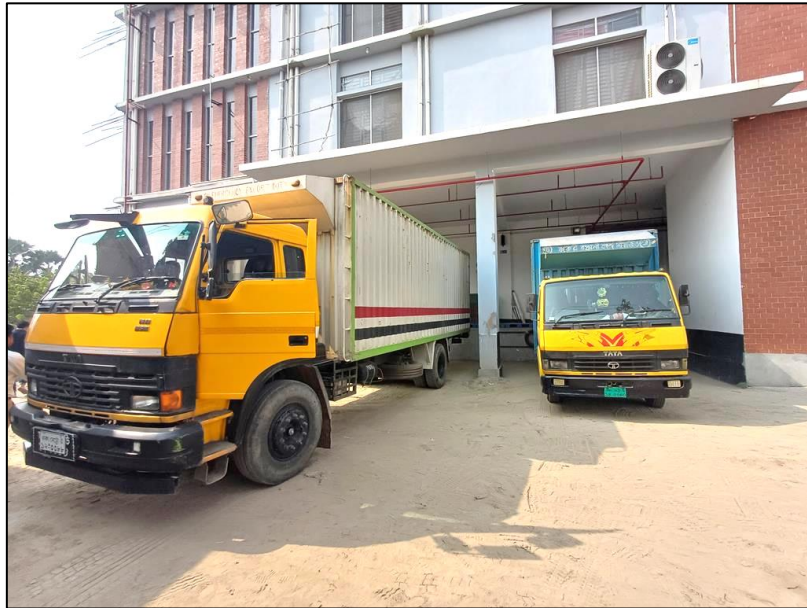
**Observation-2:** Column susceptible to vehicle impact.

**Description:** Column at the ground floor loading/unloading area was found susceptible to vehicle impact. The building engineer is required to provide barriers around the column to prevent vehicle impact.

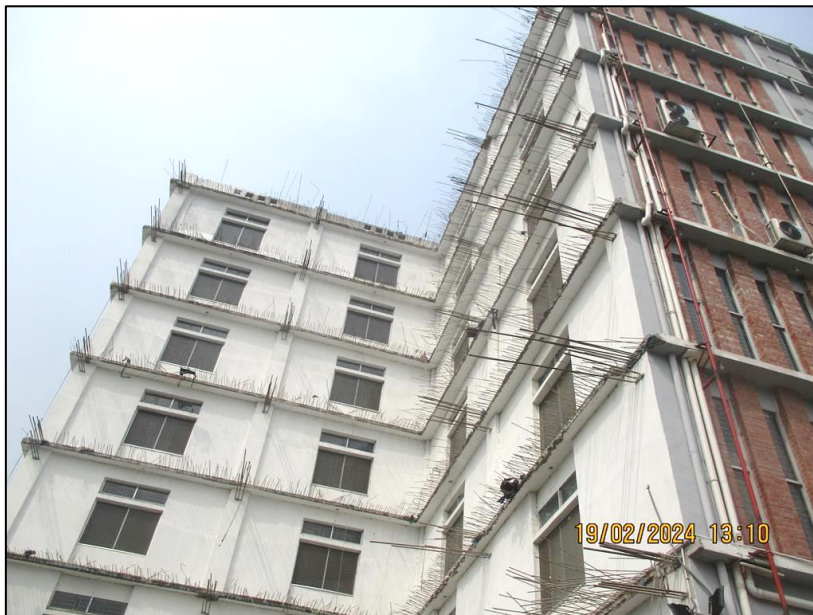
**Observation-3:** Corrosion on exposed rebar.

**Description:** Corrosion was observed on the exposed rebar. The building engineer is required to remove rust and apply anti-corrosive paint on exposed rebars.

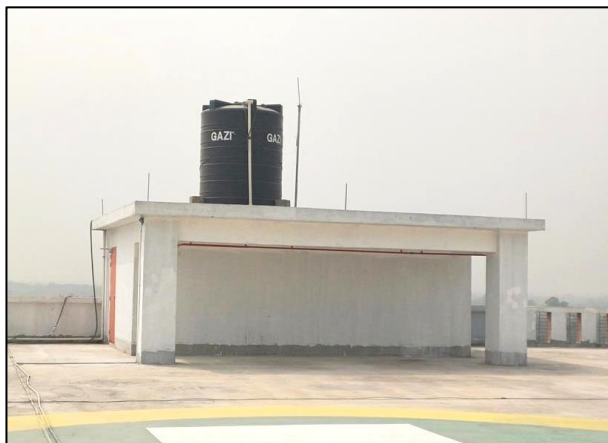
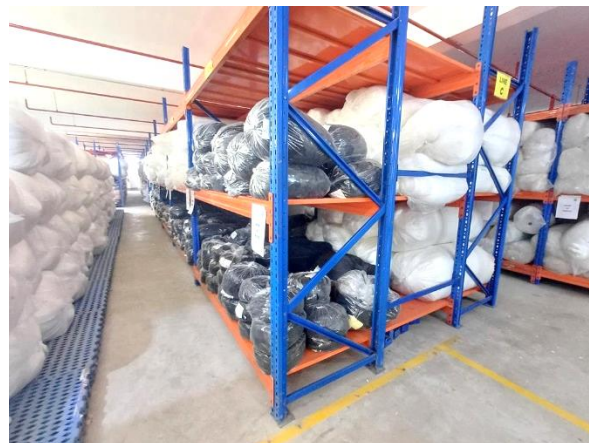
**Observation-4:** Non-structural elements found unbraced/not anchored.

**Description:** Non-structural elements suspended from, attached to, or resting atop the structure shall be adequately anchored and braced to resist earthquake forces. Factory is required to brace/anchor all non-structural elements.
