# KiDO BD Co., Limited.

Plot-117, 125 & 126, Adamjee EPZ, Siddhirganj, Narayanganj

2 January 2024

Issue 01

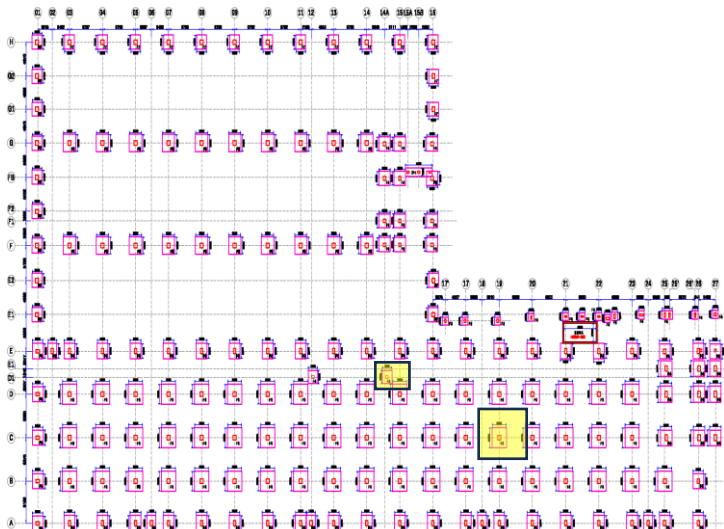
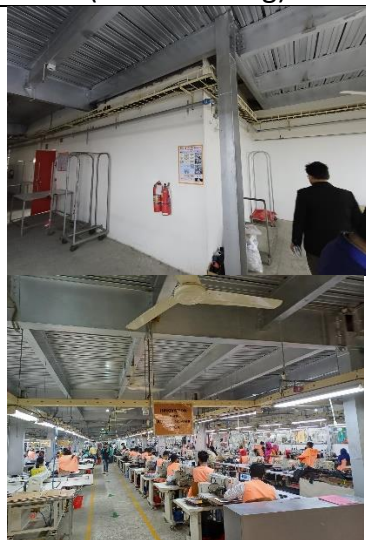
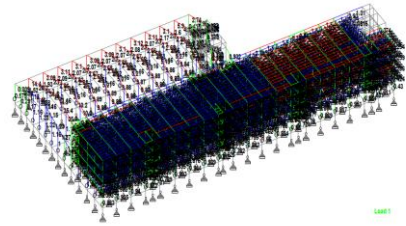
| Main Building | |
|---|---|
| <p><b>Description:</b> Columns are stressed above normal design limits considering both gravity and lateral loading. Also, the cursory calculation indicates that footings are stressed above the normal design limit at the marked locations considering floor live load of 3 kPa for the typical floors, and 1.5 kPa for the roof. The building engineer is required to review design loads and column &amp; foundation stresses. Also, produce and actively manage load management plans.</p> | |

| Observation | Action Plan | Timeline |
|---|---|---|
| Stress in the column & foundation above normal design limit (Main Building). | The building engineer is required to review the design and columns & foundation stresses. | within 6 weeks |
| | Produce and actively manage load management plans. | within 6 weeks |
| | Implement remediation work if required. | within 6 months |
| | Implement a load management plan. | within 6 months |

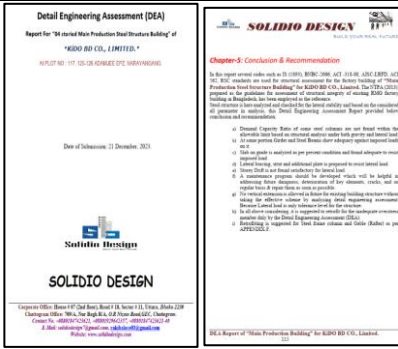
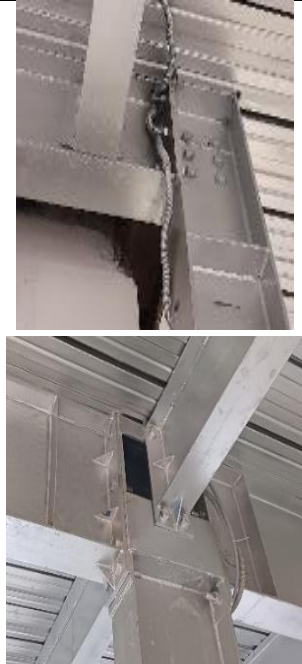
## Observation 2: Lack of information in the design report (Main Building).

| <p><b>Description:</b> In the provided design report, the RC frame analysis and demand capacity ratio, foundation adequacy checks were not incorporated. Also, steel member connection adequacy further analysis and overstressed member recommendations were not provided in the design report. Loading from water tanks and screeding are not considered in the design report. The building engineer is required to update the design report in compliance with BNBC.</p> | | |

| Observation | Action Plan | Timeline |
|---|---|---|
| Lack of information in the design report (Main Building) | Building engineer is required to update the design documents in compliance with BNBC. | within 6 weeks |
| | Complete implementation of remedial works if required. | within 6 months |

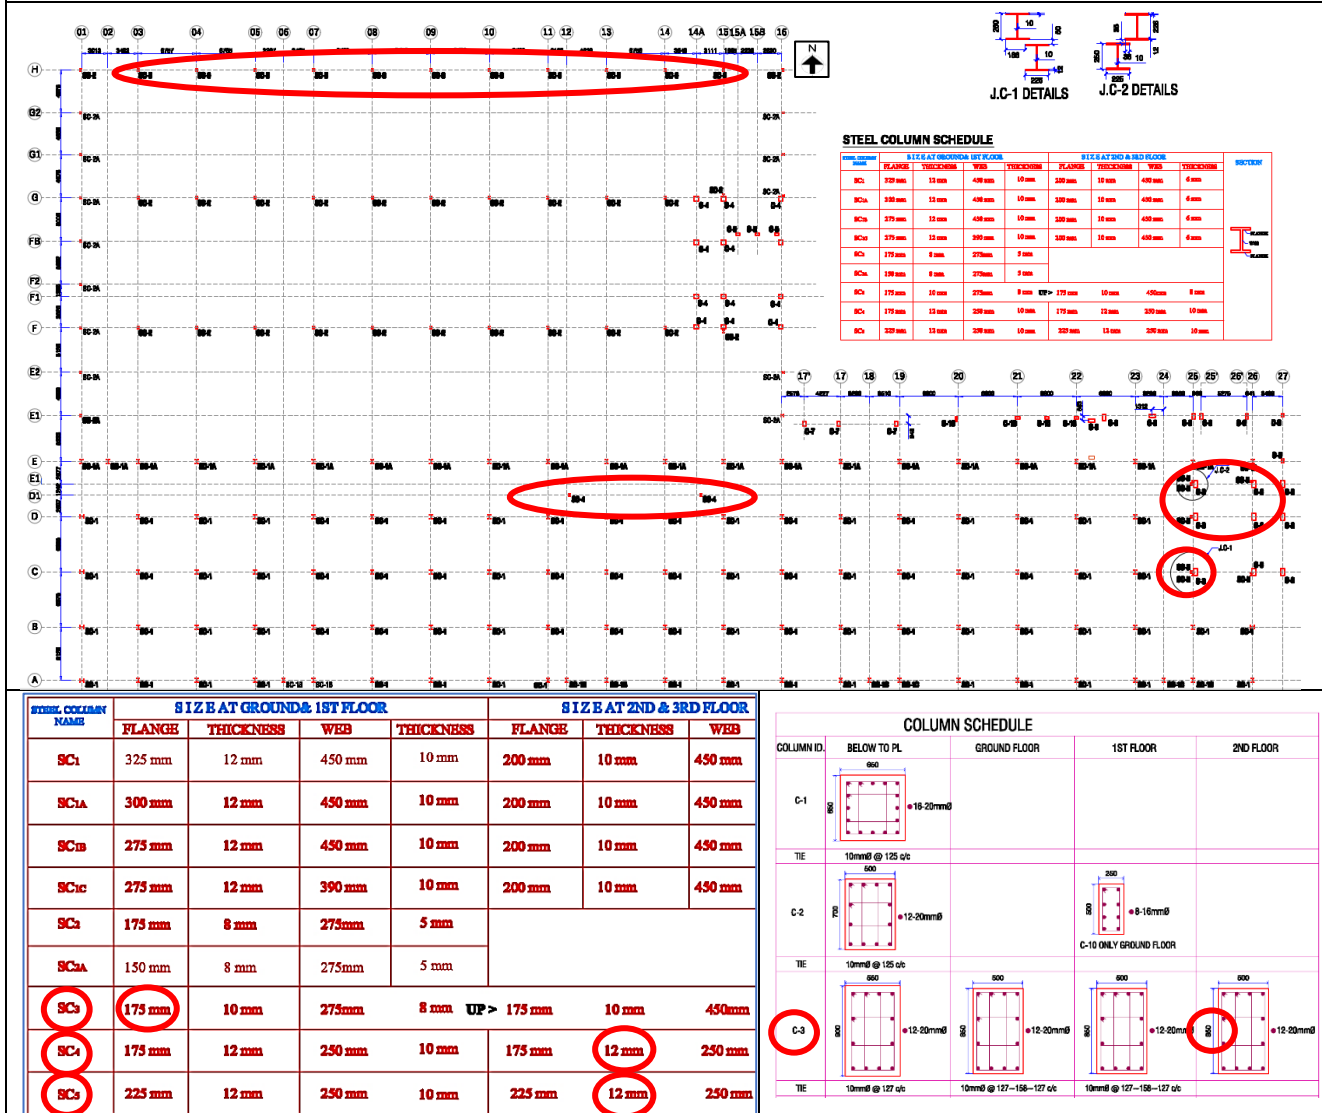
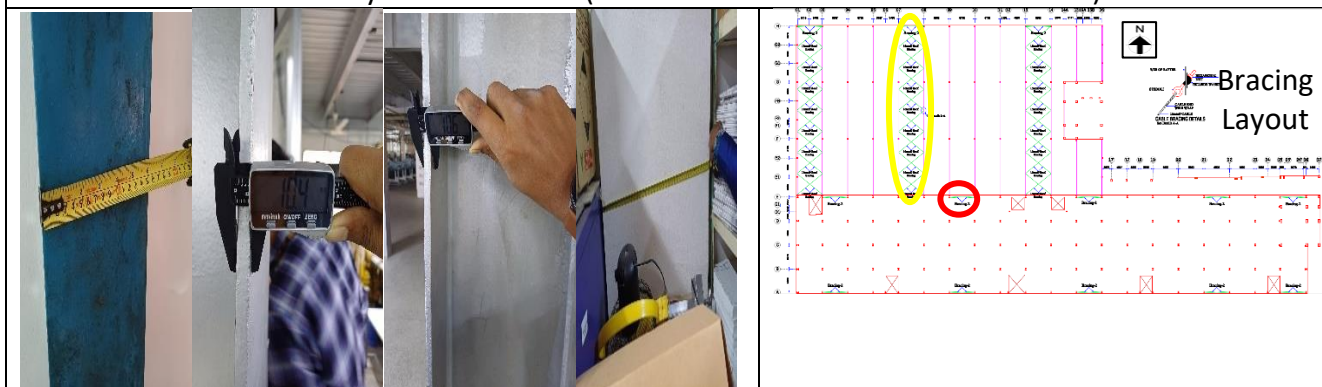
Column Layout & Schedule (mismatch in red marked area columns)

**Description:** As per the provided drawing, steel column SC3, SC4, SC5 sizes are W275~450 X F175(10), W250 X F175(12), W250 X F225(12) respectively and RC column C3 size is 500X850. During the inspection, RC column C3 size was observed as 500X700. As well as steel column SC3 flange width (150mm), SC4 & SC5 flange thickness (10mm) mismatches were observed apart from the provided drawing. Also bracing layout mismatch and missing were observed (yellow marked bracing location mismatch and red marked bracing missing).

A building engineer is required to survey the whole structure and prepare the as-built drawing reflecting the on-site condition as well as update the design report.

| Observation | Action Plan | Timeline |
|---|---|---|
| Mismatch between the provided drawing & on-site condition (Main Building). | The building engineer is required to survey the whole structure and prepare the as-built drawing reflecting the on-site condition. | within 6 weeks |

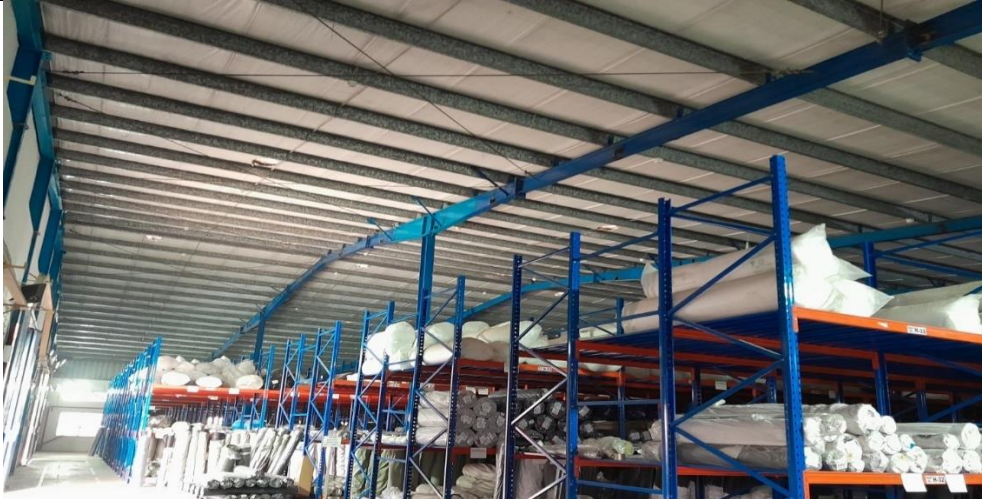
**Observation-4:** Lack of lateral load transfer media for the shed roof (Main Building).

**Description:** The shed has portal framing action in the North-South direction. However, the roof shed does not have a lateral load transfer and load-resisting system along the East-West direction. Building engineer is required to check the lateral stability of the structure and suggest proper remedial actions.

| Observation | Action Plan | Timeline |
|---|---|---|
| Lack of lateral load transfer media for the shed roof (Main Building) | Building engineer is required to check the lateral stability of the structure and suggest proper remedial actions. | within 6 weeks |
| | Complete implementation of remedial works if required. | within 6 months |

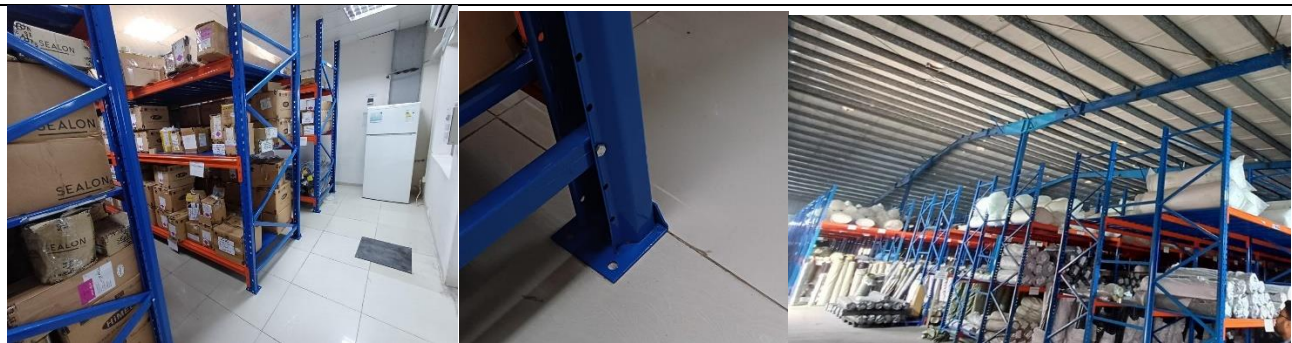
**Observation-5:** Nonstructural elements found not anchored/braced (Main Building).

**Description:** Nonstructural elements found not anchored/braced. The building engineer is required to brace/anchor all nonstructural elements including storage racks within the factory.

| Observation | Action Plan | Timeline |
|---|---|---|
| Nonstructural elements found not anchored/braced (Main Building) | The building engineer is required to brace/anchor all nonstructural elements including storage racks within the factory. | within 6 weeks |

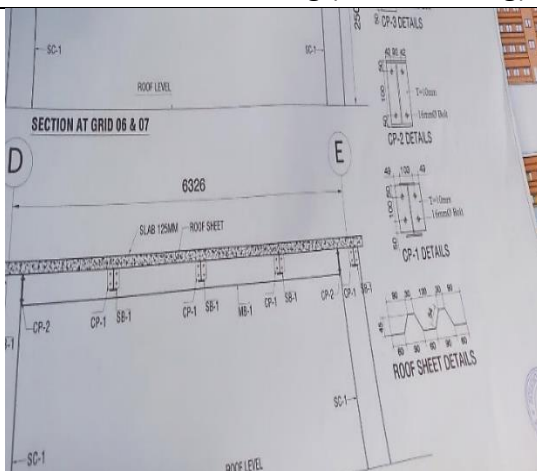
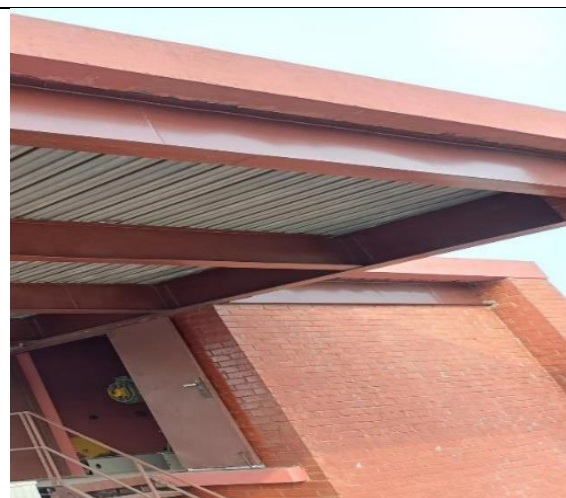
**Observation-6:** Bolt Missing (Main Building).

**Description:** During the inspection, a bolt missing was observed in the rooftop lift machine room deck beam and sub-beam. The building engineer is required to Identify all the required locations and install missing bolts.

| Observation | Action Plan | Timeline |
|---|---|---|
| Bolt Missing (Main Building) | The building engineer is required to Identify all the required locations and install missing bolts. | within 6 weeks |

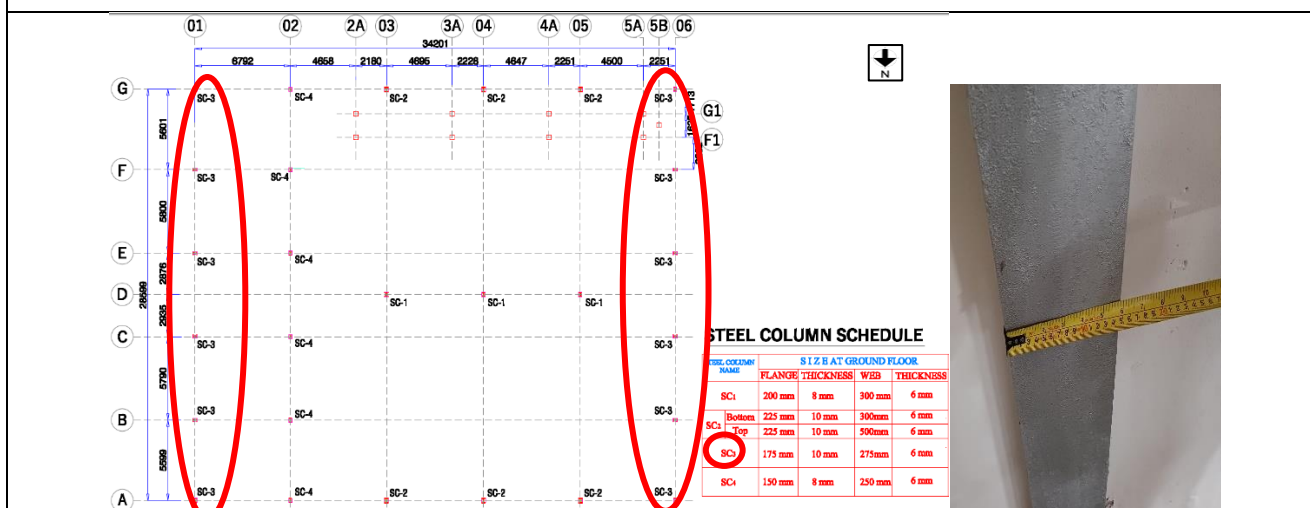
Column Layout & Schedule (mismatch in red marked area columns)

**Description:** As per the provided drawing, the steel column SC3 size is W275 X F175(10). During the inspection, SC3 size was observed as W275 X F150(10), flange width mismatch was observed apart from the provided drawing. A building engineer is required to survey the whole structure and prepare the as-built drawing reflecting the on-site condition as well as update the design report.

| Observation | Action Plan | Timeline |
|---|---|---|
| Mismatch between the provided drawing & on-site condition (Dining & Canteen Shed). | The building engineer is required to survey the whole structure and prepare the as-built drawing reflecting the on-site condition. | within 6 weeks |

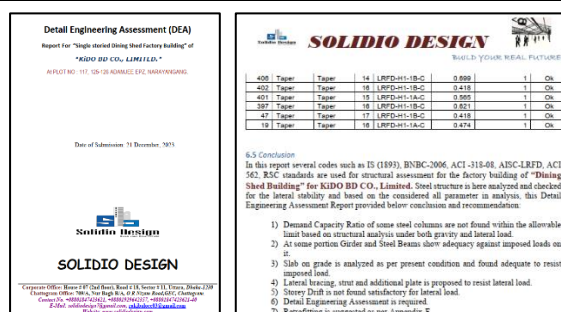
**Observation-8:** Lack of information in the design report (Dining & Canteen Shed).

**Description:** In the provided design report RC frame analysis and demand capacity ratio, foundation adequacy checks were not incorporated. Also, steel member connection adequacy further analysis and overstressed member recommendations were not provided in the design report. The building engineer is required to update the design report in compliance with BNBC.

| Observation | Action Plan | Timeline |
|---|---|---|
| Lack of information in the design report (Dining & Canteen Shed) | Building engineer is required to update the design documents in compliance with BNBC. | within 6 weeks |
| | Complete implementation of remedial works if required. | within 6 months |

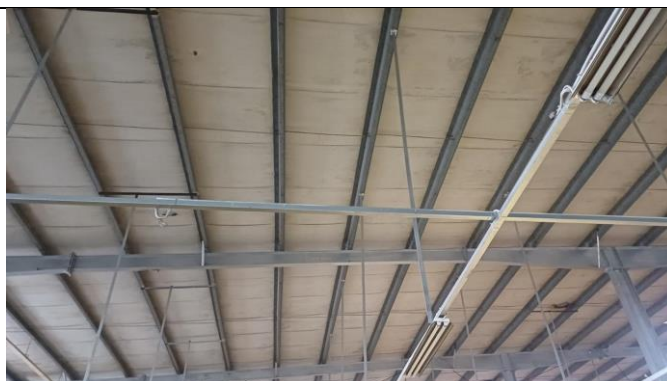
**Observation-9:** Lack of lateral load transfer media for the roof shed. (Dining & Canteen Shed).

**Description:** The shed has portal framing action in the North-South direction. However, the roof shed does not have lateral load transfer and load-resisting system along the East-West direction. Building engineer is required to check the lateral stability of the structure and suggest proper remedial actions.

| Observation | Action Plan | Timeline |
|---|---|---|
| Lack of lateral load transfer media for the shed roof (Dining & Canteen Shed) | Building engineer is required to check the lateral stability of the structure and suggest proper remedial actions. | within 6 weeks |
| | Complete implementation of remedial works if required. | within 6 months |

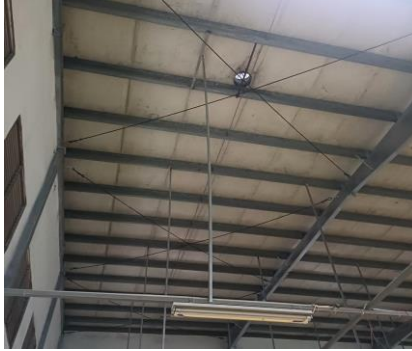
**Observation-10:** Loose cable bracing (Dining & Canteen Shed).

**Description:** During the inspection, loose cable bracing was observed at several locations as sagged. The building engineer is required to Identify all the required locations and tighten the loose cable bracings.

| Observation | Action Plan | Timeline |
|---|---|---|
| Loose cable bracing (Dining & Canteen Shed) | The building engineer is required to Identify all the required locations and tighten the loose cable bracings. | within 6 weeks |

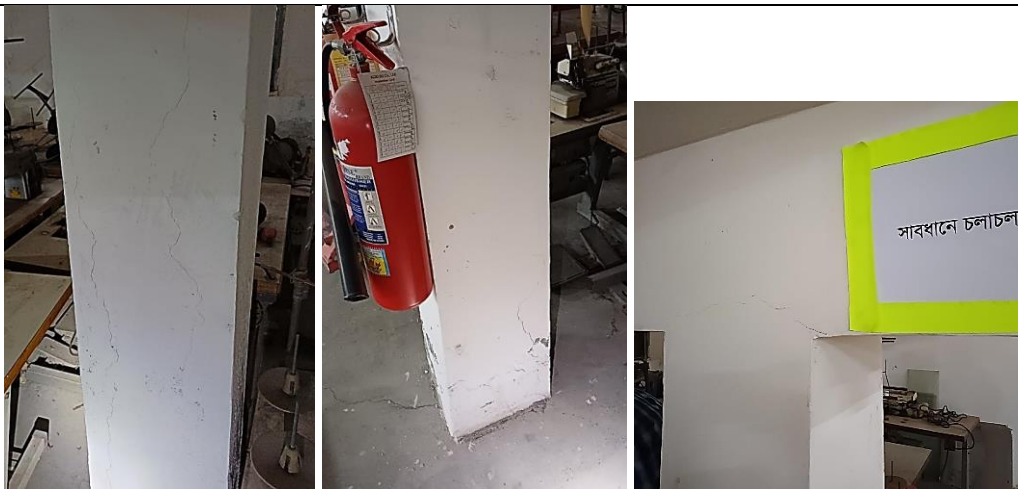
**Observation-11:** Cracks found on the RC column of the ramp (Dining & Canteen Shed).

**Description:** During the inspection, cracks were found on the RC column of the ramp at multiple locations. The building engineer is required to investigate the cracks including the reason of cracks, extend of cracks and suggest proper crack repair methodology. Factory is required to follow the recommendation of the investigation report for remedial works of cracks.

| Observation | Action Plan | Timeline |
|---|---|---|
| Cracks found on RC column of the ramp (Dining & Canteen Shed) | The building engineer is required to investigate the cracks including the reason of cracks, extend of cracks and suggest proper crack repair methodology. Factory is required to follow the recommendation of the investigation report for remedial works of cracks. | within 6 weeks |

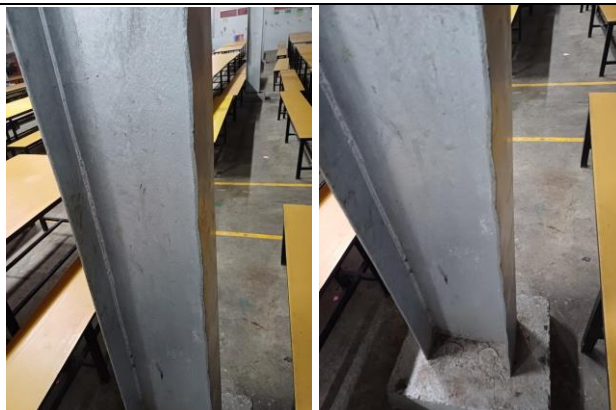
**Observation-12:** Sign of warping and tilting of steel column (Dining & Canteen Shed).

**Description:** During the inspection, a steel column was observed with the sign rapping and tilting. The building engineer is required to recommend a suitable repair methodology. And the factory is required to follow the recommendation.

| Observation | Action Plan | Timeline |
|---|---|---|
| Sign of warping and tilting of steel column (Dining & Canteen Shed) | The building engineer is required to recommend a suitable repair methodology. And the factory is required to follow the recommendation. | within 6 weeks |

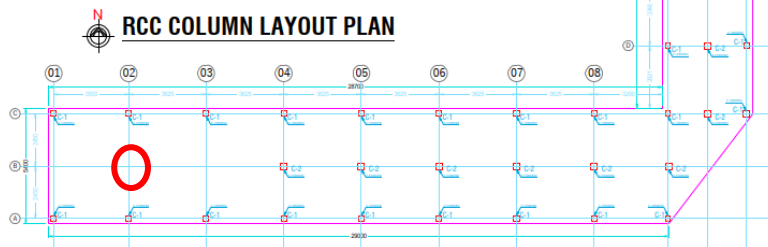
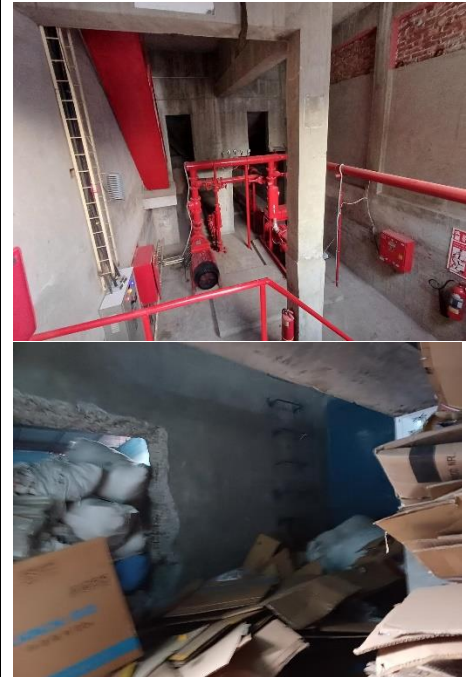
**Observation-13:** Mismatch & lack of information between the provided drawing and on-site condition.

**Description:** During the inspection, additional columns and beams were observed apart from the drawing. Also, the foundation and retaining wall details were not incorporated in the provided drawing. A building engineer is required to survey the whole structure and prepare the as-built drawing reflecting the on-site condition.

| Observation | Action Plan | Timeline |
|---|---|---|
| Mismatch & lack of information between the provided drawing and the on-site condition.<br>(Utility & Wastage Shed) | The building engineer is required to survey the whole structure and prepare the as-built drawing reflecting the on-site condition. | within 6 weeks |

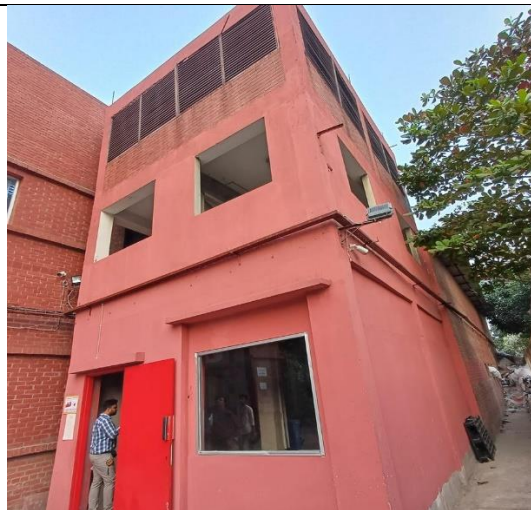
**Observation-14:** Lack of design documents (Utility & Wastage Shed).

**Description:** As per BNBC (part 6), every building or structure designed shall have its design documents prepared following the provision of Section 1.9.1. The design document shall include a design report, and a set of structural drawings, which shall be prepared in compliance with section 1.9.1.1 & section 1.9.1.2 of BNBC (part 6).

At the time of inspection, no design report was available for the mentioned structure. The building engineer is required to prepare a set of design documents in compliance with BNBC.

| Observation | Action Plan | Timeline |
|---|---|---|
| Lack of design documents<br>(Utility & Wastage Shed). | The building engineer is required to prepare a set of design documents in compliance with BNBC. | within 6 weeks |
| | Complete implementation of remedial works if required. | within 6 months |

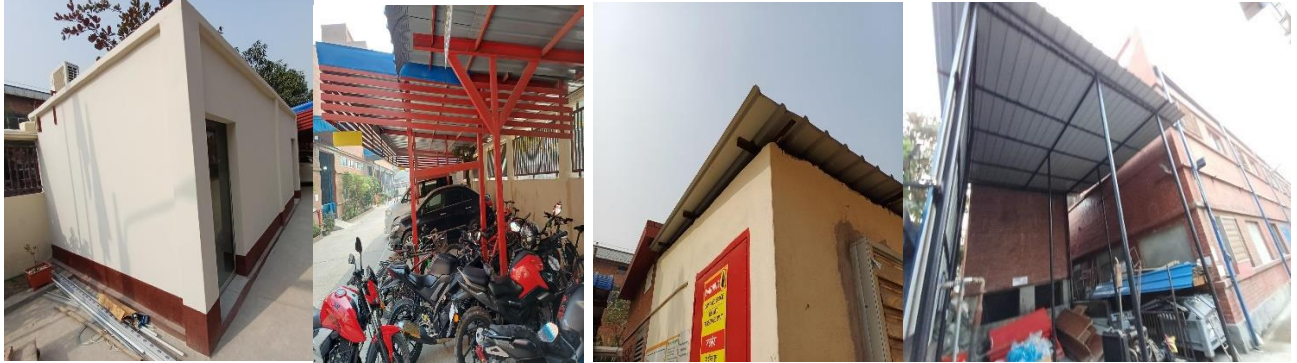
**Observation-15:** Apparently inadequate connections (Driver Shed, Parking Shed, RMS & Chemical Store, & Wastage Shed).

**Description:** Apparently inadequate connections were observed at the lightweight roof of the single-storied Sheds. The building engineer is required to check the connection adequacy of the lightweight roof against the uplift pressure of wind and suggest suitable remedial methods.

| Observation | Action Plan | Timeline |
|---|---|---|
| Apparently inadequate connections<br>(Driver Shed, Parking Shed, RMS & Chemical Store, & Wastage Shed) | Building engineer is required to check the connection of the steel roof for the uplift pressure of the wind. | within 6 weeks |
| | Complete implementation of remedial works if required. | within 6 months |

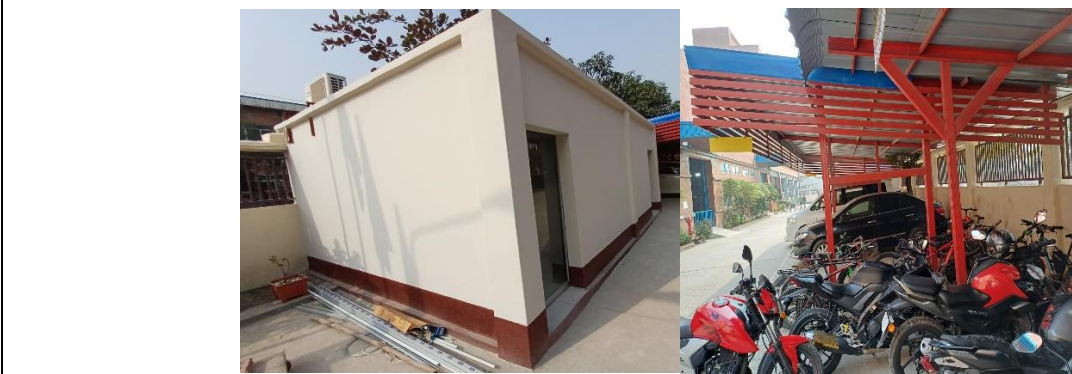
**Observation-16:** Lack of as-built drawings (Driver Shed & Parking Shed)

**Description:** As-built drawings of the ancillary structures were not available on-site at the time of inspection. The building engineer is required to prepare a full set of as-built drawings reflecting the on-site condition and submit it to RSC for review.

| Observation | Action Plan | Timeline |
|---|---|---|
| Lack of as-built drawing. (Driver Shed and Parking Shed) | The building engineer is required to prepare a full set of as-built drawings reflecting the on-site condition in compliance with section 1.9.1.2, part-6 of BNBC, and submit it to RSC for review. | within 6 weeks |
